From : Acting Production Eng. Coordinator
Date : 27/01/2014
Subject : **Floating Roof sinking Failure report of
Condensate Tank 5E-220-TB002A**

With The Reference to the sinking problem of the Floating roof of stabilized condensate tank 5E- 220- TB002A dated on 25th Jan. 2014, the problem has been assessed as described below.

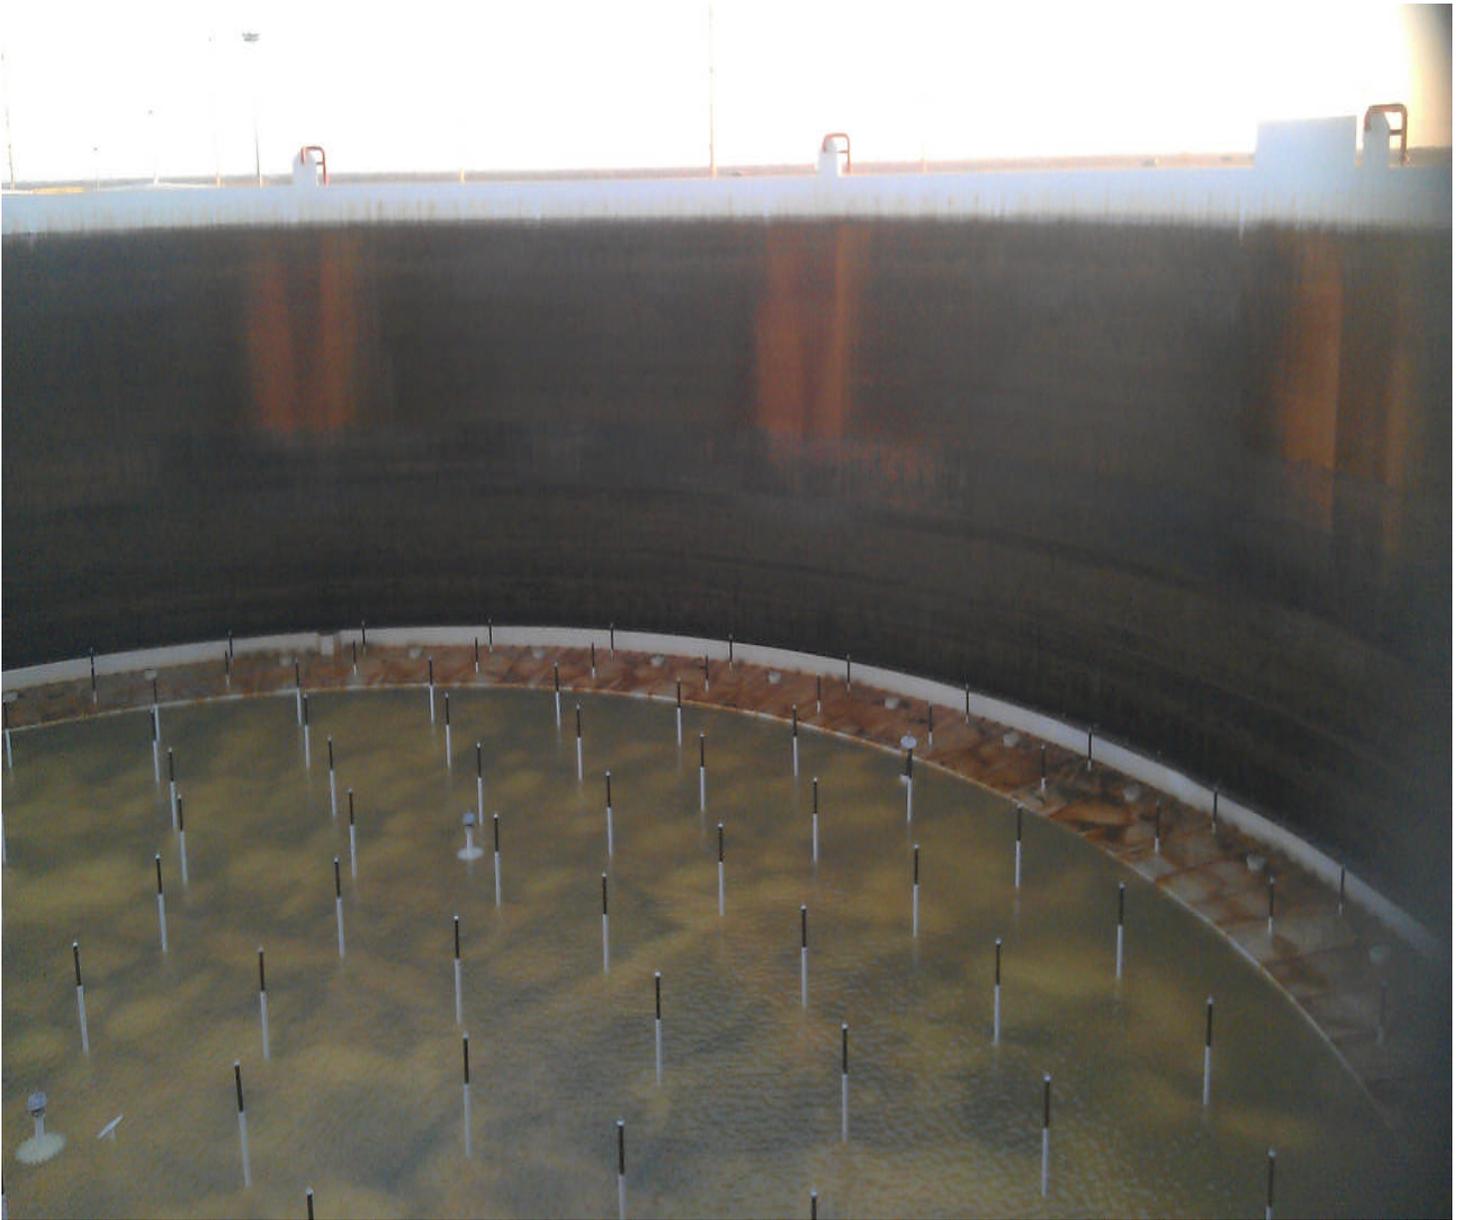
53191 50700TAHH018B 5E220TB002A "Q1" HEAT SENS.CABLE
25 Jan 2014 11:27:26.122 ALARM AL

- ESD activated on 25th Jan. 2014 at 4:56 am.
- At 06:05 the heat sensitive cable 50-700-TAHH018 A/B of stabilized condensate tank has been activated, consequently the deluge valves opened.

- At 06: 12 the diesel oil fire water pump started 40-730-PH002B
- At 11:30 the heat sensitive cable 50-700-TAHH018B activated again
- At 16:00 the complex manager detected the smell of condensate, but no abnormality in the tank could be found. The deluge valves been isolated and immediately the drain valve of the roof isolated too.

- 1- To check and repair the functionality of heat sensitive cable 50-700 TB018A/B which is the main cause of deluge system activation.
- 2- To remove the condensate above the roof ASAP, water wash is required to inspect the floating roof. Because it seems that the roof legs set were not touched the bottom side of the tank and the seal is twisted.
- 3- Improvement in the function of roof drain facilities

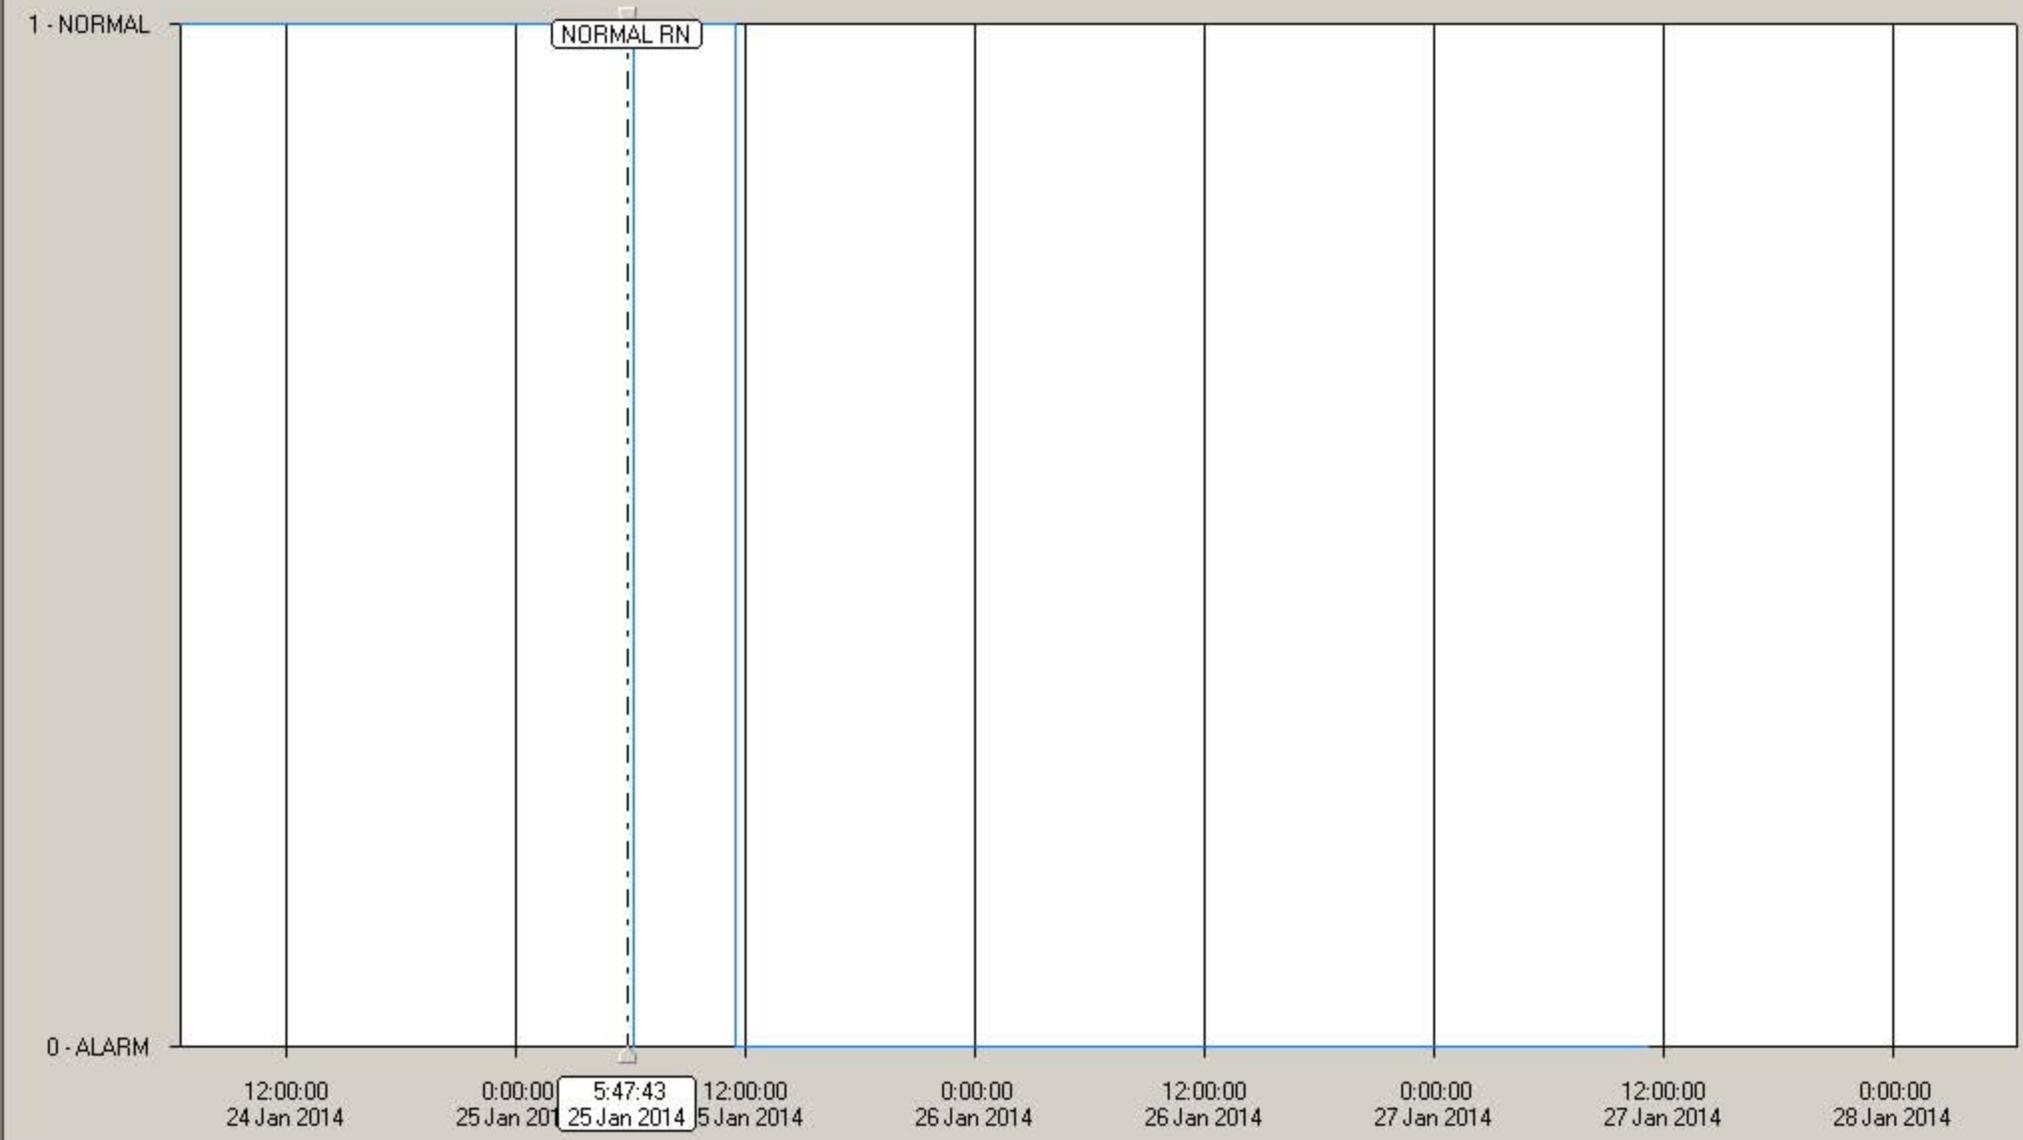
8846 | 40730PA004B | FIRE WATER JOCKEY PUMPS PA001B

- TAHH 018A alarm indicated in the DCS
- 50700Q1 FIRCUM3 alarm indicated in the control room panel
- AT 06:05 the second fire fighting pump (jockey pump) started 40-730-PA001A

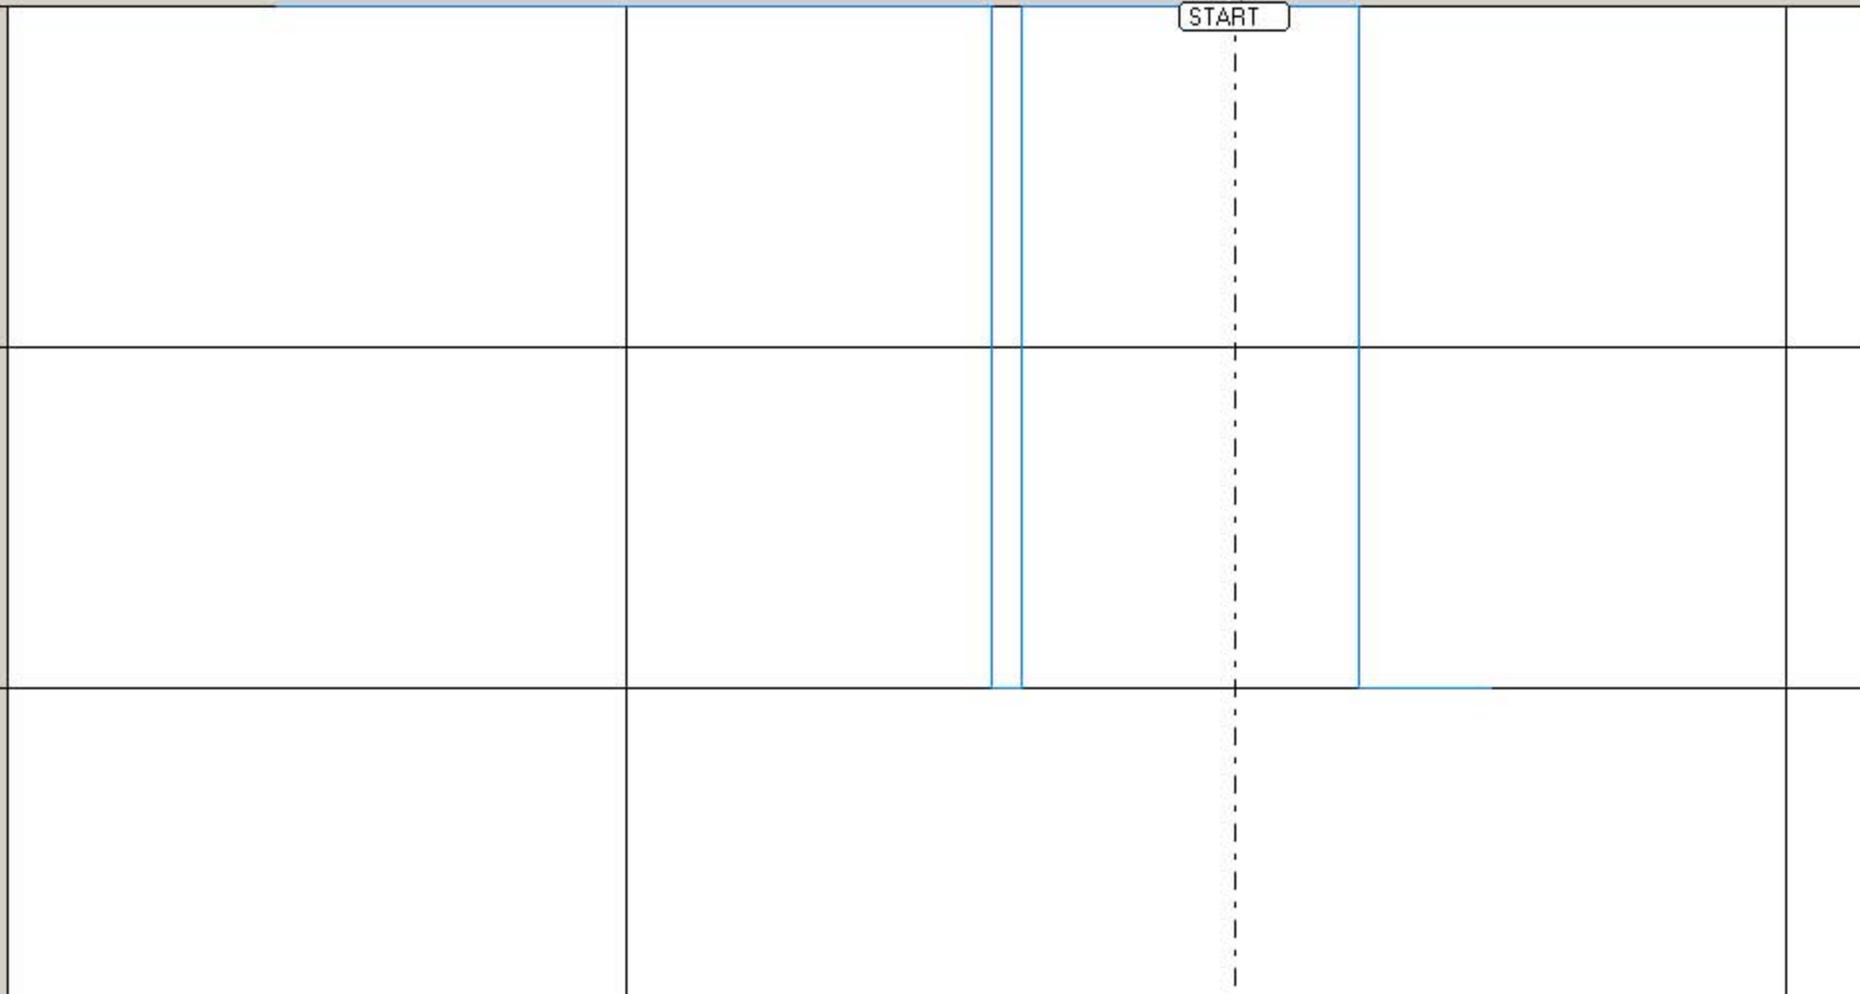
20650 40730ULPH002AW FIRE WATER PUMP PH-002-A.

- At 06:06 the fire water pump 40-730-PH001 (electrical pump) started
- At 06: 07 the diesel oil fire water pump started 40-730-PH002A
- At 06: 07 the diesel oil fire water pump started 40-730-PH002C

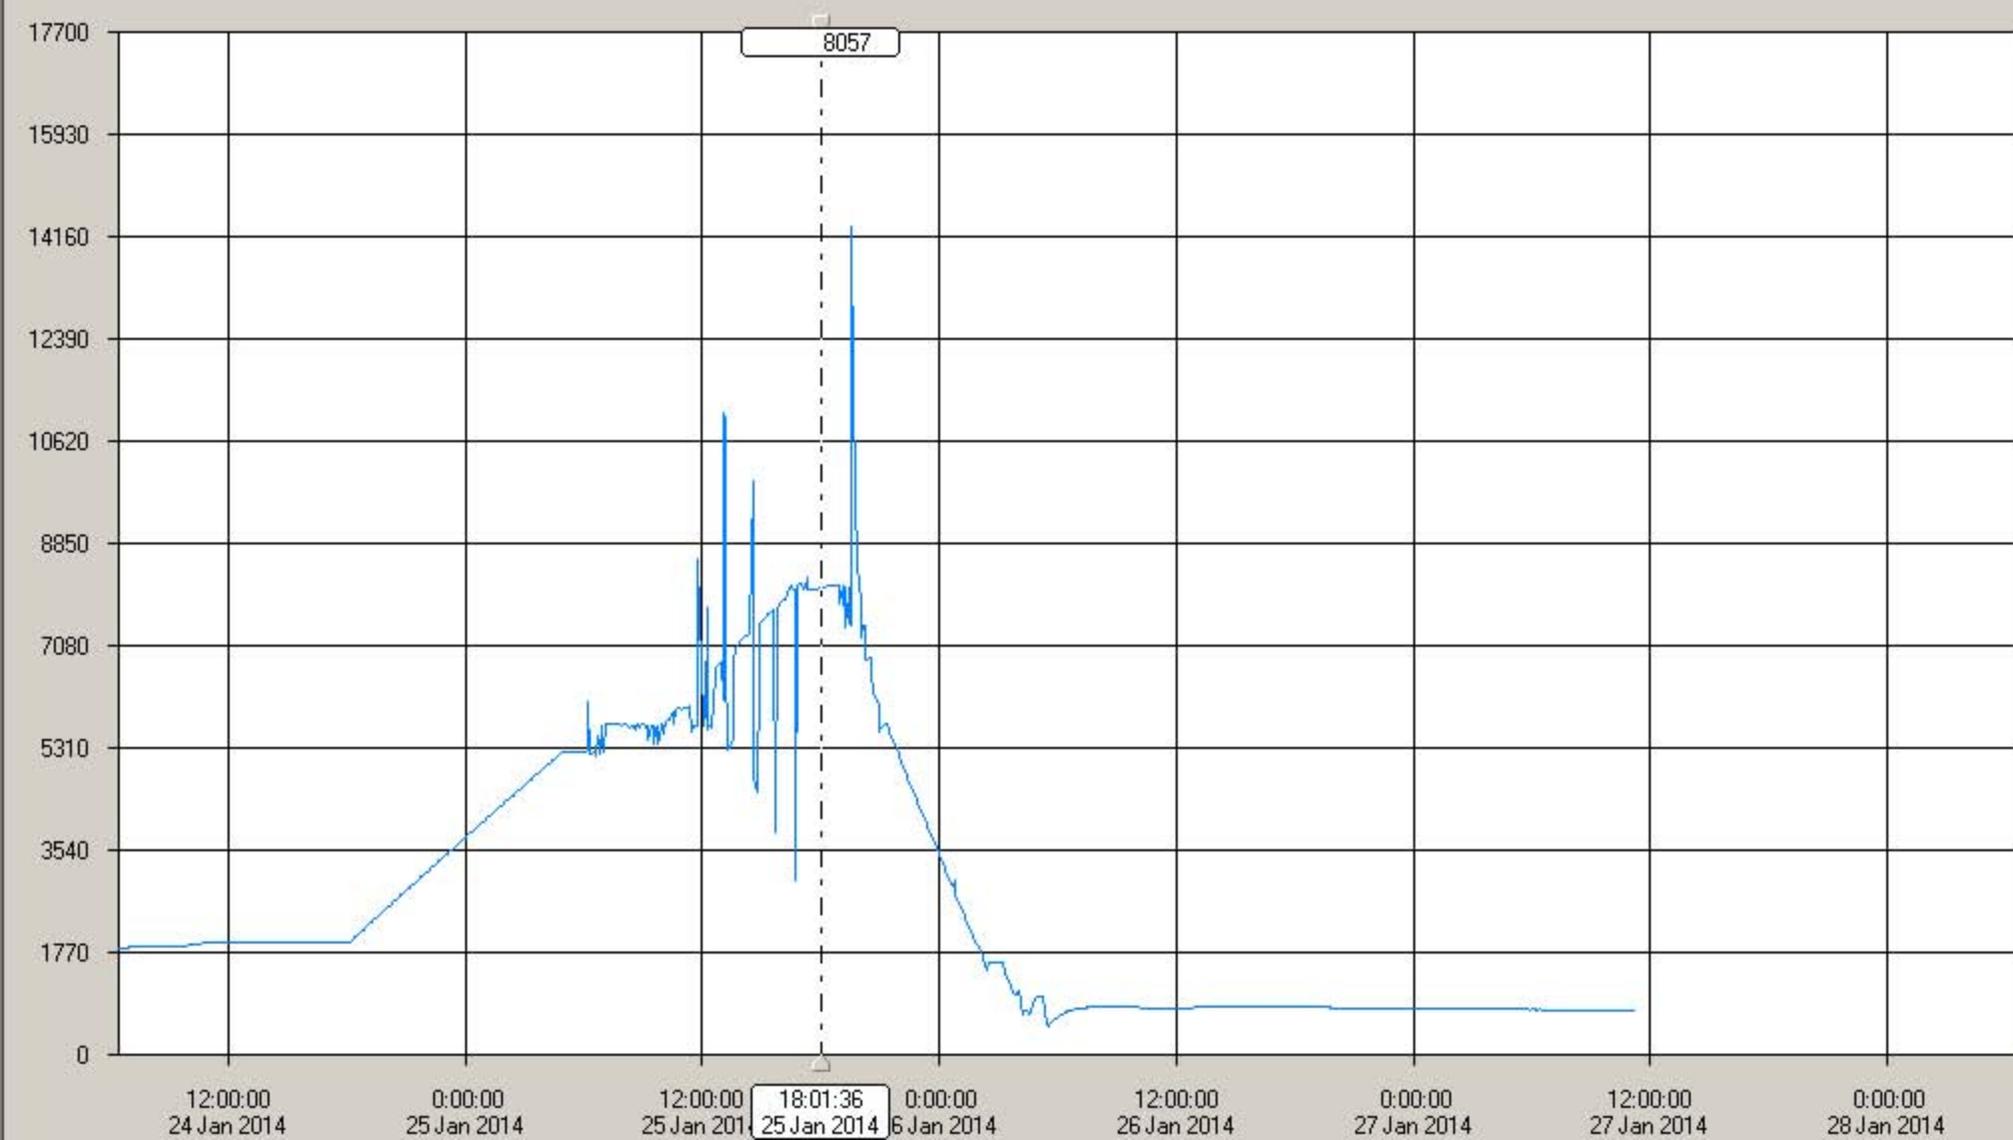
1315 5E220LI002 STABILIZED CONDENSATE STORAGE TANK TB002A
27 Jan 2014 11:15:12.520 755 L (mm)

- Safety section closed the tank area
- the condensate has been transferred to the oil buffer tank 4E-220-TB003
- the condensate level reduced to the lower level is about 80cm
- the roof legs set were not touched the bottom side of the tank
- the roof was covered by condensate and water
- The spillage condensate transferred using the vacuum truck to the waste water treatment.
- Connection was installed to drain the condensate which is covered the roof.
