SINGLE LINE DIAGRAM OF THE FAULTY FEEDER AND TWO ADJACENT FEEDERS. ALL TRIPPED ON EARTH FAULT.

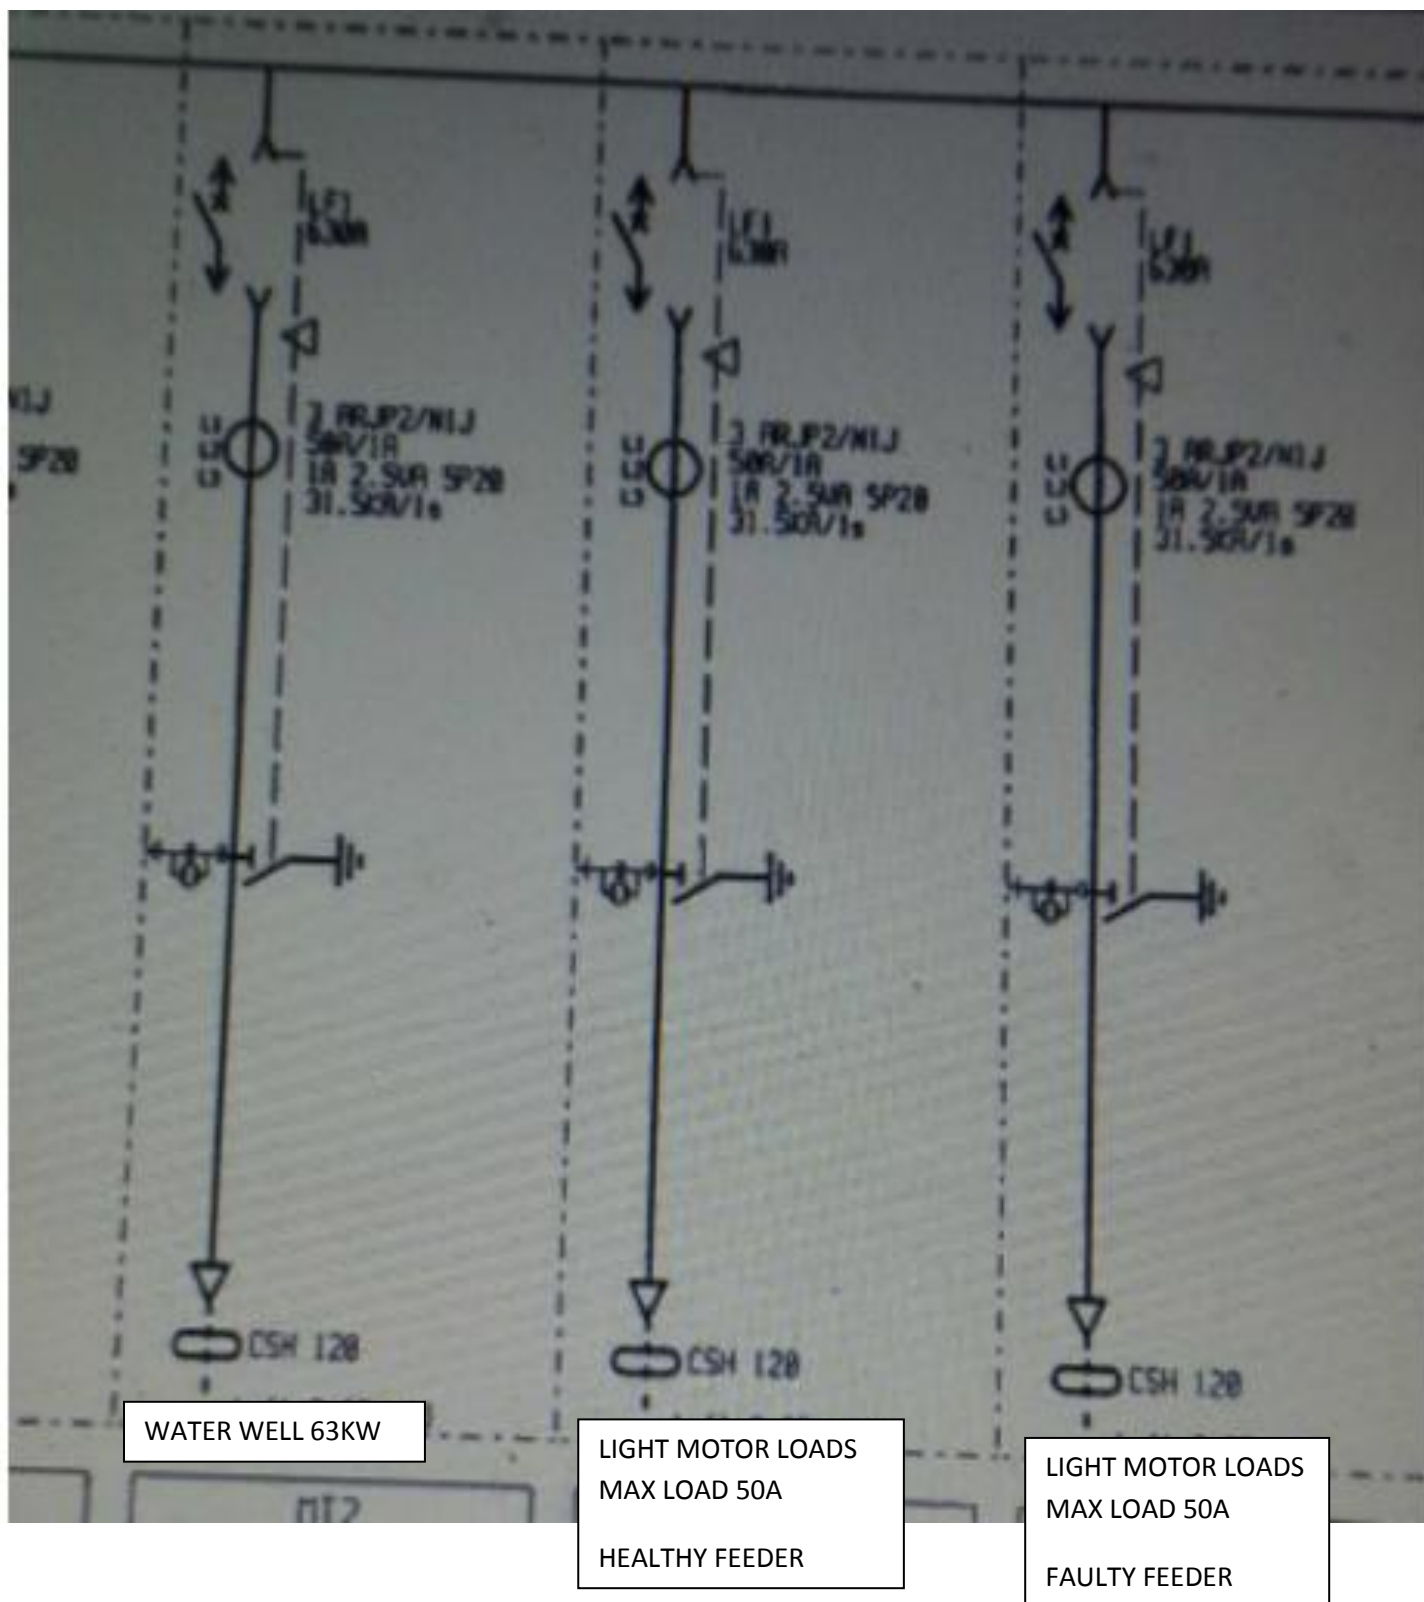
REST FEEDERS ON THE SAME BUS ARE COMPRESSORS 630KW, TRANSFORMER FEEDERS, FEW MORE WATER WELLS 63KW NONE OF THEM TRIPPED.

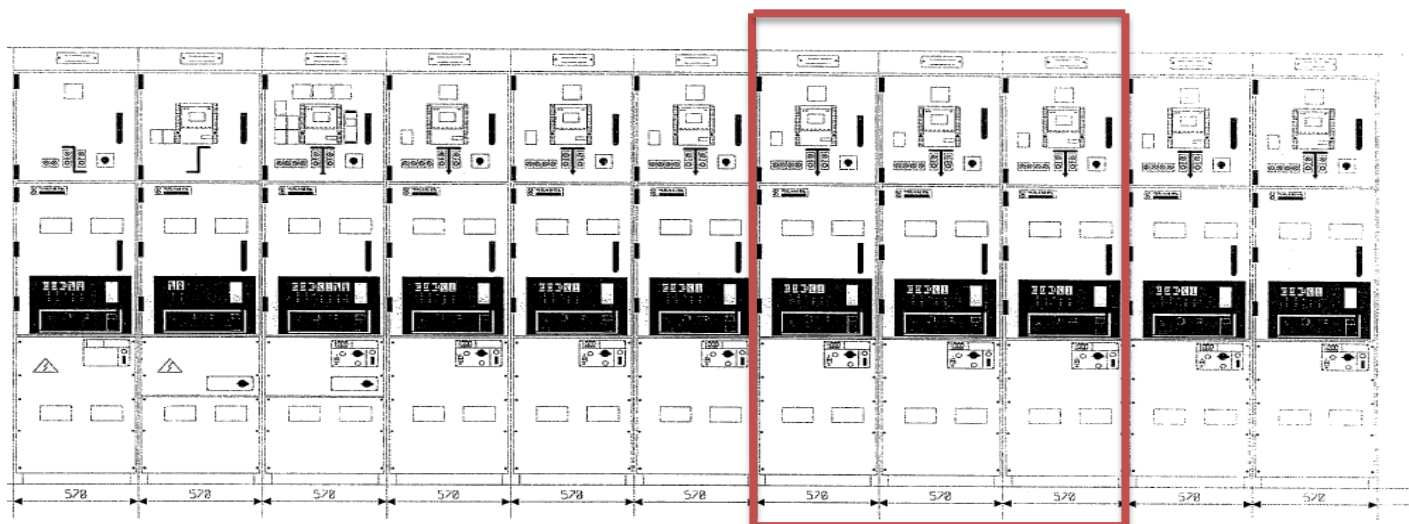
FEEDERS HAVING SAME CT RATIO 50/1 AND SAME EARTH FAULT SETTING WERE TRIPPED.
