STEEL CONNECTIONS

Engineers Slam Failed Joint Detail

Fear that slotted connection behind Pittsburgh collapse may be 'locked up' in other structures

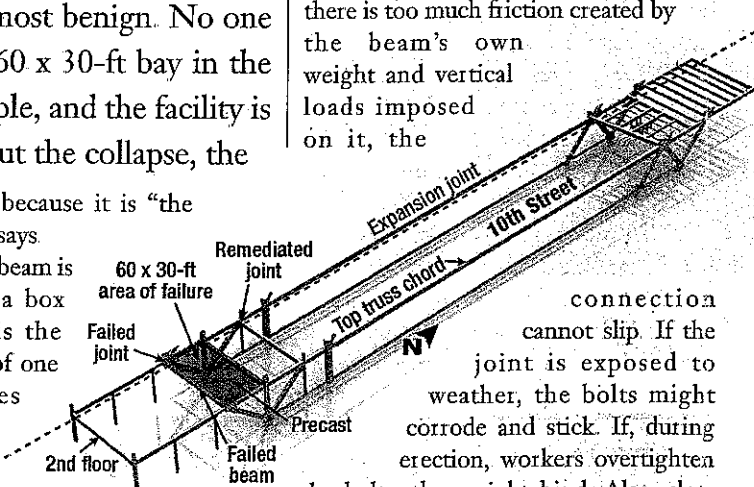
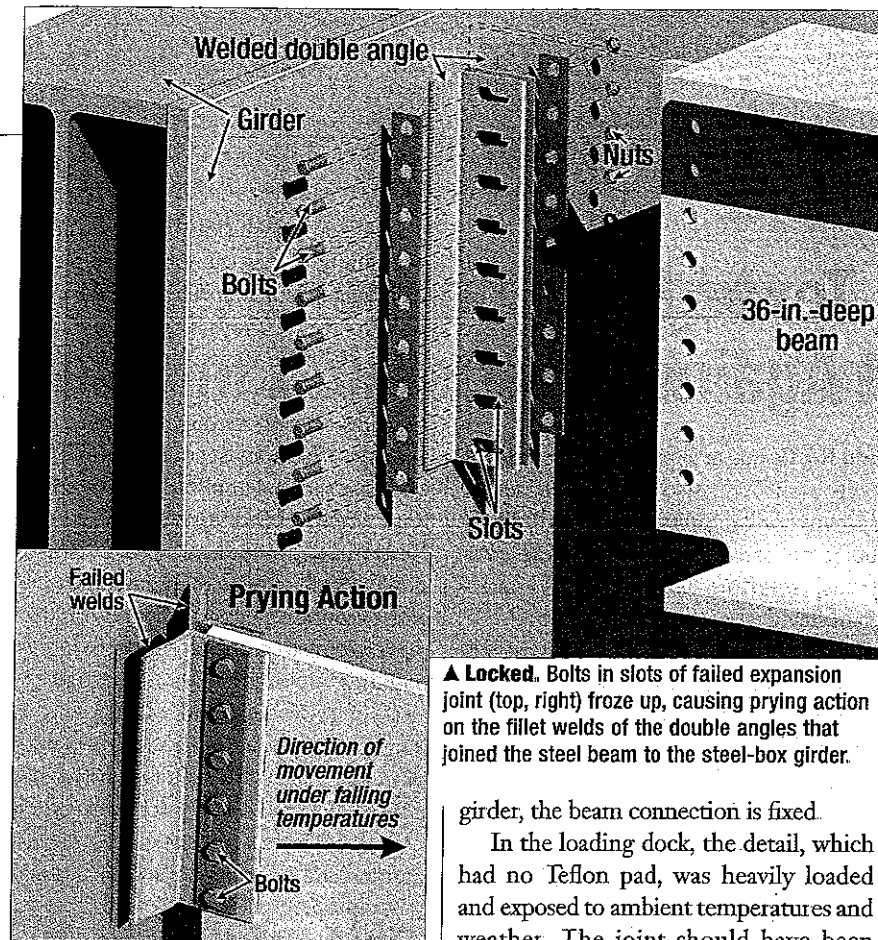
▲ Locked. Bolts in slots of failed expansion joint (top, right) froze up, causing prying action on the fillet welds of the double angles that joined the steel beam to the steel-box girder.

In the loading dock, the detail, which had no Teflon pad, was heavily loaded and exposed to ambient temperatures and weather. The joint should have been welded to the box girder in line with the beam, but geometry prevented access, says a source familiar with the structure. As a result, the 20-in.-long fillet weld was more vulnerable to prying action, which is given as the failure mechanism.

As temperatures dropped to 4° F, each building half wanted to shrink toward its own center, causing the halves to move away from each other. But the joint locked.

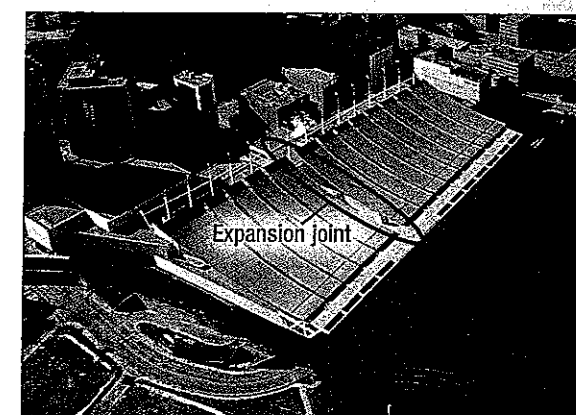
▲ Riverside. A seat (top) is replacing the failed detail and is being added at 25 other locations along the expansion joint.

Thornton Tomasetti found four other joints that needed immediate attention. The fix, including for the failed joint, is similar to a suggestion on the structural drawings: It calls for the addition of a 1-ft-square steel seat, about 1.5 ft tall, fillet-welded under the double angle. The beam slides on a 10 x 5-in. Teflon pad on the seat. The bolts are out, says Panariello.
