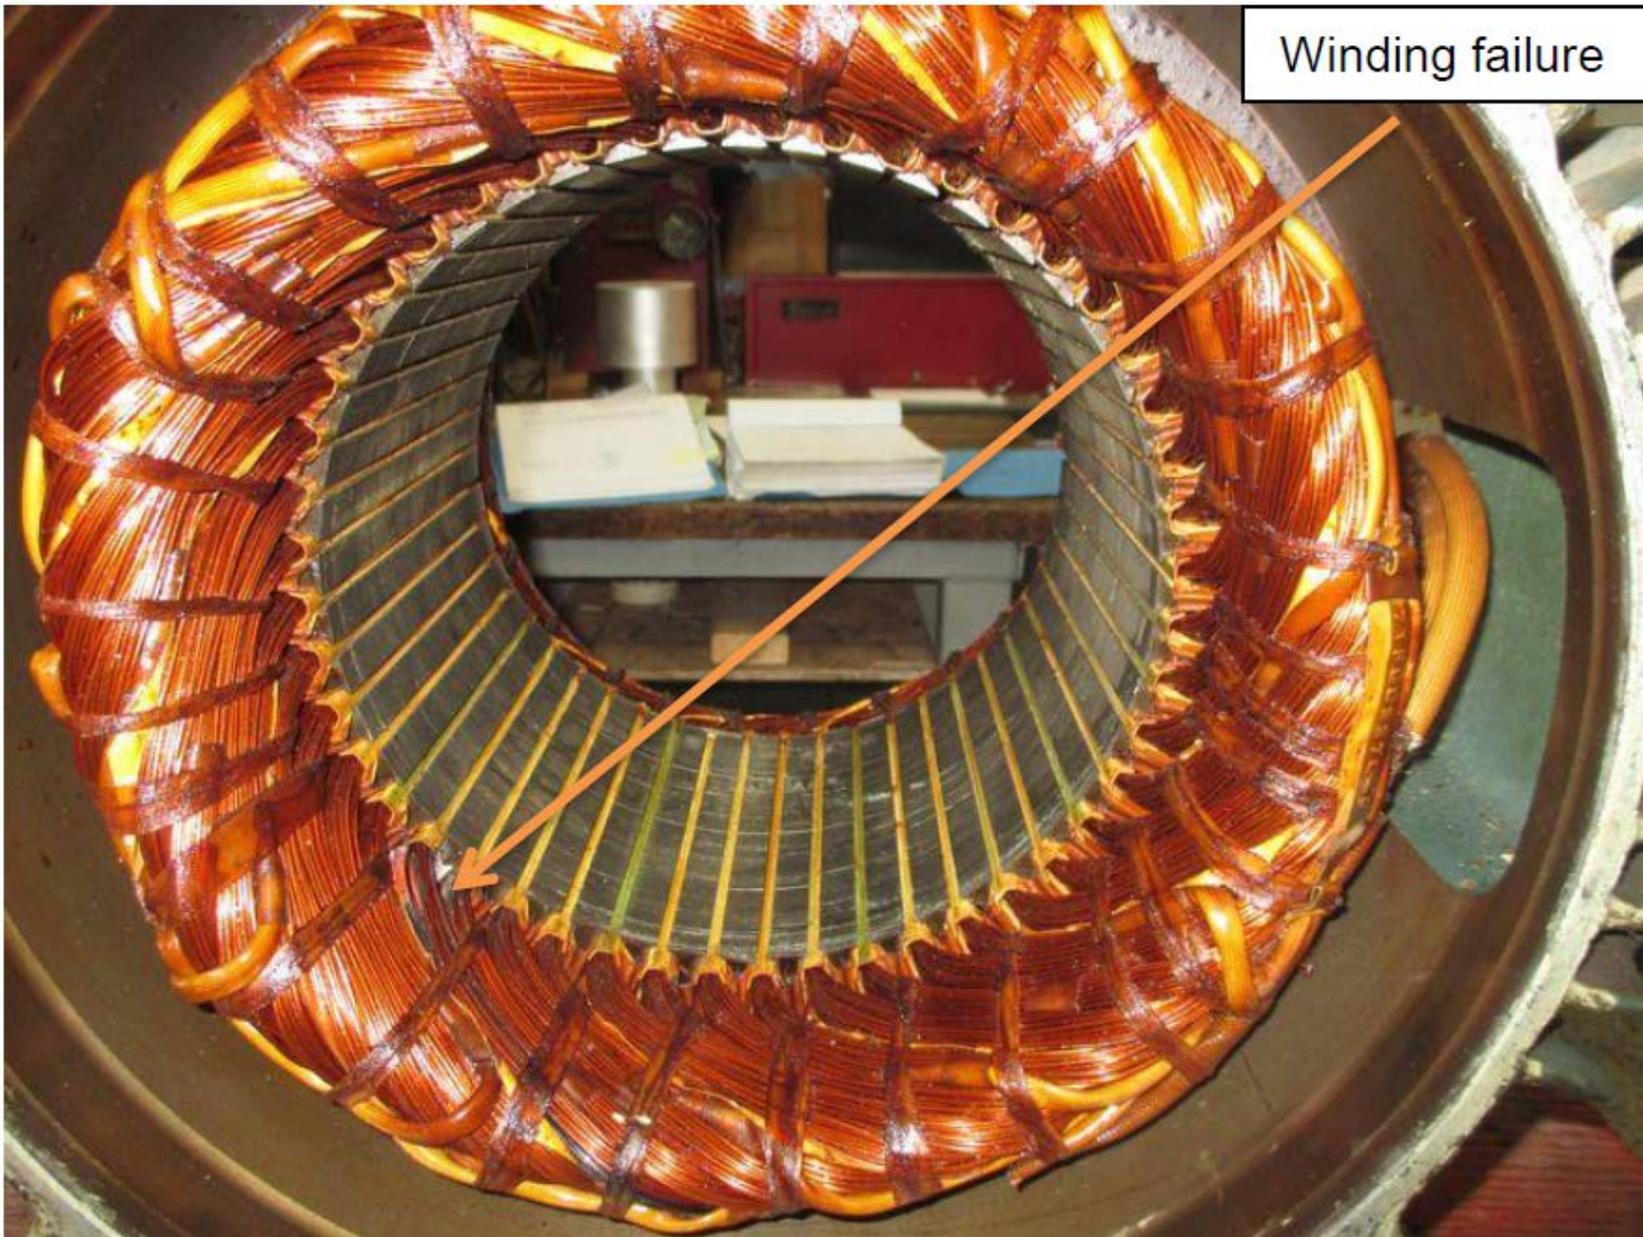
# Overview

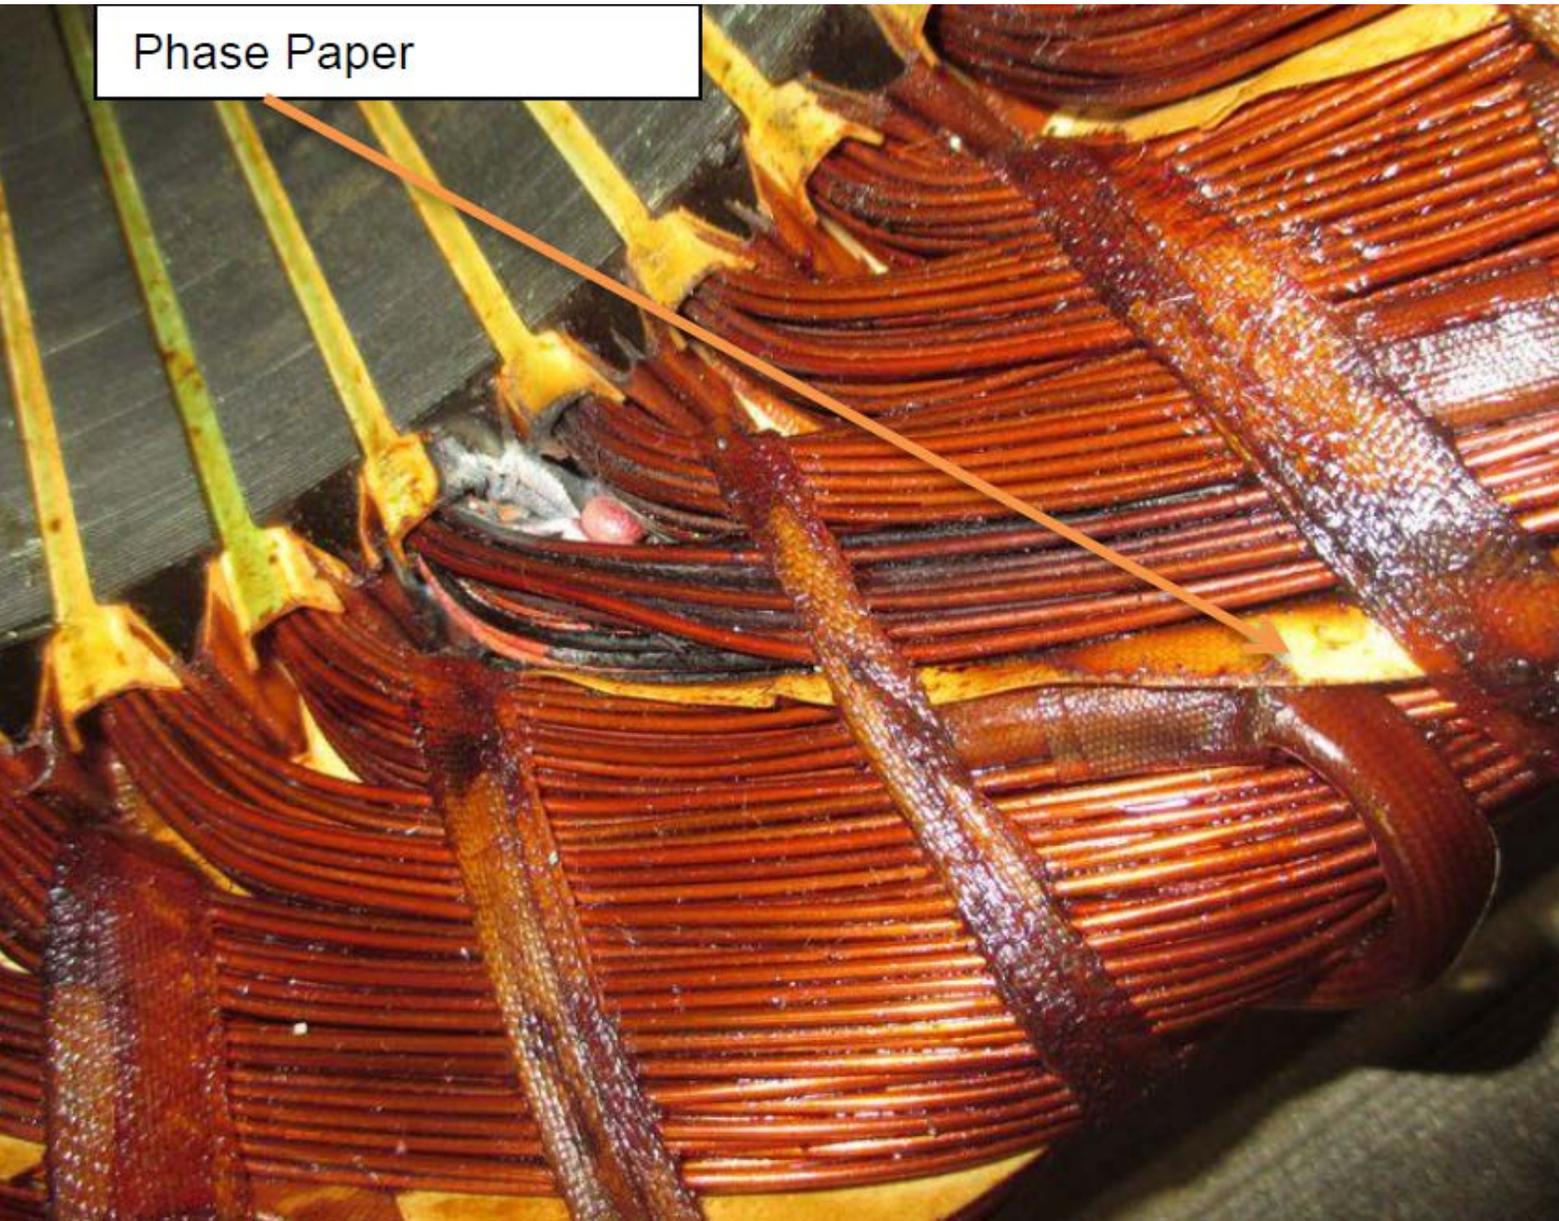
# Failure location

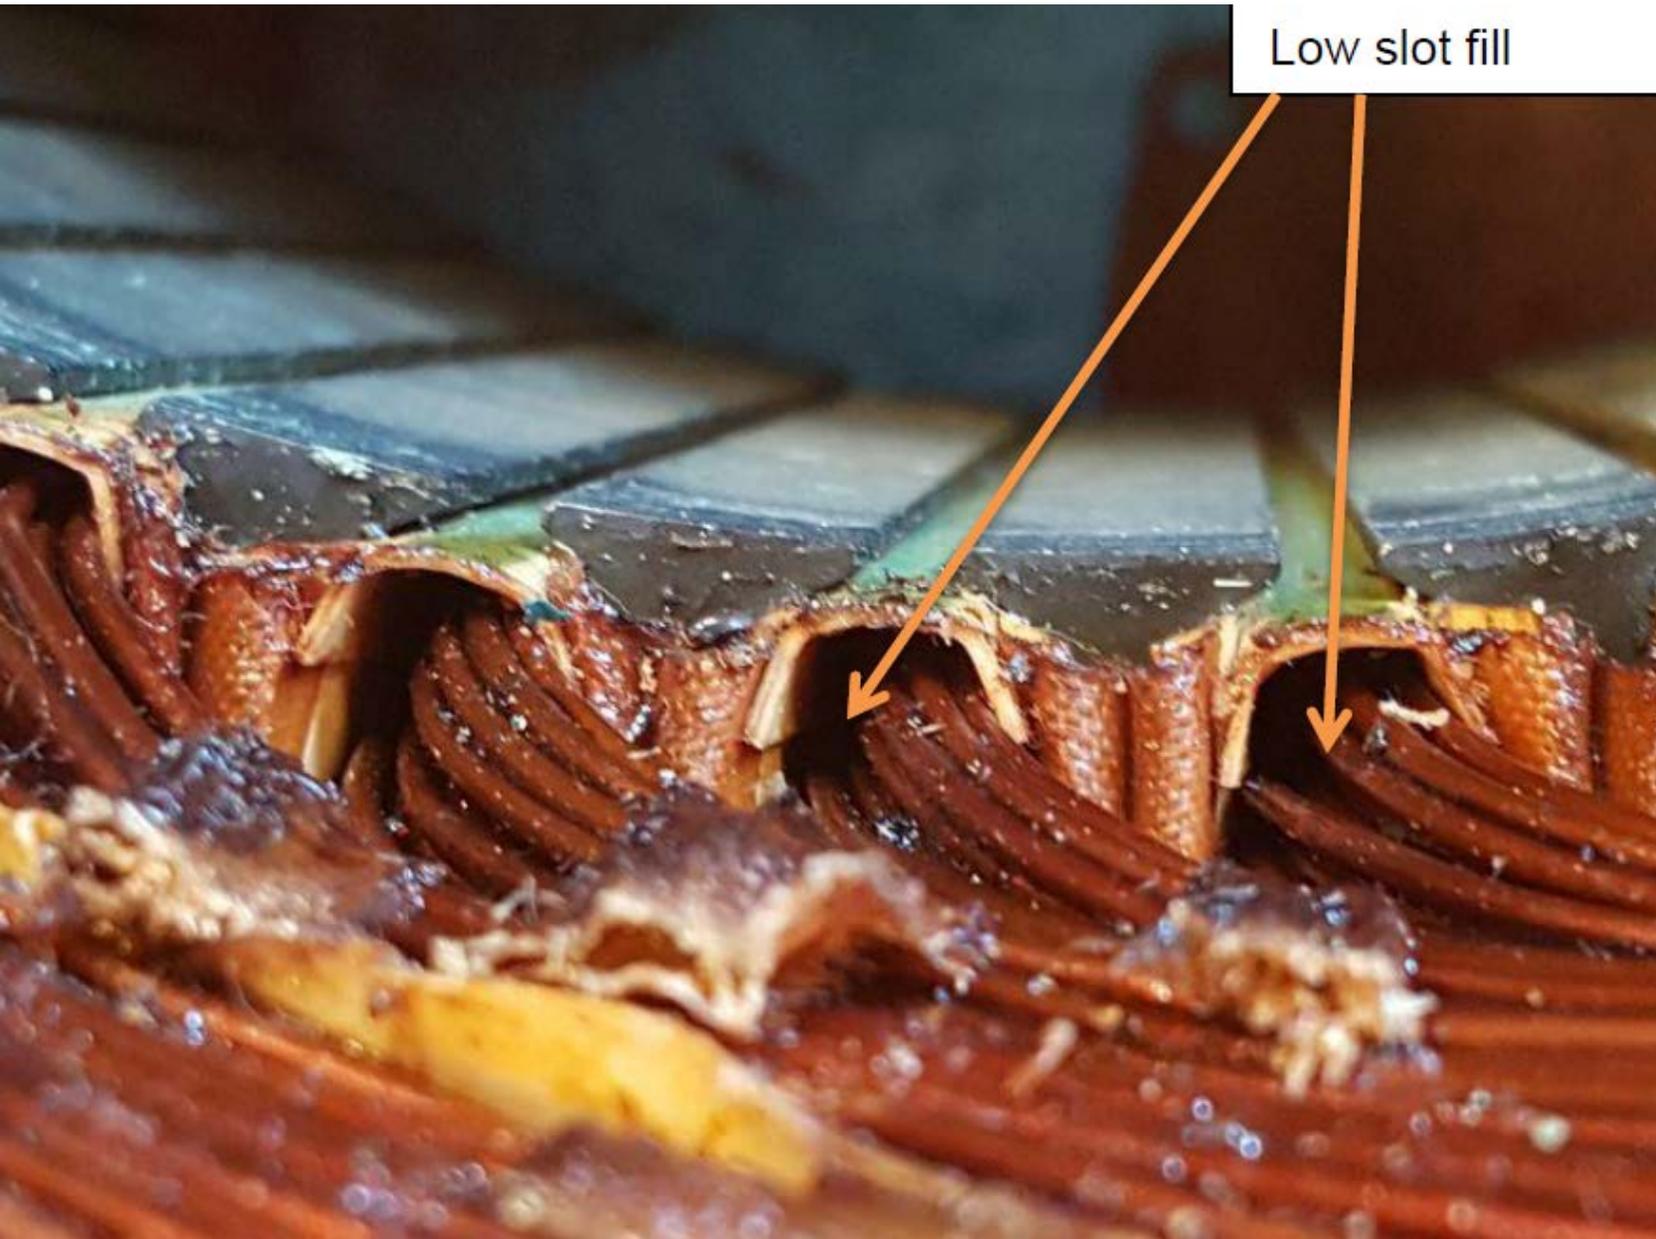
# End view suggesting low slot fill

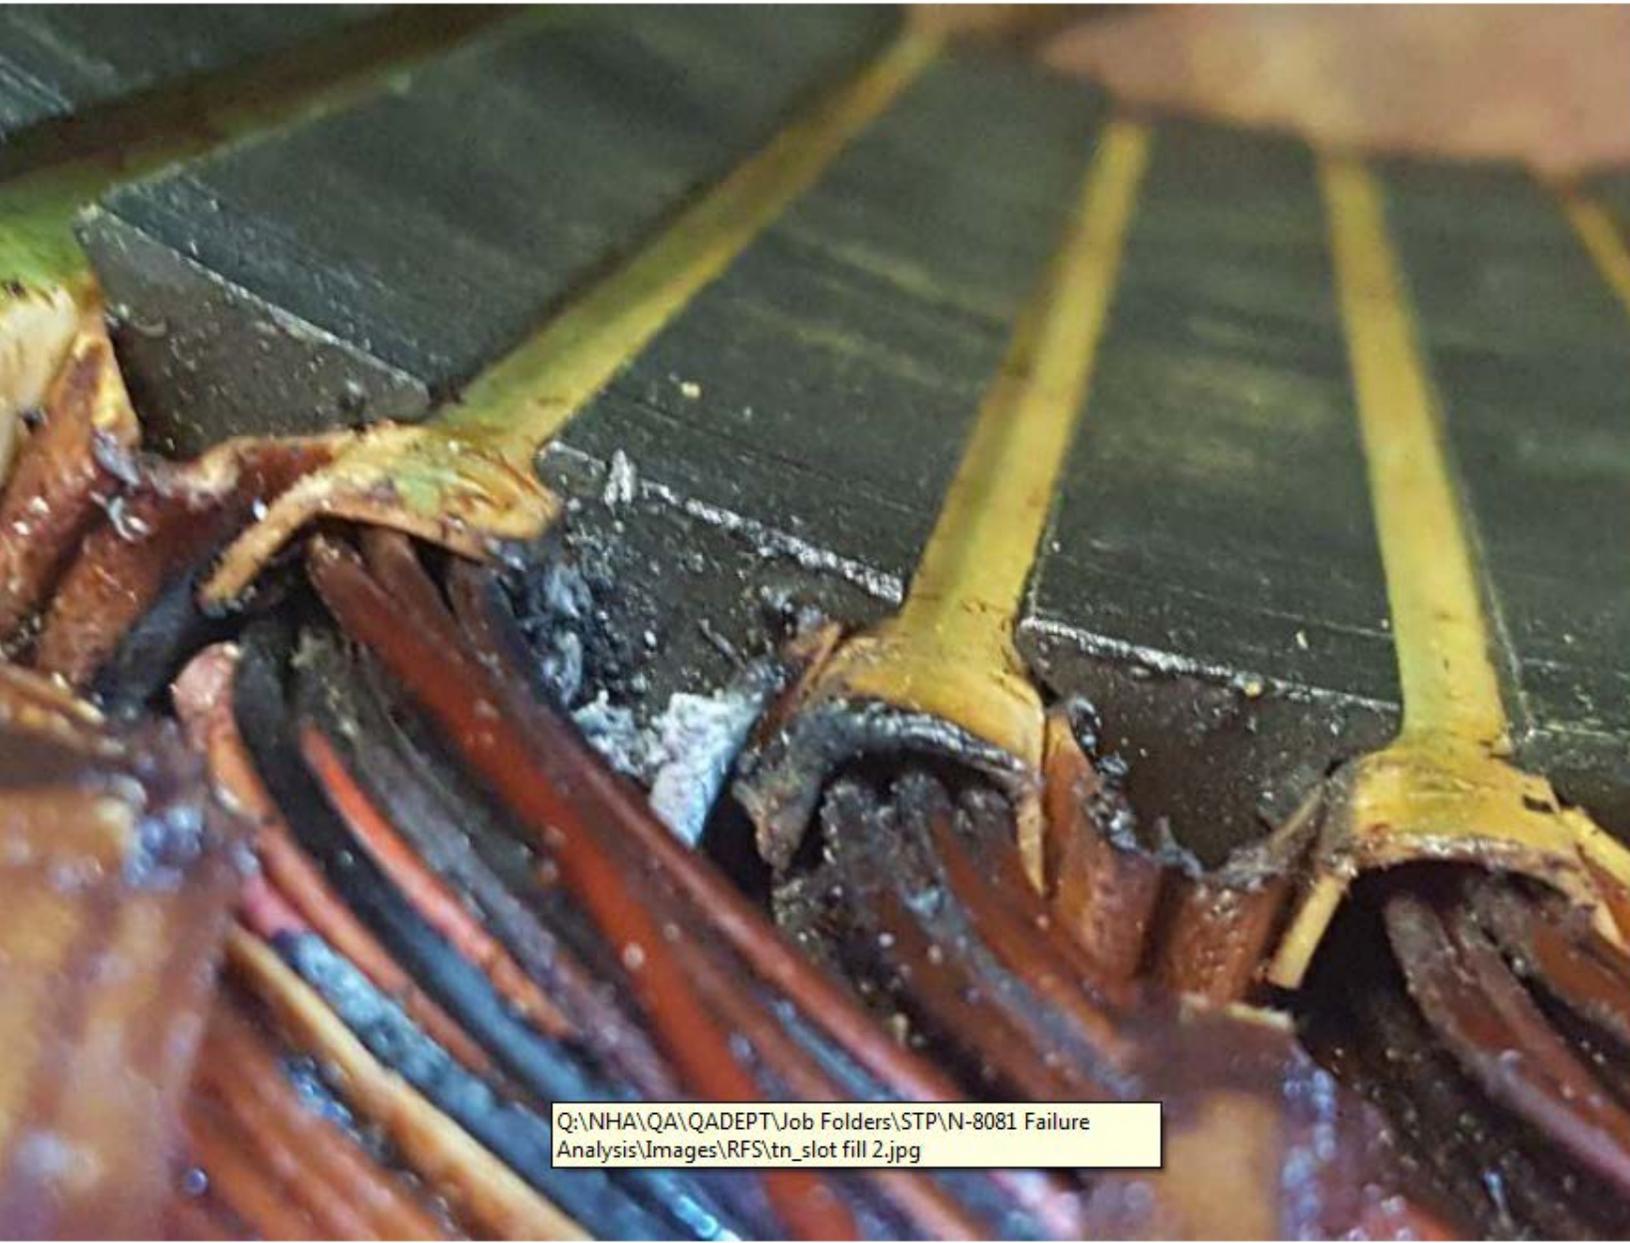
# End view in area of the failure

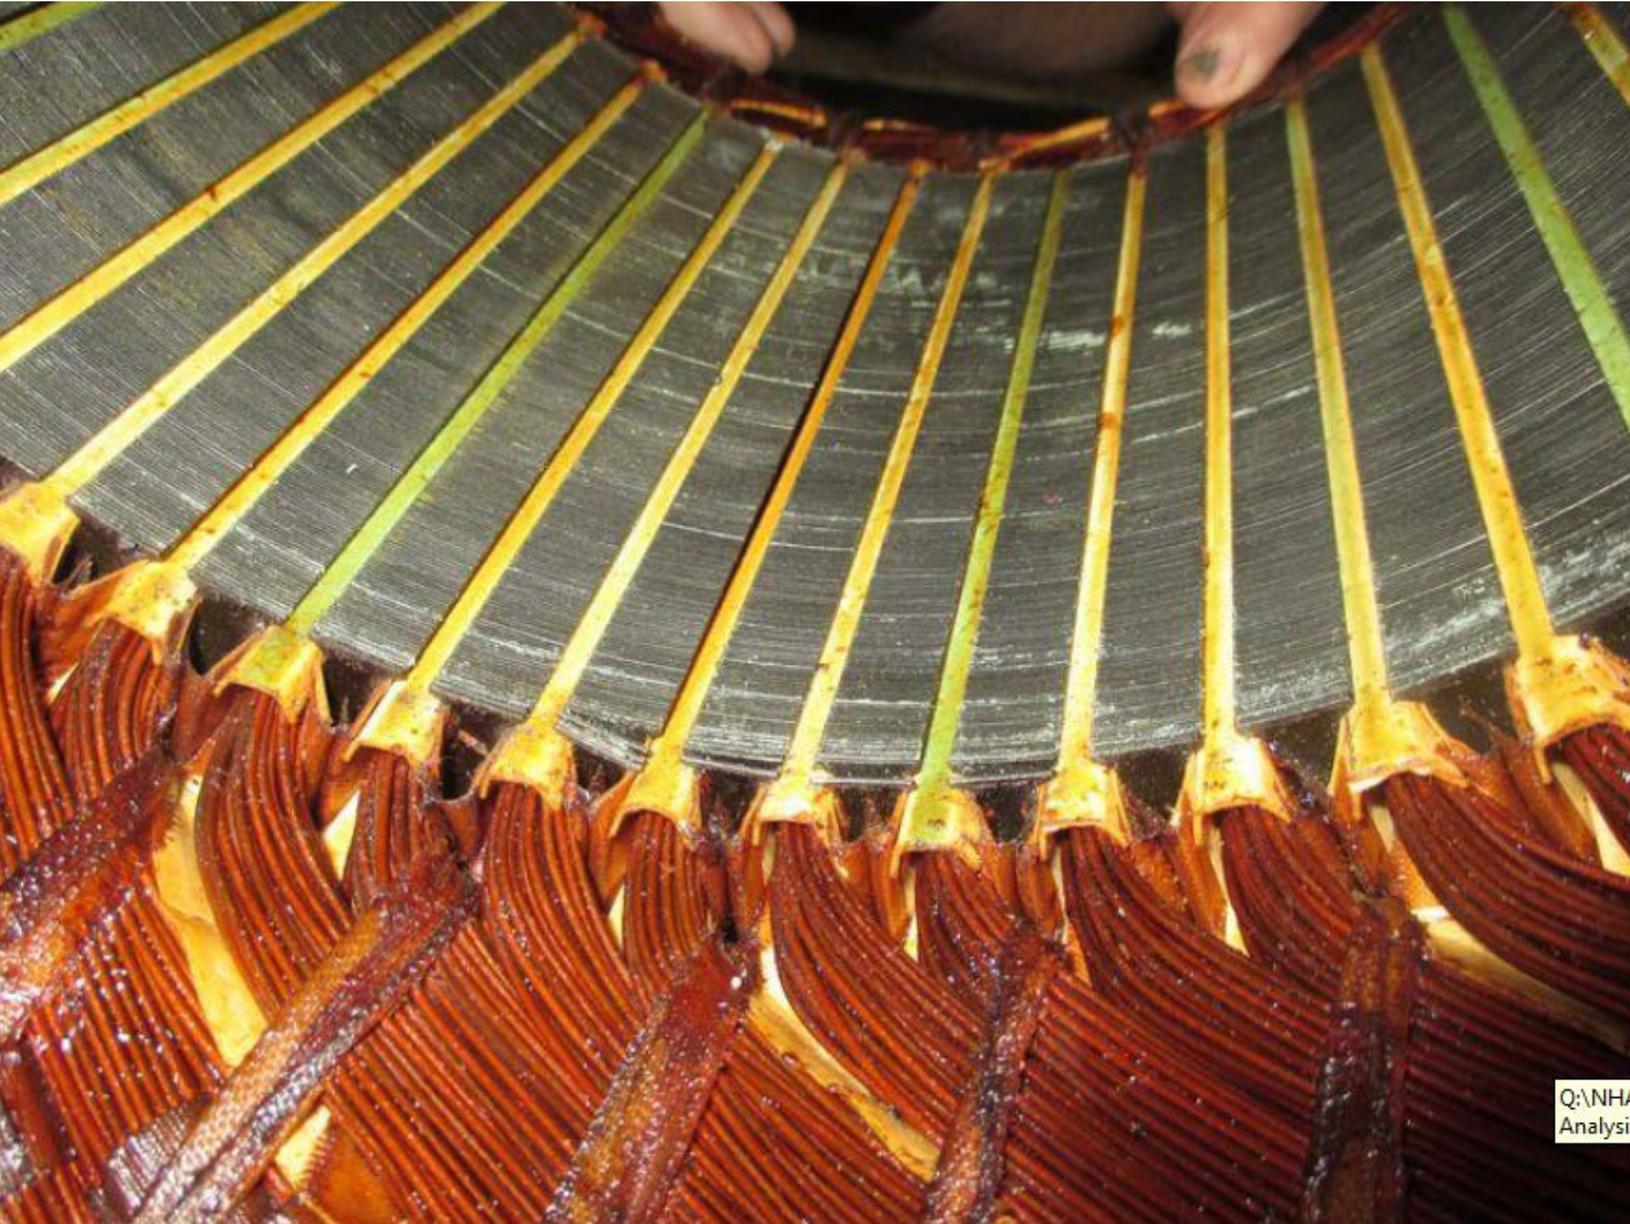
View of how the coils are pulled by endturns as they exit the slot
