Images below are taken from the failed brass fittings. All metallographic images show samples etched in a solution of ammonium hydroxide (NH_4OH), 3% hydrogen peroxide (H_2O_2) and water.

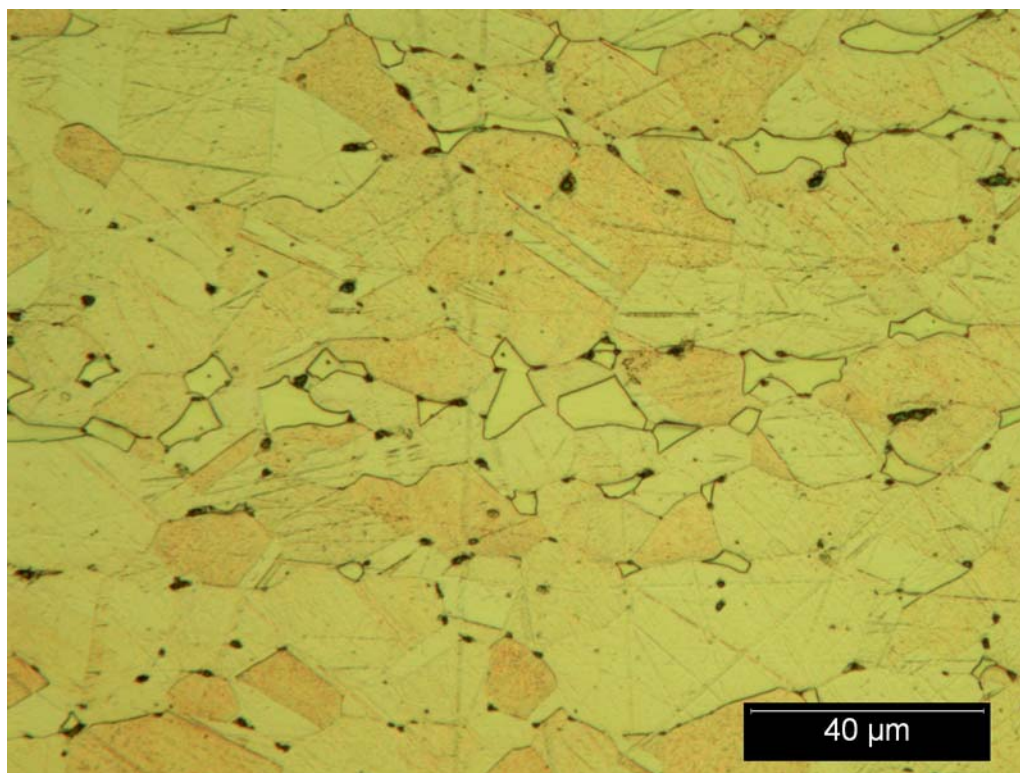
Figure 1. Metallographic mount showing beta network in the failed fitting, 500x.

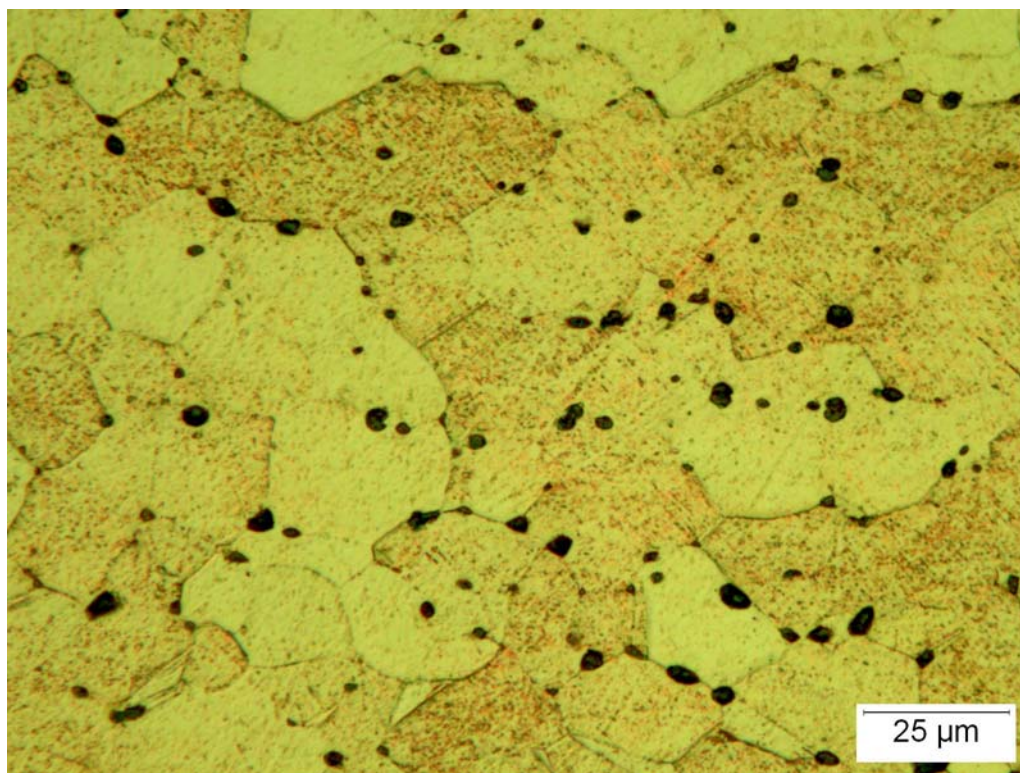
Figure 2. Metallographic mount showing lead distribution in the failed fitting, 500x.

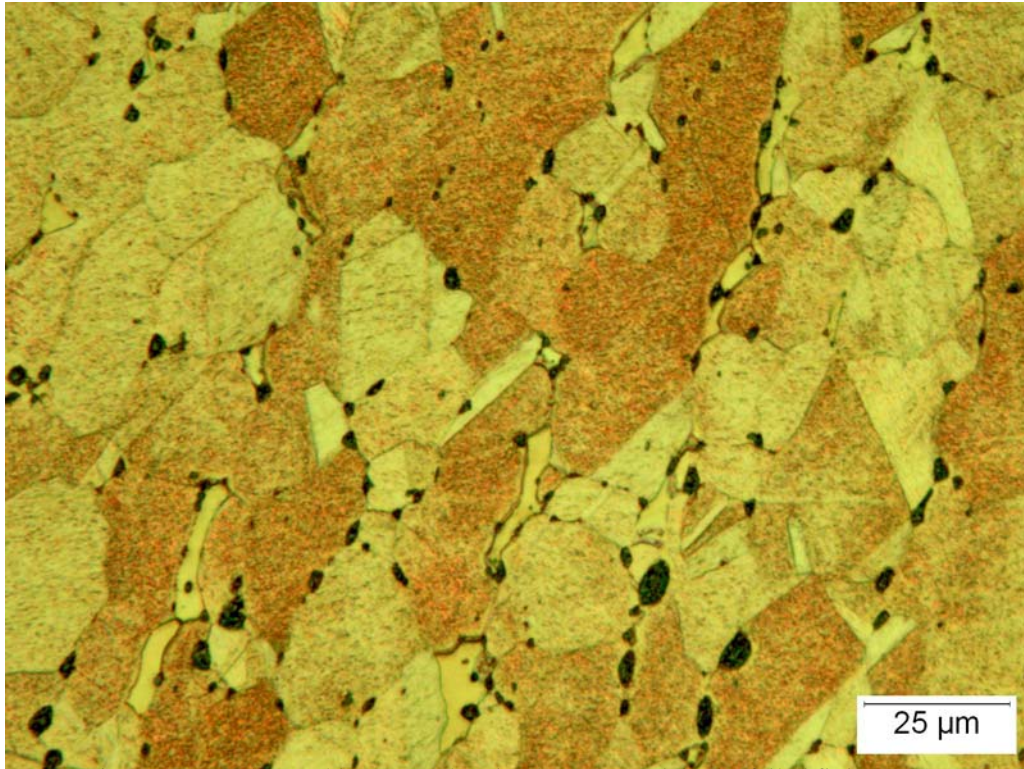
Figure 3. Metallographic mount showing beta network in the failed fitting, 200x.

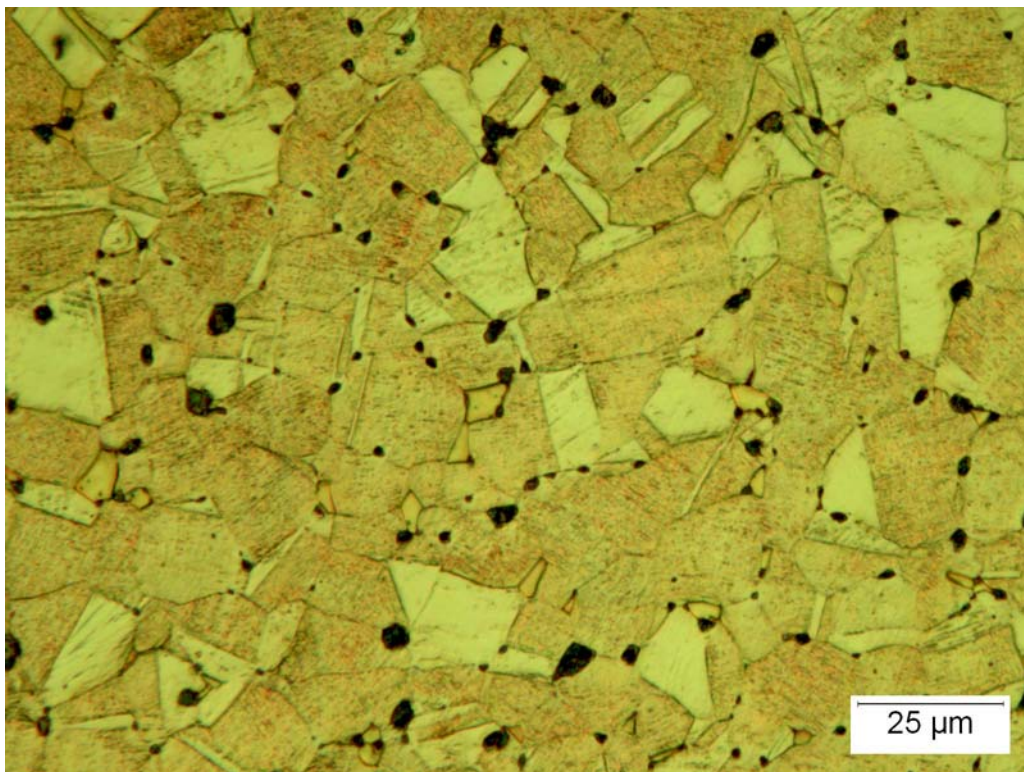
Figure 4. Metallographic mount showing beta in the failed fitting, 500x.

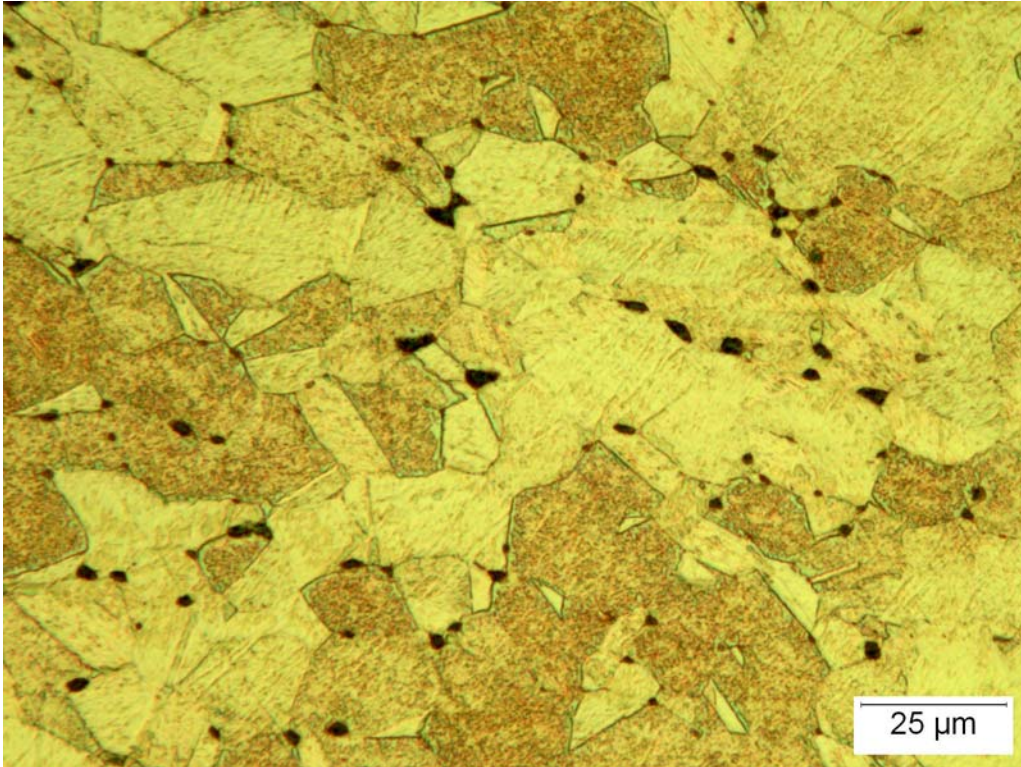
Figure 5. Metallographic mount of a non-failed fitting, 500x.

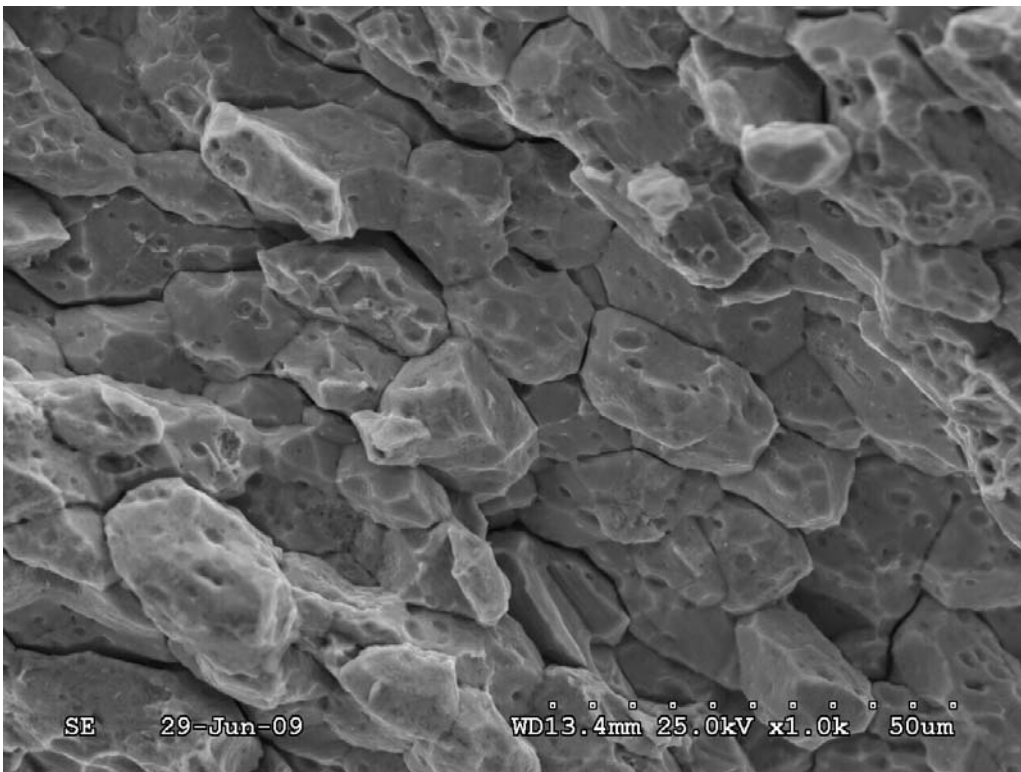
Figure 6. SEM image of fracture surface of October failure showing intergranular fracture.

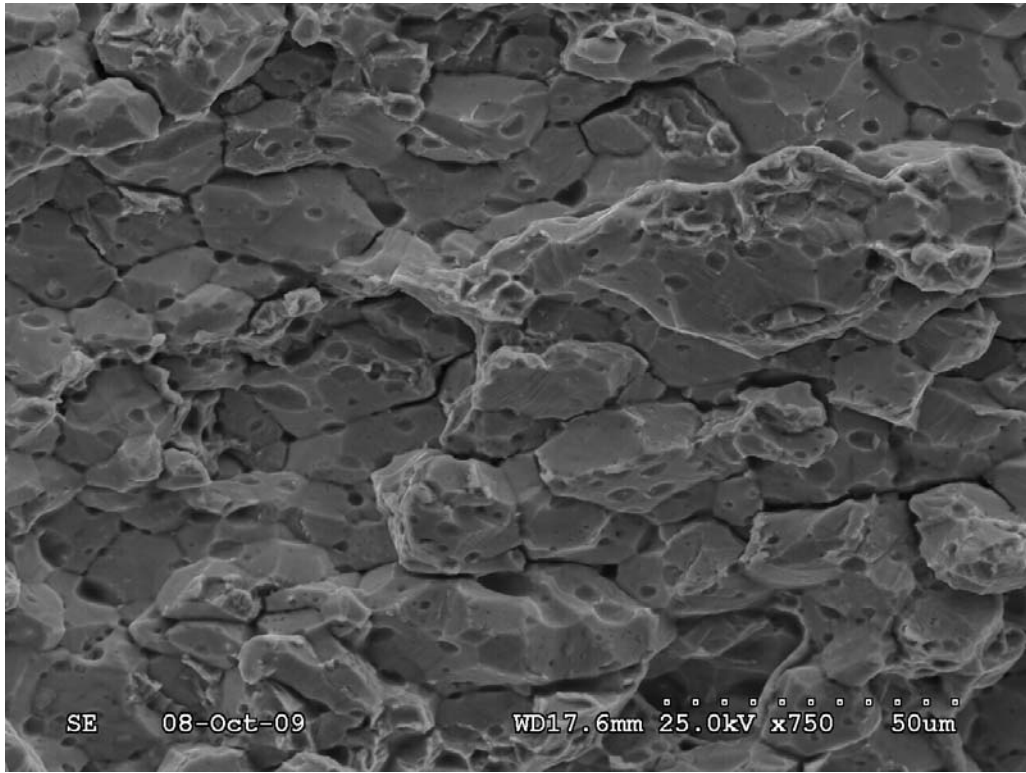
Figure 7. SEM image of fracture surface of October failure showing intergranular fracture.
