FAILURE REPORT NO: GMS-ME-FR-183

Failure Report

Toromont Compressor 52-340-KC-001B

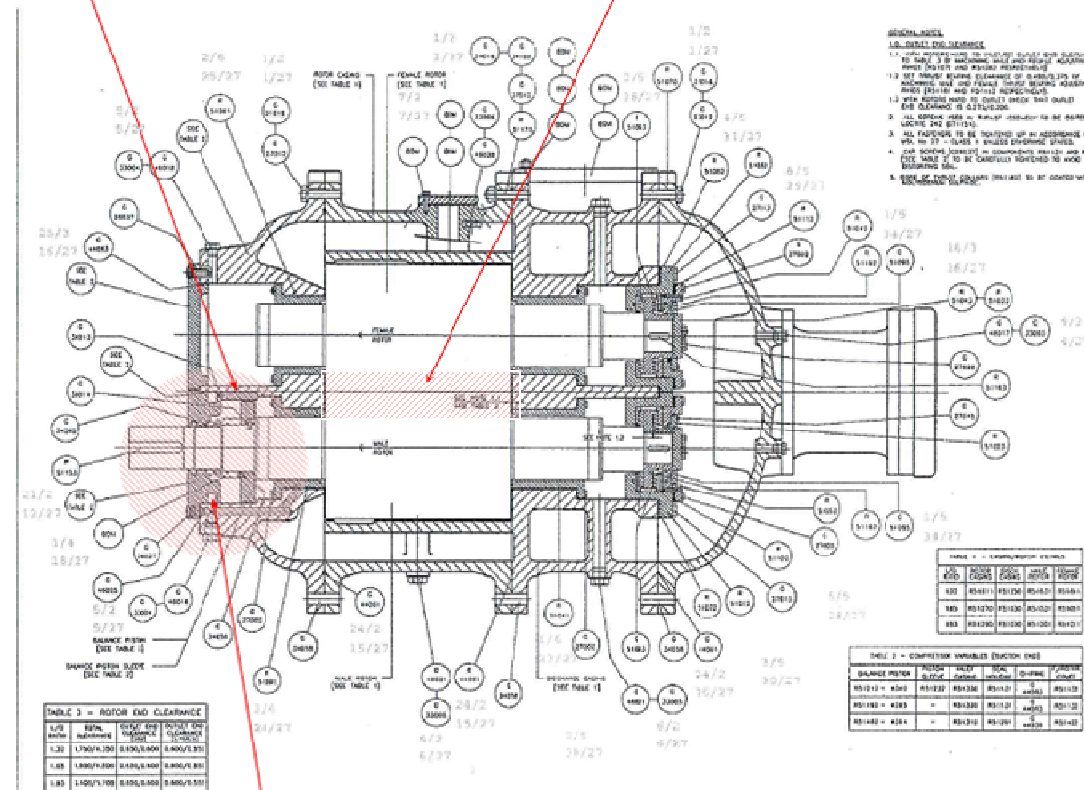
AFFECTED AREA: BALANCING PISTON

ROTORS' COMMON CONTACT SURFACE

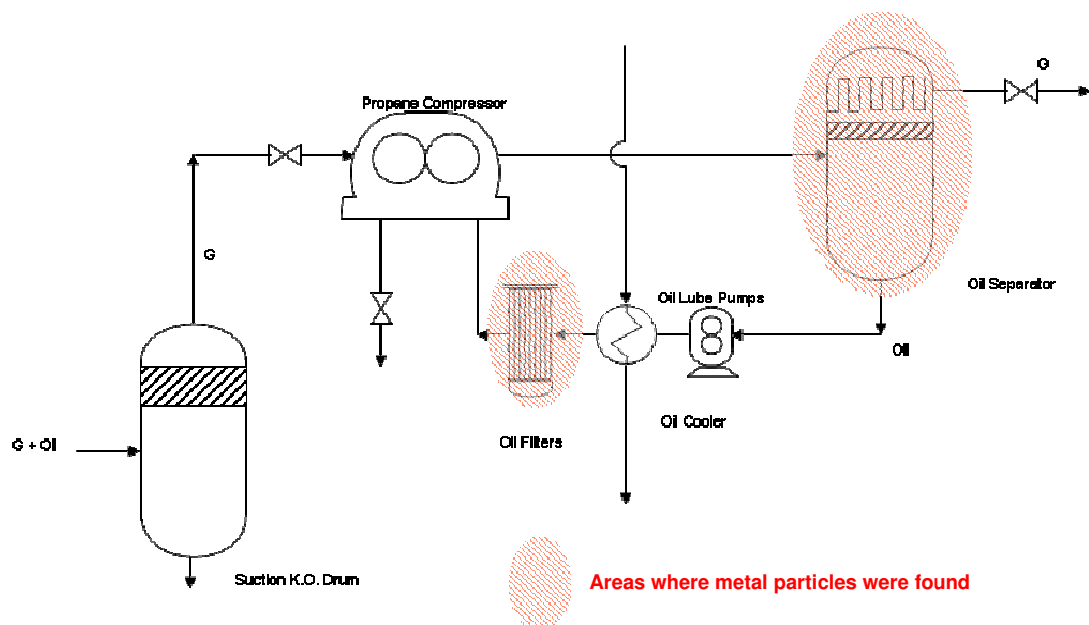
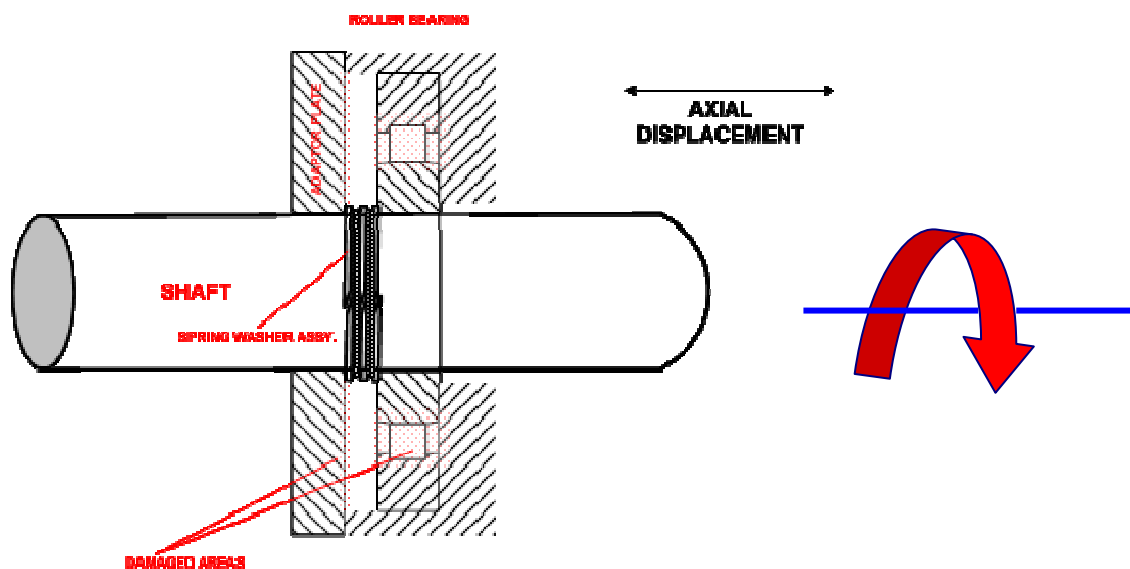
SCHEMATIC VIEW OF SPRING WASHER AND ROLLER BEARING

Pumps tagged as 52340PC002A and B were damaged by the horizontal sliding movement of the roller type bearings attached to both rotors. In pump “A” the damage was very severe, causing the lateral bearing covers to break releasing the rollers from the inner race. These elements were crushed by the rotors, which also slid against the pump’s casing. The lateral movement of the rotor assembly described before also originated contact between it and the adaptors. This issue can be observed through the radial markings carved on the adaptors’ surfaces. All the facts already mentioned could have been triggered by a gradual decrease in compression load of the curved plates that makes up the spring washers. As the proper load lowered its value, the axial forces would drive the bearings against the adaptors surface without opposition from the spring washers; therefore the axial equilibrium was lost. The continuous pounding destroyed the bearings.
