# Storage Tank Inspection-Groove like Corrosion in the Critical Zone- 2007

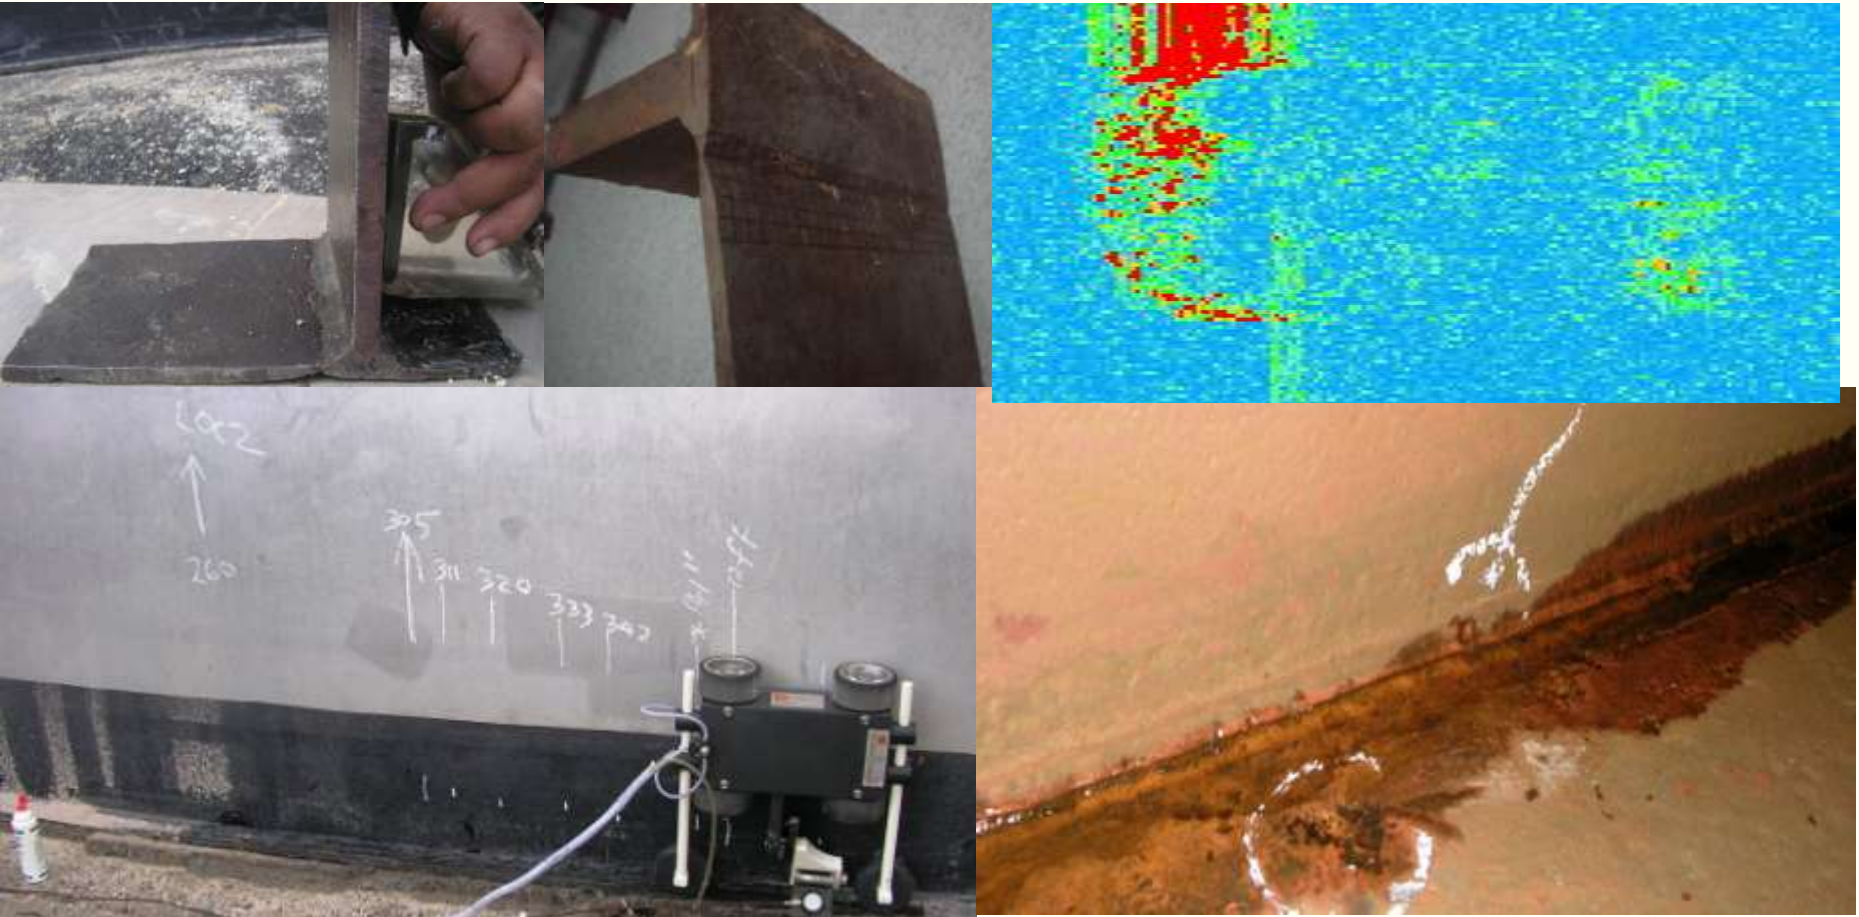
# Storage Tank Inspection- Corrosion ( Top side in critical zone)- 2008

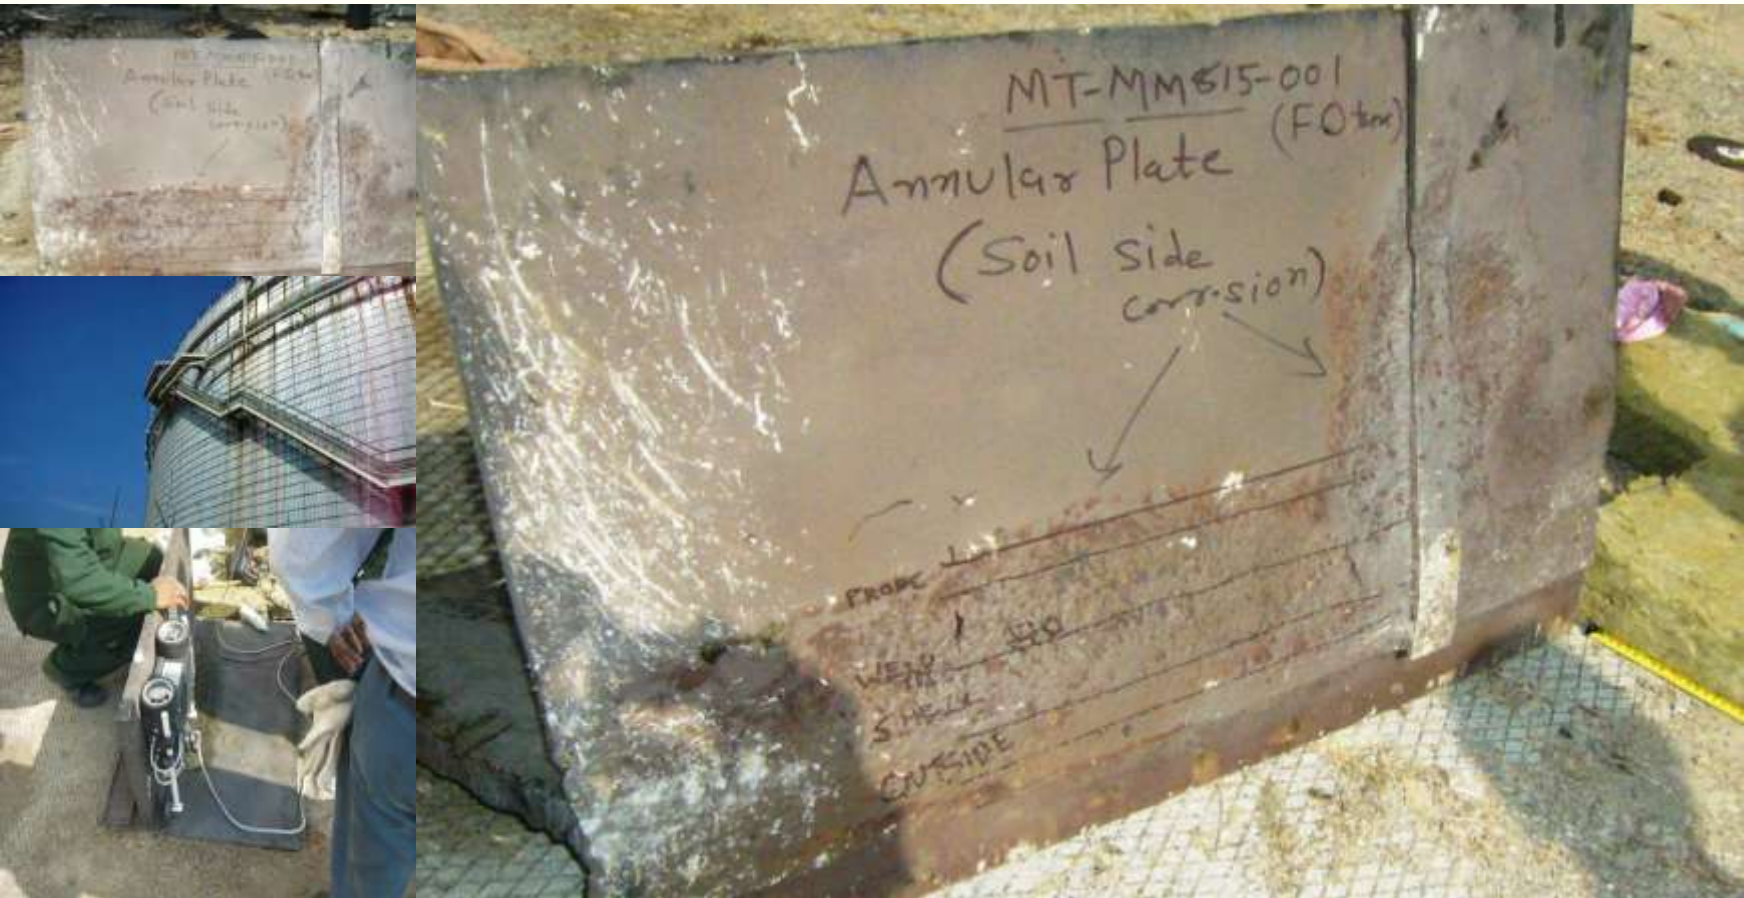
# Storage Tank Inspection- December 2008-Critical zone and Under shell plate corrosion

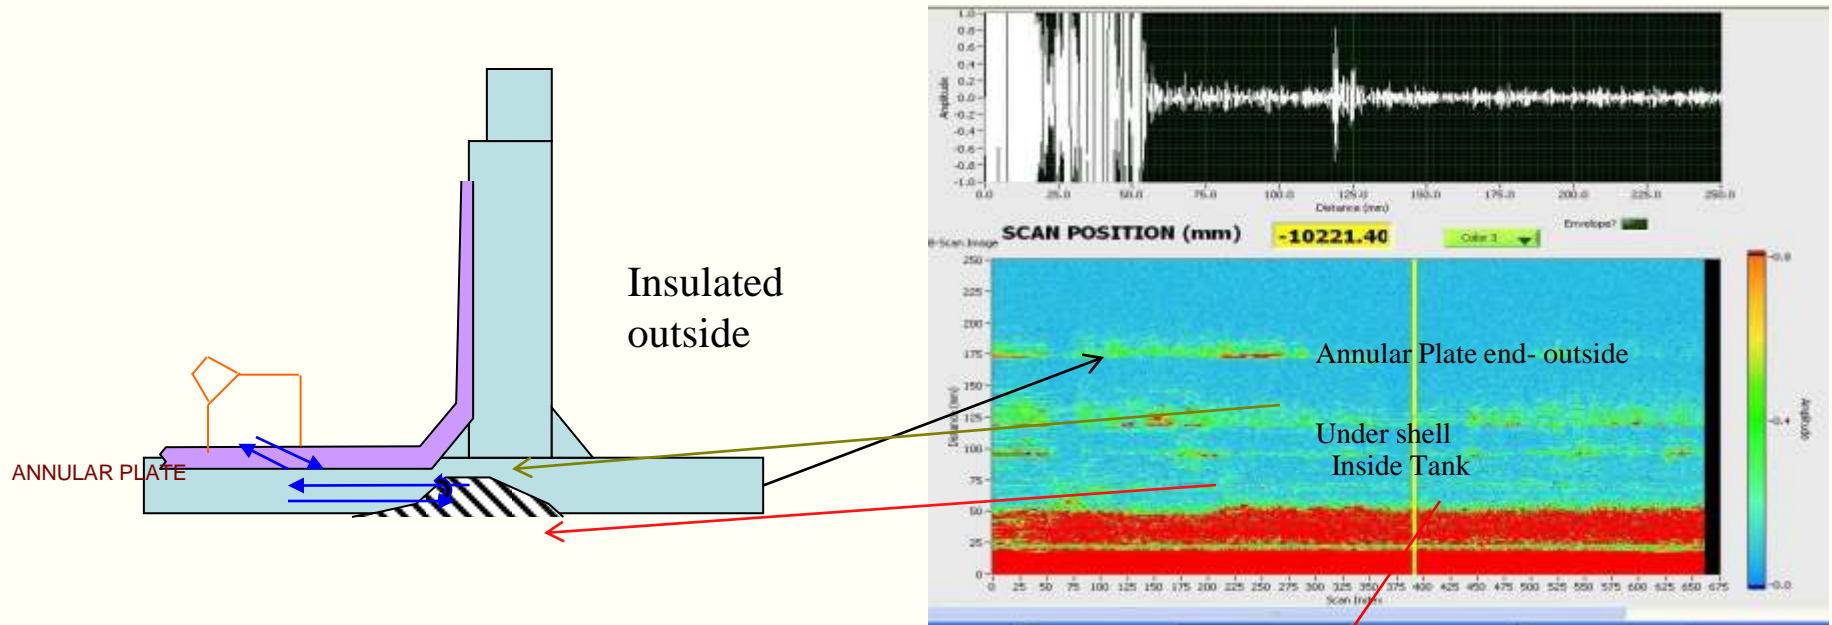
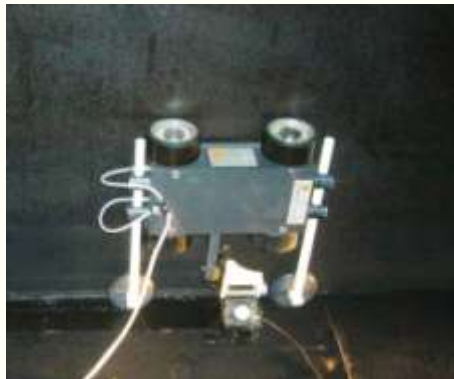
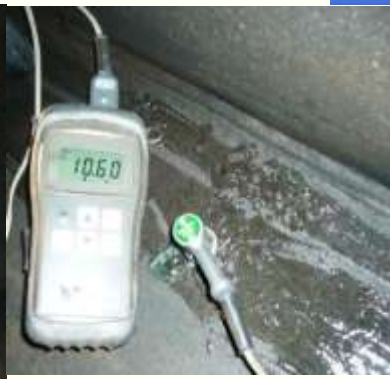
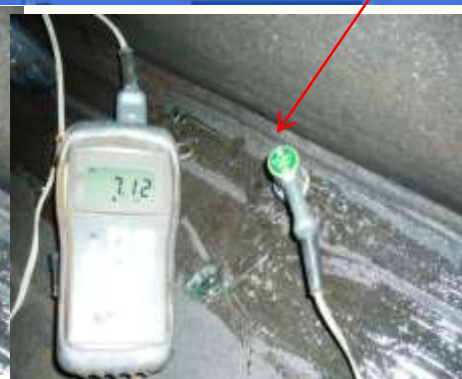
# Storage Tank Inspection- December 2008-Critical zone and Under shell plate corrosion

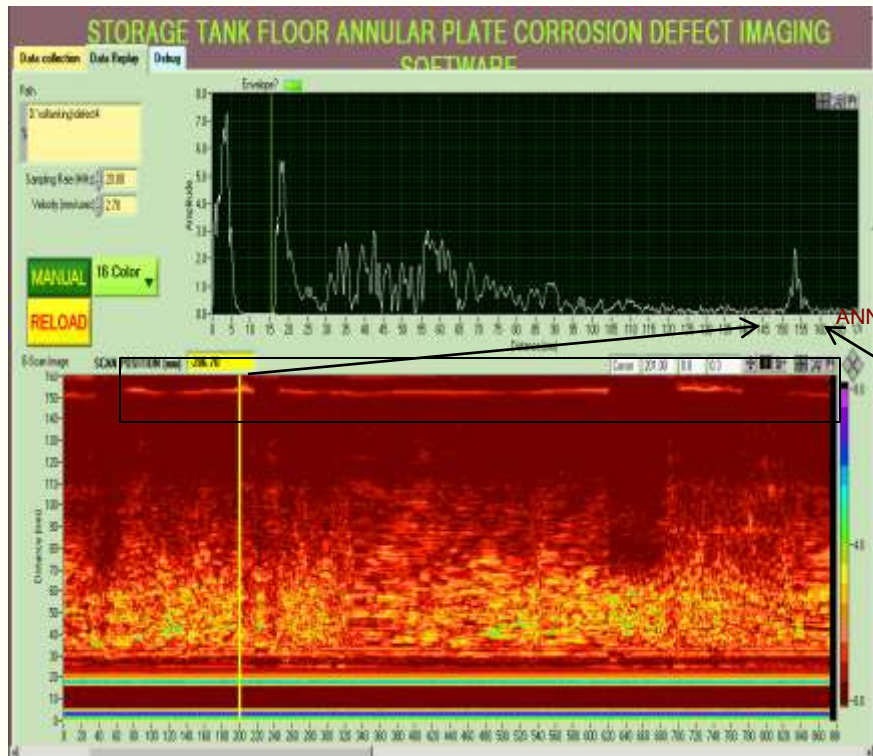
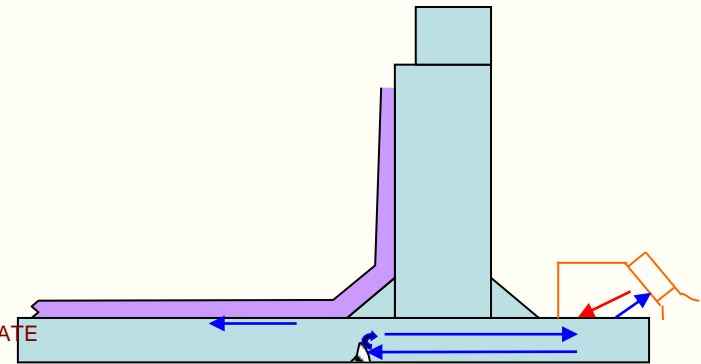
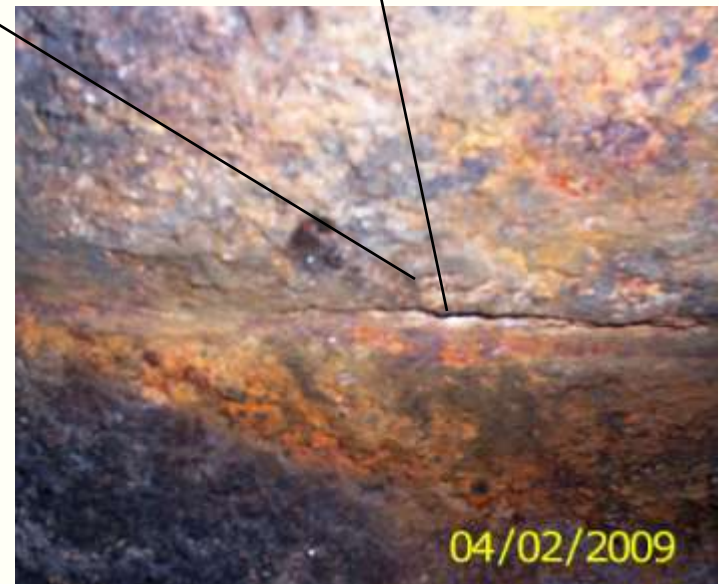
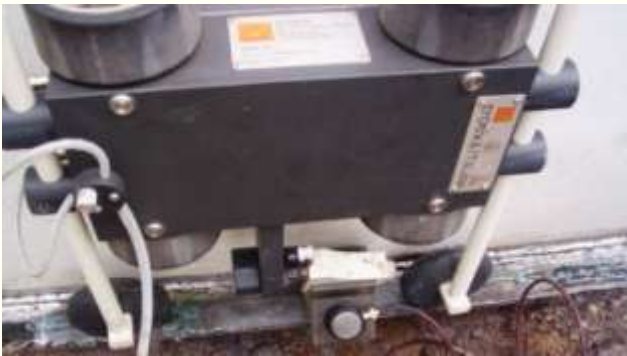
# Storage Tank Inspection- February 2009 -Crack at critical zone
