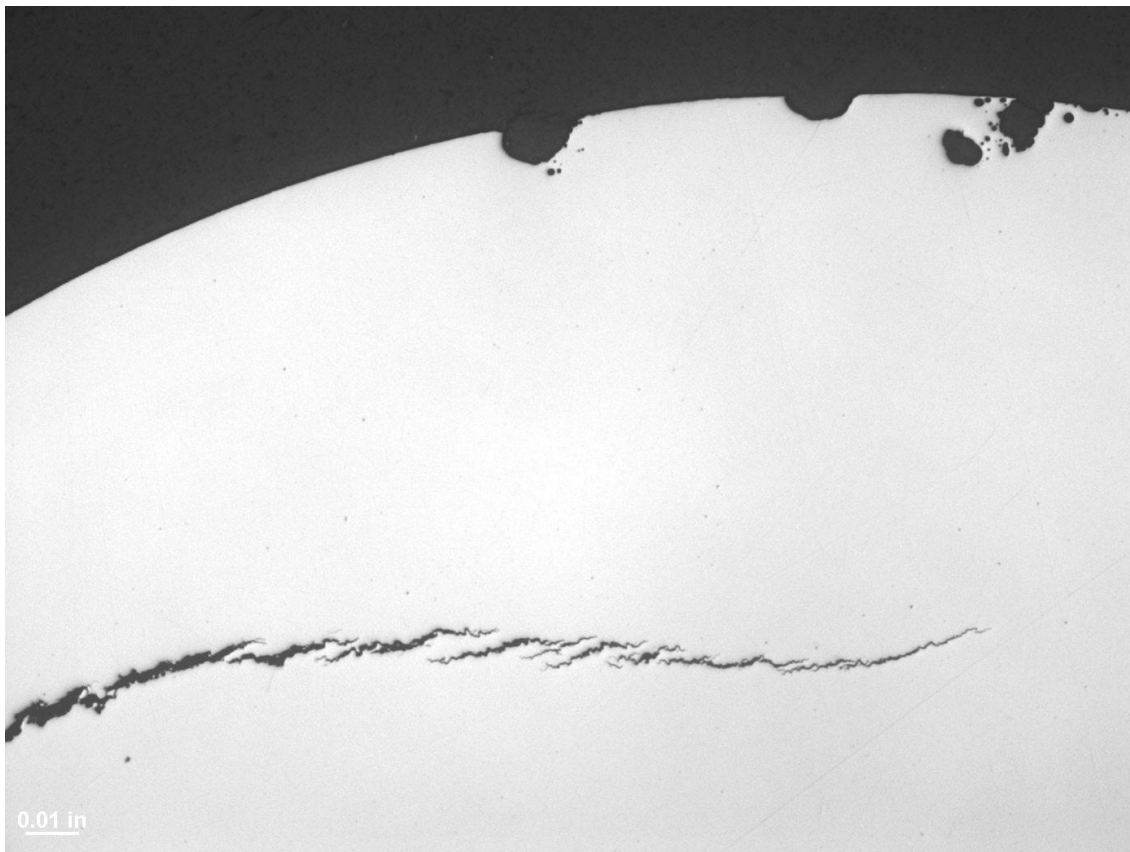
Photo 1. Overview illustrating "spider crack" area (top) and internal cracking, 25x, transverse section, as-polished

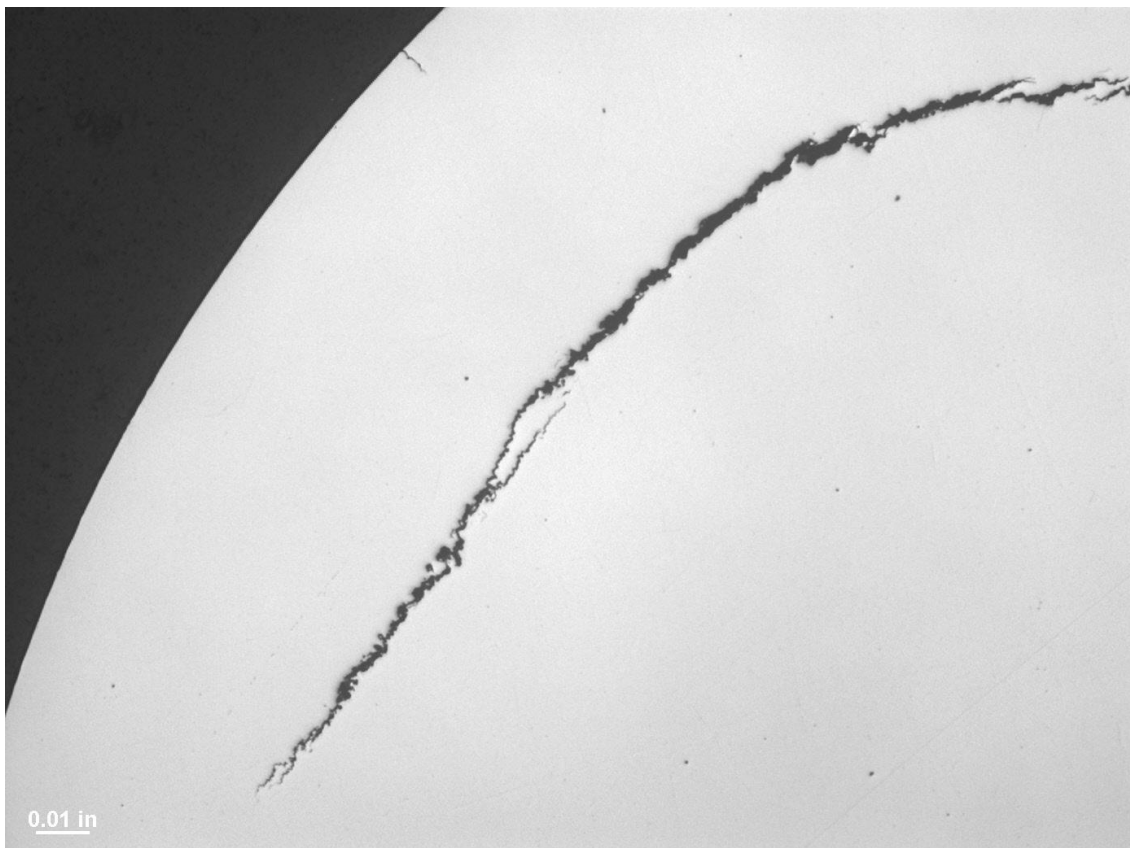
Photo 2. Continuation of photo 1 illustrating internal crack, 25x, transverse section, as-polished

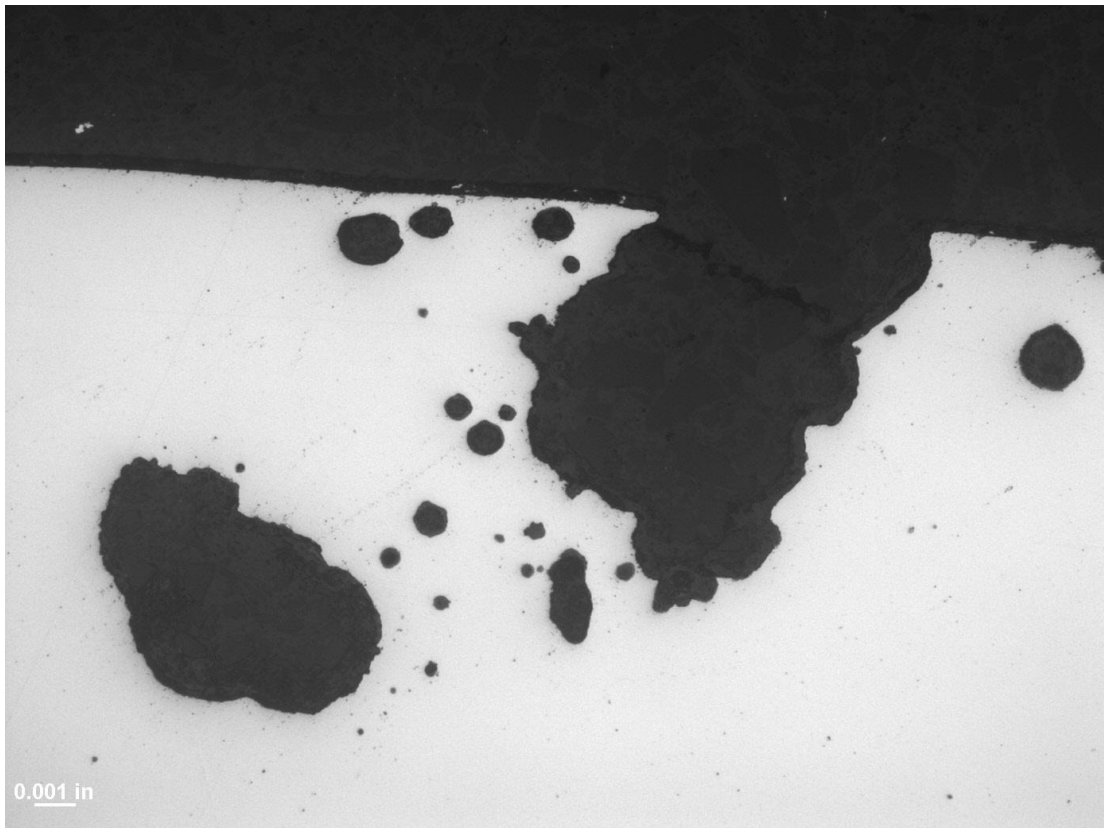
Photo 3. Closer view of spider defect area from photo 1 with internal voids, 200x, transverse section, as-polished

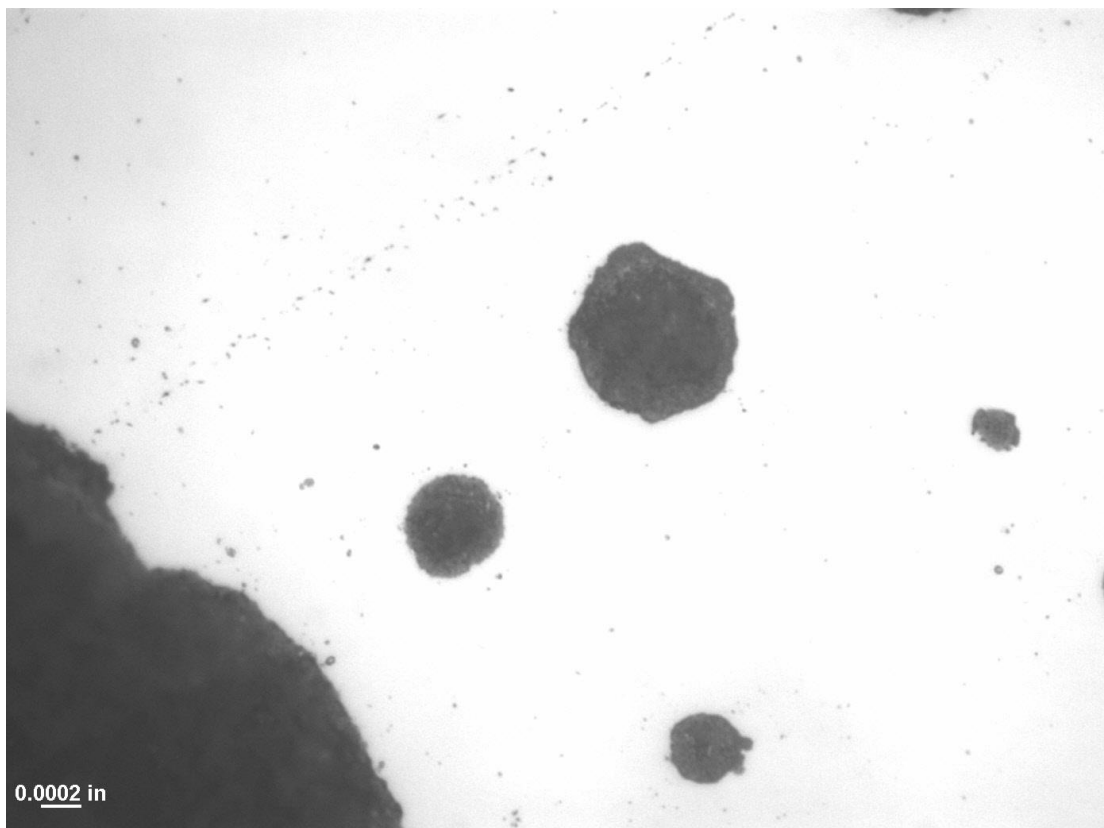
Photo 4. Closer view of internal voids outlined by thin oxide layer, 1000x, transverse section, as-polished

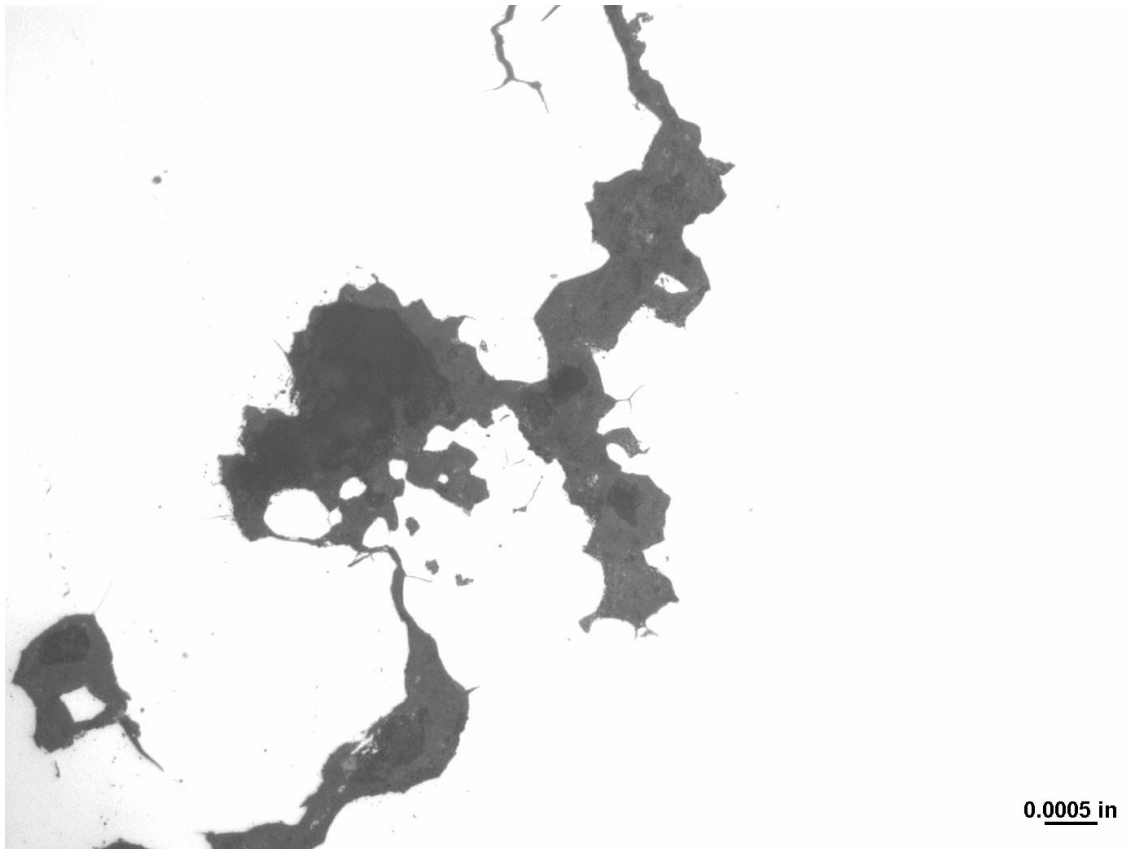
Photo 5. Closer view illustrating oxide inside the internal crack, 500x, transverse section, as-polished

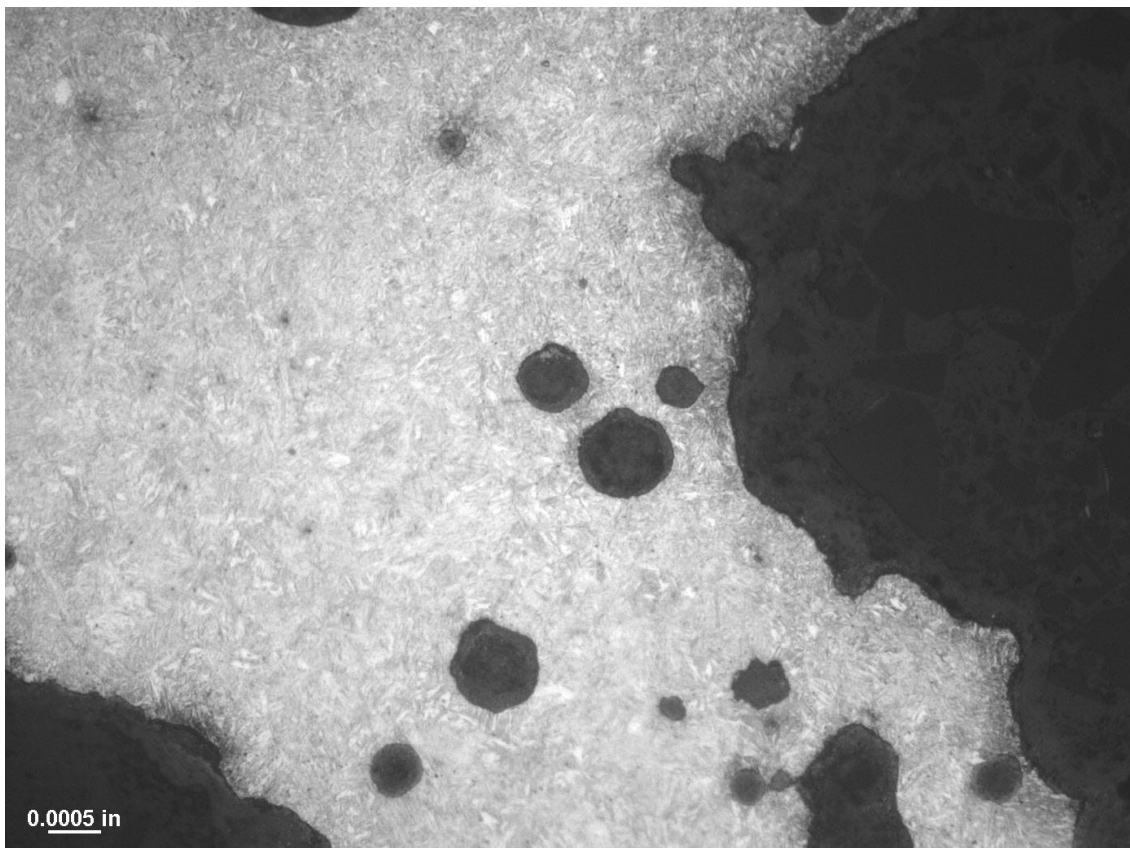
Photo 6. Additional view of "spider crack" area showing no evidence of decarburized layer, 500x, transverse section, 2% nital etch

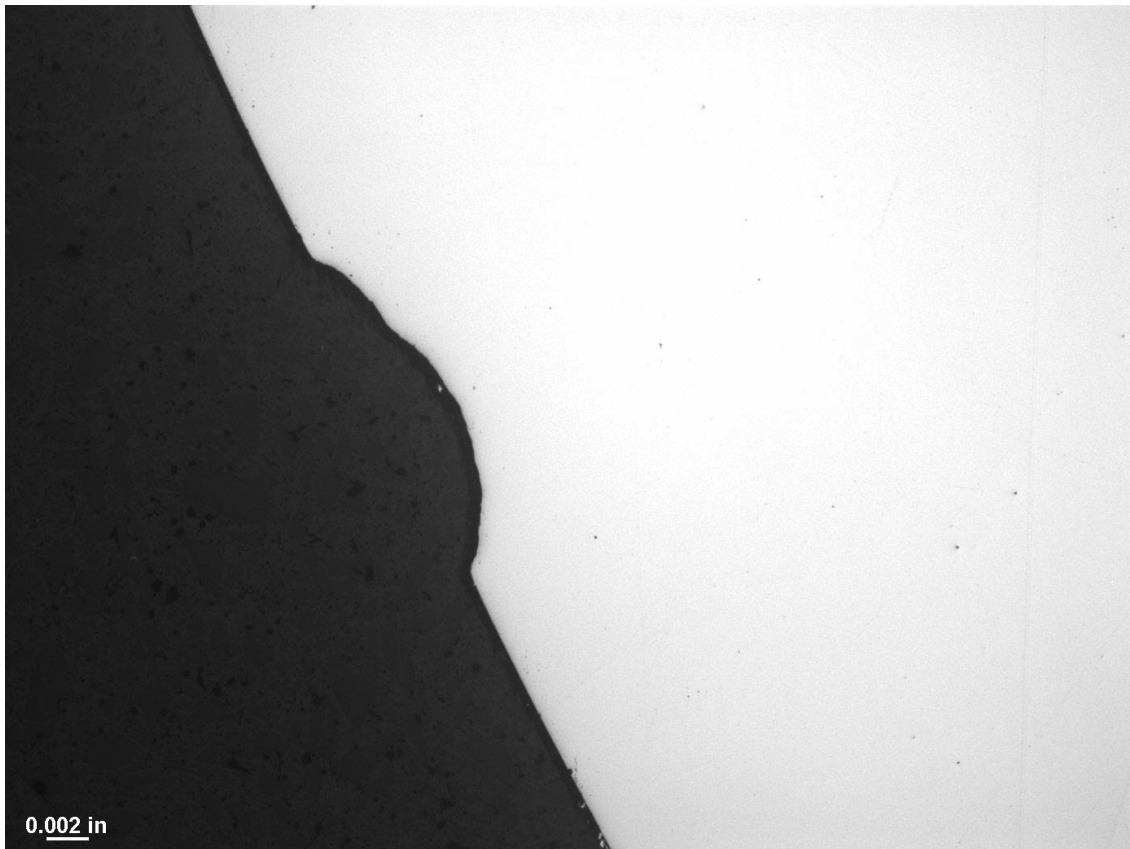
Photo 7. View illustrating seam defect, 100x, transverse section, as-polished

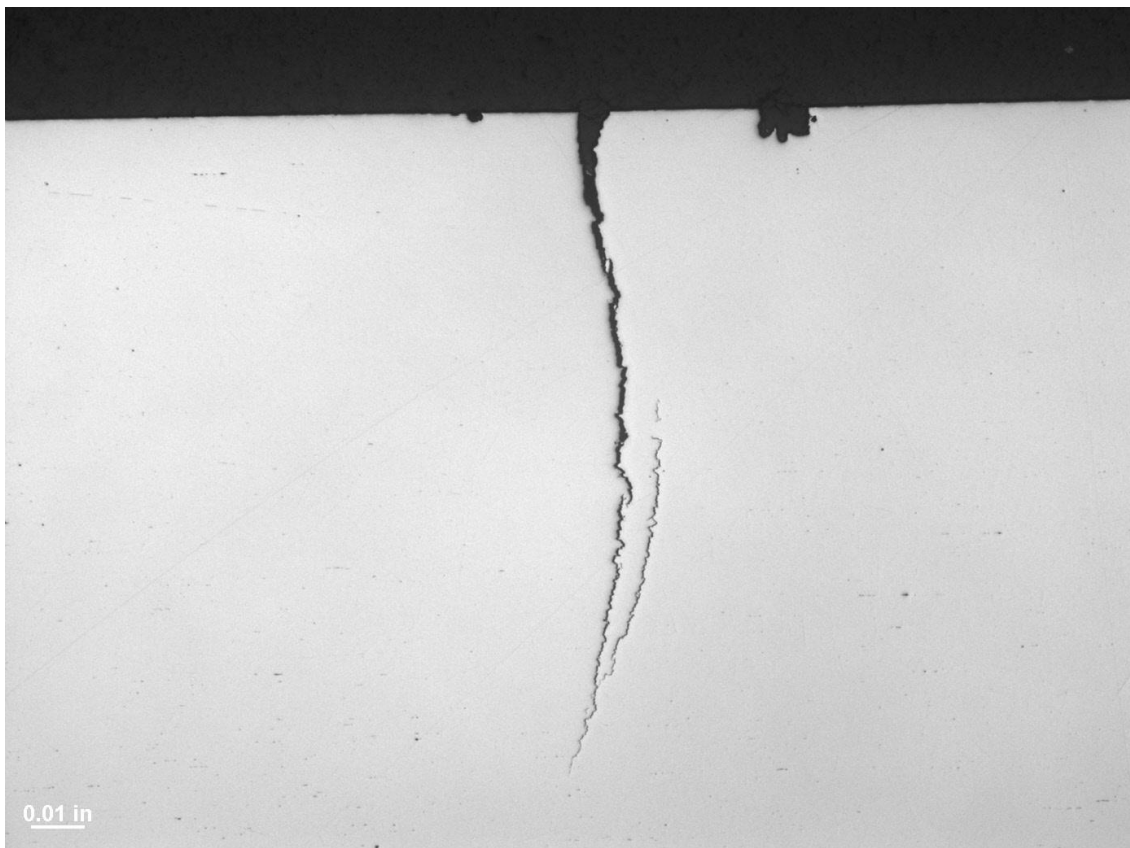
Photo 8. Overview of "spider crack" area, 25x, longitudinal section, as-polished

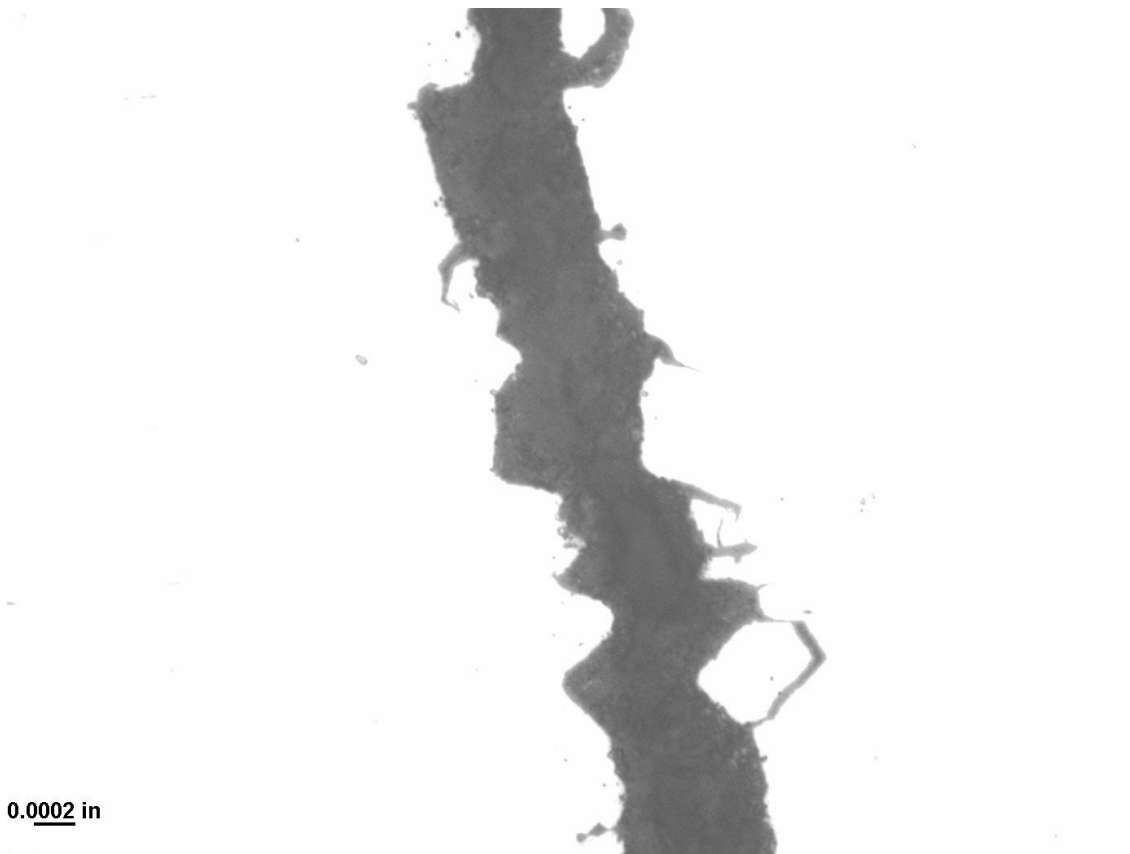
Photo 9. Closer view of photo 8 illustrating the presence of scale along crack path.

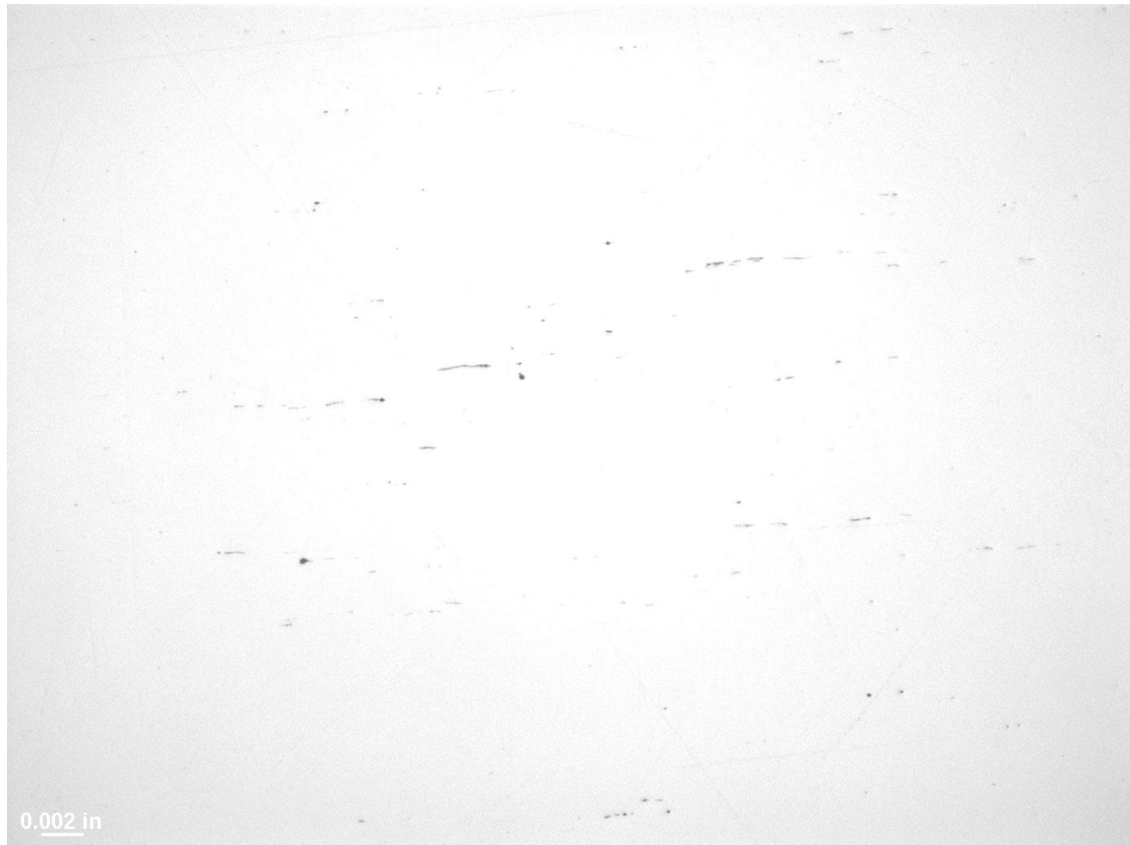
Photo 10. Core illustrating sulfide type 1½ -2 thin series nonmetallic inclusions, 100x, longitudinal section, as-polished

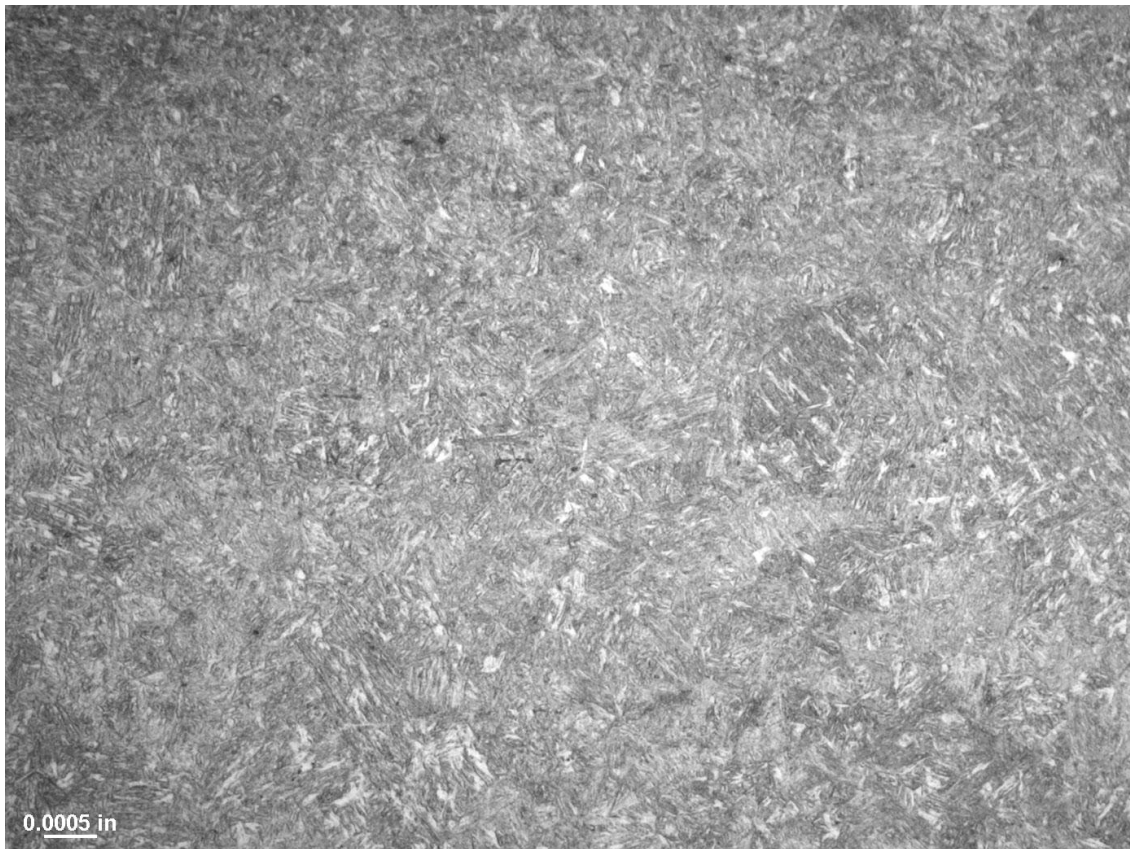
Photo 11. Typical appearance of core microstructure, 500x, transverse section, 2% nital etch.

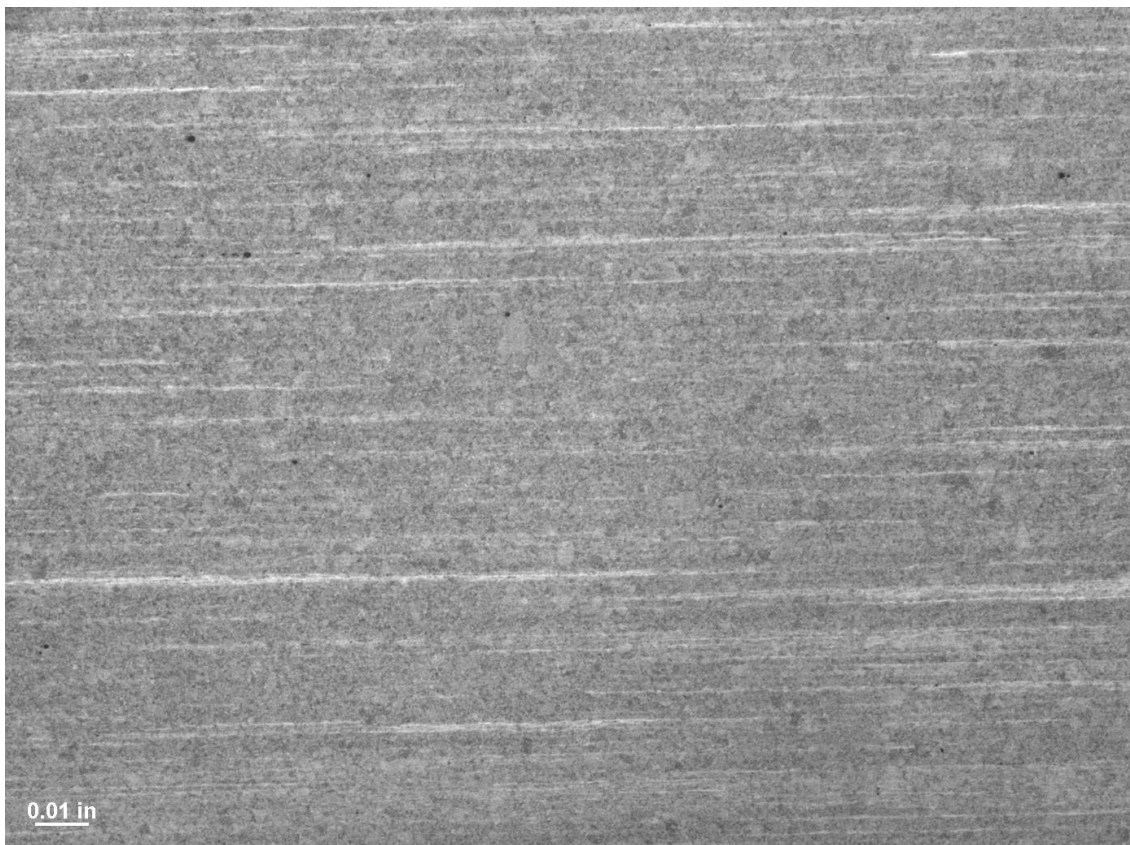
Photo 12. View through core of longitudinal section with material banding, 25x, 2% nital etch.
