Memorandum

From: Robert Ellison

Date: 6/10/2010

Construction of the sludge lagoons commenced on 28 June 2010. Initial activities included clearing and grubbing and sludge removal. Up to the 1st payment certificate – there were minor problems to do with smoke, a diversion channel, excessive clearing, etc. Minor issues typical of a construction project which were solved as they arose. Sludge stockpiling posed problems of storage – with excess volumes – that were not identified in design. This problem was resolved using a 25 tonne excavator to increase the height of the pile – as an extra to the contract. Associated problems with excess sludge necessitated extending the area of the storage with additional clearing – again at an additional cost.

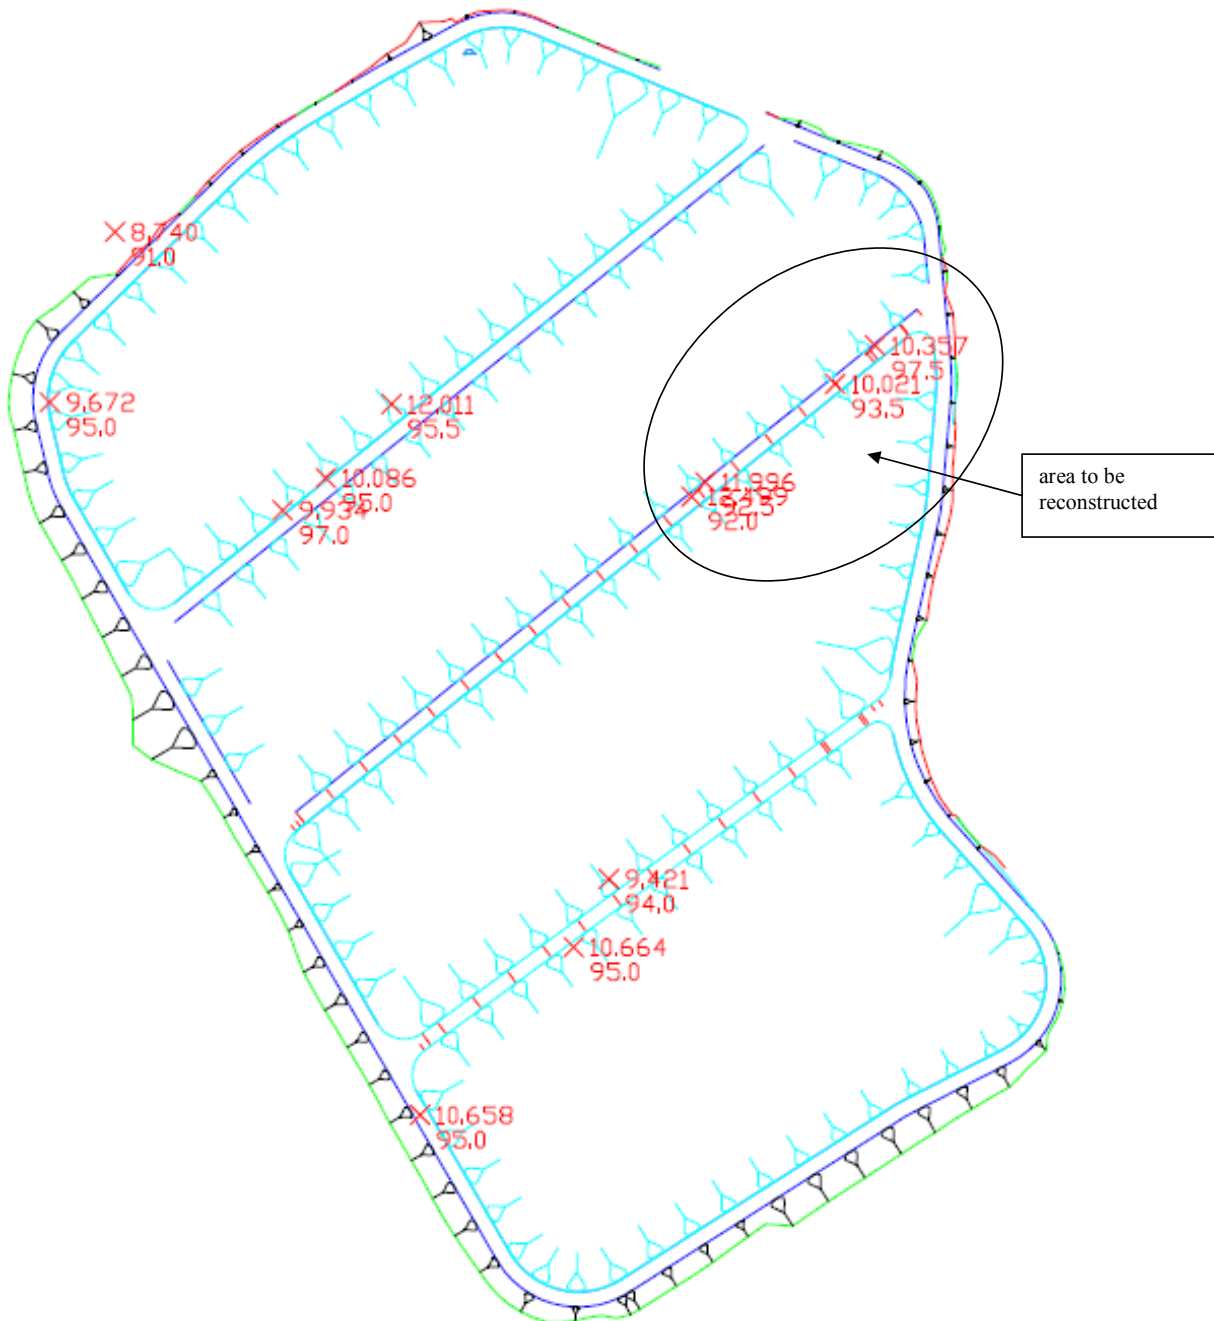
Attachment 1: Locations and levels of compaction results that are less than 98% standard

In general the results show 2 spots at 95% compaction in the outer wall, one anomalous result outside the wall and several more in internal walls. Although I might add that 3 of the lowest results previously supplied have dropped off the list. The results for compaction suggest minimal risk – although I am reluctant to make a call until it is certain that all results have been supplied. To this end we have asked Cardno Bowler – as the geotechnical testing authority for Camco - for a Level 1 inspection report to AS3798 and will review this information when available. We have also suggested that Cardno Bowler specifically review moisture content and the implications of this and as well to suggest ways forward in relation to soft spots in the wall.

We are intending to review and compare options to arrive at the best way forward. My inclination is to reconstruct in the area shown in Attachment 1.

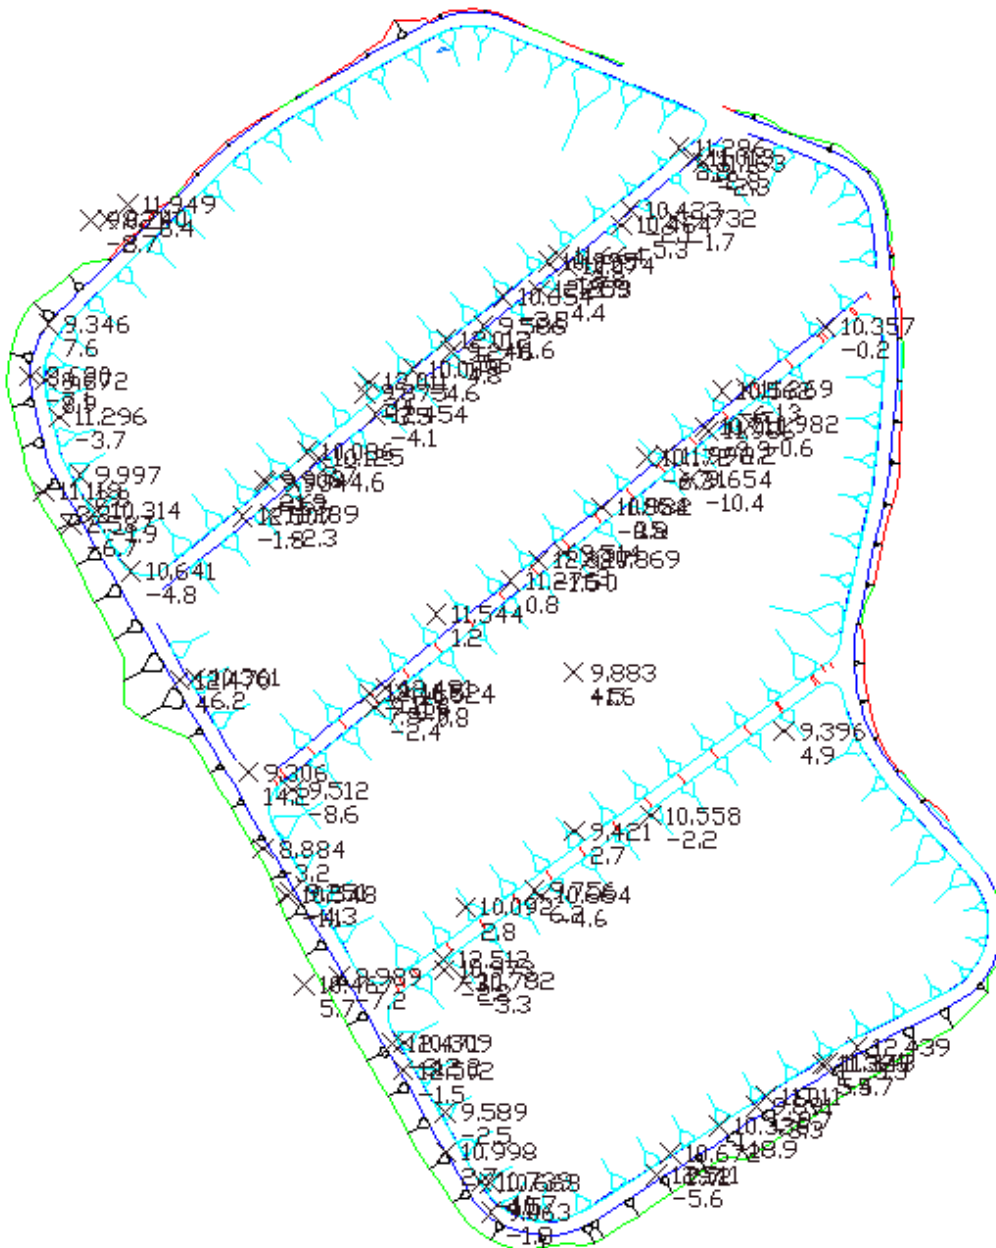
Attachment 2: Locations and levels of moisture results out of spec

GHD were concerned with moisture content in relation to permeability – and suggested that as most tests were outside of specified moisture content ranges this was a problem we had not considered. I think this is an over reaction. A typical soil with 10% water content (by weight) has 25% voids. The same material with the same dry density (tonnes/m³) with 5% moisture has 25% voids – 12.5% water and 12.5% air. It is both the voids (total for air and water) and soil structure (flocculation and dispersal) that determine permeability. Soil moisture (according to AS3798) is specified as a guide to achieving compaction with minimal effort. I think GHD have very much the wrong end of the stick on this – but it is something we may now need to deal with. As such – we have asked Cardno Bowler to address this issue and provide their take on this issue.

The results for field moisture results that are out of specification are shown in attachment 2. This includes most of the testing across most of the walls.
