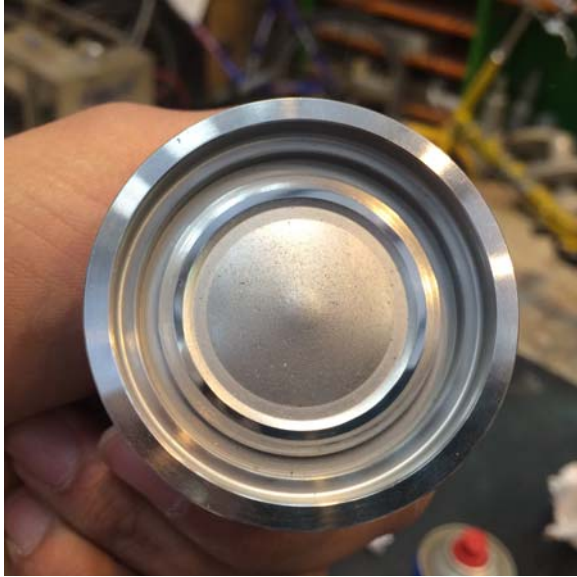
The damaged disc

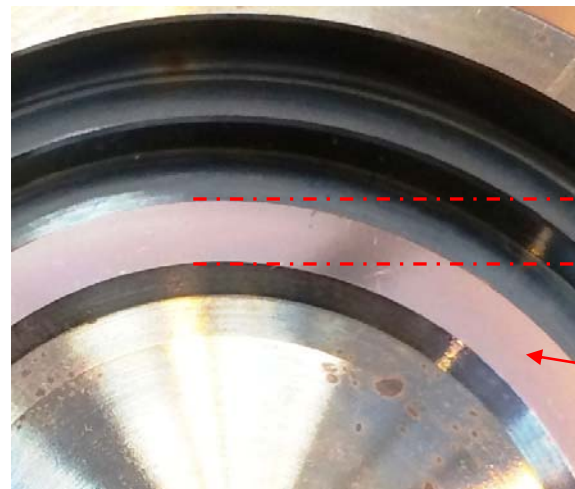
Lost more than 50%
of the seating surface

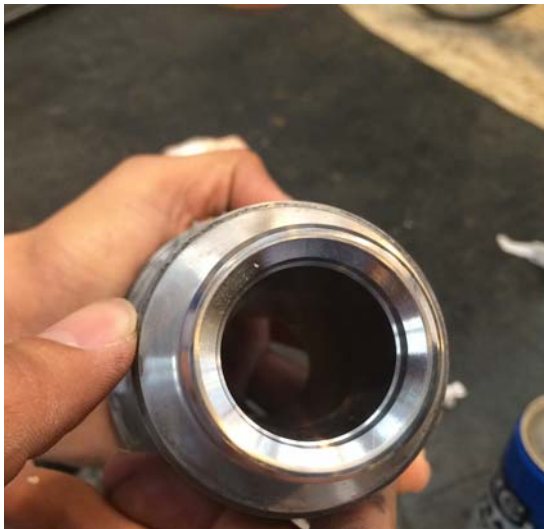
The damaged Nozzle

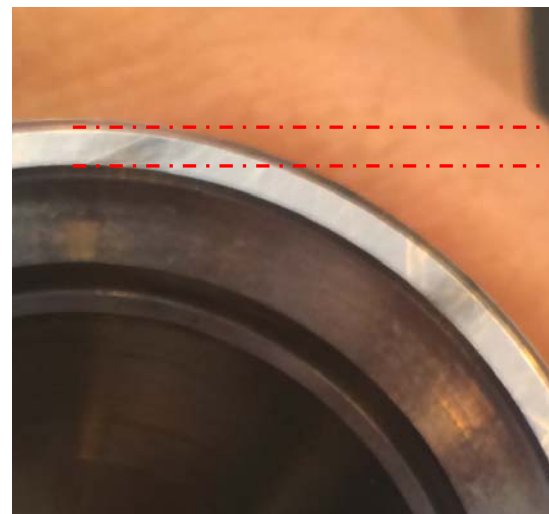
0.9 mm

Nozzle deformed
and lost around 50%
of their seating
surface

1.6 mm
