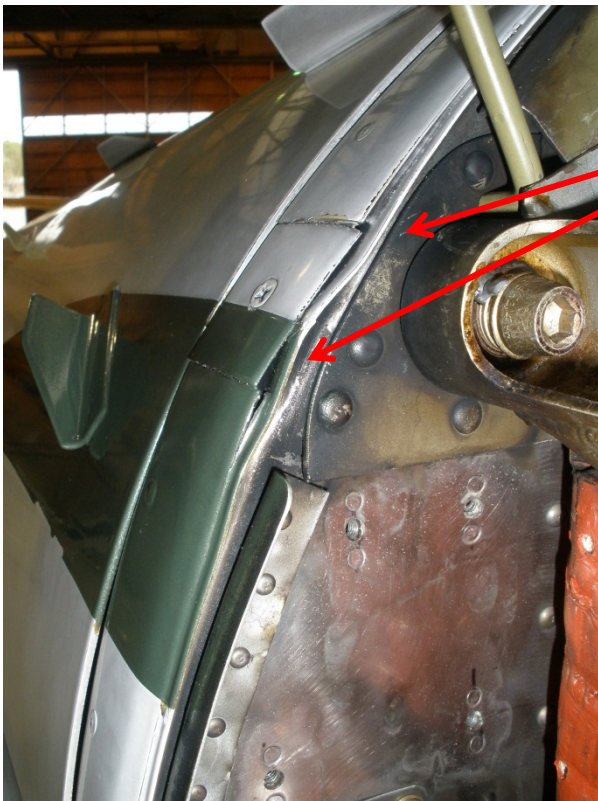
Deformation surrounding upper R/H engine frame attachment to firewall.

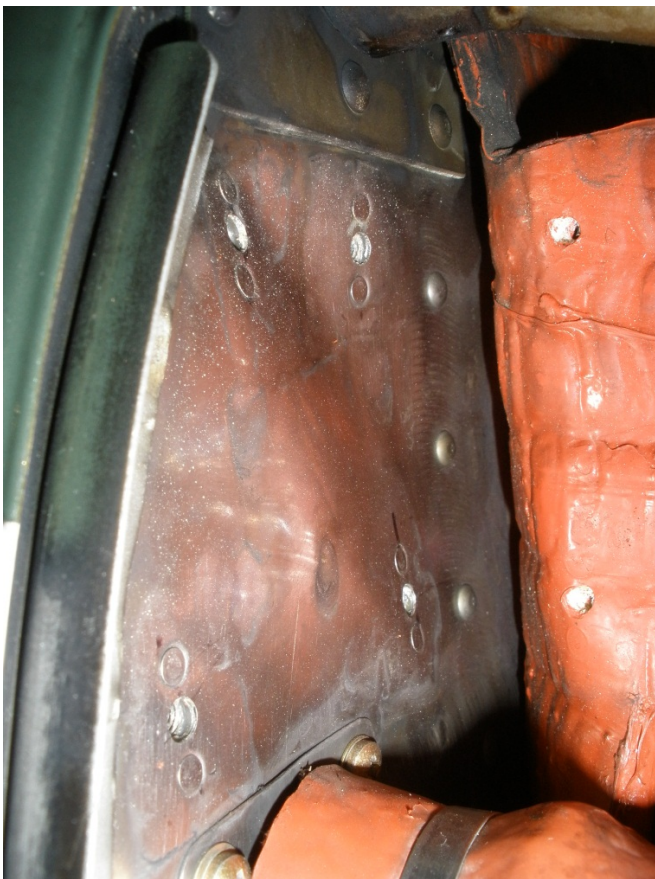
Deformation of doubler of upper R/H engine frame attachment point

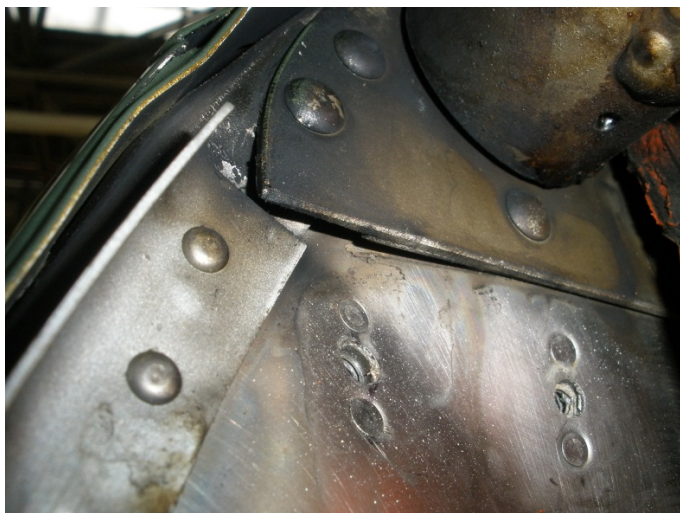
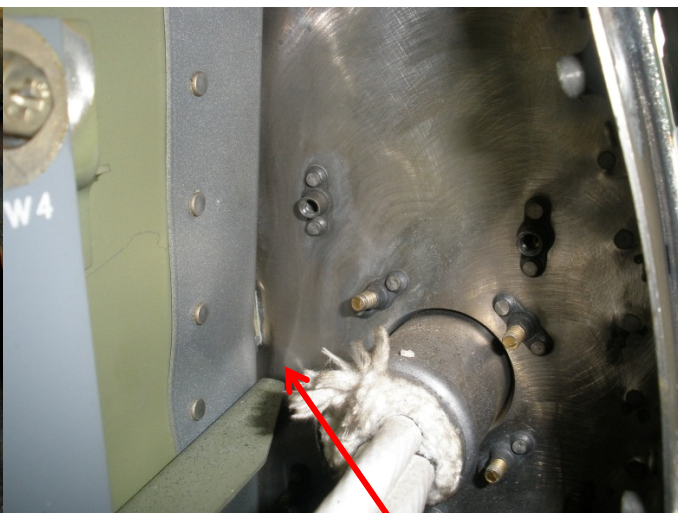
Rear side of firewall behind upper R/H engine
frame attachment point

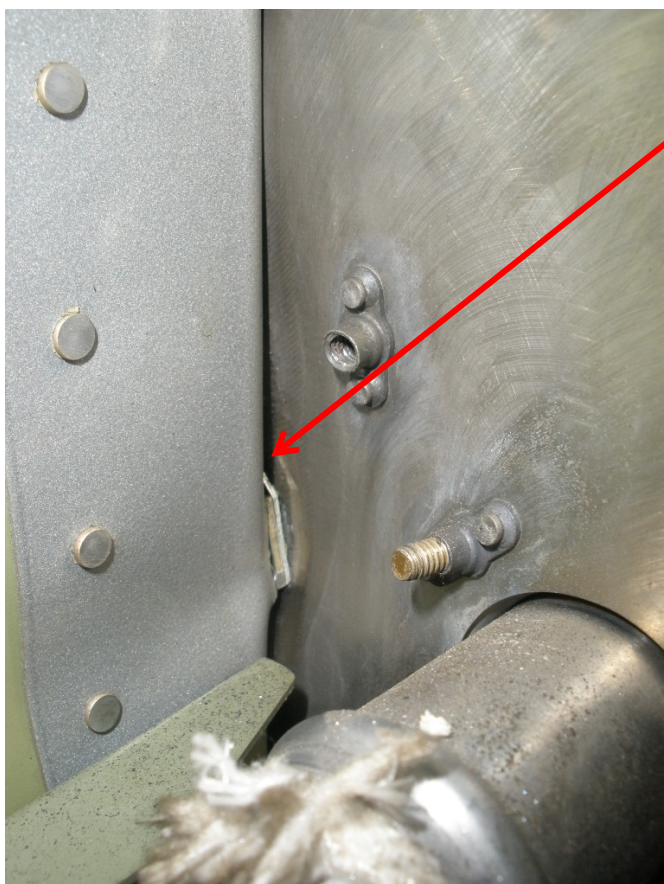
Further down above angle, on rear
side of firewall R/H side

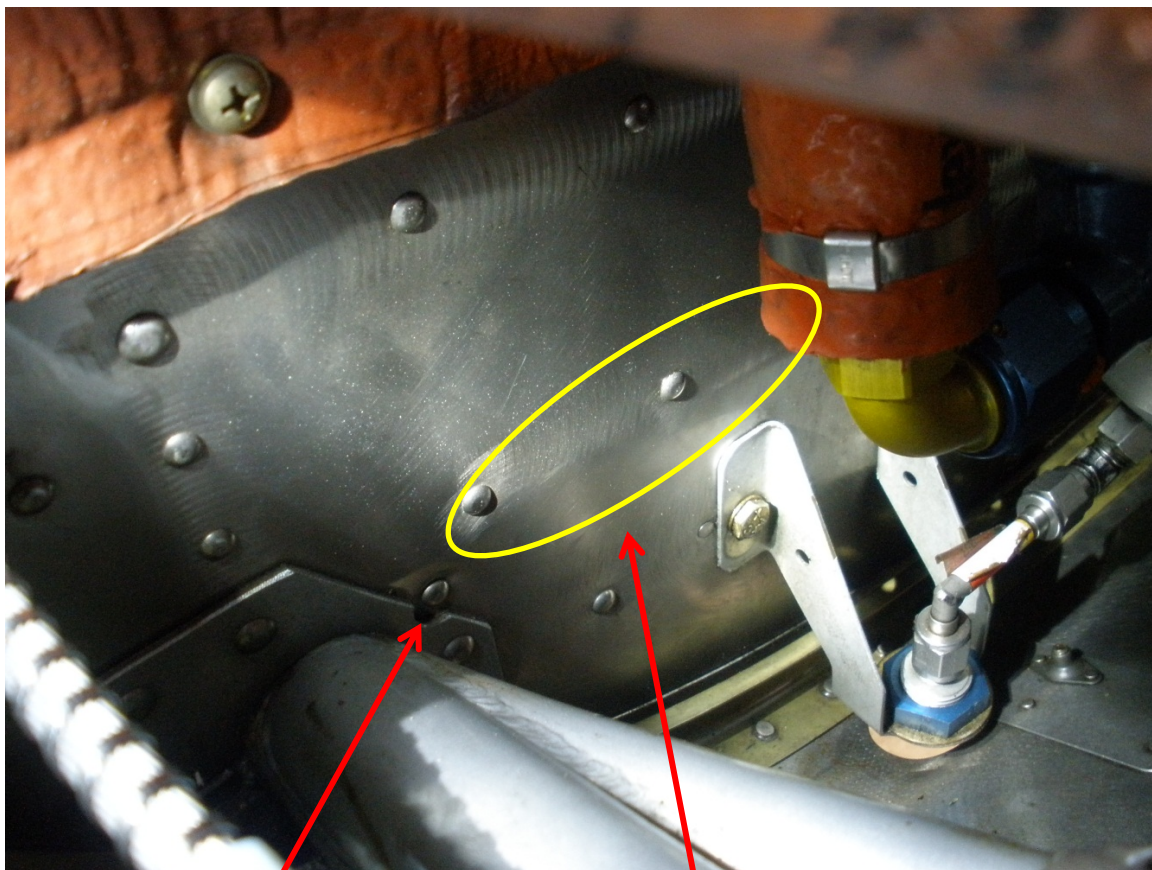
Rivet pulled in and creasing evident around lower R/H engine frame attachment point to firewall.

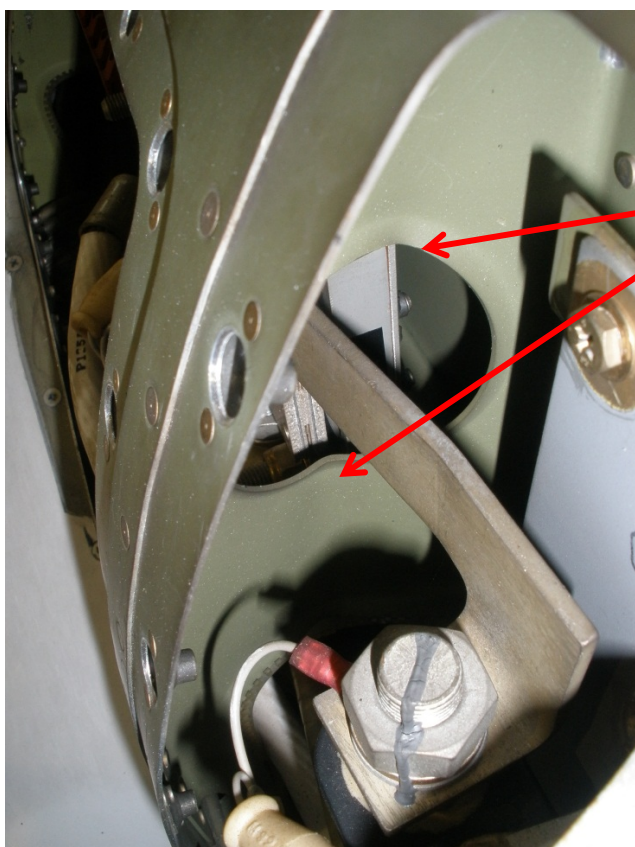
Forward View

Next frame back from firewall R/H side on engine nacelle.

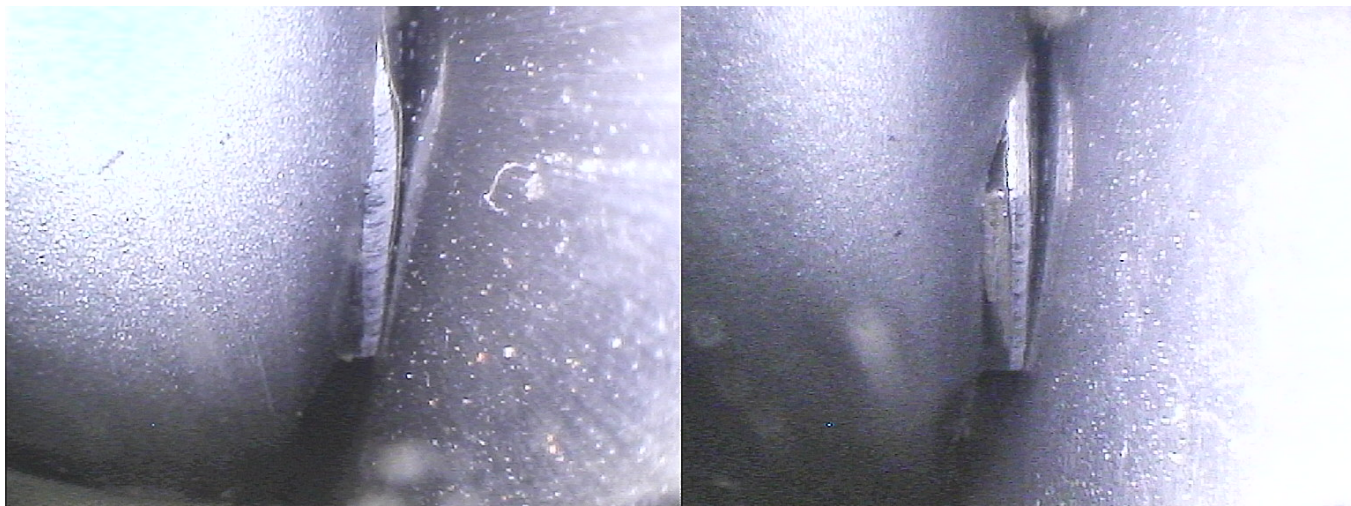
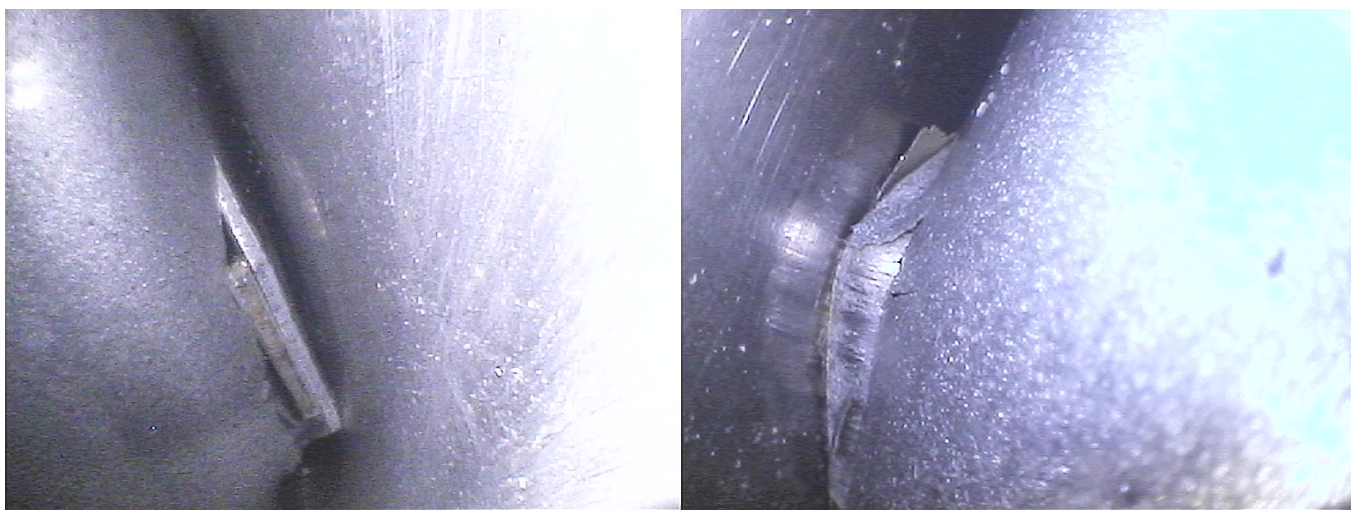
Rear View

More pictures of rear side of firewall showing torn metal attachment points. View is magnified as pictures were taken with a borescope. Looking at LH Nacelle box where it connects aft of the firewall.

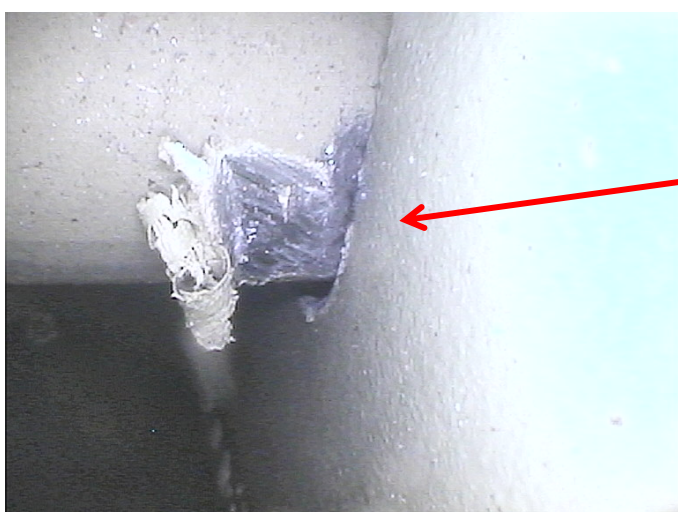
Chaffing mark on stringer through frame on engine nacelle.
