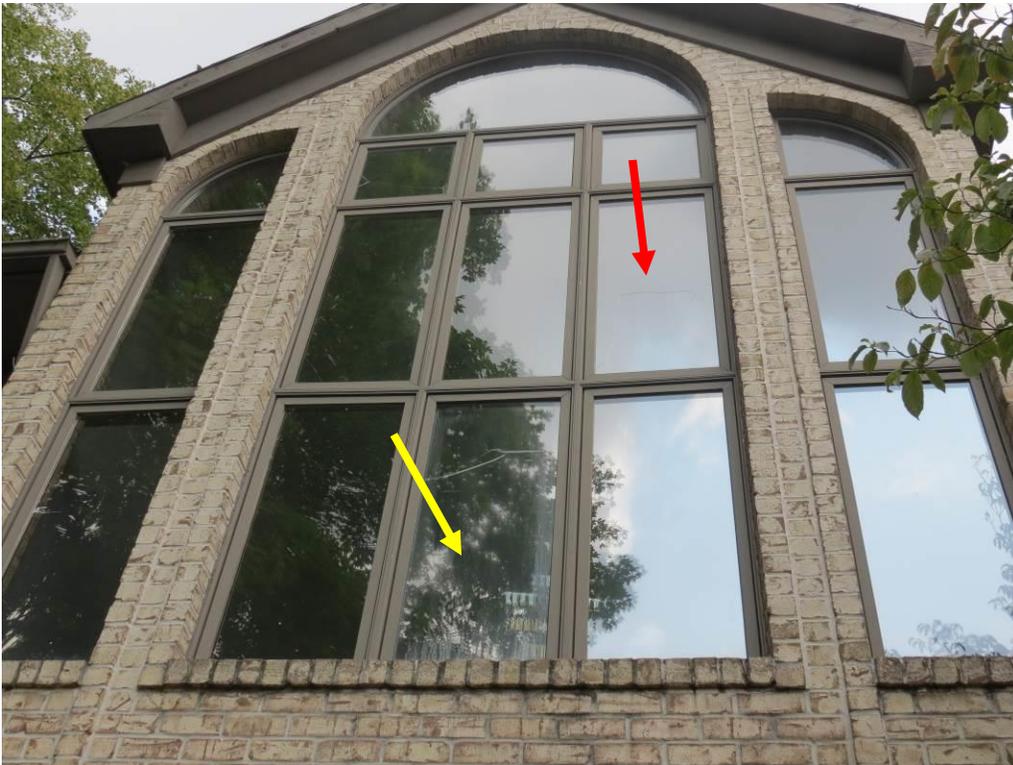
Photograph 2: Horizontal crack in window pane (indicated by red arrow). Heavy condensation build up between panes is indicated by yellow arrow.

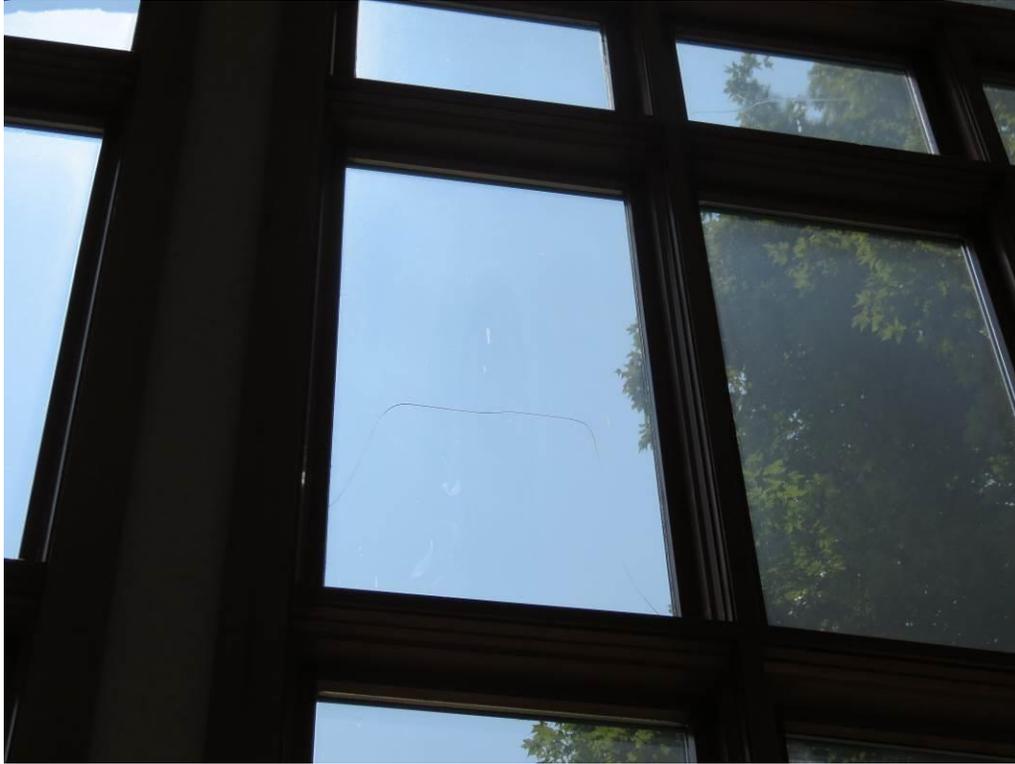
Photograph 3: Interior view of horizontal crack in window pane.

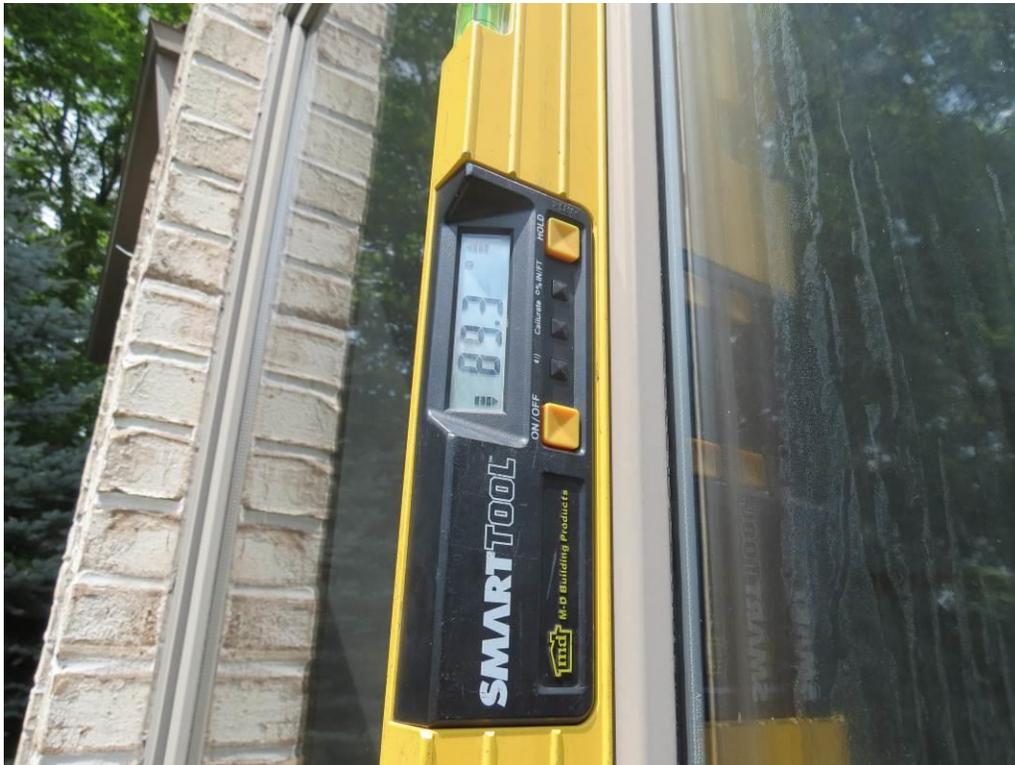
Photograph 4: Window is leaned inward by as much as a measured 0.7 degrees.

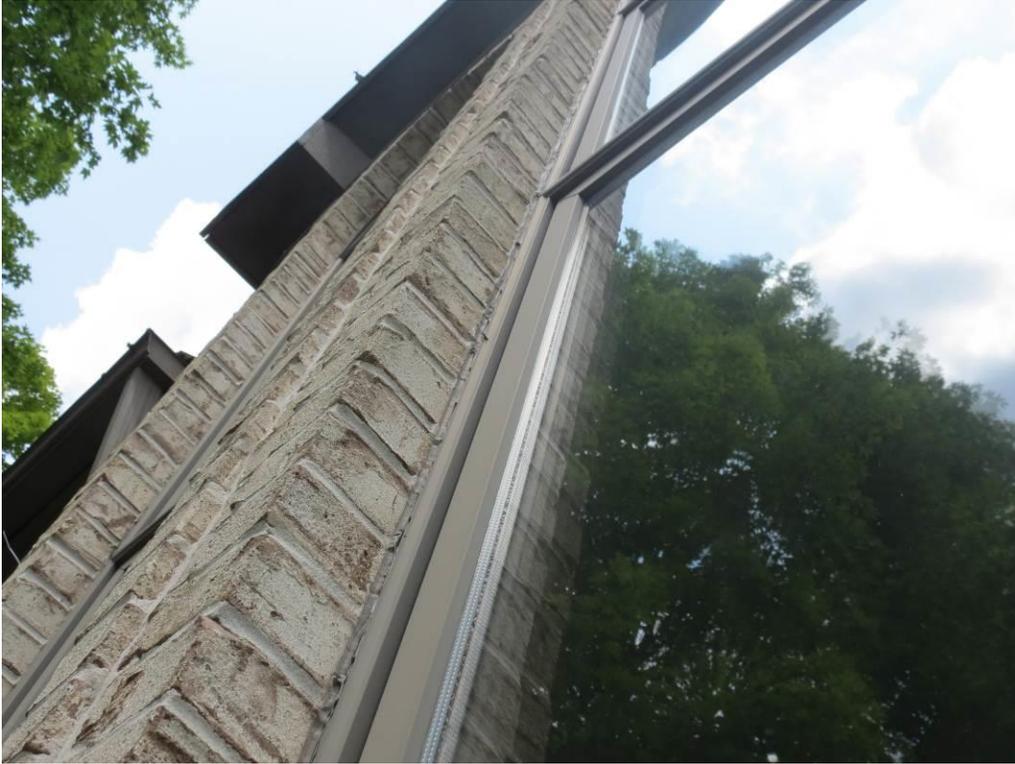
Photograph 5: No apparent separation between window frame and brick veneer.

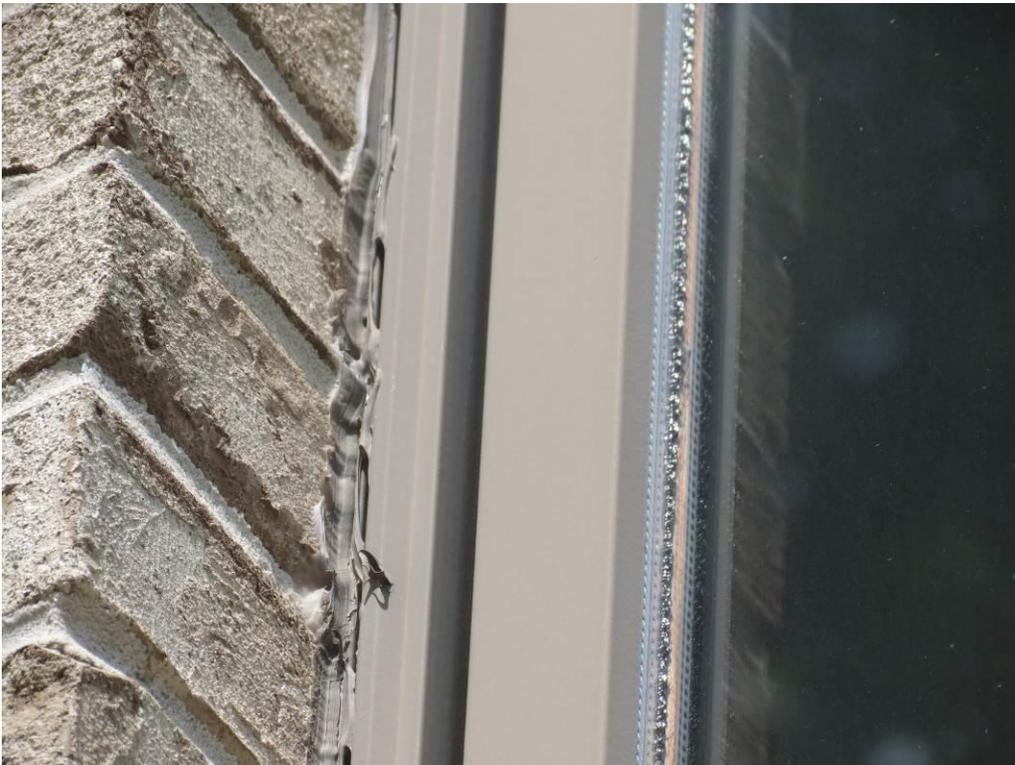
Photograph 6: No apparent separation between window frame and brick veneer. No tears in caulk.

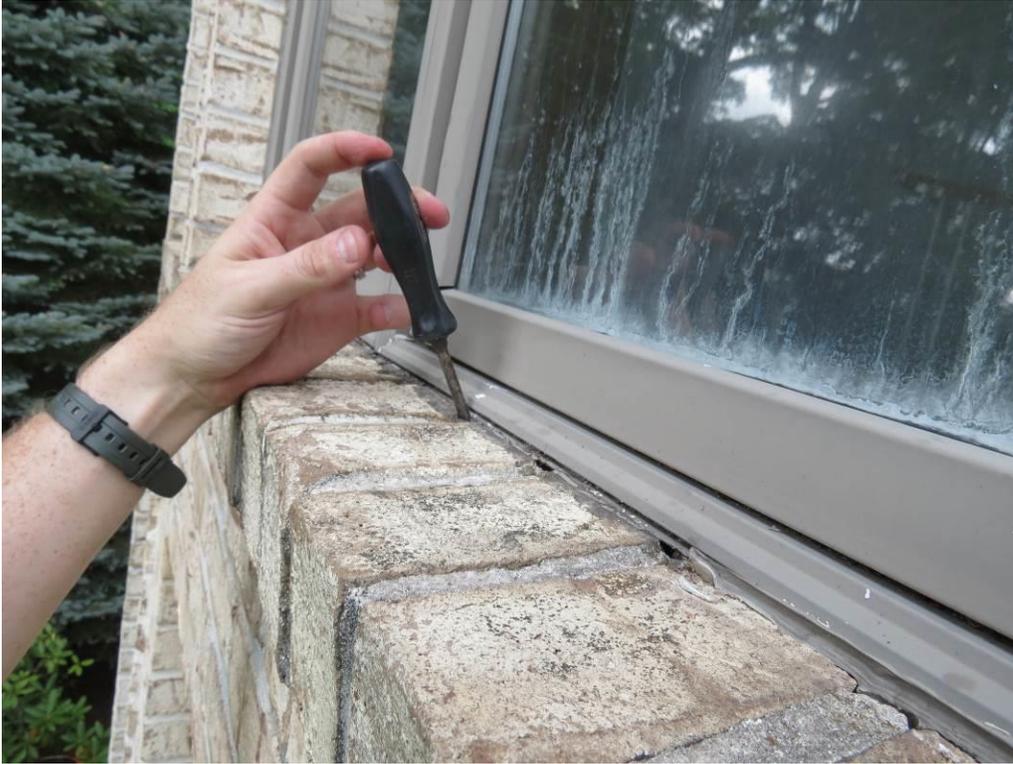
Photograph 7: Gaps between brick sill and window.

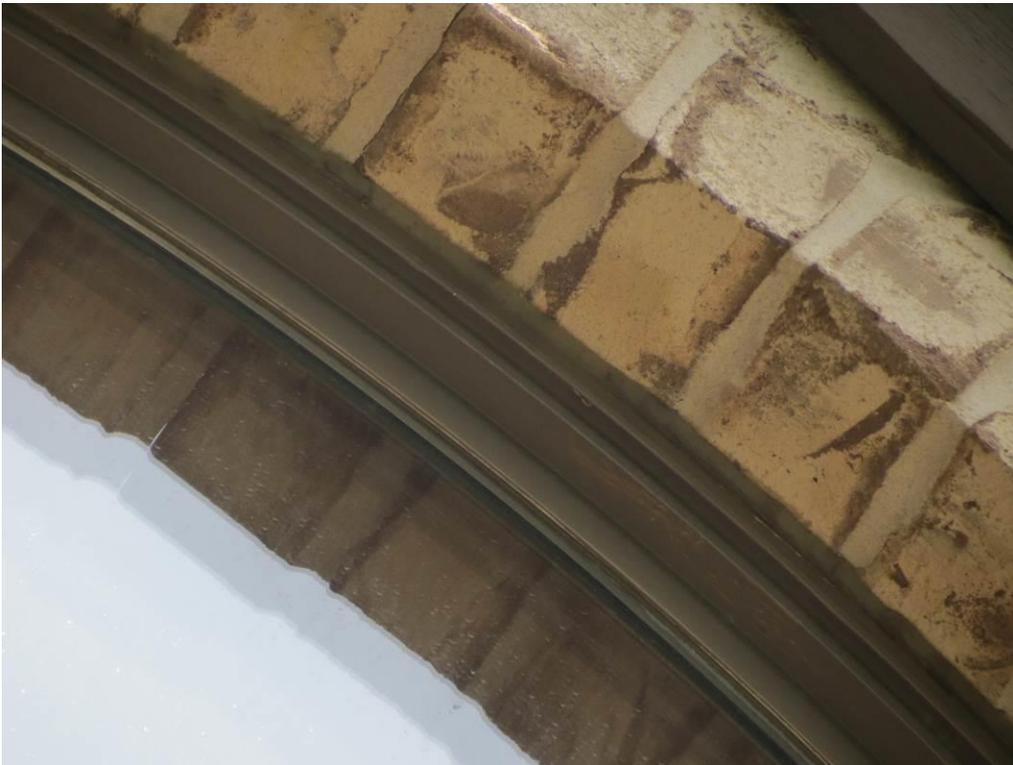
Photograph 8: No apparent movement between top of window and bottom of rowlock coursing above window.

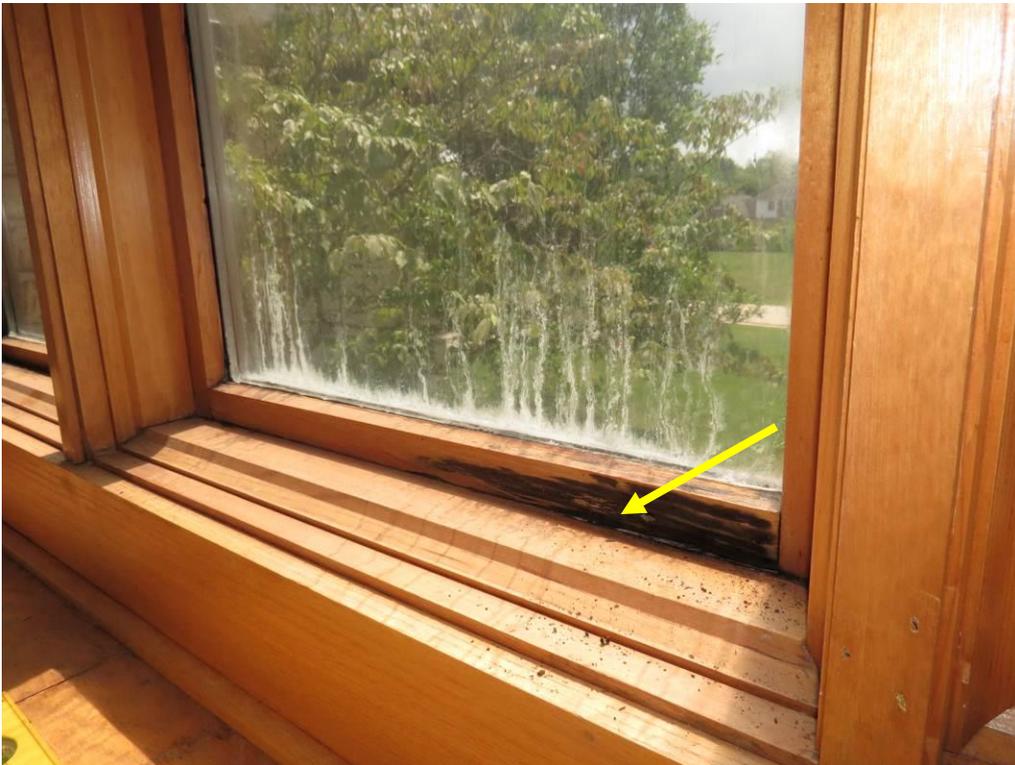
Photograph 10: Condensation build up. Black staining in area of wood rot (yellow arrow).

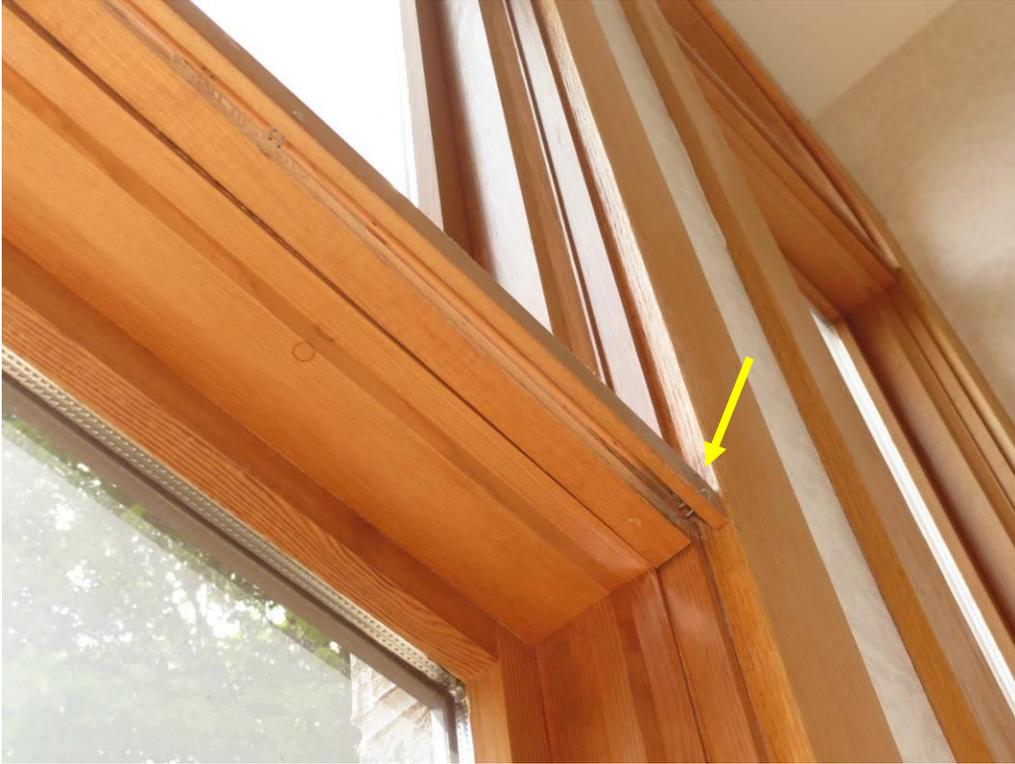
Photograph 11: Staple pop (indicated).

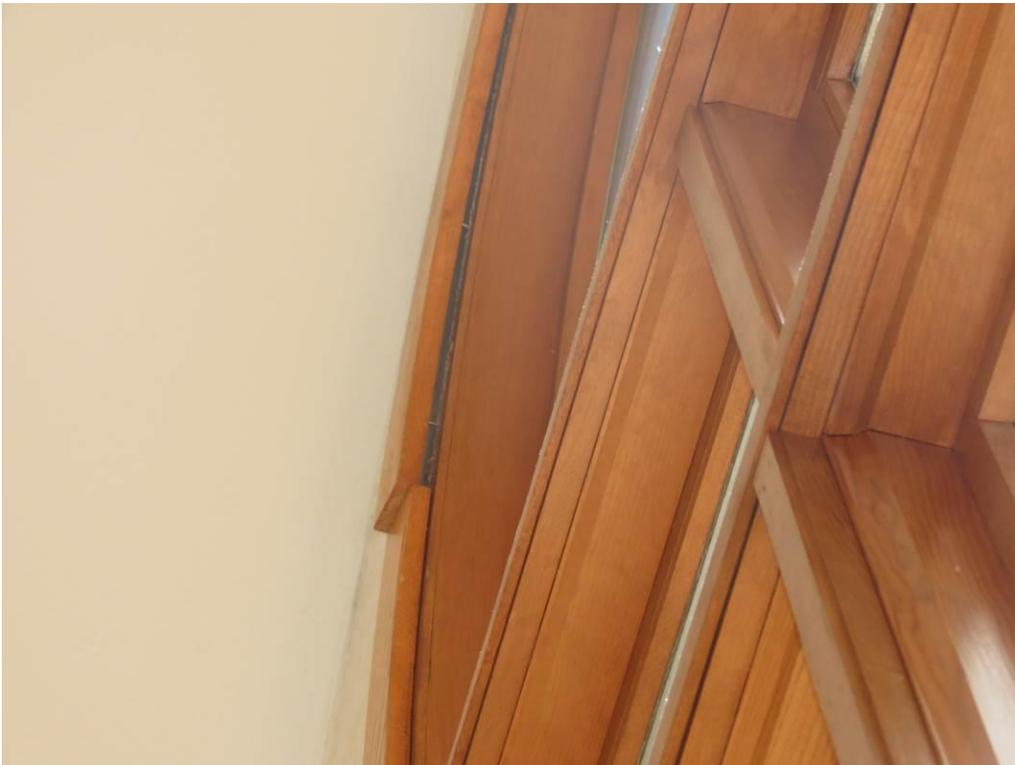
Photograph 12: Popped-off paneling.
