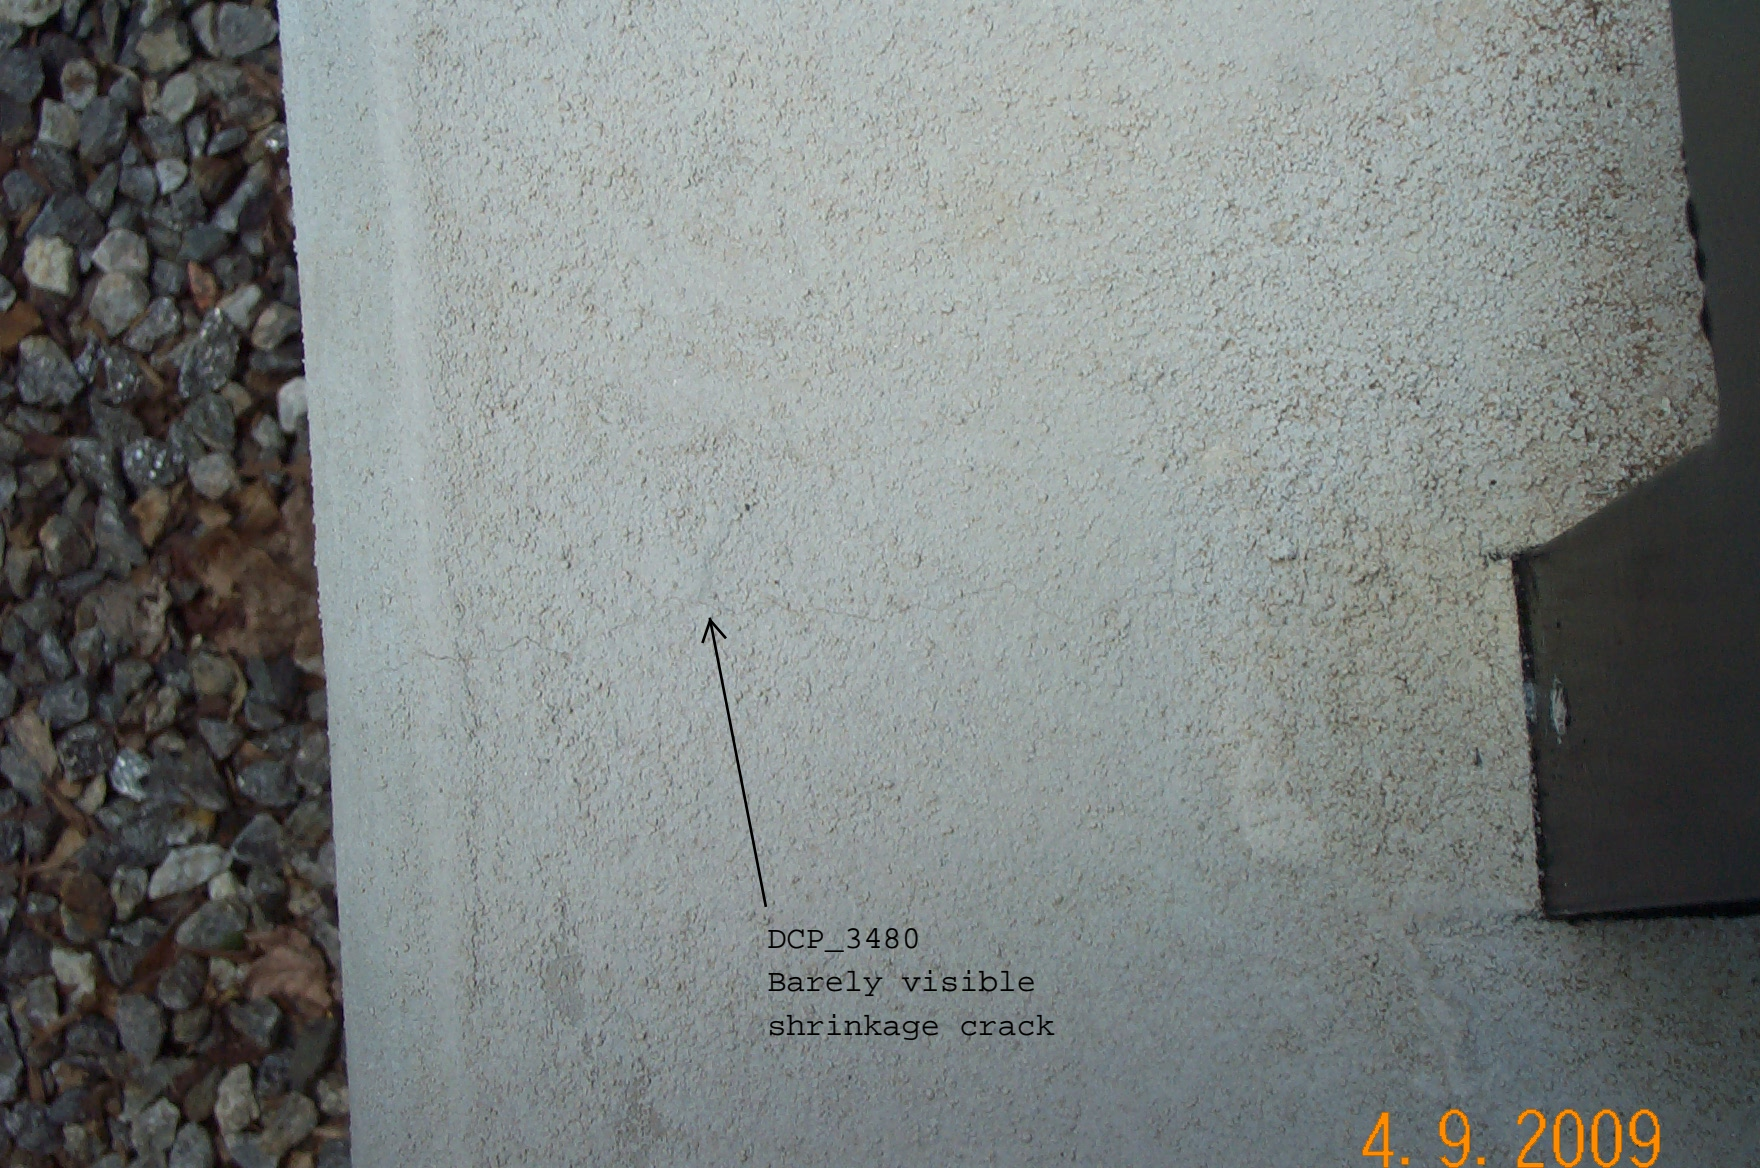
DCP_3480

Barely visible
shrinkage crack

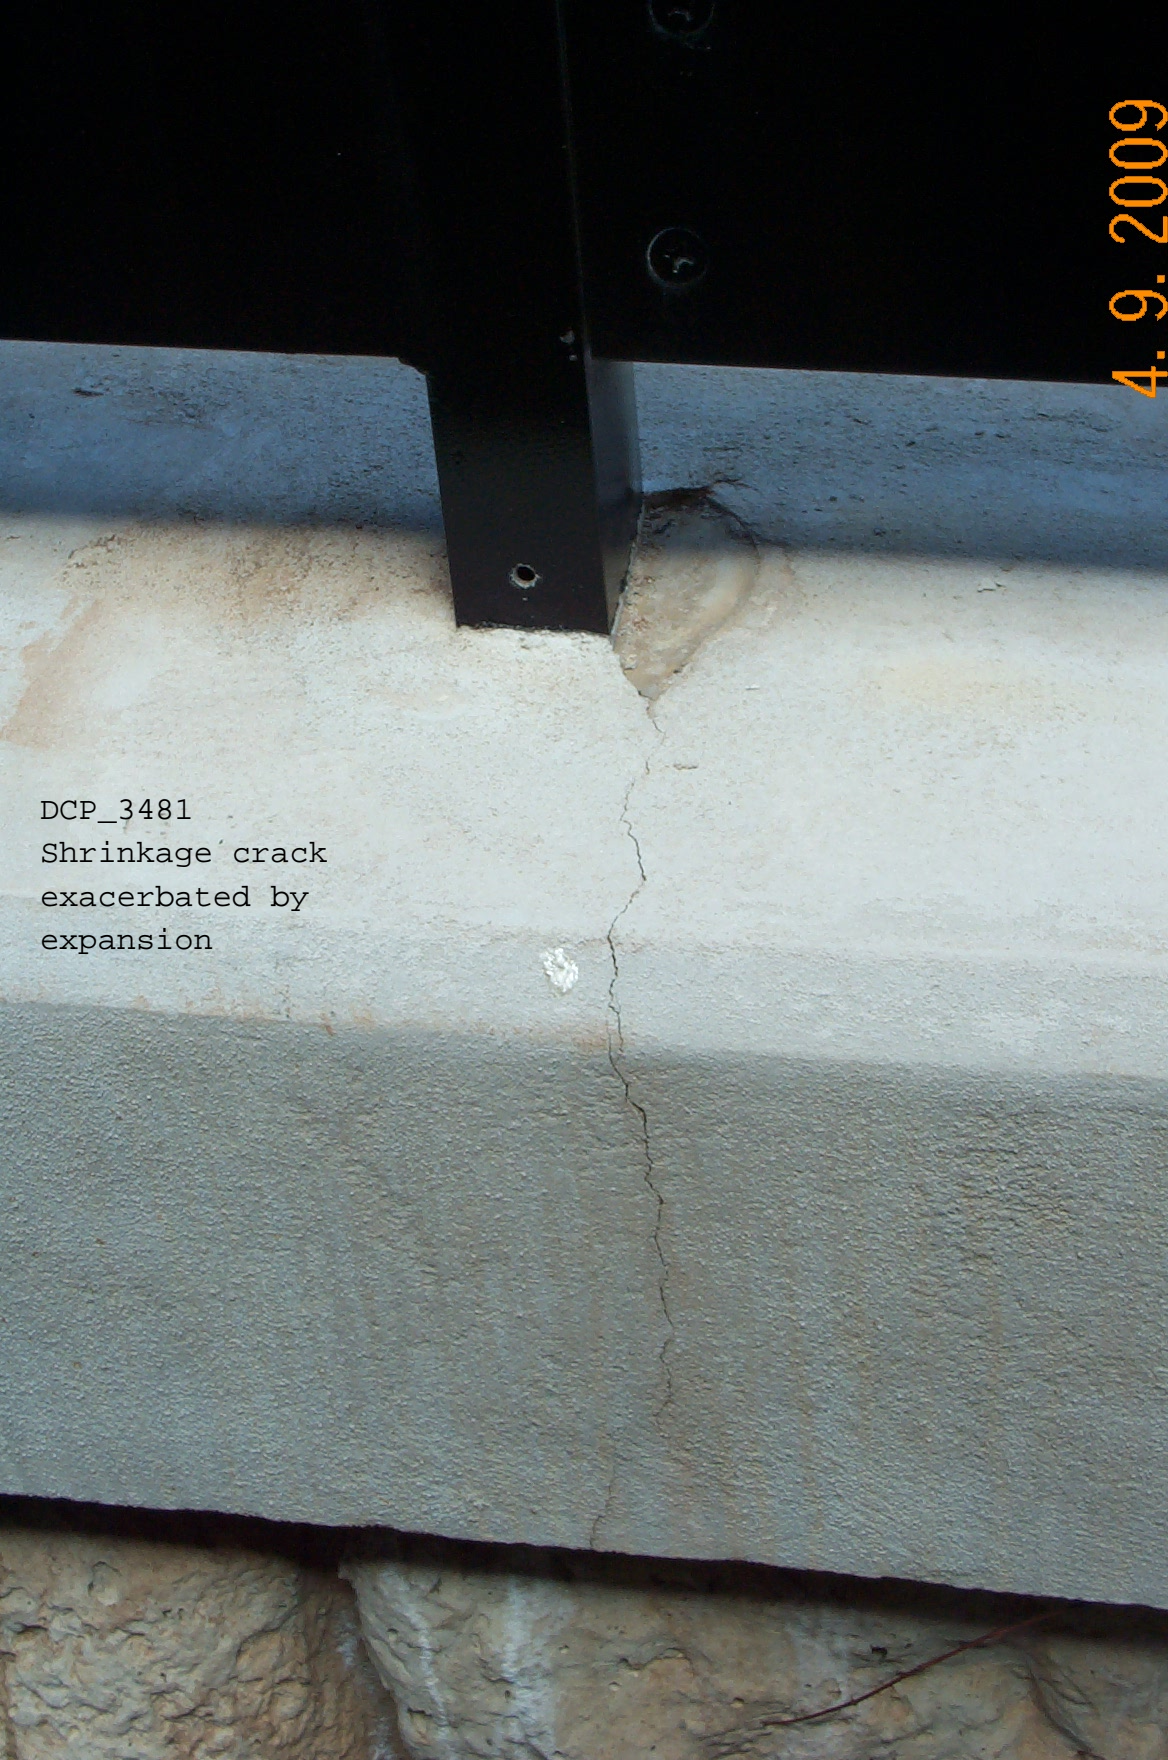
DCP_3481
Shrinkage crack
exacerbated by
expansion

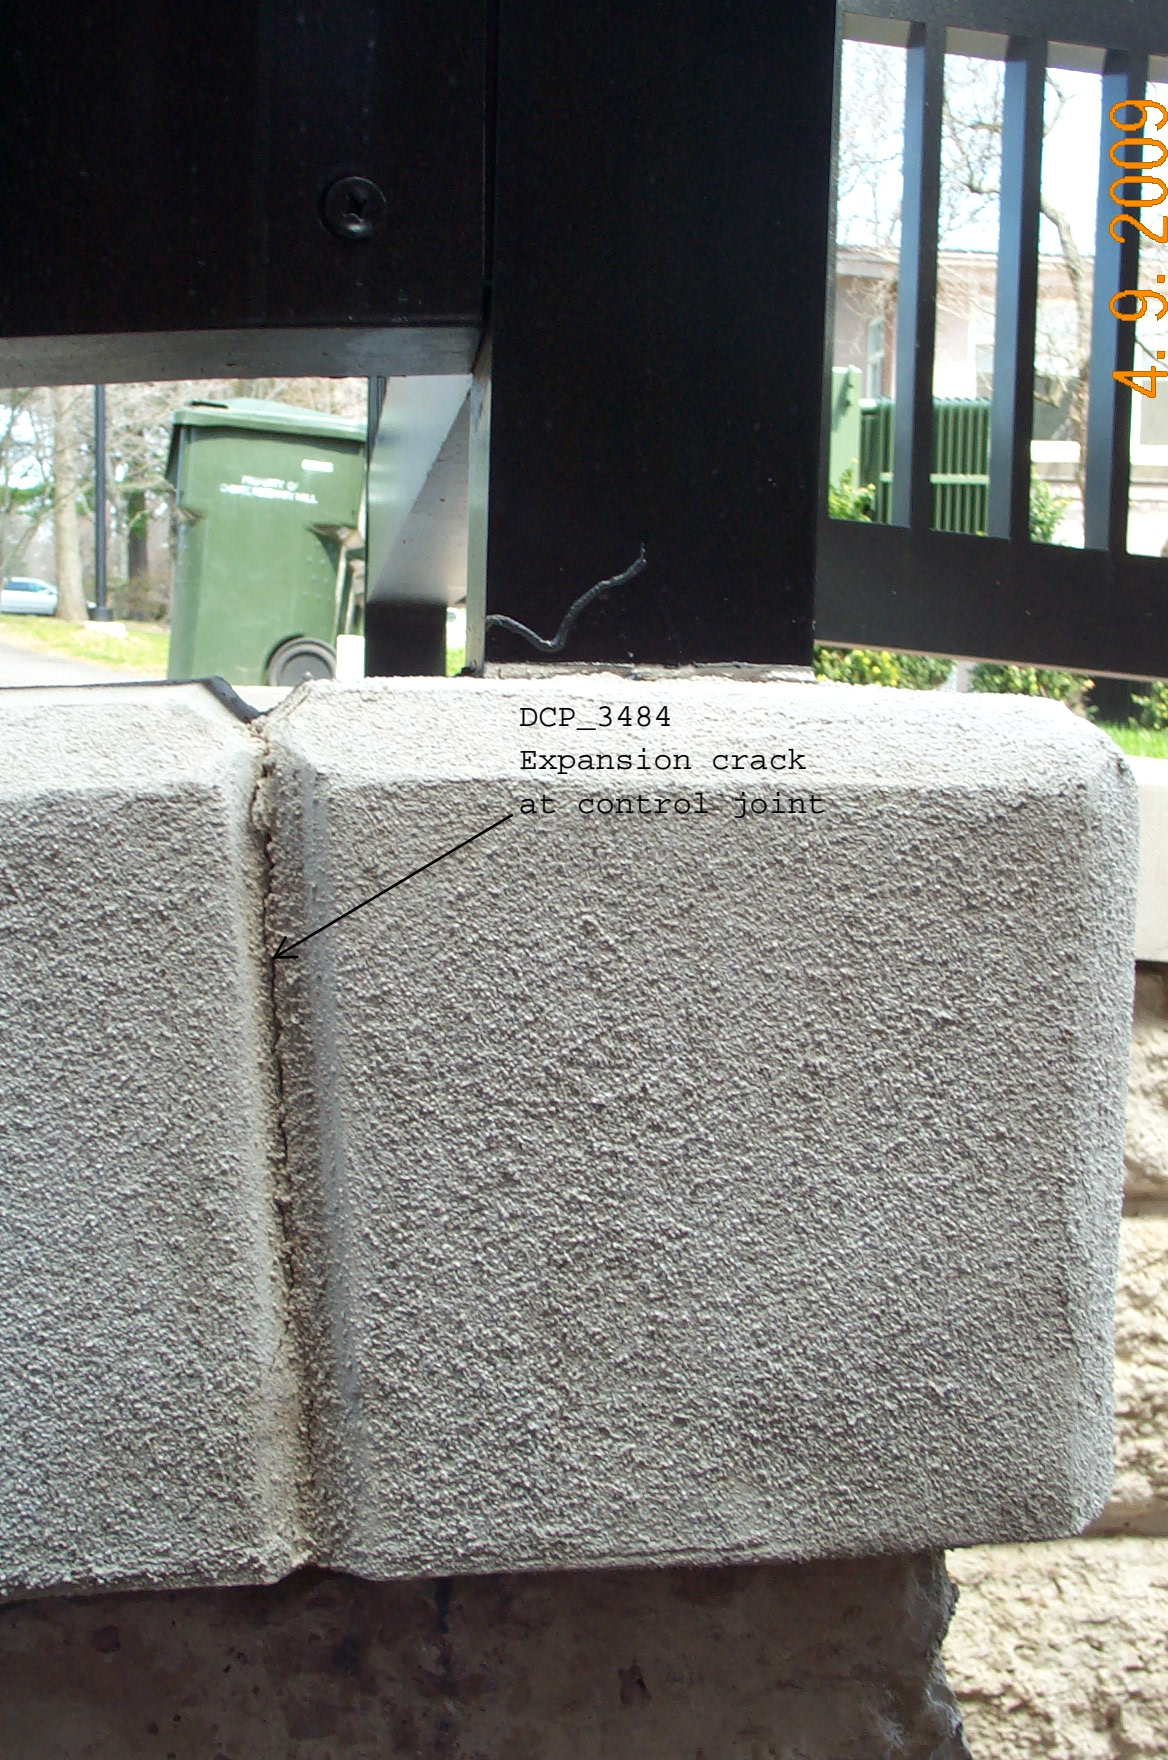
DCP_3484

Expansion crack
at control joint
