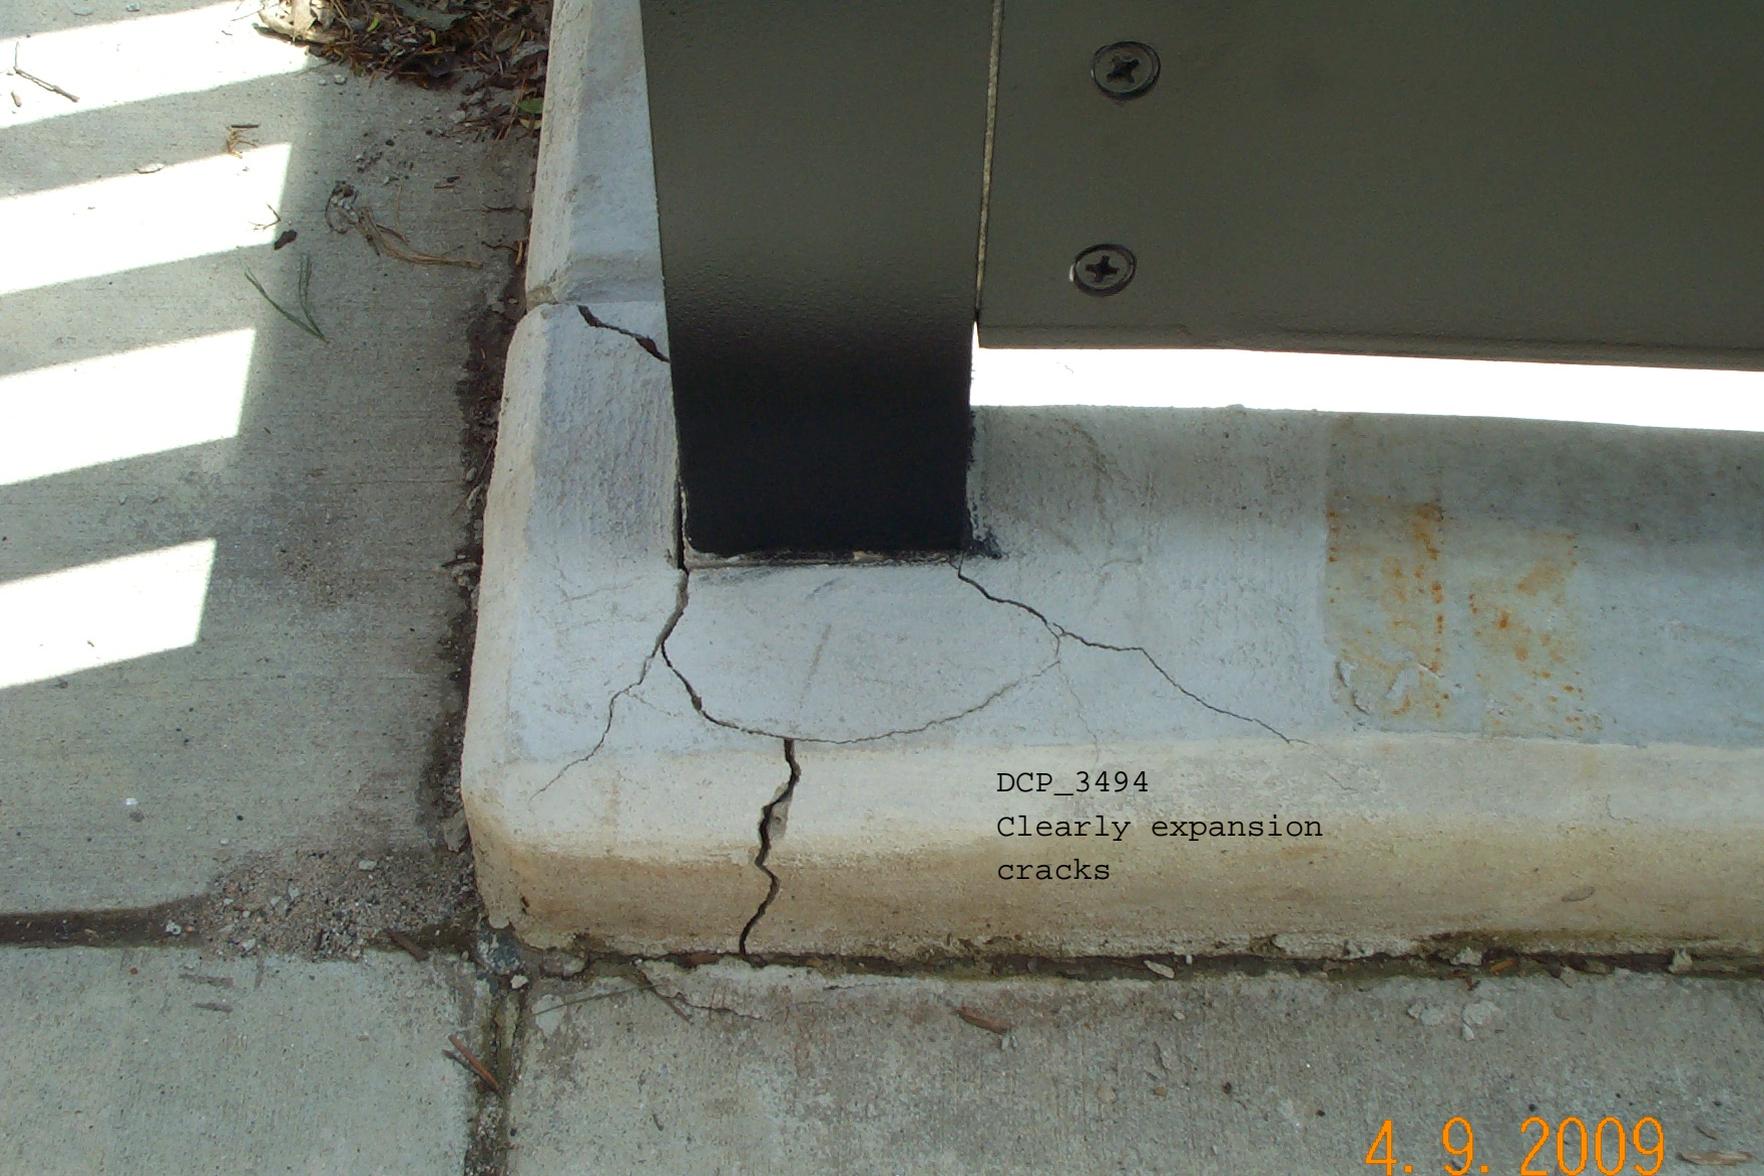
DCP_3494
Clearly expansion
cracks
