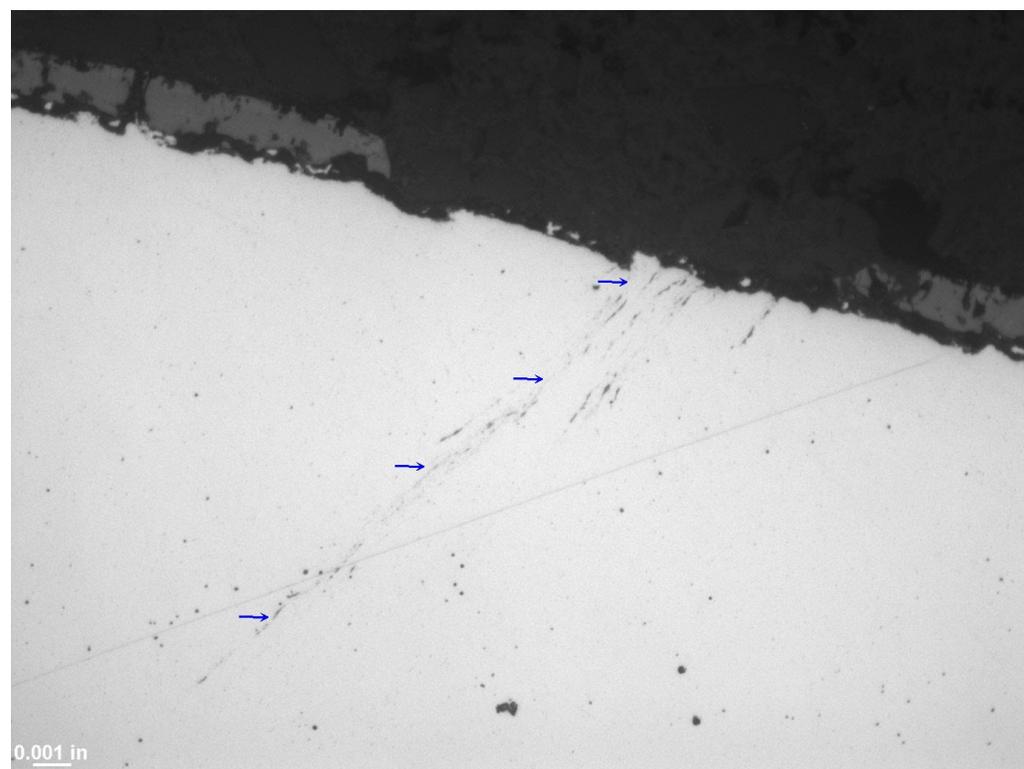
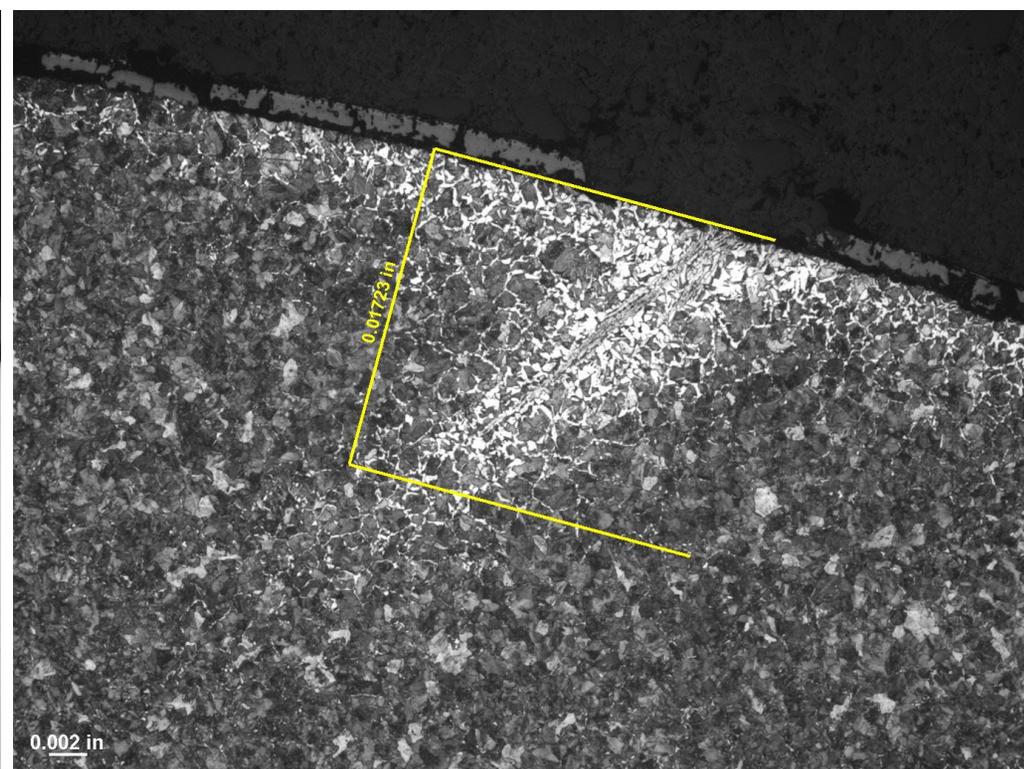
Views of rolled-in scale in polished (left photo, 200x) and etched (right photo, 100x) condition.  
The defect is heavily decarburized and penetrates to approximate depth 0.017".

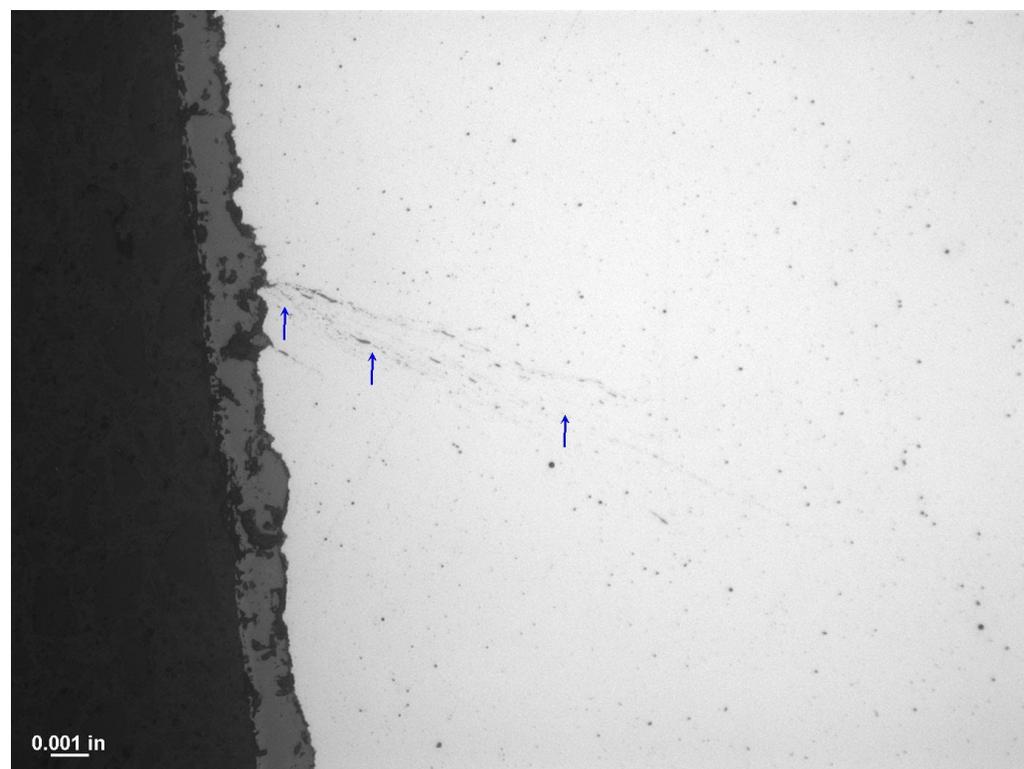
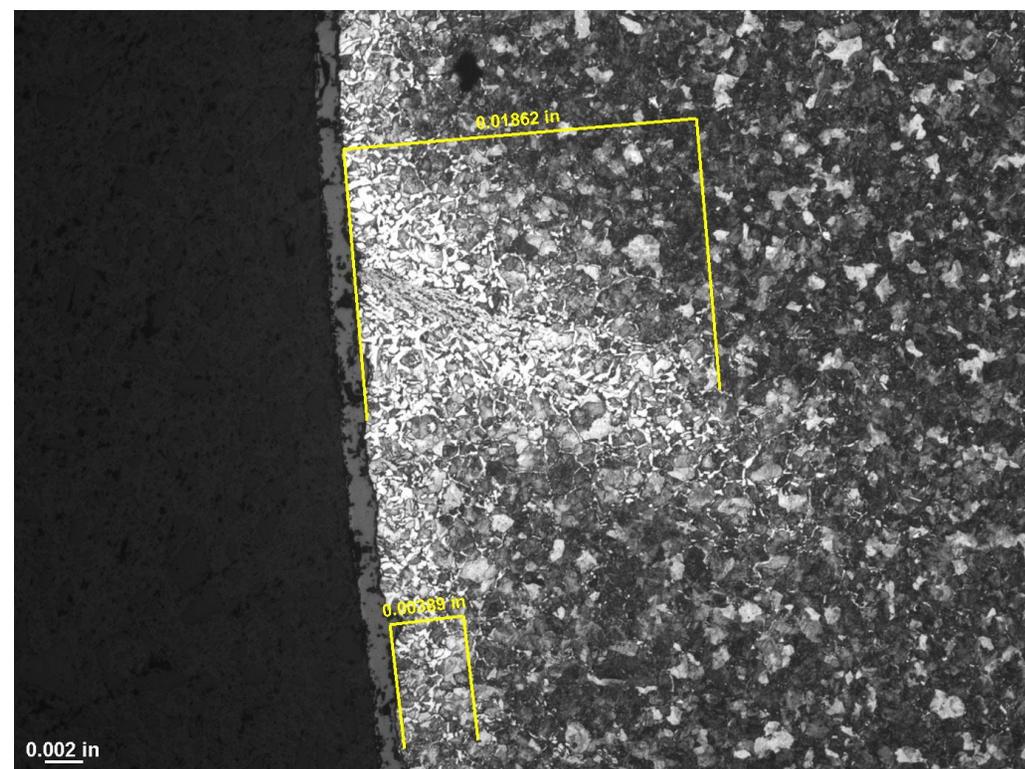
Additional views of rolled-in scale in polished (left photo, 200x) and etched (right photo, 100x) condition.  
The defect is heavily decarburized and penetrates to approximate depth 0.018".  
A thin decarburized layer of roughly 0.003-0.004" was visible around the full perimeter.
