**Depressurisation  
475 km north-west of Manila,  
Philippines  
25 July 2008  
Boeing Company 747-438, VH-OJK**

Released under Section 25 of the *Transport Safety Investigation Act 2003* as part of ATSB Preliminary Report AO-2008-053

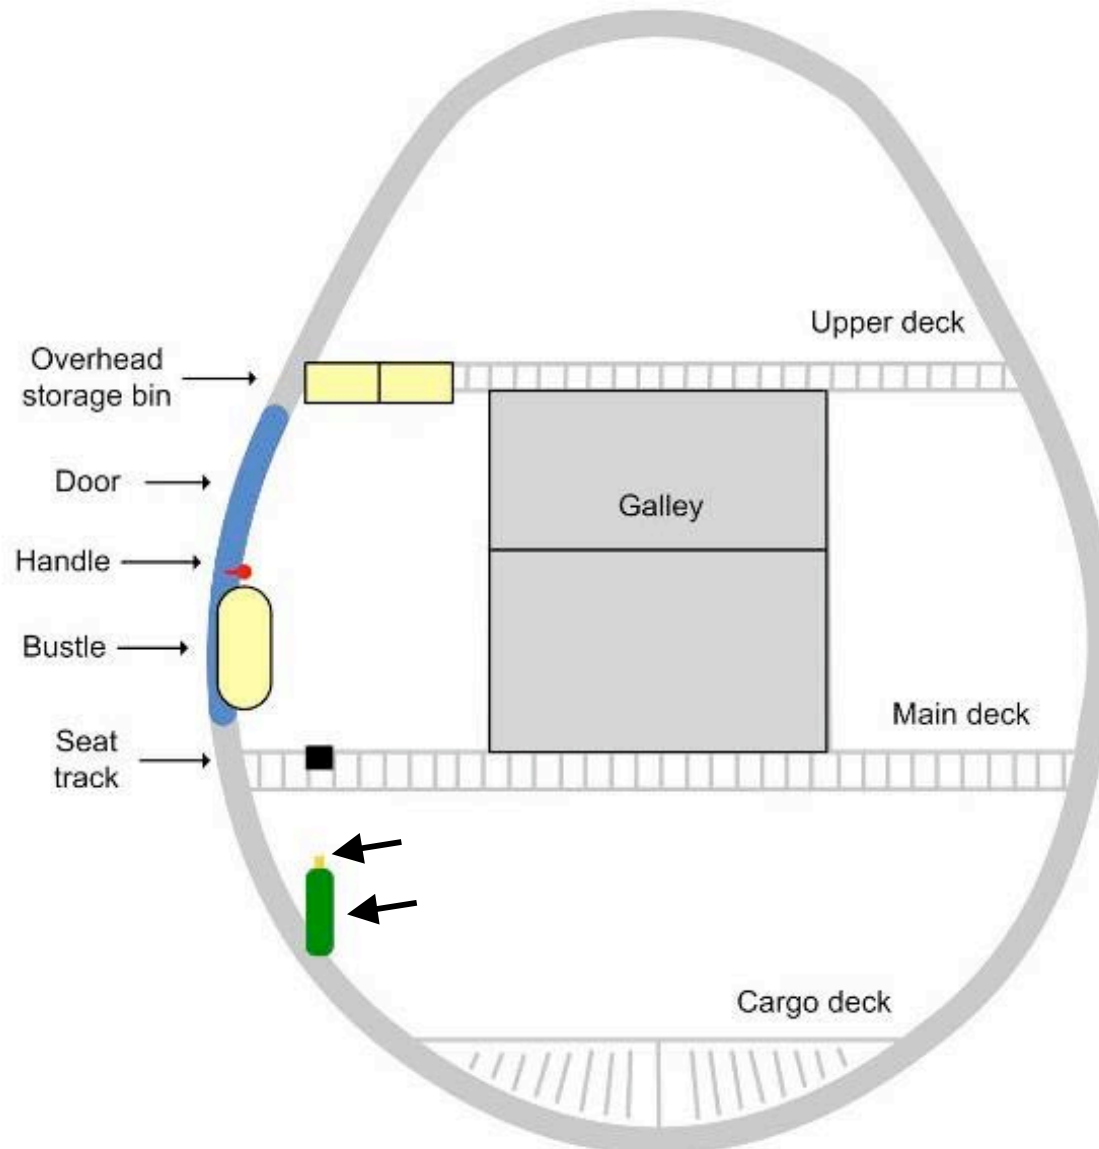
**1. Normal arrangement  
(Oxygen cylinder and valve arrowed)**

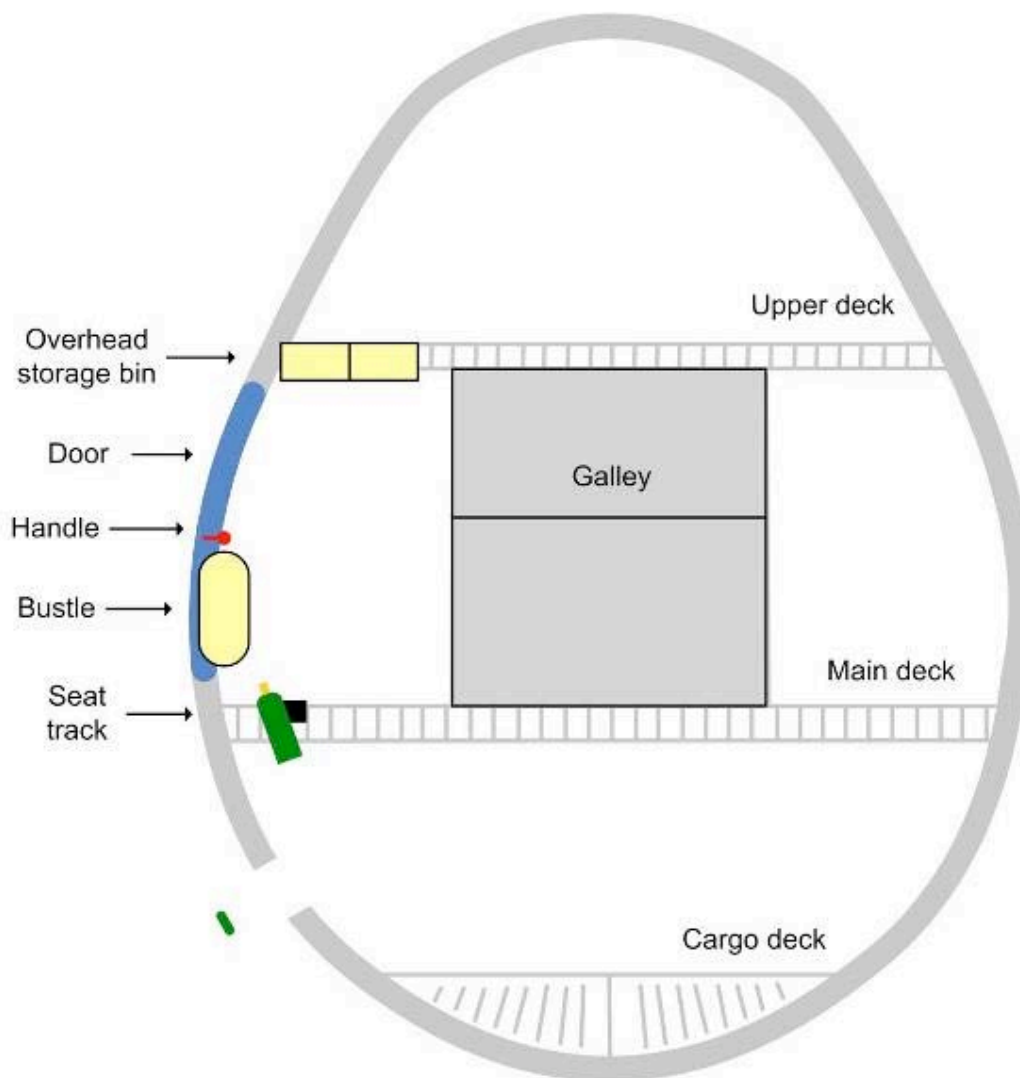
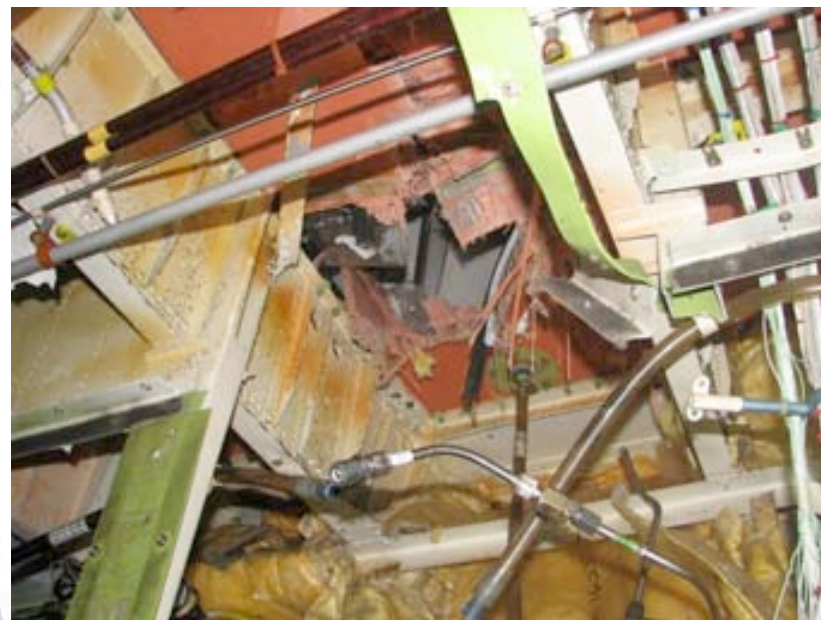
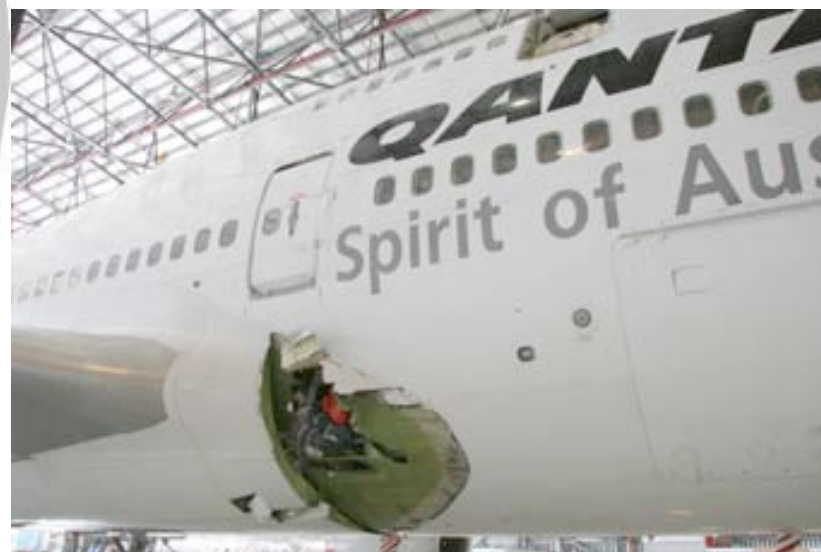
**2. Cylinder failure produces fuselage rupture, with bulk of the cylinder length propelled upward through the cabin floor.**

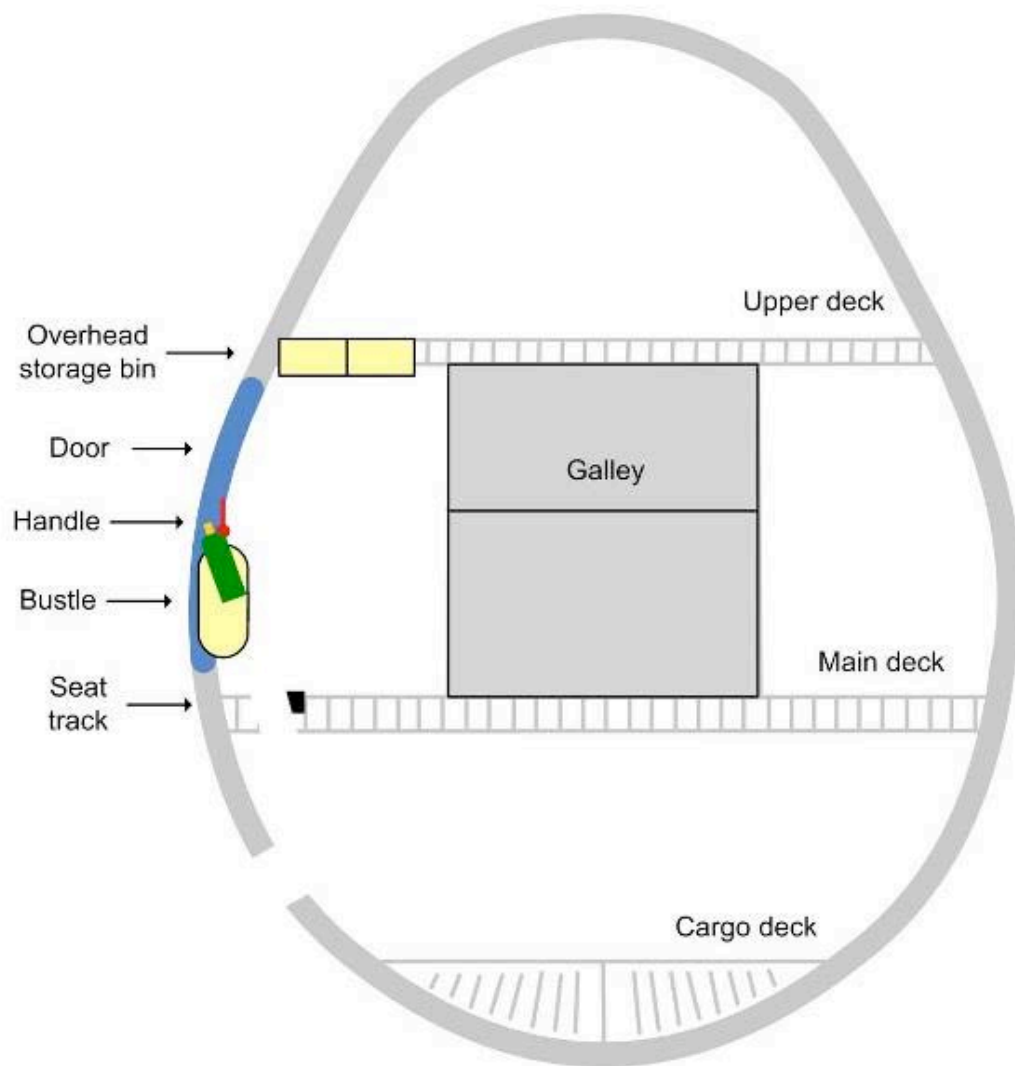
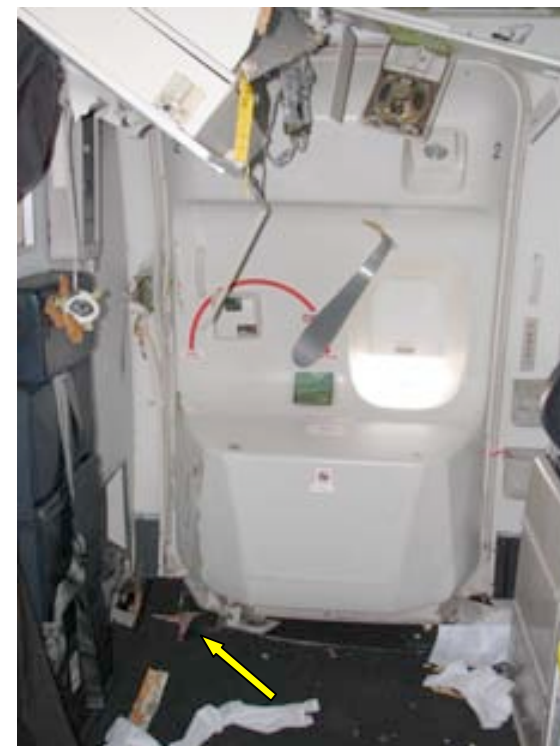
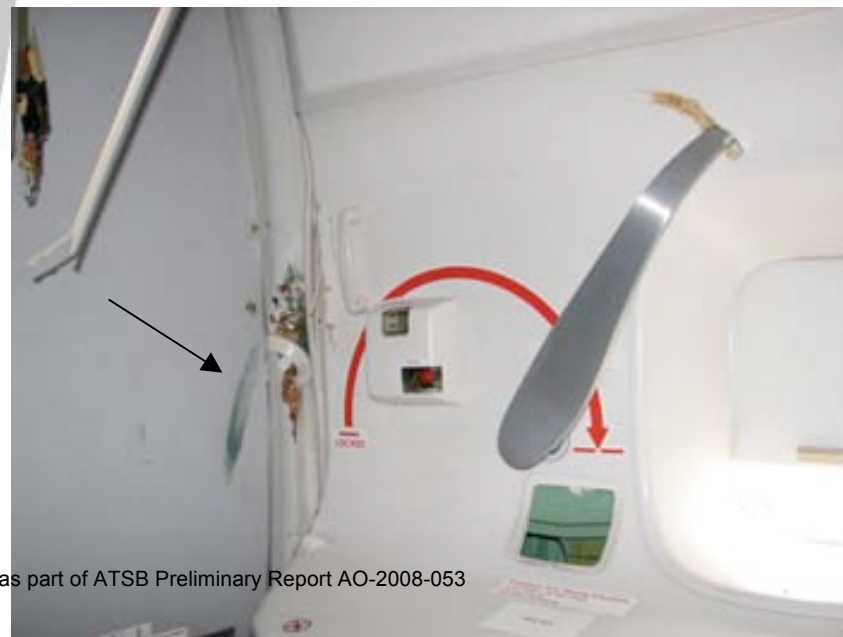
### 3. Cylinder impacts R2 door frame and internal door handle.

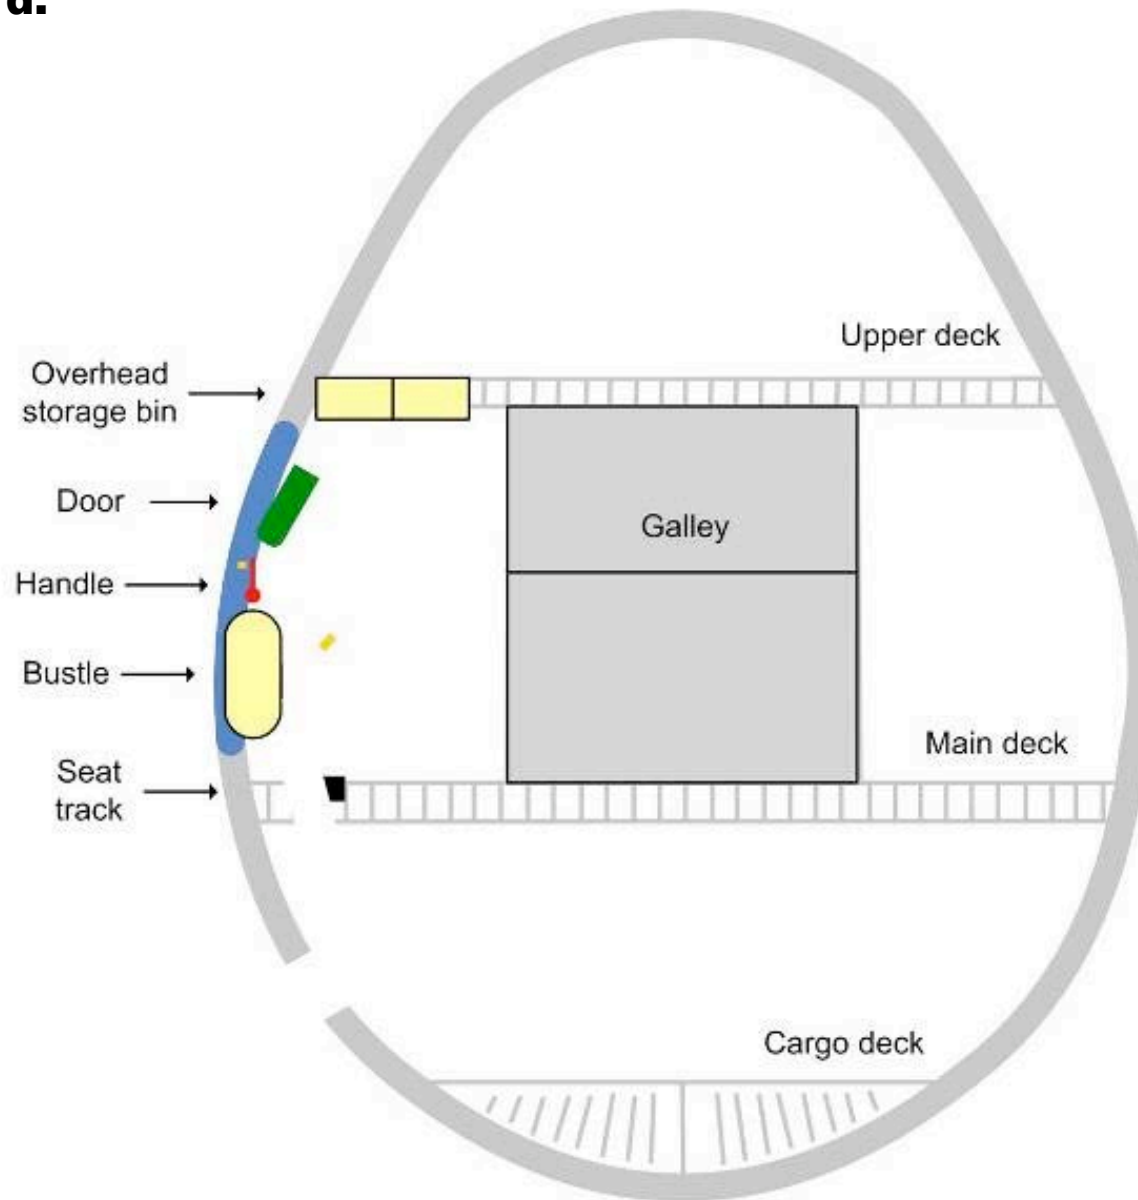
**4. Door frame impact breaks off cylinder valve and causes cylinder to invert while continuing to travel upward.**

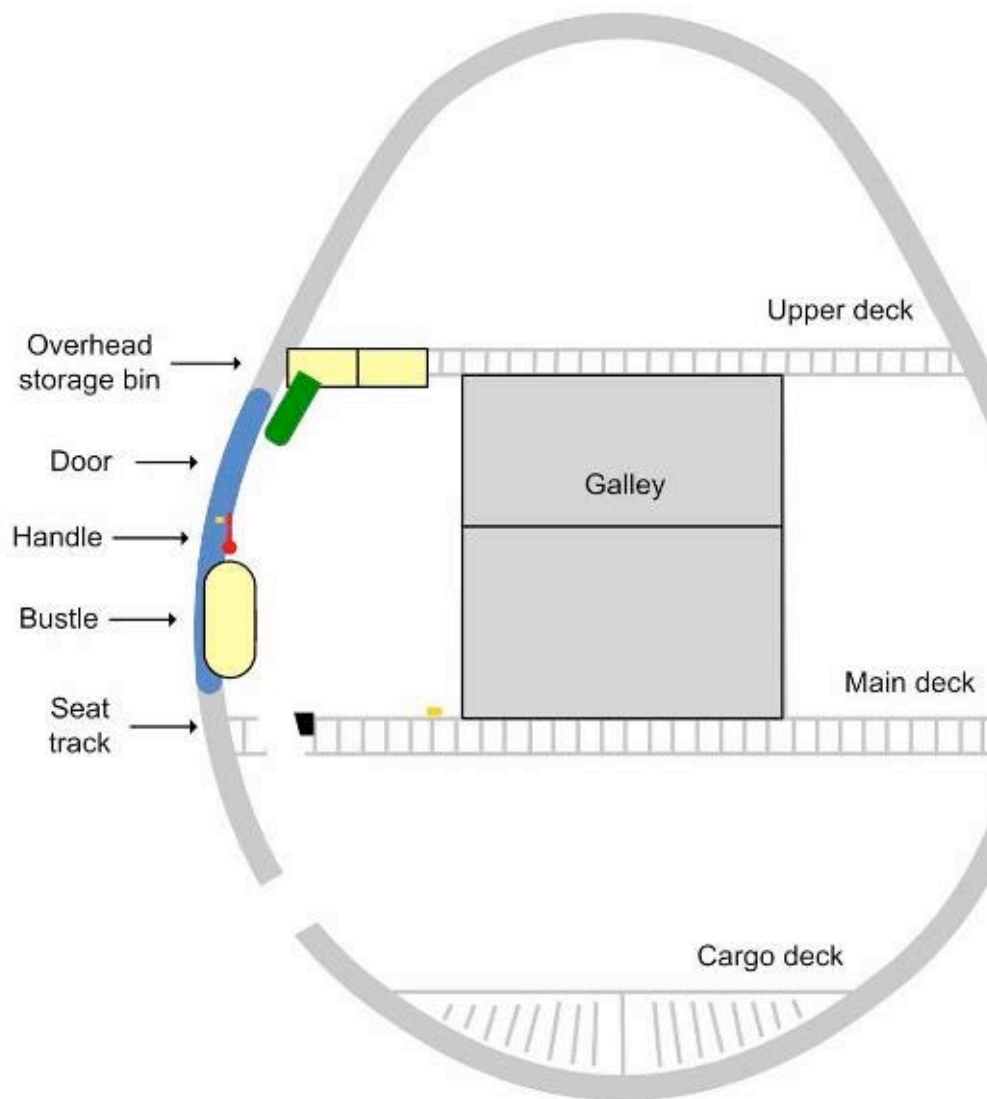
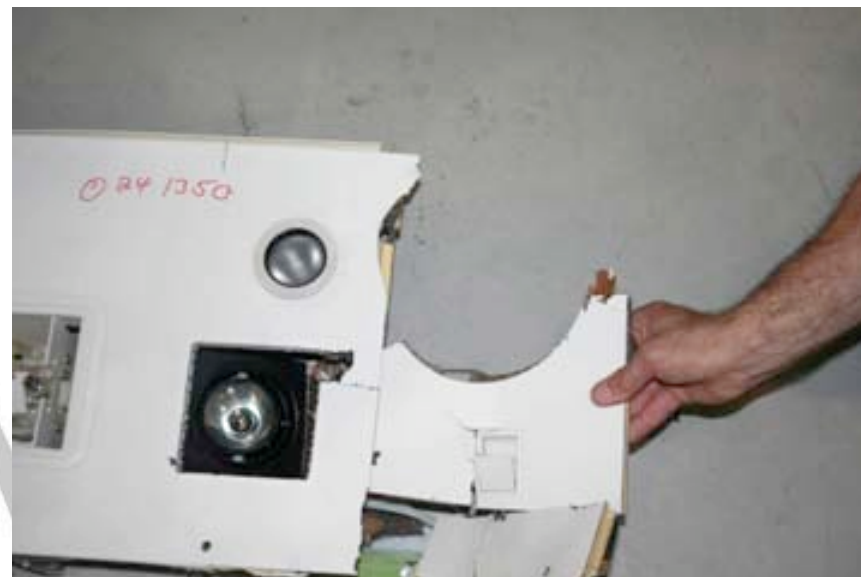
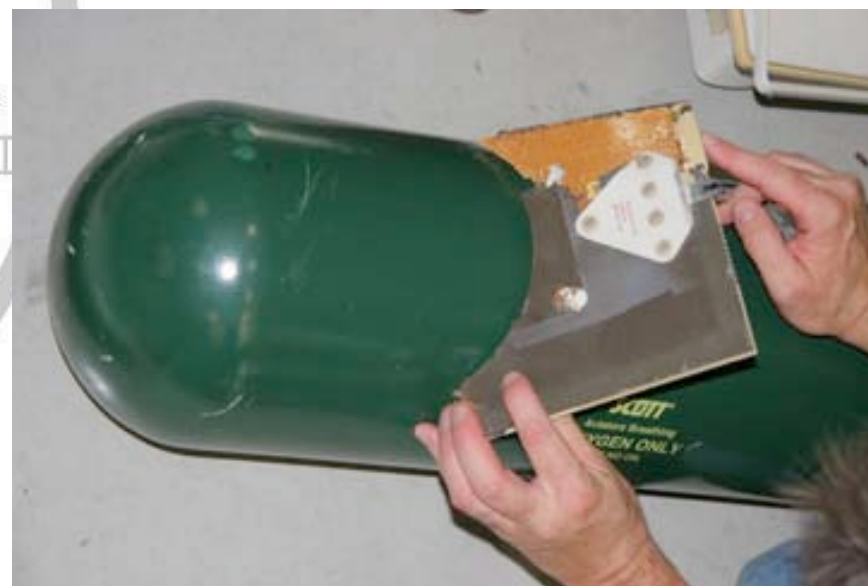
**5. Cylinder impacts overhead panelling end-on, producing circular cut-out type damage.**

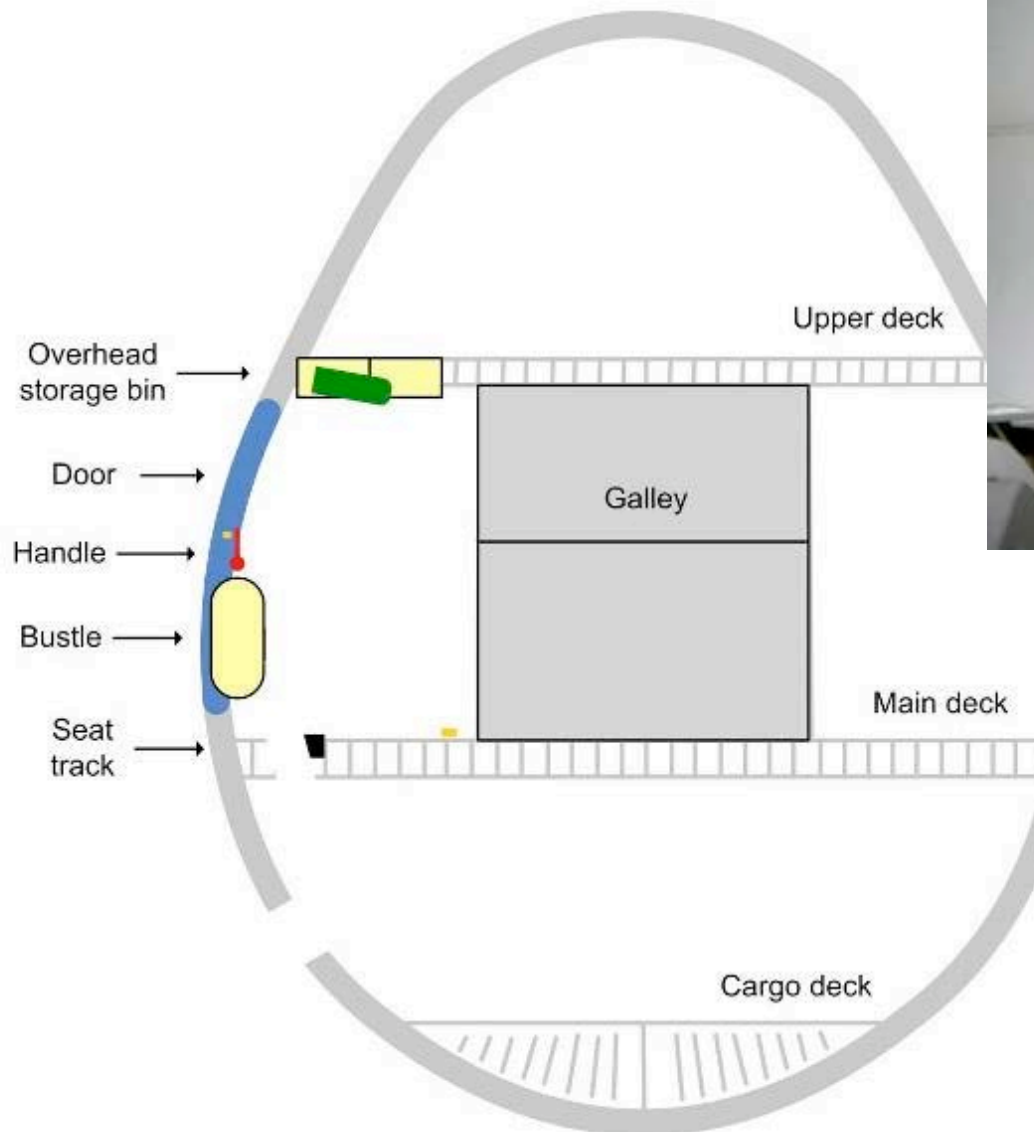
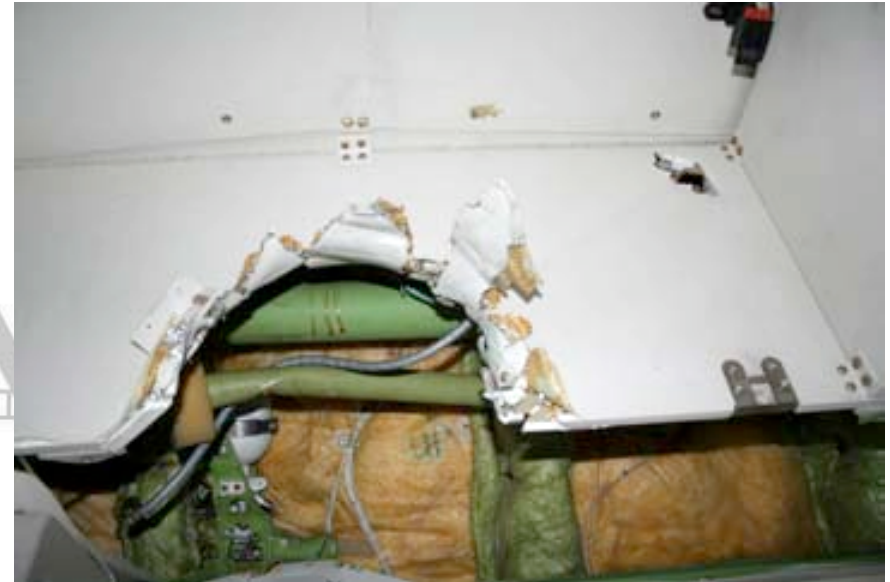
**6. Still rotating cylinder impacts overhead storage bin, producing semi-circular crushing damage.**

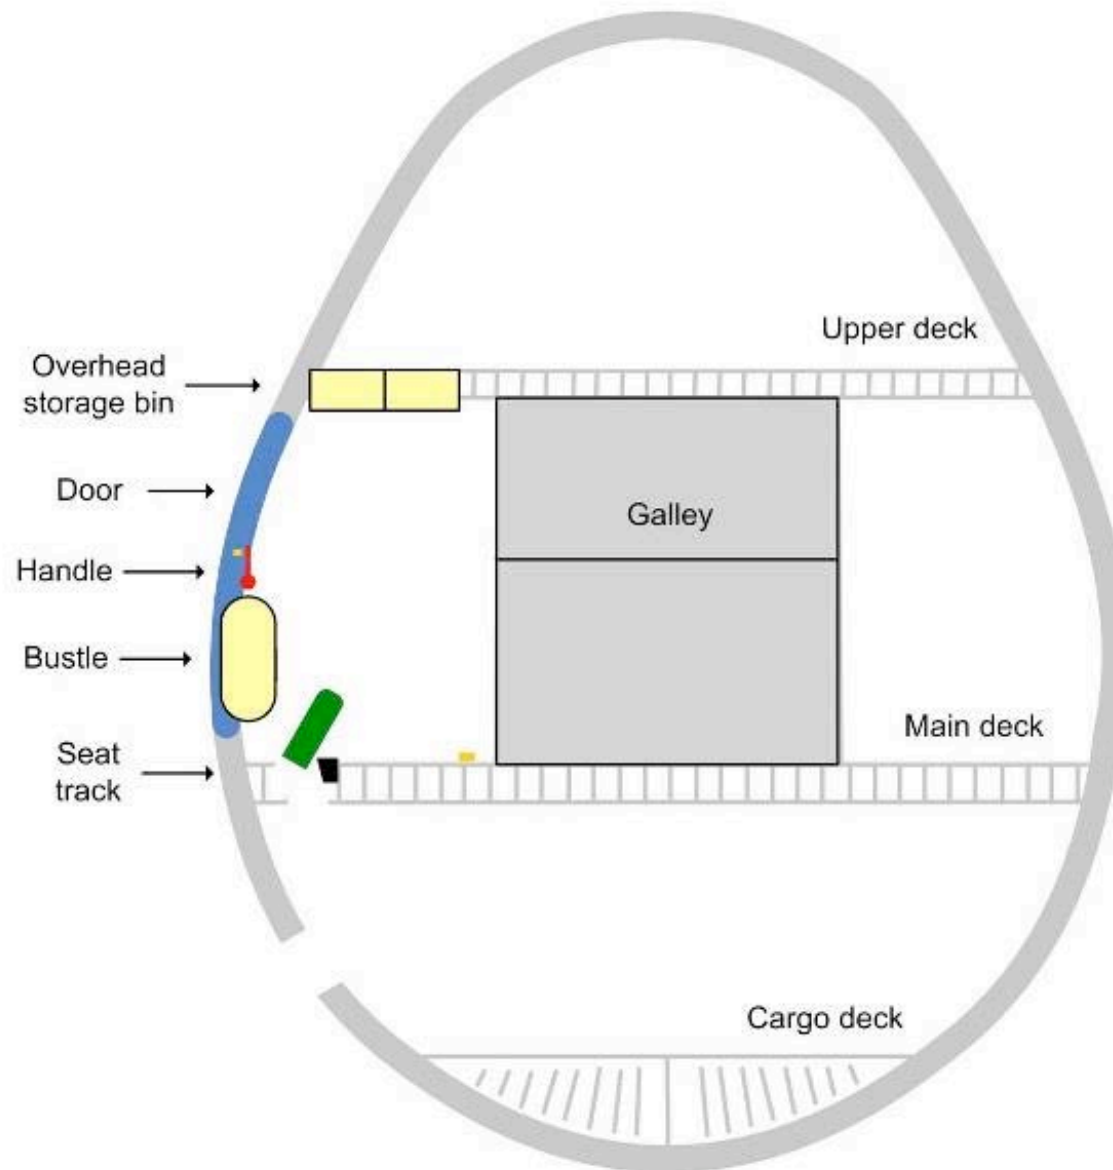
**7. Cylinder falls to cabin floor and exits the aircraft through the ruptured fuselage .**
