Possible Scenario: bad alignment NDE bearing-rotor

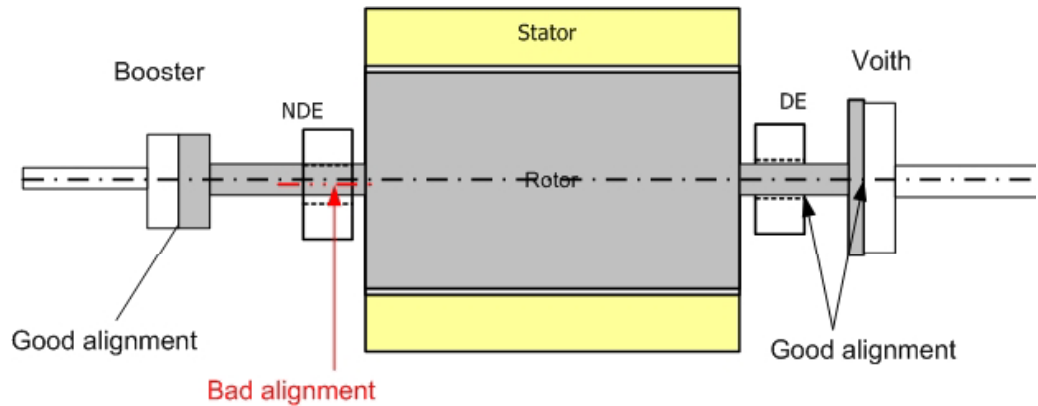
Initial situation (2009)

Measurement performed in 2009 showed:

- Good alignment Rotor-Booster
- Good alignment Rotor-Voith
- Correct clearance between shaft and bearing (calculated On the base of the measured shaft and bearing diameters)

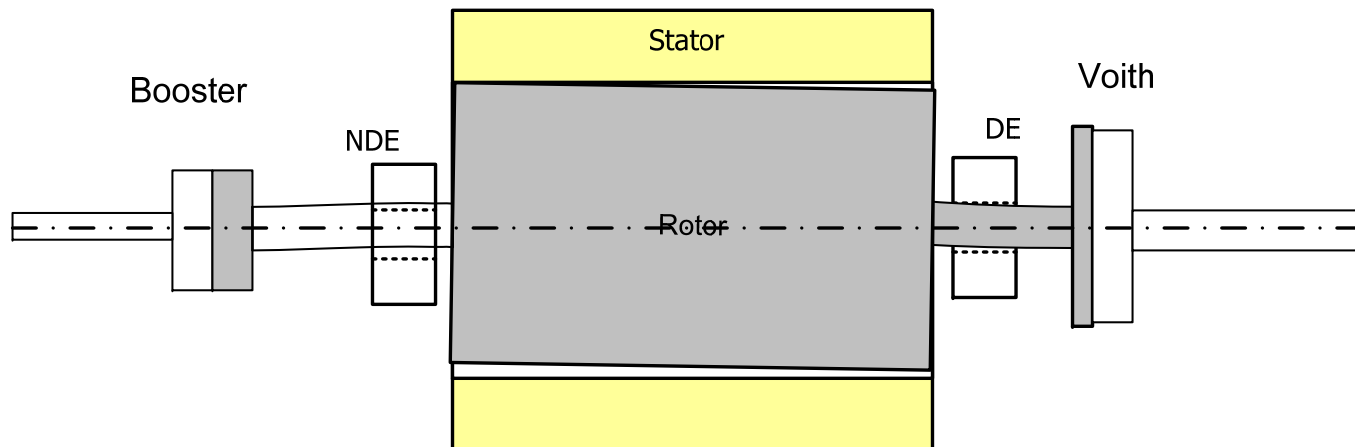
Situation when the rotor rubbed the stator

- Dry friction between shaft and NDE bearing babbitt especially during the start of the motor
- After a certain period, the babbitt is so damaged that the shaft-NDE bearing clearance has increased .
- This allows the rotor to go obliquely to the right
- On each start the rotor is pulled toward the stator (right side) by the dry friction combined with a newly appeared unbalanced magnetic pull
- The babbitt is more and more eroded and after a certain time, the rotor can reach the stator and rub it.
