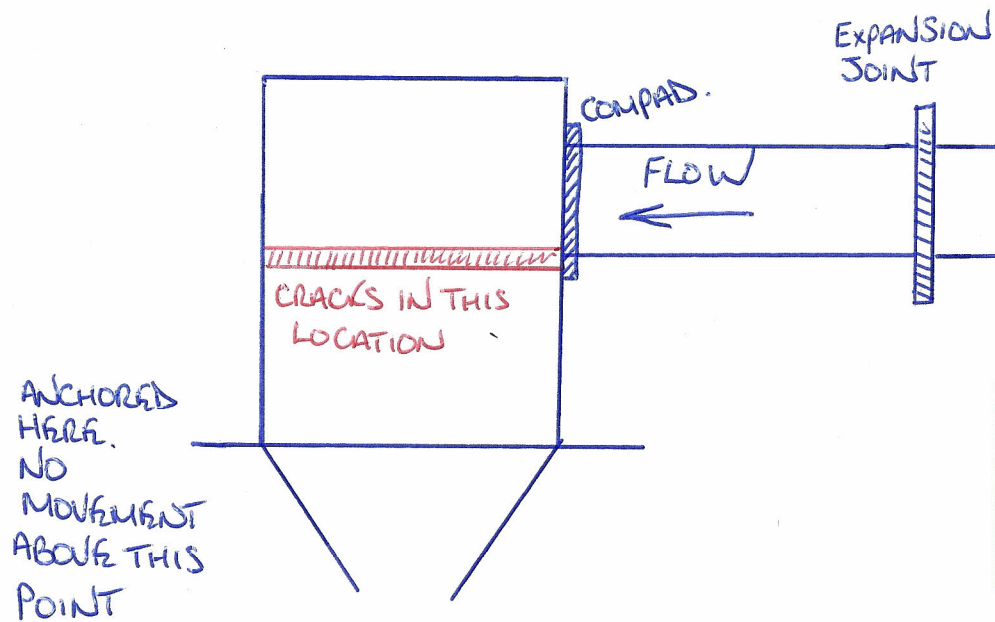
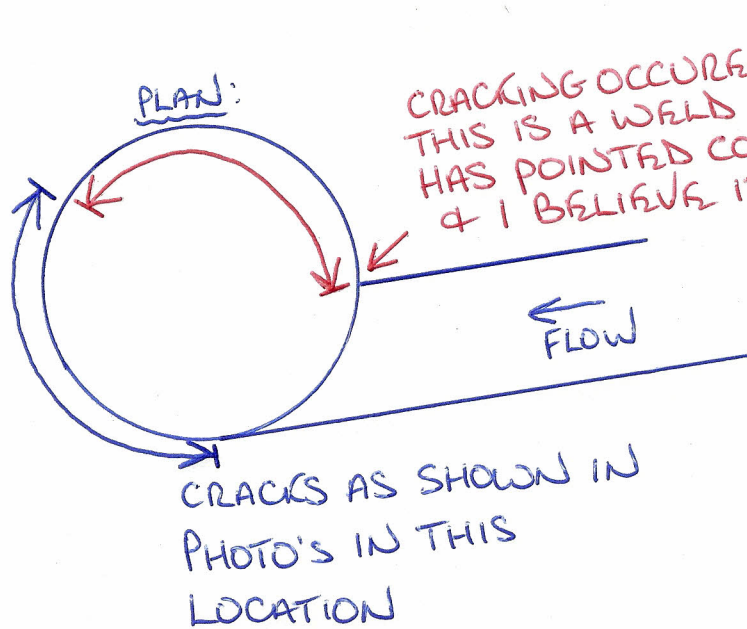
CRACKING OCCURED HERE AS WELL, THIS IS A WELD DESIGN PROBLEM, THE COMPAD HAS POINTED CORNERS! THE CRACK HAS RUN AS SHOWN & I BELIEVE IT IS JOINING UP ALL THE FATIGUE CRACKS, WHICH ARE ALSO FATIGUE BUT A SEPERATE MECHANISM.
