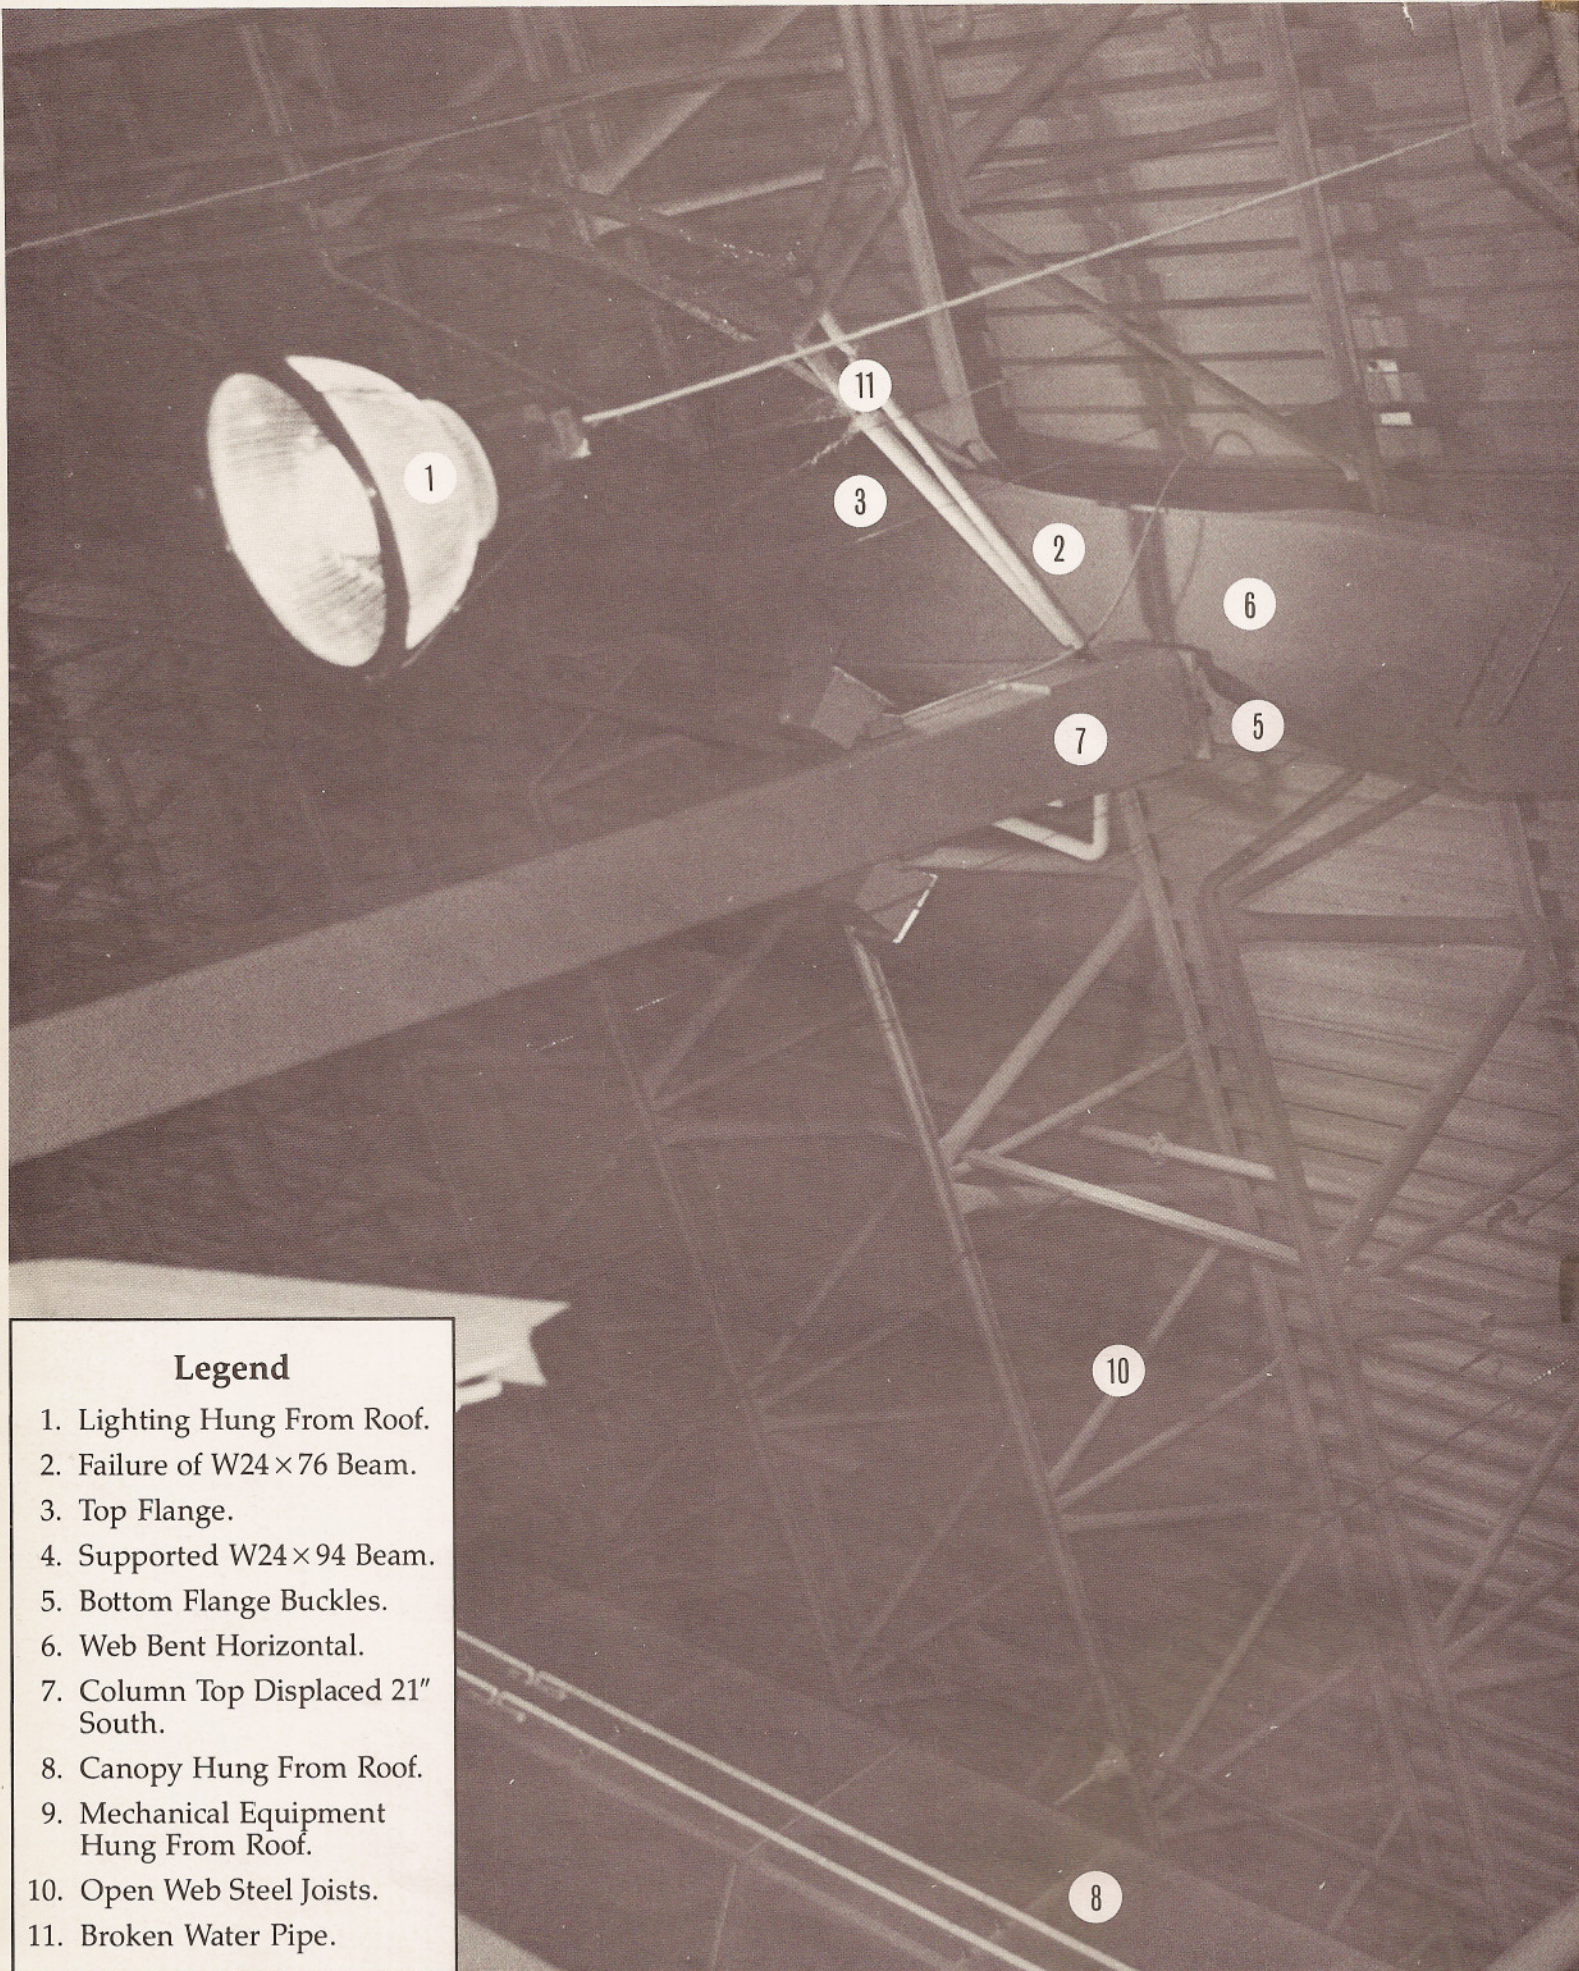
1. Lighting Hung From Roof.
2. Failure of W24 \times 76 Beam.
3. Top Flange.
4. Supported W24 \times 94 Beam.
5. Bottom Flange Buckles.
6. Web Bent Horizontal.
7. Column Top Displaced 21" South.
8. Canopy Hung From Roof.
9. Mechanical Equipment Hung From Roof.
10. Open Web Steel Joists.
11. Broken Water Pipe.
