# UPTHRUST PROBLEMS ON MULTISTAGE VERTICAL TURBINE PUMPS

**Donald R. Smith**

**Stephen Price**

Engineering Dynamics Inc.

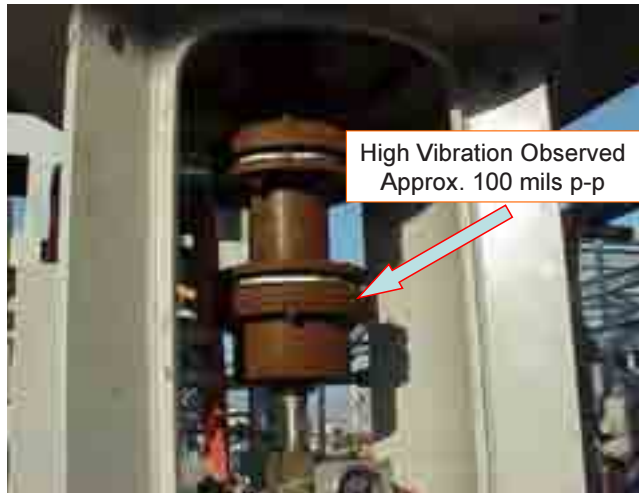
Figure 7. Excessive Vibration on Pump Coupling and Pump Shaft.

During the process of obtaining the ODS vibration data on the motor and thrust stand of pump A, excessive vibrations were visually observed on the pump coupling. The vibration levels on the pump coupling hub and the upper pump shaft were estimated to be in the range of 100 mils peak-to-peak (Figure 7). These

vibration levels were clearly excessive and were considered to be in the danger level. The observed vibration levels on the motor coupling hub were significantly lower compared to the pump coupling hub, which indicated that the coupling was effective in isolating the vibration between the pump shaft and the motor shaft.

The shaft vibration and runout data were reviewed with the pump manufacturer. Everyone agreed that the vibration levels were considered to be dangerous and could result in a failure of the coupling, shaft seal, and/or thrust bearing. The excessive runout indicated that the shaft was probably bent.

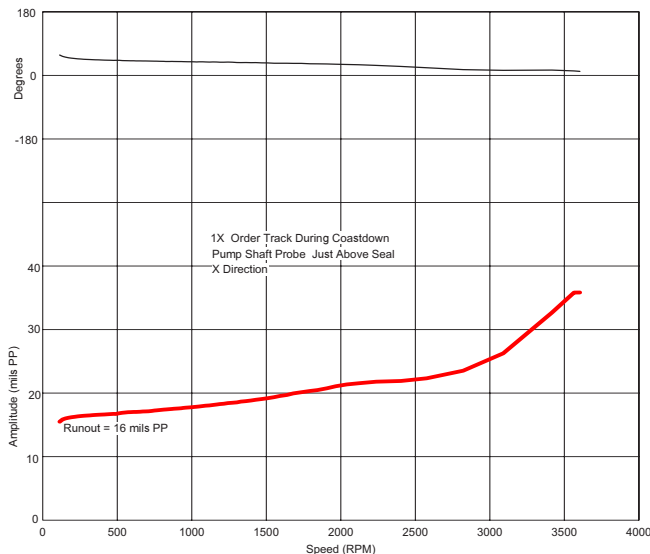
Figure 8. Bode Plot of Pump Shaft Vibration During Coastdown.

After the proximity probes were installed, the pump was started, operated at full speed for only a few seconds, and then shut down. Figure 8 is a plot of the  $1\times$  running speed shaft vibration and phase (Bode plot) during the coastdown. At operating speed, the pump shaft vibration near the seal was approximately 36 mils peak-to-peak. Slow roll data indicated that the shaft runout was approximately 16 mils peak-to-peak (note that this pump had been in service for approximately 500 hours at the time of the test).

This runout greatly exceeded the allowable runout at the seal. API 610 (1995) states that the total indicated runout shall not exceed 0.0005 inch per ft (4  $\mu$ m per 100 mm) of length, or 0.003 in (80  $\mu$ m) over the total shaft length.

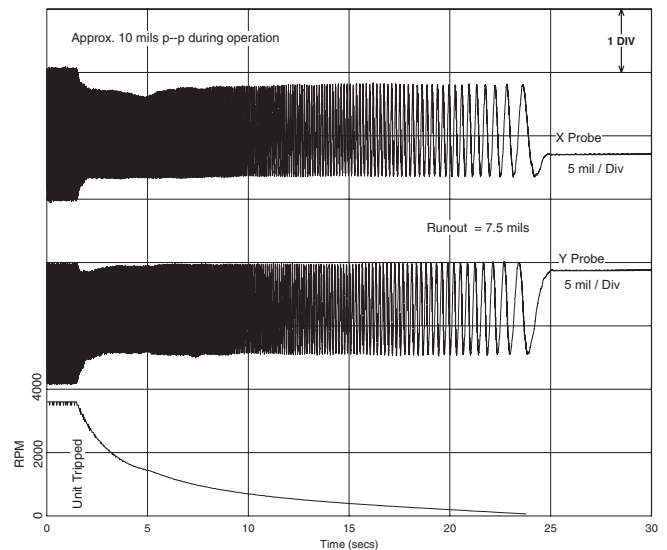
Figure 9. Time-Domain Plot of Pump Shaft Vibration and Pump Speed During Coastdown.

Pump C had not been run; therefore, it was decided to measure the pump shaft runout prior to starting the pump. The shaft was rotated by hand and the shaft runout at the seal was measured to be approximately 1 mil peak-to-peak, which was considered to be acceptable. The pump was subsequently put into operation and the shaft vibration reached approximately 10 mils peak-to-peak at  $1\times$  running speed. Figure 9 is a time-domain plot of the shaft vibration and pump speed just prior to shutdown and during the coastdown. As shown, the runout increased to approximately 7.5 mils peak-to-peak after operation, which indicated that the shaft was bowed or cocked during this short run.

The pump manufacturer recommended that the pump shaft be raised approximately 3/16 inch, which also required adjusting the seal position. When the pump was restarted, the vibration levels immediately increased to approximately 18 mils peak-to-peak. After operating for a few seconds, the mechanical seal began to smoke and the pump was shut down.

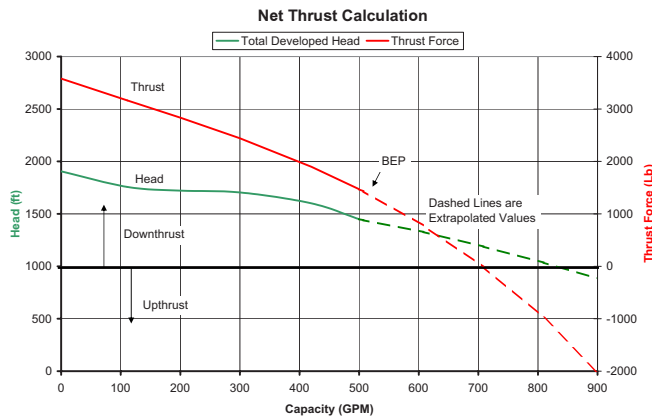
Figure 12. Computed Thrust Values and Total Developed Head Versus Flow Rate.

The thrust values were extrapolated for high flow rates beyond the BEP (Figure 12). As shown, at the higher flow rates the thrust changed from downthrust to upthrust. The pump manufacturer did not compute the thrust forces for the conditions with zero

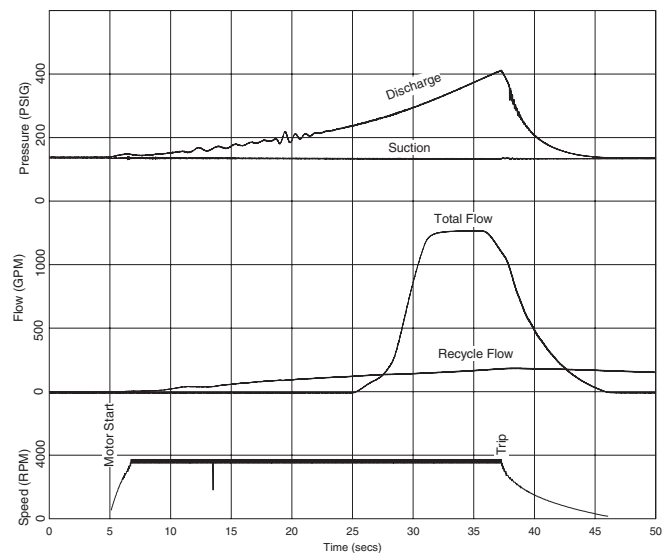
The pump reached full speed in approximately 1.75 seconds. However, the discharge pressure increased very slowly and required approximately 30 seconds to increase to 400 psi (Figure 17).

Figure 17. Time-Domain Plot of Pressure, Flow, and Speed During First Startup of Pump C with Fully-Open Discharge Valve (Vapor or Flashing in Piping).

The flowmeter, which senses flow to the plant (total flow), did not indicate any flow until approximately 20 seconds after the pump started (Figure 17). The flowmeter indicated that the flow rate increased over a 30 second interval to a maximum of approximately 1200 gpm, which caused the pump to be tripped by the DCS on excessive flow rate. It is felt that this indicated flow rate was too high and was incorrect because this flow rate was well beyond the pump maximum flow rate. The high indicated flow rate could have been due to vapor or flashing in the piping that could have caused the orifice flowmeter to read incorrectly.

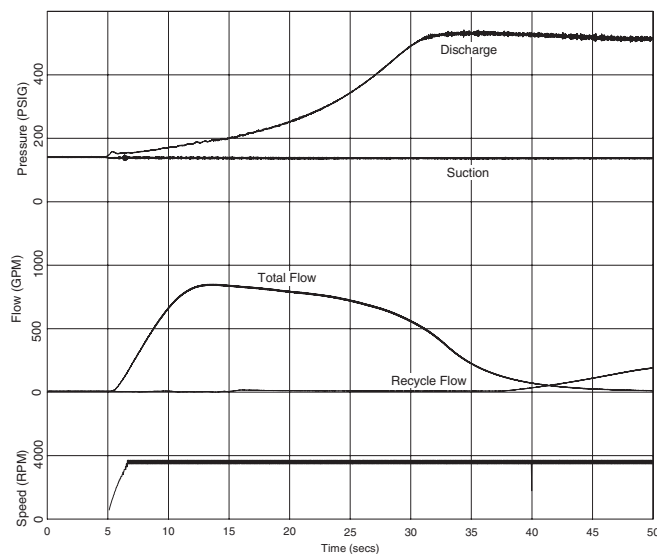
The pump was started using the same procedure with the discharge valve fully-open. Again, the discharge pressure increased very slowly and required approximately 25 seconds to reach 500 psi (Figure 18). During this start, the maximum indicated flow rate was approximately 850 gpm, which could have been the actual flow rate. The motor current data shown in Figure 19 did not remain constant and the motor amps reduced slightly during this period of high indicated flow rate, which suggests that these flow rates were real.

Figure 18. Time-Domain Plot of Pressure, Flow, and Speed During Second Startup of Pump C with Fully-Open Discharge Valve (No Vapor in Piping).

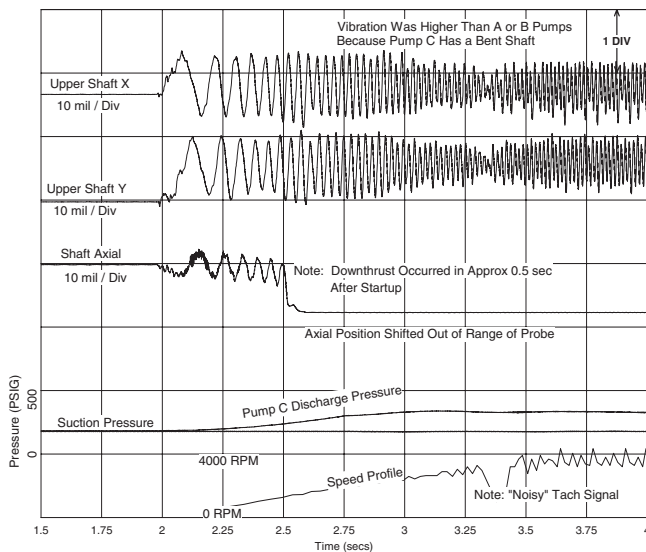
The pump reached full speed in approximately 1.5 seconds (Figure 20) and the discharge pressure immediately increased to approximately 350 psi in approximately 1 second. The pump shaft position changed from upthrust to downthrust in approximately 0.5 seconds (Figure 20) compared to approximately 15 to 25 seconds when the pump was started with the discharge valve in the fully-open position.

Figure 20. Time-Domain Plot of Shaft Radial Vibration, Shaft Axial Position, Pressure, and Running Speed During Startup of Pump C with Partially-Closed Discharge Valve.

As shown in Figure 20, the pump shaft radial (X, Y) vibrations were reduced when the pump shaft changed to the downthrust position. The radial vibration levels remained fairly constant over a large flow range after the pump switched to the downthrust condition.

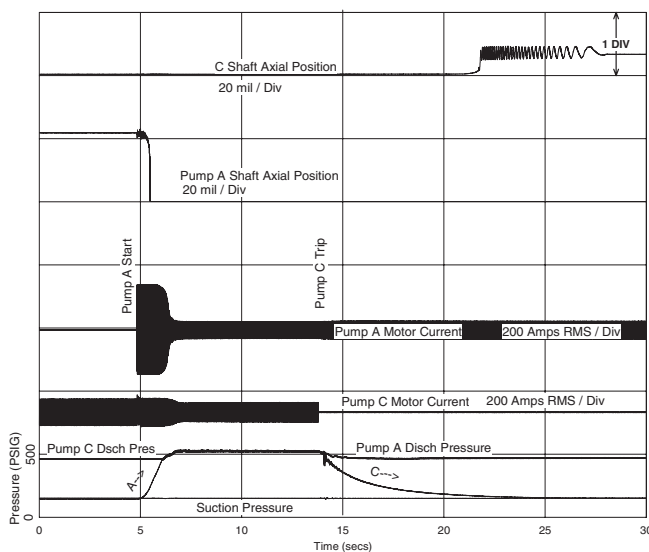
Pump C was tripped approximately nine seconds after pump A was started. After pump C tripped, the pump C shaft axial position switched to the upthrust position when the discharge pressure was reduced to the suction pressure (Figure 22).

Figure 22. Time-Domain Plot of Flow, Shaft Axial Position, Pressure, and Motor Amps of Pumps A and C During Startup of Pump A with Pump C Operating and Shutdown of Pump C.
