# UPTHRUST PROBLEMS ON MULTISTAGE VERTICAL TURBINE PUMPS

**Donald R. Smith**

**Stephen Price**

Engineering Dynamics Inc.

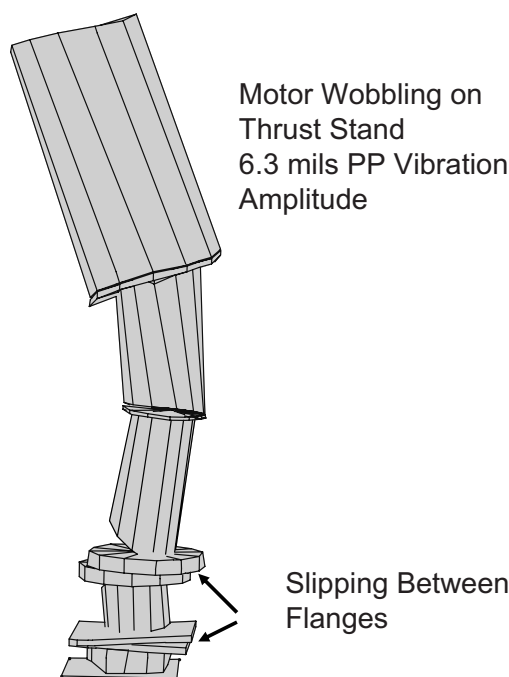
Figure 6. Operating Deflection Mode Shape at  $1\times$  Running Speed.

The ODS model is shown in Figure 5. A selected single frame of the vibration animation at  $1\times$  running speed is shown in Figure 6. Note that the vibrations are exaggerated in the plot to allow the ODS to be easily visualized. As shown in the ODS, the maximum vibration levels were measured near the top of the motor in the N-S direction. The maximum vibration levels were approximately 6.3 mils peak-to-peak (1.2 in/sec zero-to-peak).

The ODS indicated that the motor was “rolling” or “wobbling” on top of the thrust stand. In addition, slipping was observed between the flanges connecting the discharge head to the barrel. Subsequent to the ODS testing, several of the flange bolts were determined to be loose and were tightened; however, tightening the bolts did not reduce the vibration to acceptable levels.

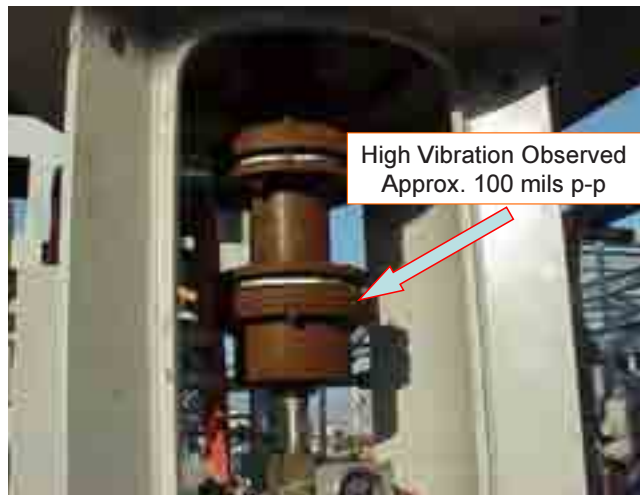
Figure 7. Excessive Vibration on Pump Coupling and Pump Shaft.

During the process of obtaining the ODS vibration data on the motor and thrust stand of pump A, excessive vibrations were visually observed on the pump coupling. The vibration levels on the pump coupling hub and the upper pump shaft were estimated to be in the range of 100 mils peak-to-peak (Figure 7). These

vibration levels were clearly excessive and were considered to be in the danger level. The observed vibration levels on the motor coupling hub were significantly lower compared to the pump coupling hub, which indicated that the coupling was effective in isolating the vibration between the pump shaft and the motor shaft.

The shaft vibration and runout data were reviewed with the pump manufacturer. Everyone agreed that the vibration levels were considered to be dangerous and could result in a failure of the coupling, shaft seal, and/or thrust bearing. The excessive runout indicated that the shaft was probably bent.

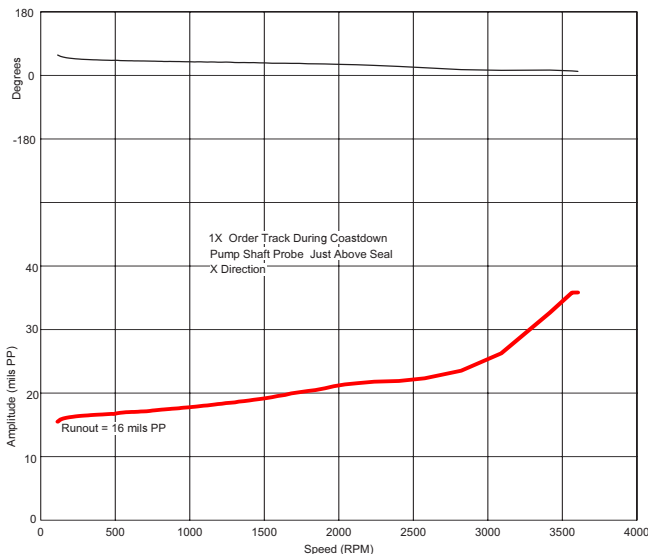
Figure 8. Bode Plot of Pump Shaft Vibration During Coastdown.

After the proximity probes were installed, the pump was started, operated at full speed for only a few seconds, and then shut down. Figure 8 is a plot of the  $1\times$  running speed shaft vibration and phase (Bode plot) during the coastdown. At operating speed, the pump shaft vibration near the seal was approximately 36 mils peak-to-peak. Slow roll data indicated that the shaft runout was approximately 16 mils peak-to-peak (note that this pump had been in service for approximately 500 hours at the time of the test).

This runout greatly exceeded the allowable runout at the seal. API 610 (1995) states that the total indicated runout shall not exceed 0.0005 inch per ft (4  $\mu$ m per 100 mm) of length, or 0.003 in (80  $\mu$ m) over the total shaft length.

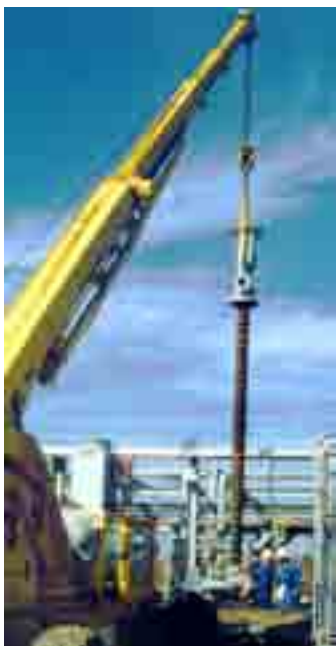
Figure 10. Pump Assembly Being Removed.

The problems experienced by the pumps (excessive motor vibration, excessive shaft vibration, bent shafts, and seal problems)

were all classical symptoms of excessive upthrust. The pump manufacturer agreed and indicated that the pump thrust had not been recalculated for operation with ethane. All three pumps were then returned to the manufacturer for restaging (Figure 10).

The 31-stage pump was originally supplied with 15 standard impellers and 16 hydraulically balanced impellers for operation with gasoline. For operation with ethane, the pump was reconfigured with 28 standard impellers and only three hydraulically balanced impellers.

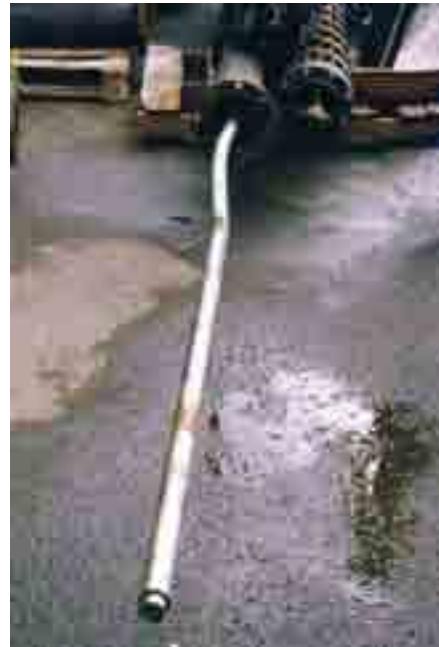
The pump rotor was seized and the intermediate shaft was bent several inches (Figure 13). The shaft had to be cut into several pieces to remove the impellers (Figure 14). The shaft showed excessive wear at all of the bearing locations (carbon bushings). All of the carbon bushings were destroyed. The carbon bushings were

Figure 13. Pump Shaft from Pump A. (Shaft was bent after the shaft seized. The motor tripped on high amps.)

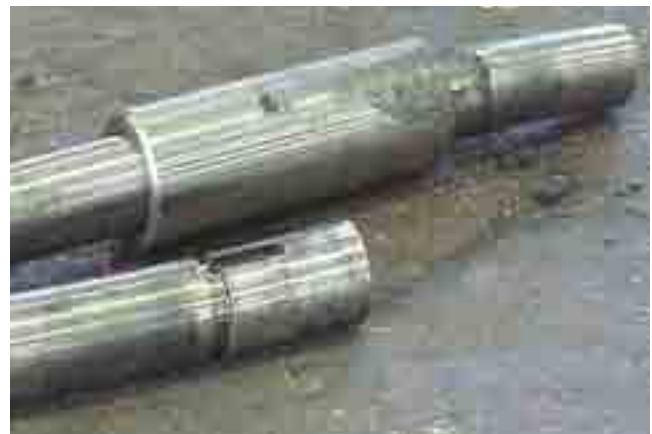
Figure 14. Damaged Pump Shaft Cut into Pieces to Remove Impellers.

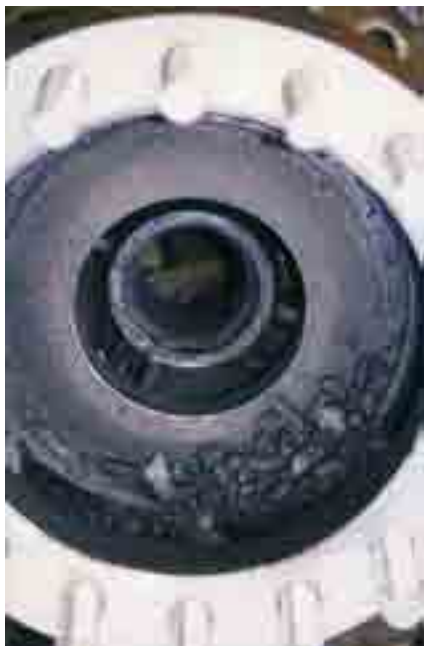
broken into several small pieces, which were lodged in the impellers (Figure 15). In addition, there were also large quantities of carbon powder in the impellers. All of the wear rings were badly worn and there was evidence of galling between the wear rings on the impellers and the wear rings on the stationary parts.

Figure 15. Impeller from Pump A During Disassembly after Pump Failure. (Note carbon particles and dust from destroyed carbon bushings.)

possibly due to a lack of liquid flow through the impellers. The lack of flow would result in a lack of lubrication of the carbon bushings, which in turn would create excessive heat and the failures of the carbon bushings. After the carbon bushings failed, the wear rings on the impellers contacted the stationary parts, which resulted in galling between the stainless steel parts.

- The pump stainless steel wear rings were replaced with nickel bronze wear rings to reduce the possibility of galling.

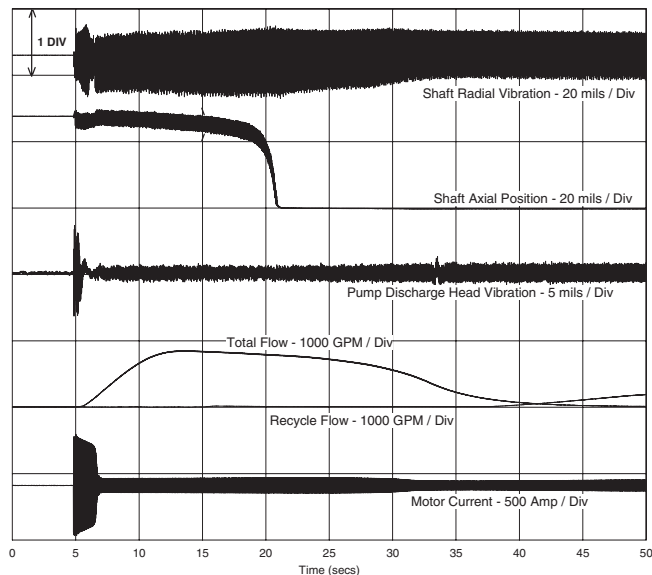
Figure 19. Time-Domain Plot of Shaft Radial Vibration, Shaft Axial Position, Flow, and Motor Amps During Second Startup of Pump C with Fully-Open Discharge Valve.

The shaft was in the upthrust position for approximately 15 to 20 seconds until the discharge pressure increased above 200 psi. As shown in Figure 19, the shaft vibration decreased as the pump discharge increased above 200 psi, because the pump downthrust increased with the higher discharge pressure. As discussed, the pump is designed to operate in downthrust with the shaft in tension.

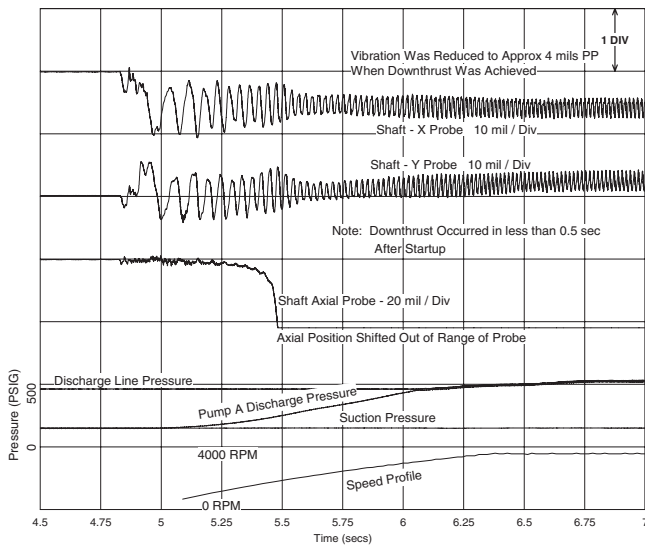
Figure 21. Time-Domain Plot of Shaft Radial Vibration, Shaft Axial Position, Pressure, and Running Speed During Startup of Pump A with Pump C Operating.

Pump A was started with pump C in service. Since another pump was in service, the pump was started with the discharge valve fully-open. As shown in Figure 21, the pump shaft shifted to the downthrust position in approximately 0.5 seconds after the startup. The discharge pressure began to increase immediately as the pump running speed ramped to full speed. After the pump shifted to the downthrust position, the vibration levels were immediately reduced from approximately 9 mils peak-to-peak to the original runout value of 4 mils peak-to-peak.
