TPO WEATHERING TEST ROOF IN LAS VEGAS, NEVADA.

Seven-Year TPO Report

An Update on Western States Roofing Contractors Association's TPO Weathering Farm Project

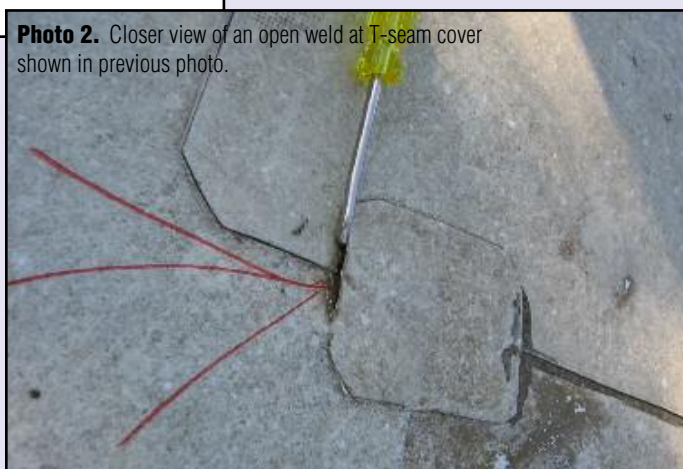
Photo 2. Closer view of an open weld at T-seam cover shown in previous photo.

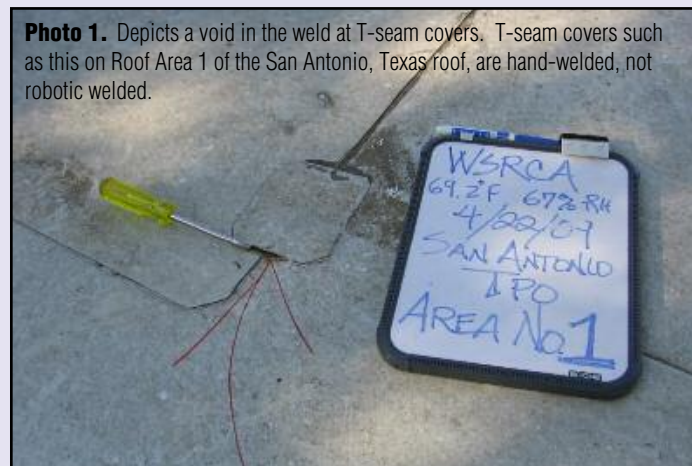
Photo 1. Depicts a void in the weld at T-seam covers. T-seam covers such as this on Roof Area 1 of the San Antonio, Texas roof, are hand-welded, not robotic welded.

All hot-air welded seams, which are randomly probed during the inspections, are proving to have great weld integrity. A few isolated, small voids were found during the most recent round of inspections. (See Photos No. 1 through 8.) A void was found in the weld at a T-seam cover on Roof Area 1, at the San Antonio, Texas site. In addition, a small void was observed at a field seam on San Antonio Roof Area 3, at the transition point between a hand-weld to a robotic weld, and at a hand-welded T-seam cover on that same Roof Area. A small void was also observed at a field seam on Seattle Roof Area 1 and at a penetration flashing boot on that same roof area.

These types of issues after 7 years appear to be relatively normal occurrences for single-ply roof membranes where there are hand-welded seams, and appear to be attributable to minor cold weld locations during application. A few other seam voids were observed, but were generally smaller than those depicted here. All robotic welds probed thus far on all four of the test roofs were found to be intact, except a few at the intersection where a hand-weld joined the start of a robotic weld.

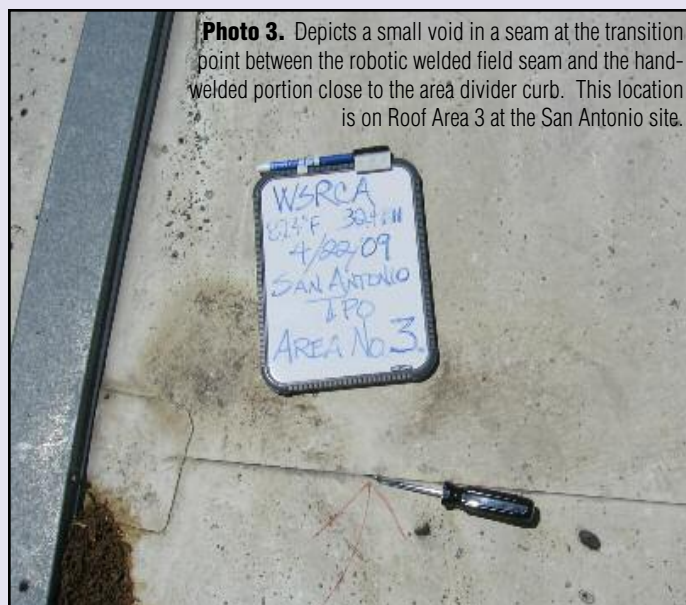
Photo 3. Depicts a small void in a seam at the transition point between the robotic welded field seam and the hand-welded portion close to the area divider curb. This location is on Roof Area 3 at the San Antonio site.

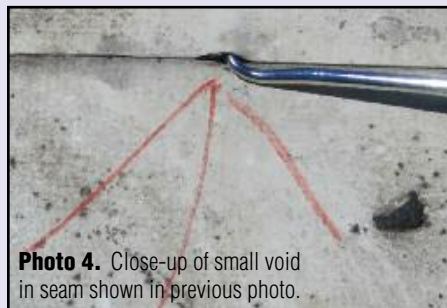
Photo 4. Close-up of small void in seam shown in previous photo.

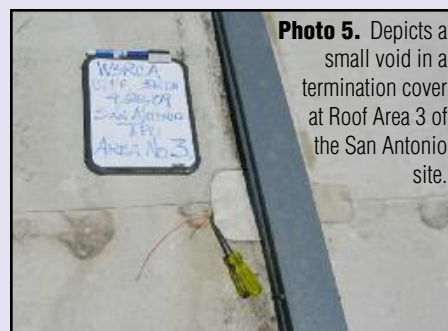
Photo 5. Depicts a small void in a termination cover at Roof Area 3 of the San Antonio site.

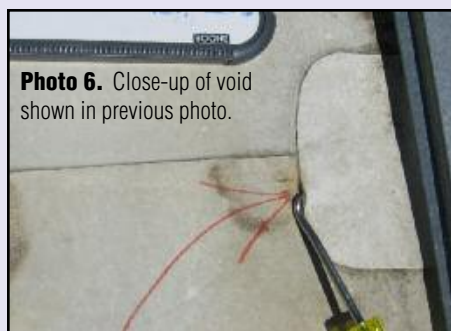
Photo 6. Close-up of void shown in previous photo.

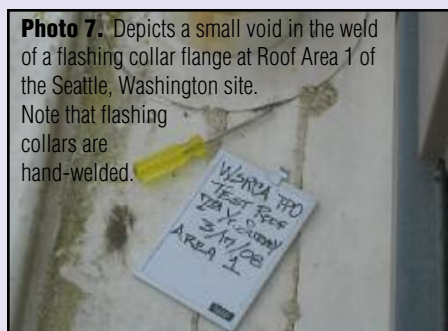
Photo 7. Depicts a small void in the weld of a flashing collar flange at Roof Area 1 of the Seattle, Washington site. Note that flashing collars are hand-welded.

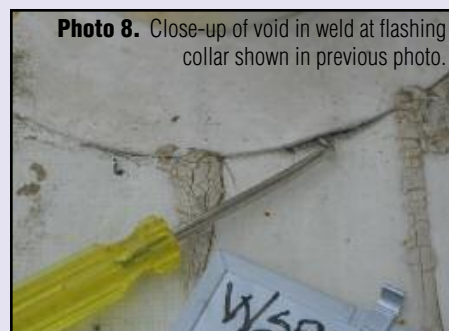
Photo 8. Close-up of void in weld at flashing collar shown in previous photo.

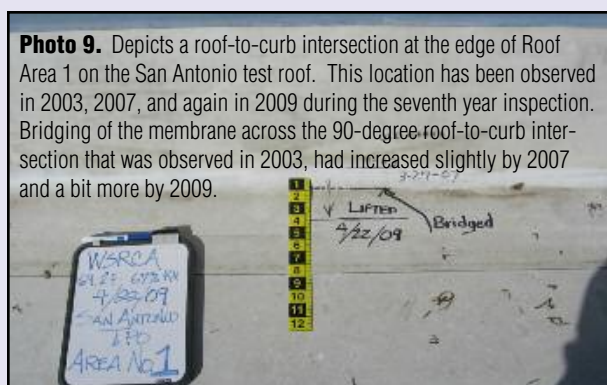
Photo 9. Depicts a roof-to-curb intersection at the edge of Roof Area 1 on the San Antonio test roof. This location has been observed in 2003, 2007, and again in 2009 during the seventh year inspection. Bridging of the membrane across the 90-degree roof-to-curb intersection that was observed in 2003, had increased slightly by 2007 and a bit more by 2009.

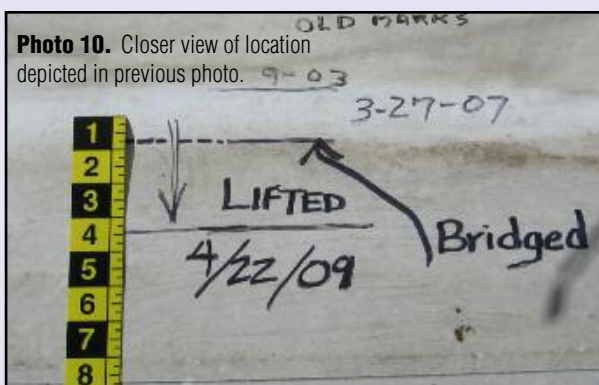
Photo 10. Closer view of location depicted in previous photo.

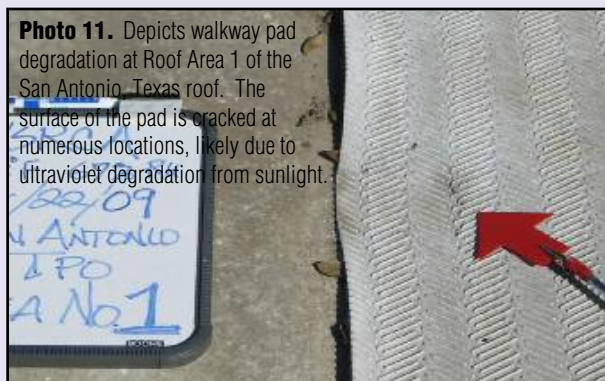
The San Antonio test roof has a significant amount of on-roof equipment where manufacturer supplied walk pads were installed to protect the roof membrane from maintenance traffic. As observed on Roof Areas 1 and 2 of the San Antonio roof, walk

pads have degraded significantly since the 2007 inspection. (See Photos 11 through 14.) Walk pads on Roof Areas 3 and 4 appear to be in relatively serviceable condition. (See Photos 15 through 18) However, instances of apparent walk pad shrinkage were observed on Roof Area 3. (See Photos 16 and 17.) The shrinkage is evidenced by the diagonal wrinkles in the underlying roof membrane on both sides of the walk pad caused by the walk pad pulling on the membrane. Some of the walk pad material on Roof Area 3 is installed in fairly long runs and it is those longer sections where the

Photo 11. Depicts walkway pad degradation at Roof Area 1 of the San Antonio, Texas roof. The surface of the pad is cracked at numerous locations, likely due to ultraviolet degradation from sunlight.

The failed walk pads are no longer properly protecting the underlying membrane and should be replaced. Unfortunately replacement will require cutting and patching the

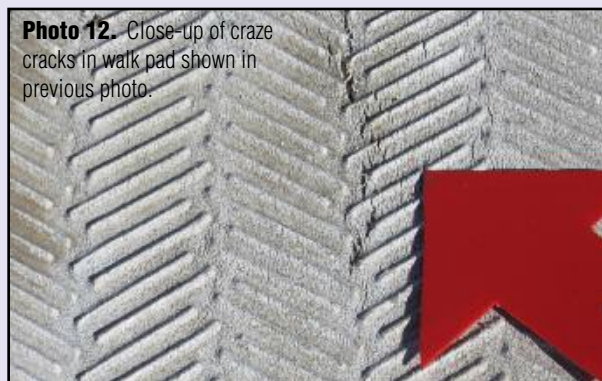
Photo 12. Close-up of craze cracks in walk pad shown in previous photo.

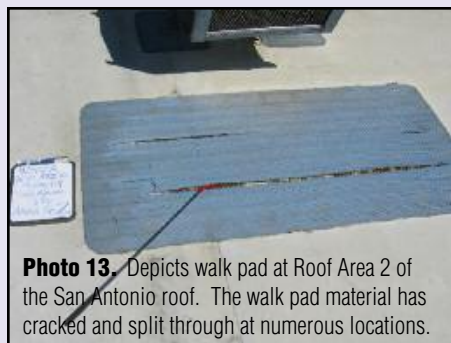
Photo 13. Depicts walk pad at Roof Area 2 of the San Antonio roof. The walk pad material has cracked and split through at numerous locations.

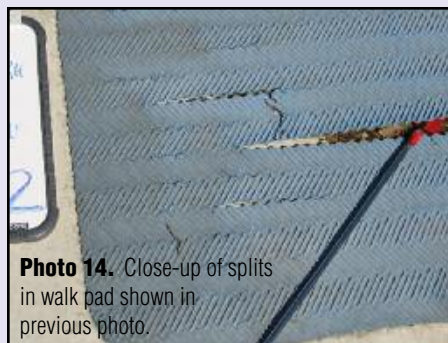
Photo 14. Close-up of splits in walk pad shown in previous photo.

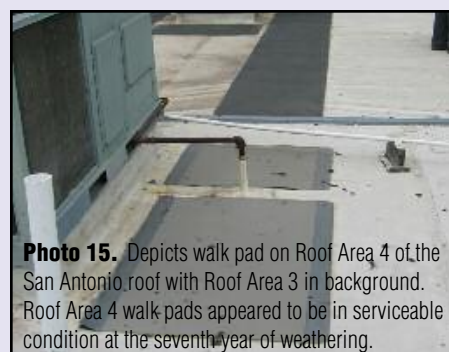
Photo 15. Depicts walk pad on Roof Area 4 of the San Antonio roof with Roof Area 3 in background. Roof Area 4 walk pads appeared to be in serviceable condition at the seventh year of weathering.

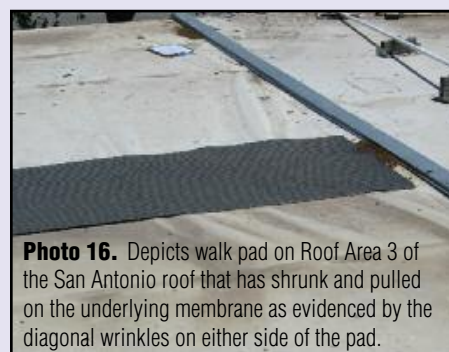
Photo 16. Depicts walk pad on Roof Area 3 of the San Antonio roof that has shrunk and pulled on the underlying membrane as evidenced by the diagonal wrinkles on either side of the pad.

The roof walkway pads installed on Roof Area 3, which have clearly shrunk and impinged strain onto the underlying membrane, should also be replaced, and again this must include cutting and patching the underlying membrane. It was observed that this walk pad material is darker than the roofing membrane and this may be

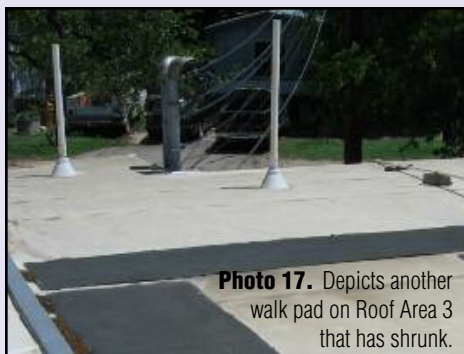
Photo 17. Depicts another walk pad on Roof Area 3 that has shrunk.

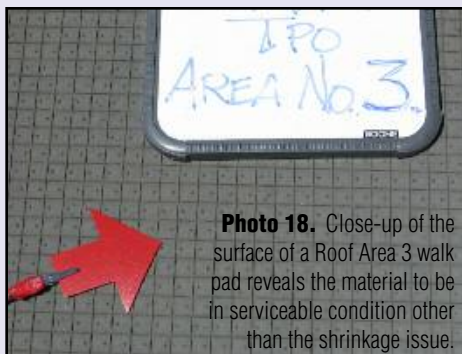
Photo 18. Close-up of the surface of a Roof Area 3 walk pad reveals the material to be in serviceable condition other than the shrinkage issue.

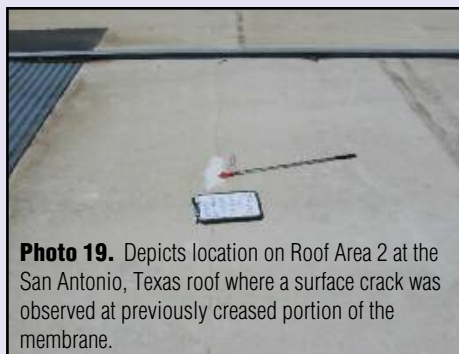
A small surface crack through the upper portion (i.e., top coating) of the membrane was observed during the seventh-year inspection of Roof Area 2 at the San Antonio, Texas roof. The crack occurred at a location where the membrane had originally been

creased during installation. (See Photos 19 and 20.) The red pointer in the photos indicates the crack location. Red arrows added to the photo indicate the crease. Note that the crack was repaired during the inspection. Note that at the time/era of this installation, it was common for the applicators to fold back the membrane and to crease it or to place weight on the fold to hold the membrane back. Manufacturers recognized that this may cause problems with TPO membranes and now discourage this practice.

Photo 19. Depicts location on Roof Area 2 at the San Antonio, Texas roof where a surface crack was observed at previously creased portion of the membrane.

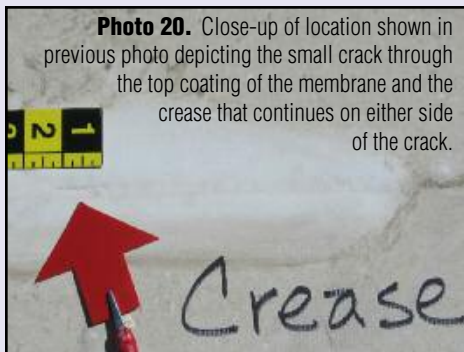
Photo 20. Close-up of location shown in previous photo depicting the small crack through the top coating of the membrane and the crease that continues on either side of the crack.

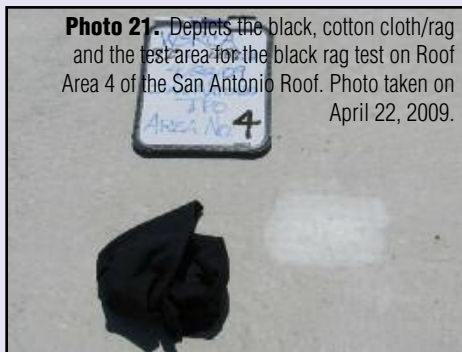
test." Dust, rain, and debris can add to roof surface composition, however, this rag test showed minimal chalking or pickup on the cloth. It had been approximately three days since any significant rainfall. Very slight chalking was detected at most locations tested. Slight chalking is an indication that some weathering has occurred, but the amount observed appears minimal and to be expected in TPO roof membranes of this age. Note that precipitation had occurred on April 16th, 17th and 18th, with 0.11 inches falling on the 16th, 0.76 inches on the 17th and 0.60 inches on the 18th. A trace of precipitation was recorded on the 19th and the 20th and 21st were dry and sun-

Photo 21. Depicts the black, cotton cloth/rag and the test area for the black rag test on Roof Area 4 of the San Antonio Roof. Photo taken on April 22, 2009.

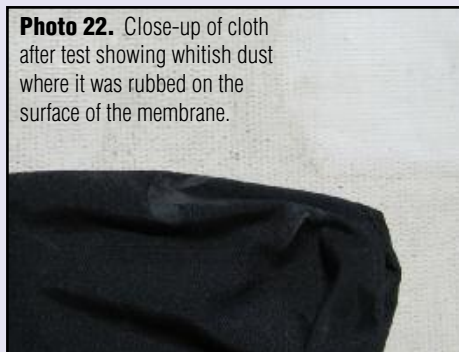
Photo 22. Close-up of cloth after test showing whitish dust where it was rubbed on the surface of the membrane.

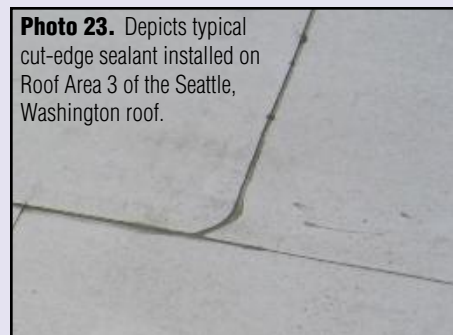
Photo 23. Depicts typical cut-edge sealant installed on Roof Area 3 of the Seattle, Washington roof.

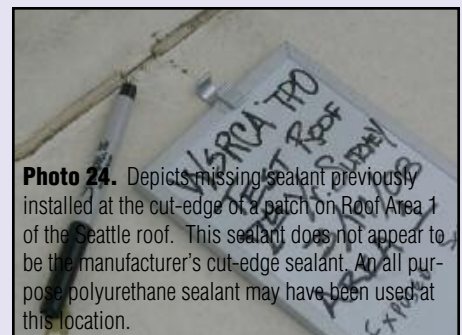
On the Seattle, Washington Roof in Roof Area 1, sealant applied at cut edges of some patches and flashings appears to be reaching the end of its useful service life and in a few locations it has separated and failed. The sealant appeared to be a type not recommended for use as cut-edge sealant that was applied at a repair location. (See Photo 24.) The type of failure observed appears to be similar to typical urethane-based sealant aging. Urethanes tend to lose their flexibility and elongation properties

over time when exposed to natural ultraviolet radiation from the sun. It has been observed that these types of sealants can begin to craze and separate after seven to ten years of service and require replacement. Failure of the sealant at cut edges may make the exposed scrim at the edge susceptible to water absorption, which could lead to wicking and/or membrane damage. All purpose sealants are not recommended for sealing cut edges. For this reason, it is recommended that the manufacturer's cut edge sealant be used to seal all cut edges of the membrane that are exposed.

Photo 24. Depicts missing sealant previously installed at the cut-edge of a patch on Roof Area 1 of the Seattle roof. This sealant does not appear to be the manufacturer's cut-edge sealant. An all purpose polyurethane sealant may have been used at this location.

Sealant installed at cut-edges should be repaired where it has degraded, eroded, is missing or has failed as observed on Roof Area 1 of the Seattle, Washington test roof. Sealant should be replaced with the manufacturer's supplied cut-edge sealant.
