Damaged DO boards of Transformer Protection IED

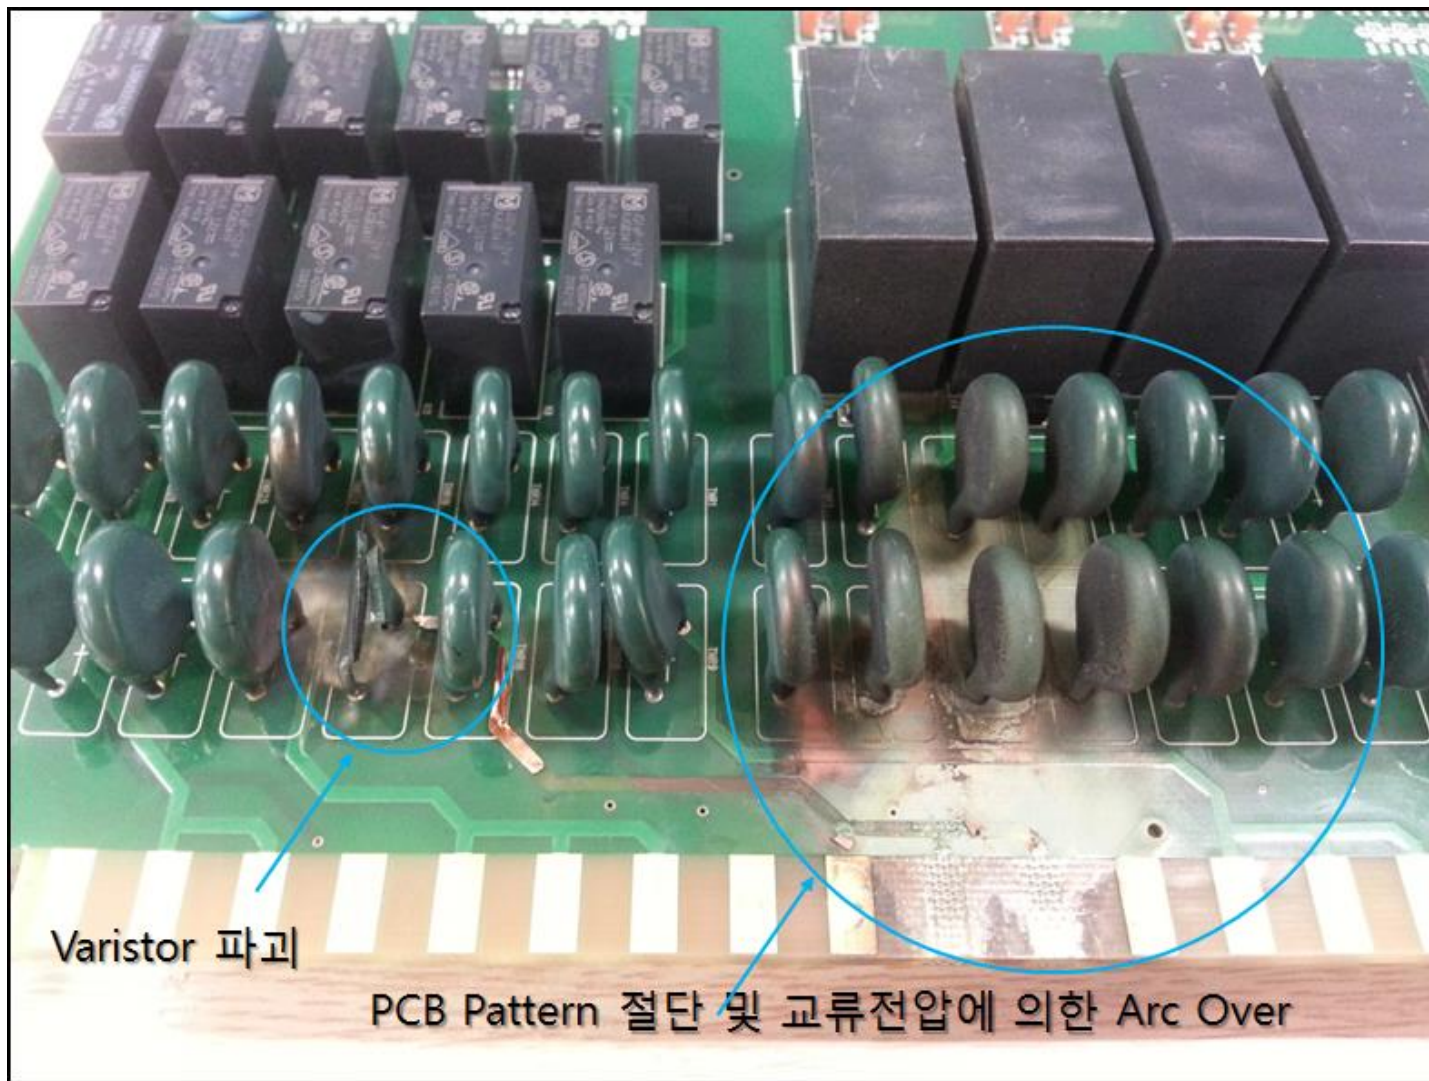
Varistor 파괴

PCB Pattern 절단 및 교류전압에 의한 Arc Over

Soots evidence resulted from
SPD damages

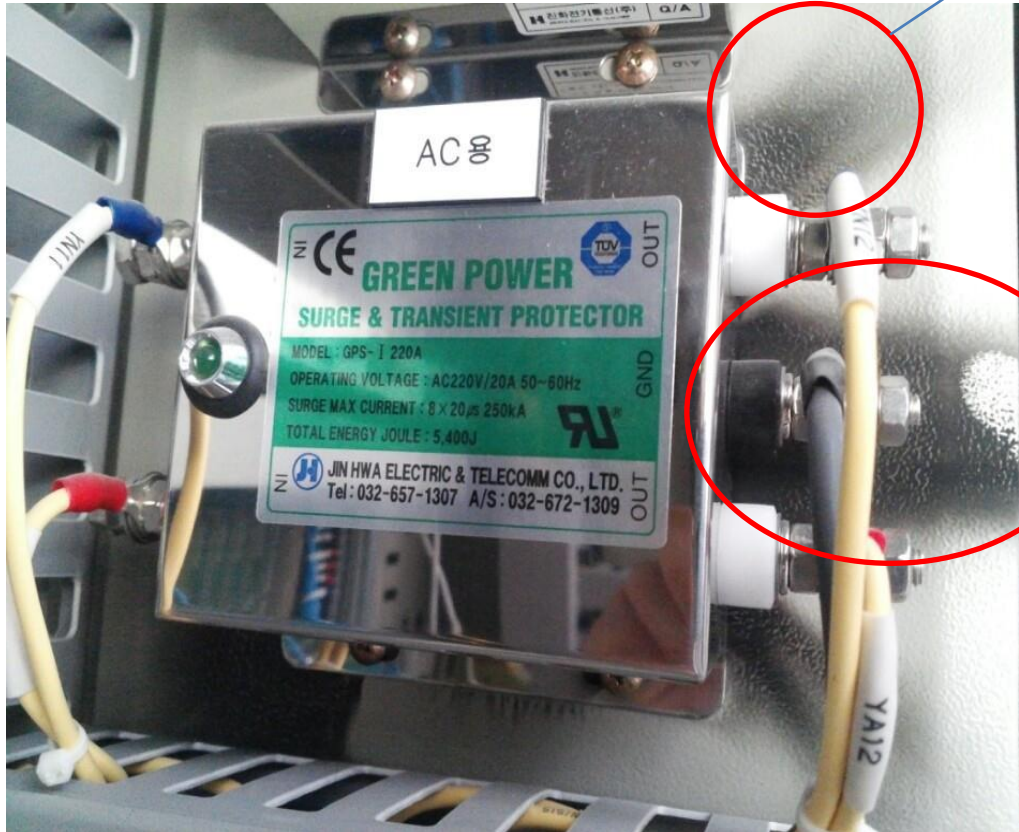
Damaged Surge Protector in AC Power Panel
