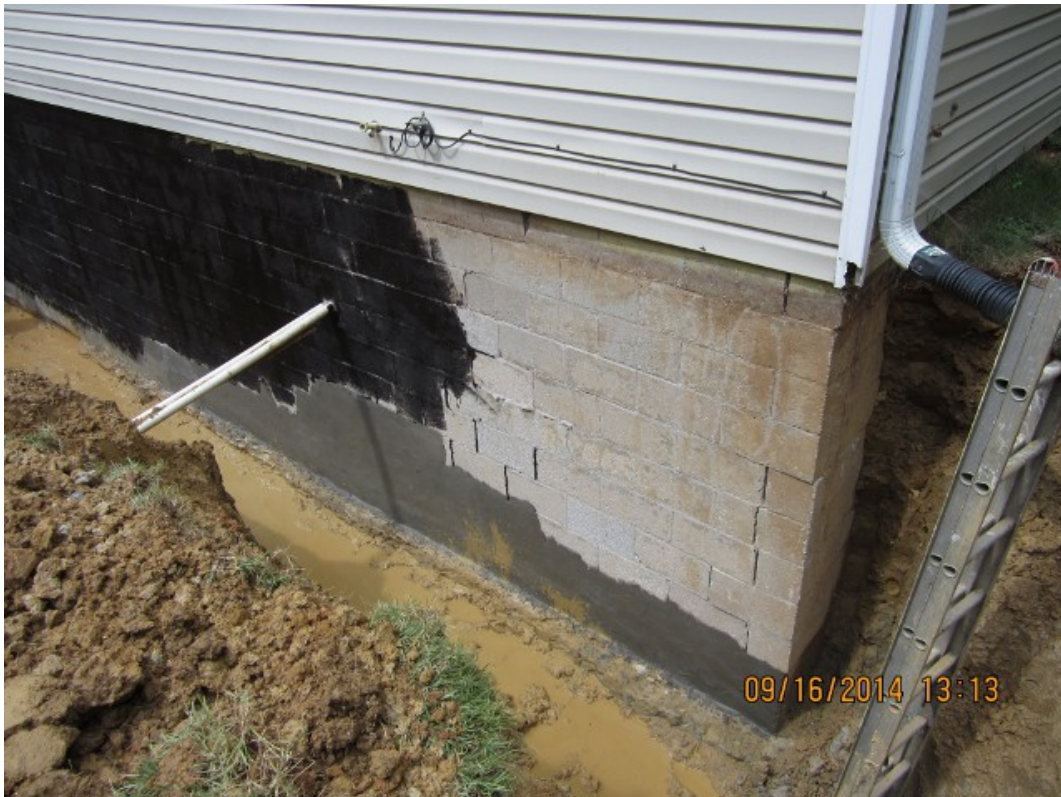
bad corner - vertical cracks at corner, and wall going to the left has moved inward at the top

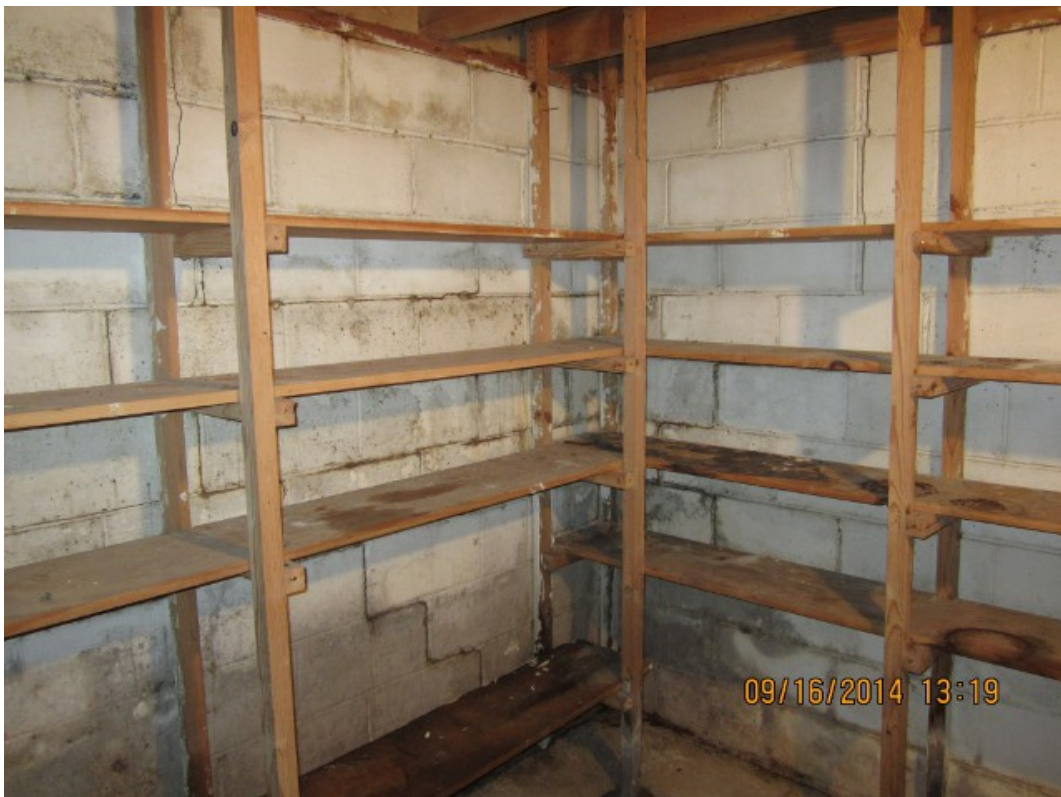
different bad corner. lots of cracking and out-of-plane movement

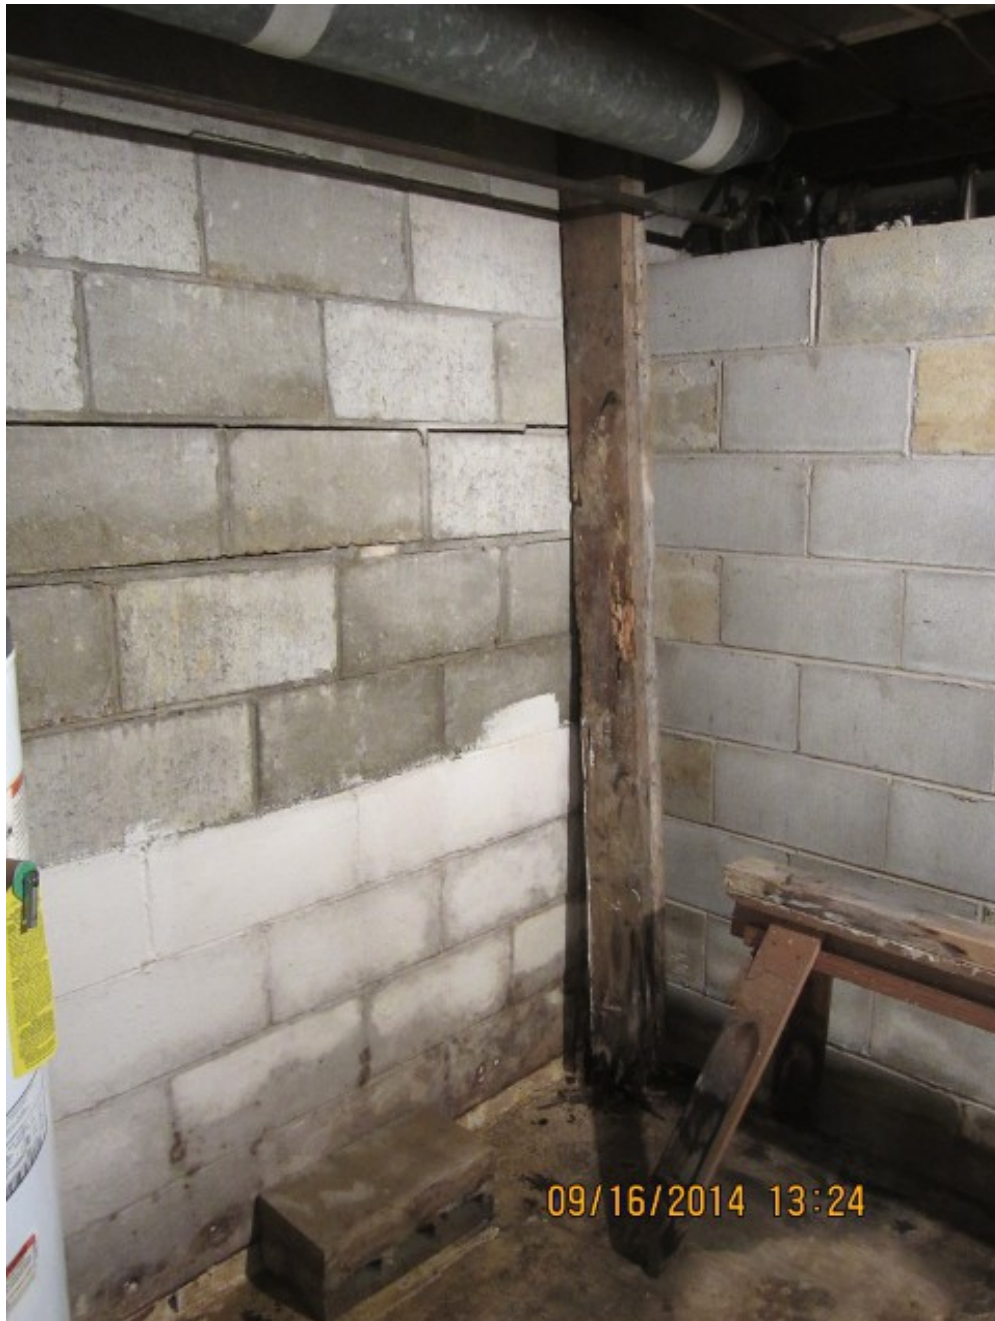
another bad spot. back wall with 4" deflection. CMU buttress and original wood "repair" - sheared off from rot

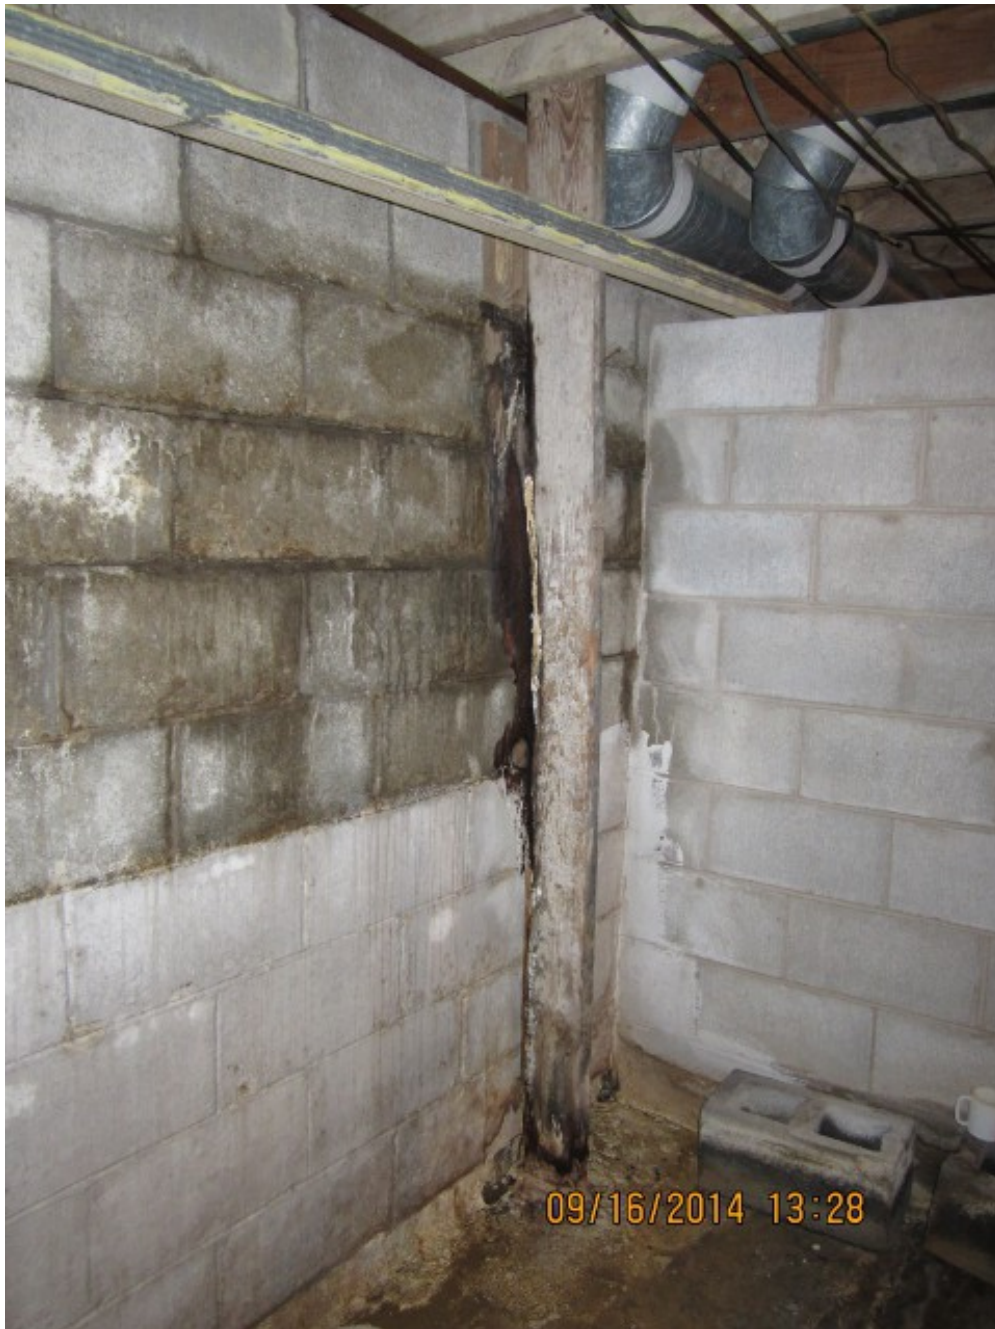
further along that same back wall. still lots of movement.

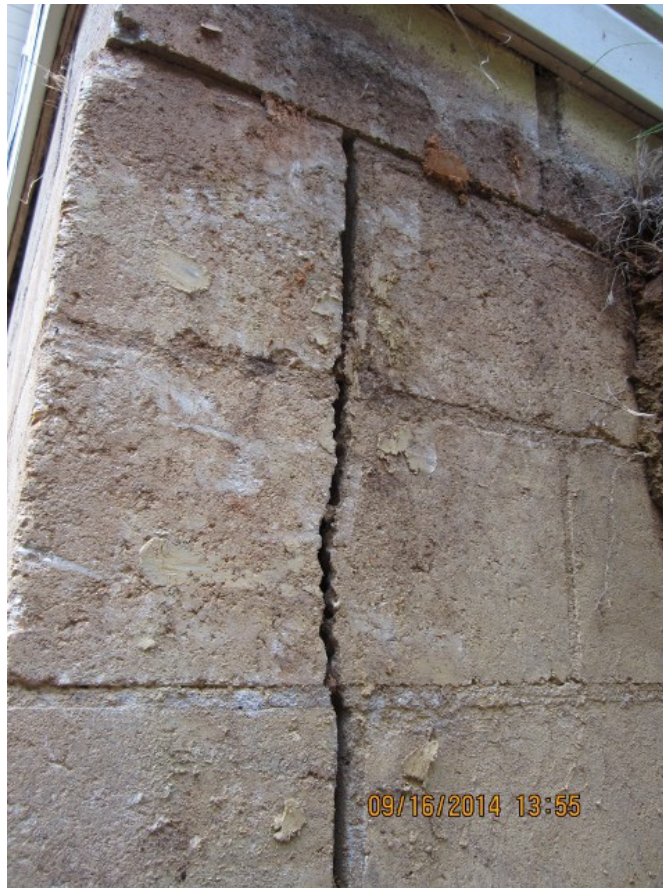
vertical cracking at the corner in the first picture, and out-of-plane movement outward.

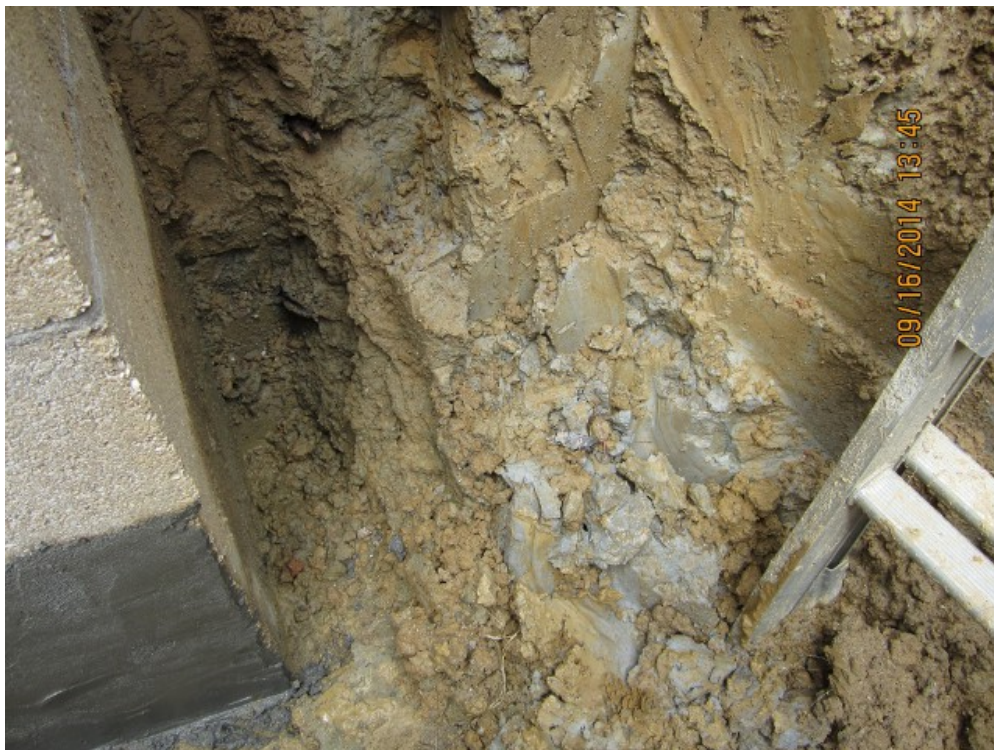
grey "pot clay", somewhat covered by red clay runoff
