MEASUREMENT POINT	OVERALL LEVEL	HFD / VHFD
-----		
BO.3151.02 - GRATE Preheat Off-Gas Fan		(31-May-16)
	OVERALL LEVEL	1K-20kHz
M1H	.163 mm/Sec	.391 G-s
M1V	.223 mm/Sec	.378 G-s
M1A	1.12 mm/Sec	.632 G-s
M2H	.217 mm/Sec	.233 G-s

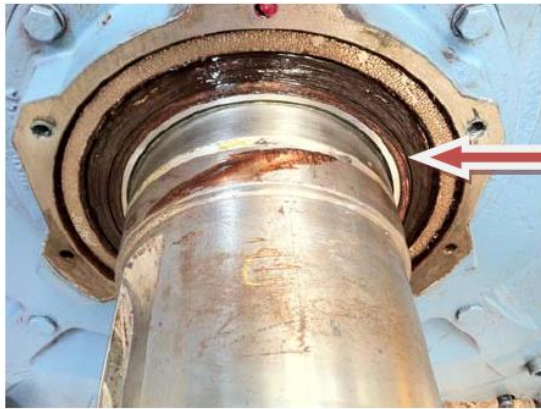
Bearing grease Decolorised

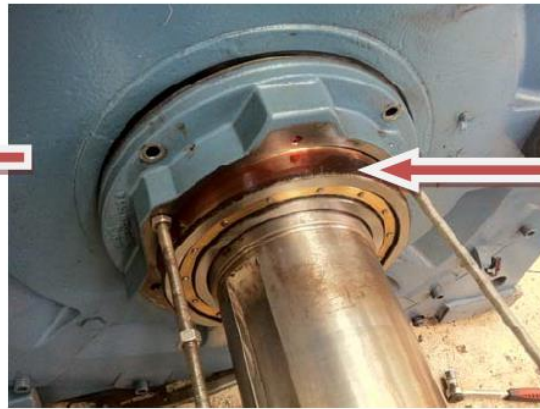
Bearing Scewed & Overheated

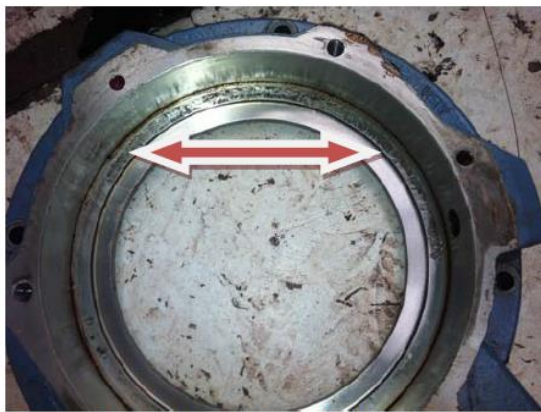
Outer Bearing Housing Damaged

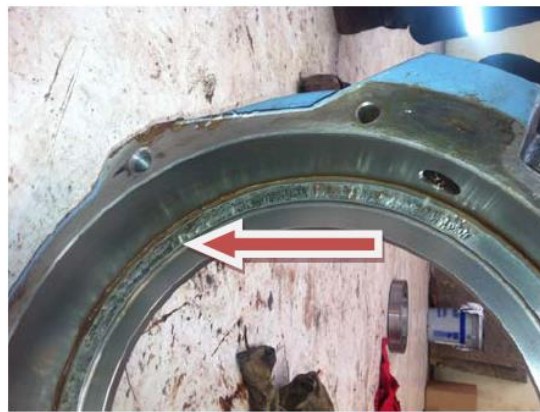
Outer Bearing Housing Damaged

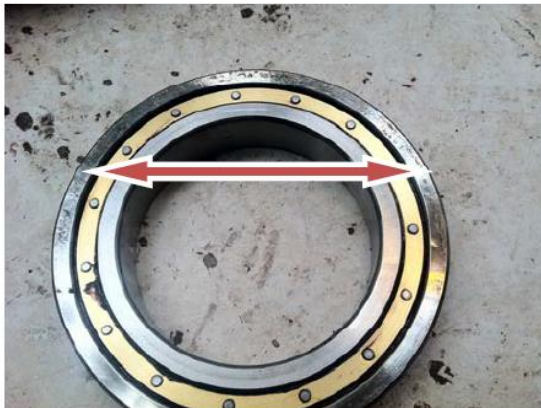
Drive End bearing outer runner axially Damaged

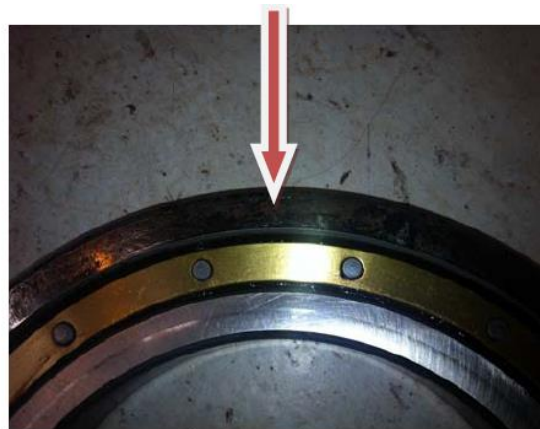
Drive End bearing outer runner axially Damaged

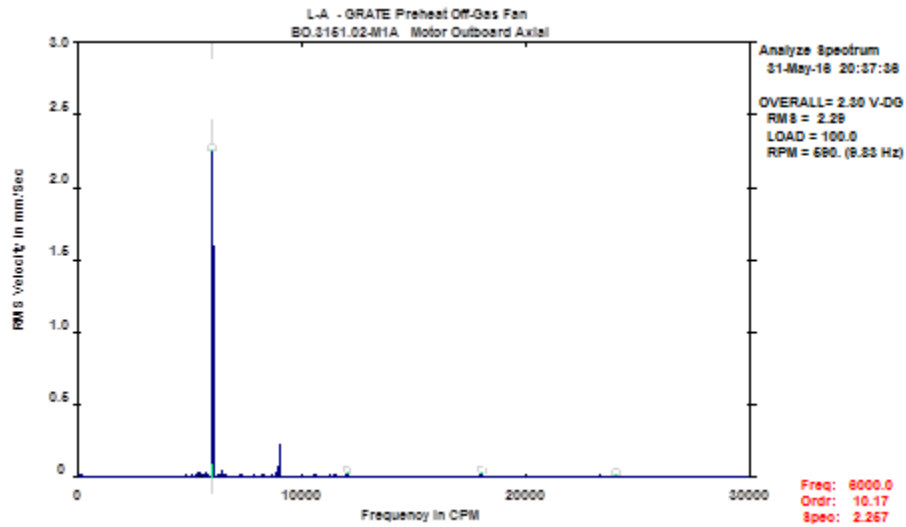
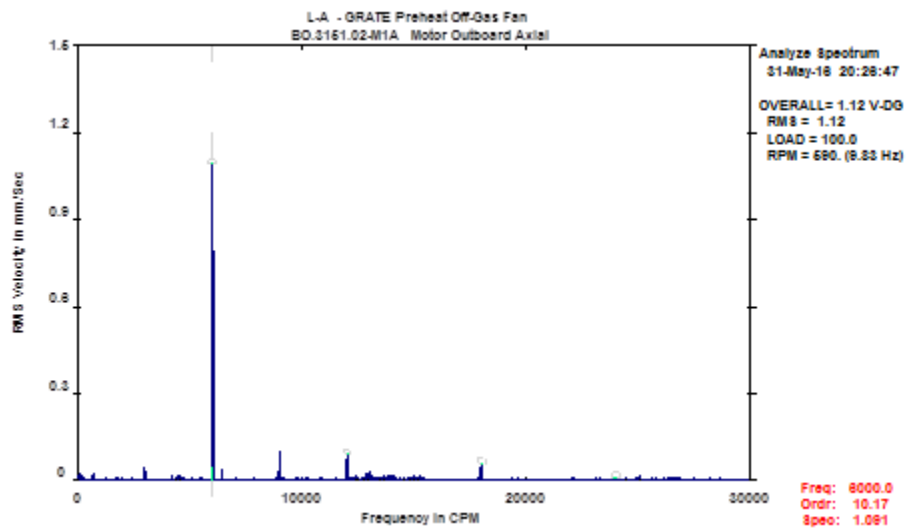
### Motor NDE Axial Vibration Spectrum

- Motor NDE axial vibration is slightly higher than radial vibration
- 2 X Electrical line frequency seen in the spectrum.
- Humming & Modulating sound heard from motor during the trial.
- Sudden drop in 2X Line frequency vibration noticed when motor is switched off.
