# Safety & Technical Alert

## Avoiding the Dangers of Mismatching Hammer Unions

This bulletin describes general categories of hammer union connection and component mismatches. These mismatch conditions are a result of a failure to positively identify hammer union connections and components. The potential for mismatched hammer union connections and components applies to all manufacturers of hammer union end connections.

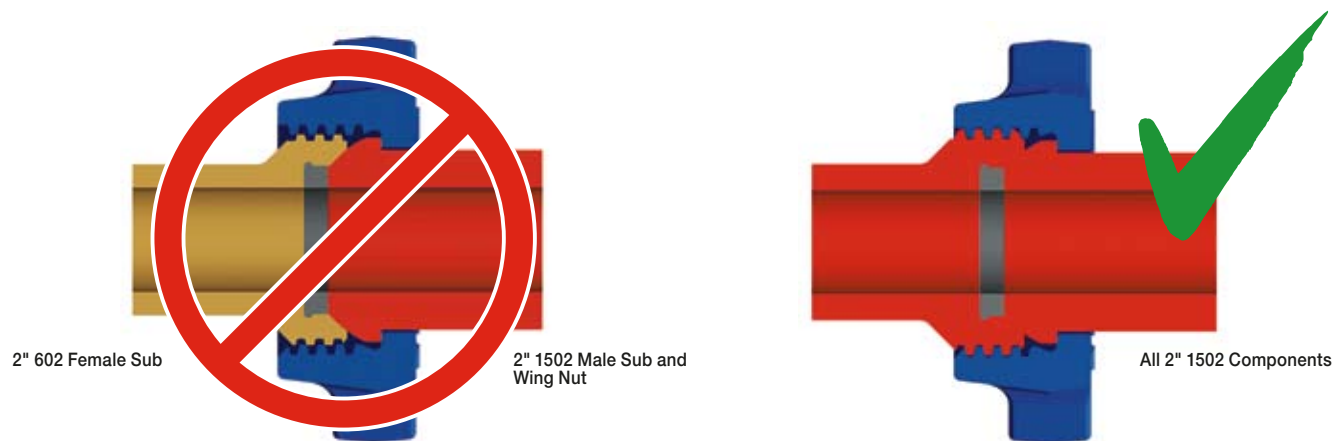
An example of this combination is the 2" Figure 602 and the 2" Figure 1502 Union. The threads on the 2" Figure 602 female sub, for instance, will slightly engage the internal threads of the 2" Figure 1502 wing nut, resulting in an incorrect and hazardous connection.

In the illustration below, the incorrect combination on the left shows the slight engagement of the female sub threads and the wing nut threads. This type of combination may, under some circumstances, appear to seal and may hold the desired amount of pressure for a period of time. The combination of 2" Figure 1502 components on the right illustrates the correct combination showing full thread engagement.

To avoid connecting a wing nut onto an incompatible female sub, users must always assure that these end connections are positively identified with identical size, figure number, and pressure rating.

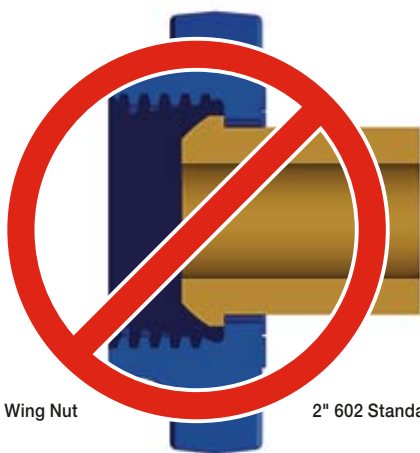
2" 1502 Wing Nut

An example of this combination is the assembly of a 2" Figure 602 standard male sub (non-detachable) installed in a 2" Figure 1502 wing nut.

In the illustration on the left below, note the slight amount of engagement of the male sub in the wing nut. When installed on a female sub, this combination may seal and hold the desired amount of pressure for a period of time. Full engagement of the correct combination of components is shown on the right.

2" 602 Standard Male Sub

To avoid assembling incompatible wing union components together, users must always assure that the wing nuts, male subs, and segments are positively identified as being of the same size, figure number, pressure rating, and manufacturer.

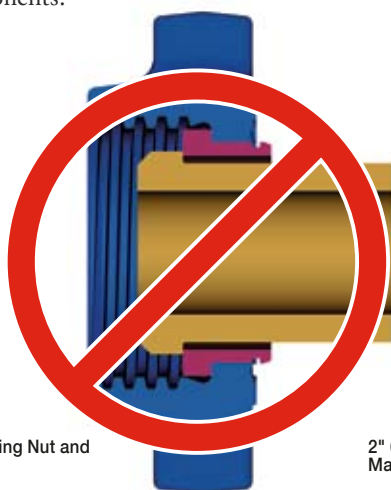
2" 1502 Wing Nut and  
Segments

An example of these combinations is a 2" Figure 602 detachable male sub installed in an assembly with a 2" Figure 1502 wing nut and retainer segments.

Since many products are machined integrally with male subs, it is important to make sure that the correct union components are used. The illustration below on the left shows an incorrect assembly of 2" Figure 602 and 2" Figure 1502 components. As has been indicated previously, a combination of this type with a female sub may seal and hold a desired amount of pressure for a period of time. The illustration on the right shows a correct combination of 2" Figure 602 components.

2" 602 Detachable  
Male Sub

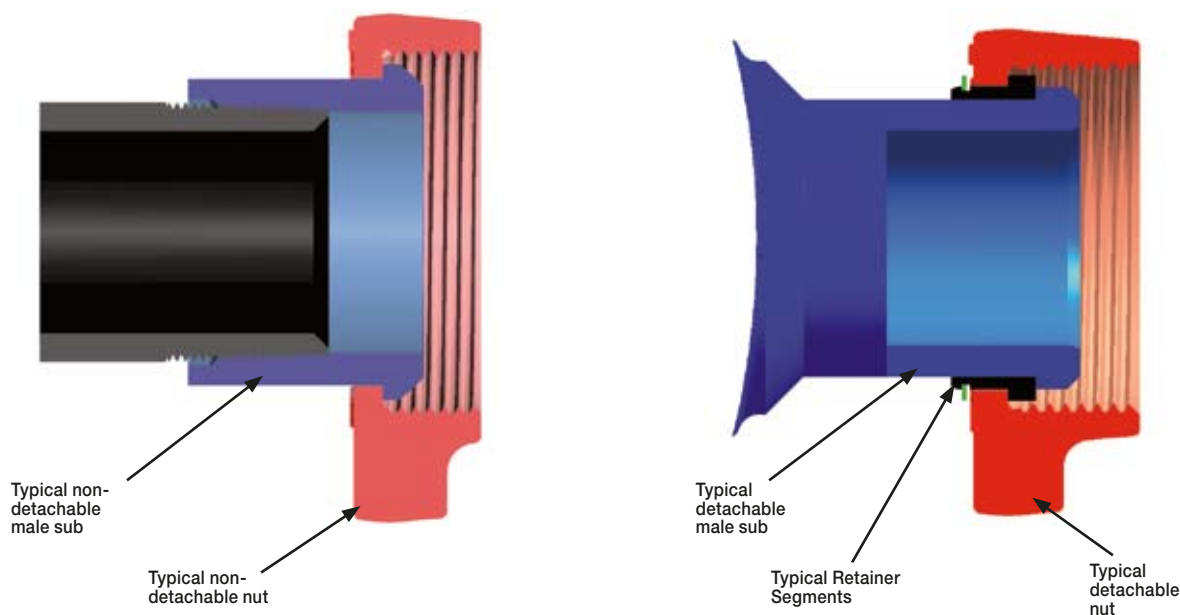
Wing unions (illustrated below on left), which are manufactured with non-detachable nuts, require the nut to be assembled to the male sub end before the subs are assembled by welding or thread make-up to other equipment. The detachable nut wing union design (illustrated below on right) employs a lower profile shoulder on the male sub end and the addition of retainer segments that are inserted between the nut and male sub to retain the nut on the male sub end.

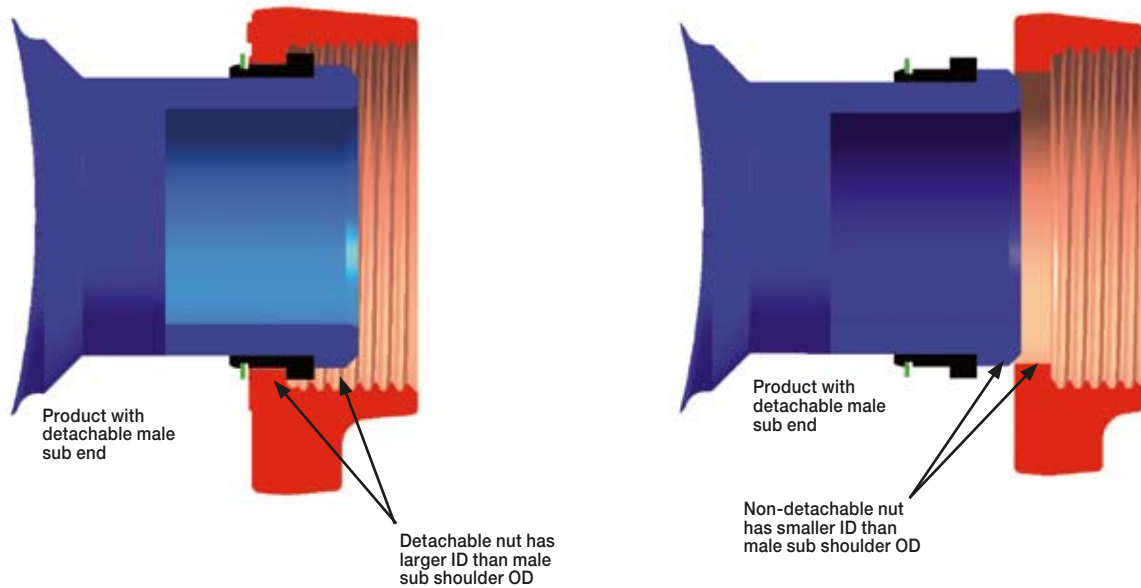
Normally valves, swivel joints and other service line equipment using integral wing union end connections are constructed such that it would be impossible to capture a non-detachable nut between the male sub shoulder and the rest of the product as shown below.

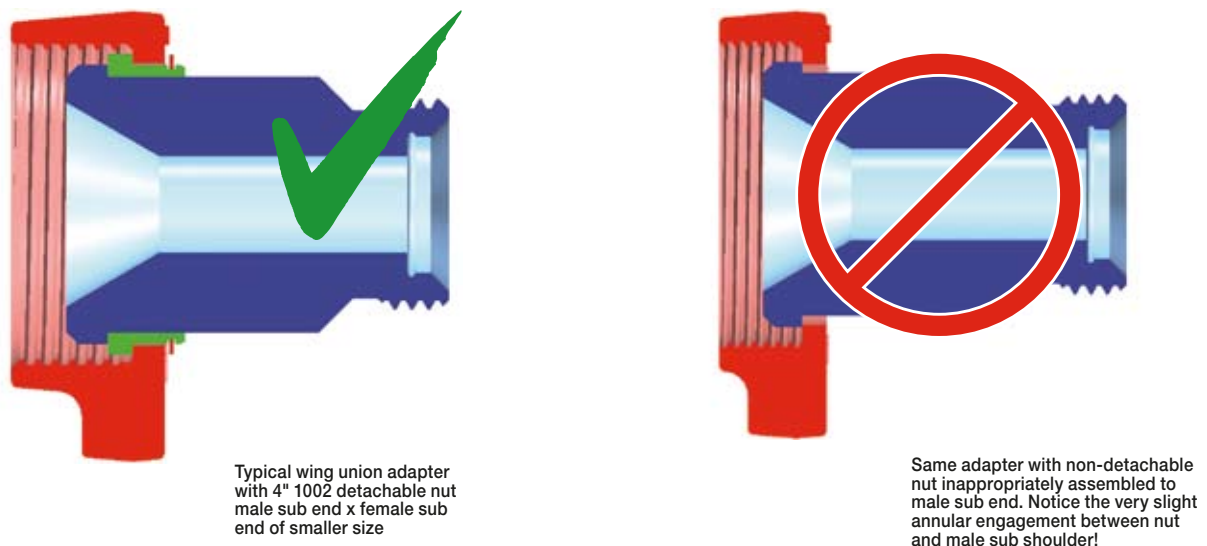
In some special situations, such as certain wing union adapters and assemblies using threaded or butt weld male subs, it is possible to slip the non-detachable nut from behind a detachable male sub shoulder (see figure below on left). On the 3" and 4" sizes of figure 602 and 1002 wing unions, the annular engagement between the back of the male sub shoulder and inner shoulder of the non-detachable nut engages only slightly - not nearly enough to produce a safe connection (see figure below on right). This condition would result in a connection that could unexpectedly separate under normal operating conditions.

To avoid the unsafe condition described on the previous page, the user must confirm that the appropriate wing nut is being used for a given end connection. All 3" and 4" figure 1002 and 602 detachable nuts currently manufactured by FMC Technologies have the identifier "DET" forged into the back of detachable nuts (see figure below on left). On these sizes, if this identifier is not present, the nut must not be used on detachable wing union connections. Another obvious indication of inappropriate use of non-detachable nuts on detachable wing union connections of both 3" and 4" figure 602 and 1002 sizes is the excessive amount of play between the inside diameter of the nut shoulder and the outside diameter of the sub behind the male sub shoulder (see figure below on the right). If this condition is ever encountered, the wing union connection must be disassembled and investigated for mismatch of components.

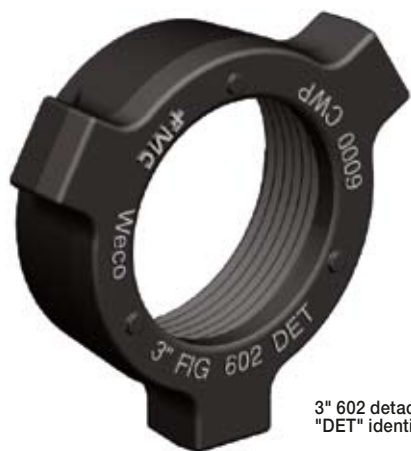
3" 602 detachable nut with "DET" identification.

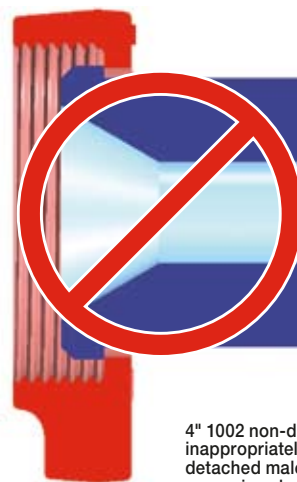
4" 1002 non-detachable nut inappropriately assembled to a detached male sub end. Notice the excessive play between the ID of the nut and male sub OD behind the shoulder.

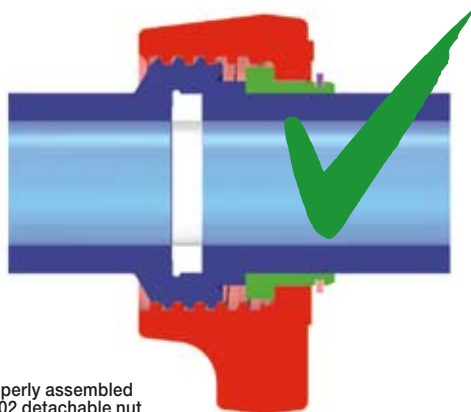
A properly assembled 2" 1002 detachable nut wing union connection.

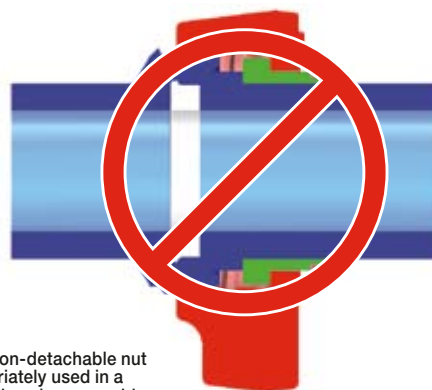
Unlike the 3" and 4" figure 602 and 1002 wing unions, the 2" size non-detachable nut does not engage the male sub shoulder of a detachable nut connection. However, another issue arises if a non-detachable nut is used on a detachable nut connection. On a properly assembled 2" 602 and 1002 detachable nut wing union connection the nut fully engages the threads of the female sub (see figure below on left). Using the shorter non-detachable, which will appear to properly assemble over the retainer segments of a detachable male sub end connection, results in inadequate engagement of the female sub threads by the nut (see figure below on right).

2" 1002 non-detachable nut inappropriately used in a detachable union assembly. Notice the resulting lack of thread engagement with the female sub.

This unsafe condition can be encountered on any product employing detachable male sub end connections. To avoid this condition, it is important to ensure the correct nut is used. Like the 3" and 4" figure 602 and 1002, the 2" size also has the identifier "DET" forged onto the back of the detachable nut. If the identifier is not present, the nut must not be used on a detachable wing union connection.
