# HYDRO GEO<sup>EXPLORATION</sup>

## INITIAL GEOLOGY ASSESSMENT SUMMARY

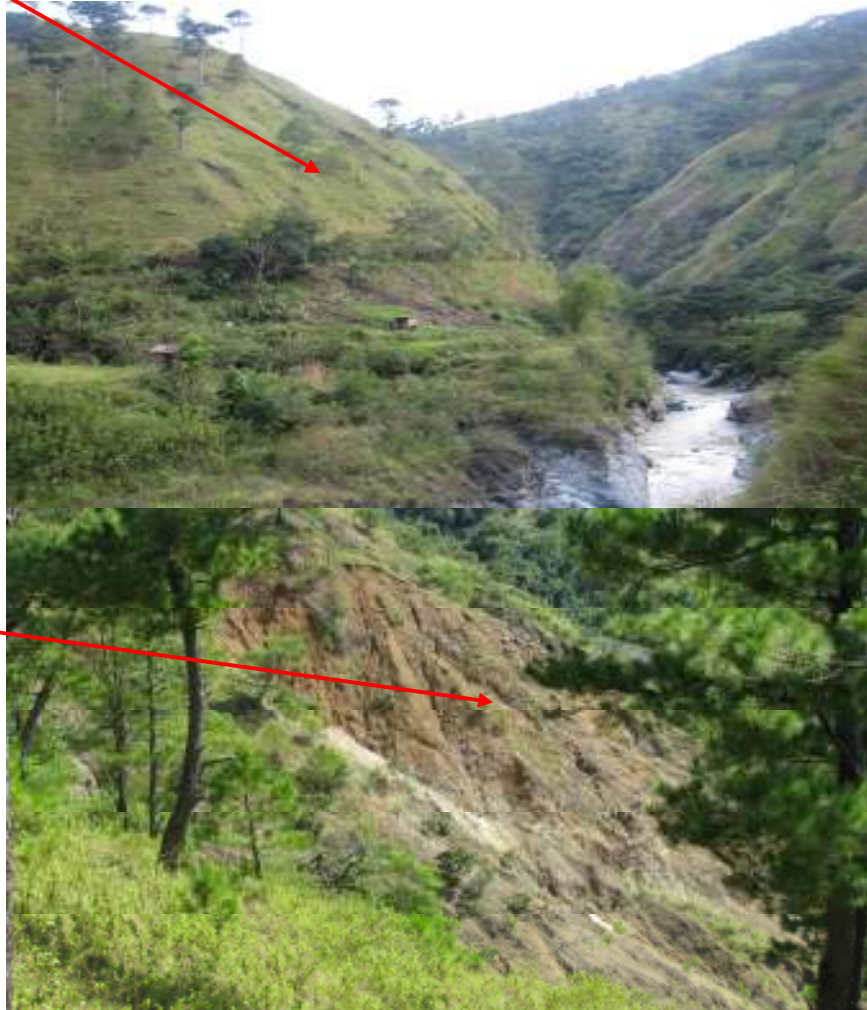
Generally ranging from 40-80 degrees

Landslide with circular mode of failure.

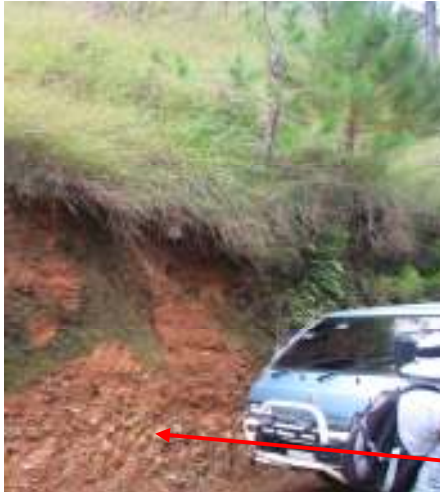
**SOIL DESCRIPTION:**  
coarse angular clayey GRAVEL

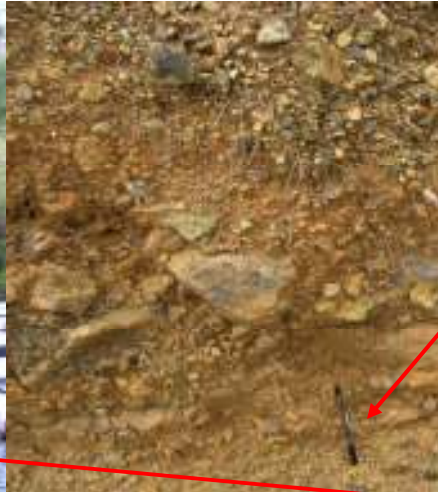
**SOIL DESCRIPTION:**  
fine granular silty CLAY loam

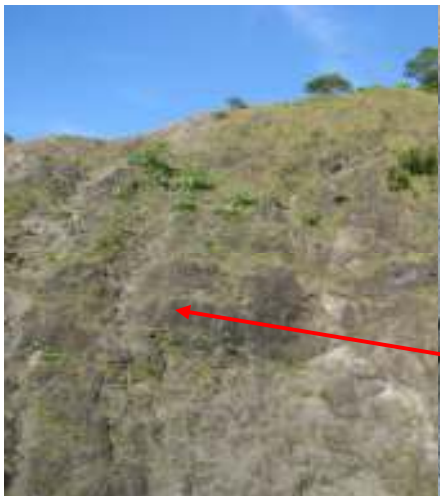
**ROCK DESCRIPTION:**  
ANDESITE

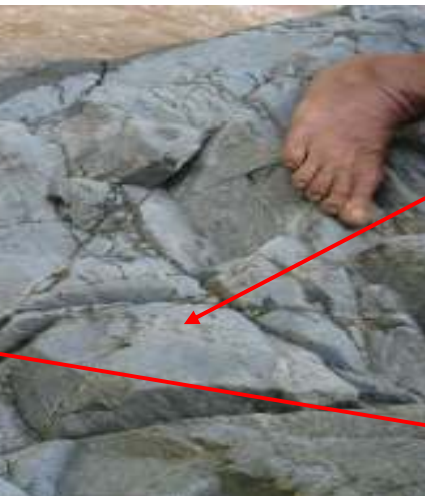
**ROCK DESCRIPTION:**  
DIORITE

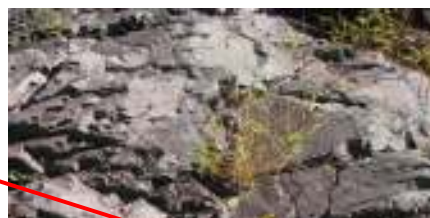
**ROCK DESCRIPTION:**  
BASALT

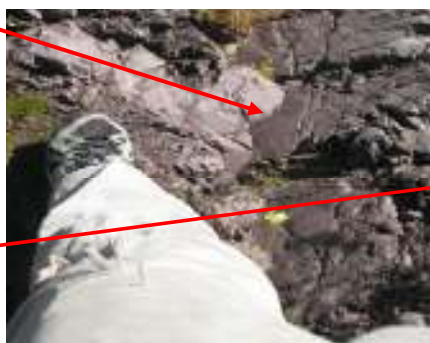
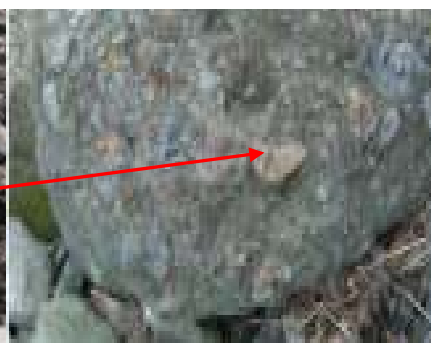
**ROCK DESCRIPTION:**  
VOLCANIC BRECCIA

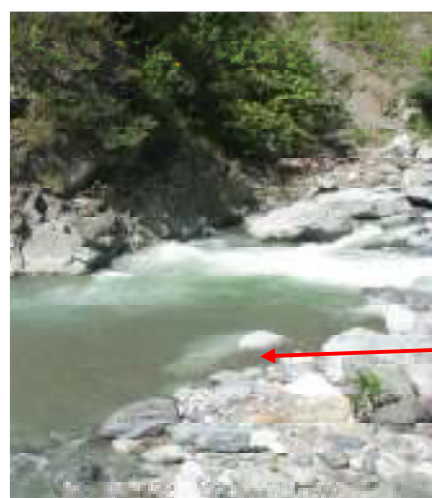
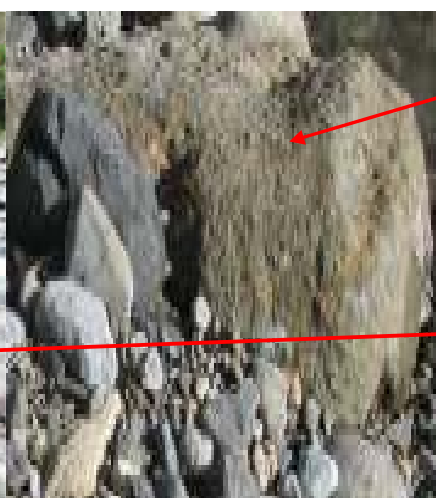
**RIVERBED DESCRIPTION:**  
sandy GRAVEL with alluvium of igneous rocks considered as cobbles and boulders in size.
