THE EXCALIBUR GONDOLA INCIDENT

December 16, 2008

Prepared by: Provincial Safety Manager,
Passenger Ropeway and
Amusement Devices

Report No.: RPT-5031-00

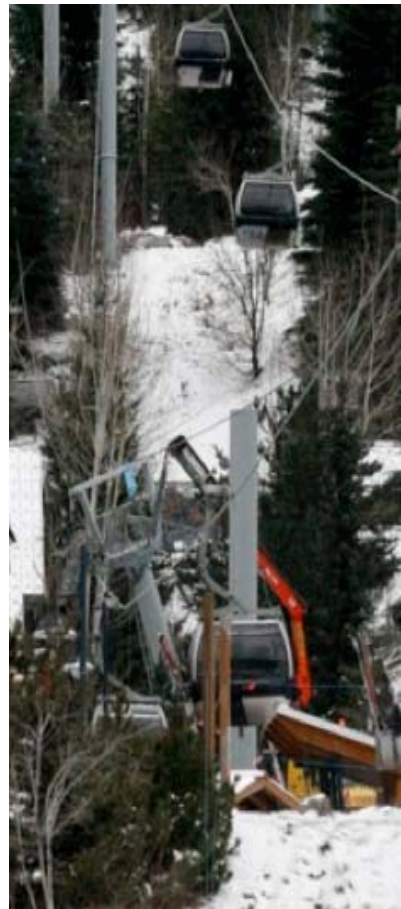
FIGURE 1.

Tower #4 Separation

the return station. The lift mechanic instructed the drive station to keep the lift secure. He left to inspect the lift line and discovered that Tower #4 had completely separated at a point just below the bolted splice coupling plate connecting the upper and lower sections together. The upper section of Tower #4 was located on the ladder side of the lower tower section. The upper tower section was in an upright position and was supported by communication cables attached to the top of the lifting gantry and the haul rope, which was located just under the tower cross-arm.

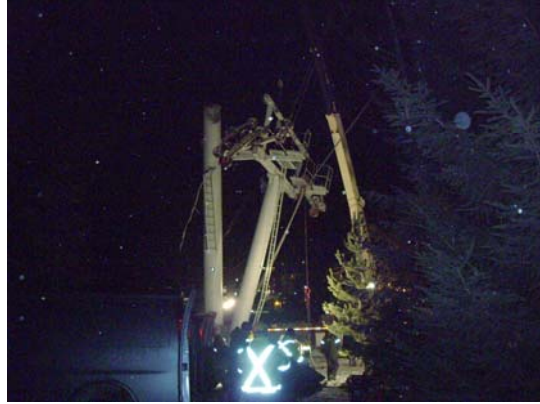
FIGURE 2.

View of upper section of Tower #4 supported by haul rope and communication line (crane in place to prepare for removal of upper tower section)

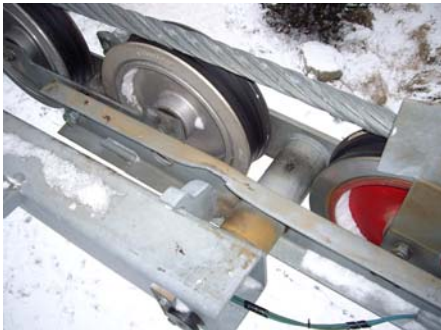
FIGURE 3.

View of damage to Tower #3 DH sheave assembly

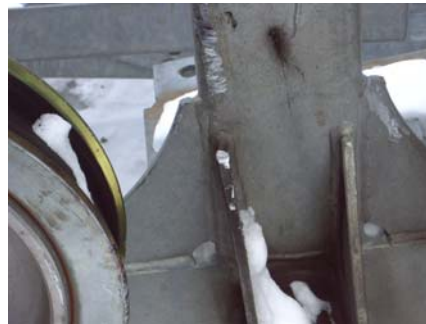
FIGURE 4.

View of impact damage to \ Tower #4 DH sheave assembly

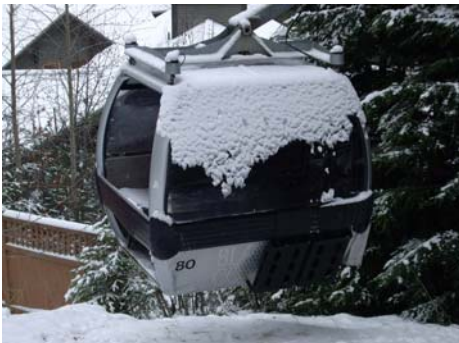
Figure 5

View of impact damage to Cabin #80

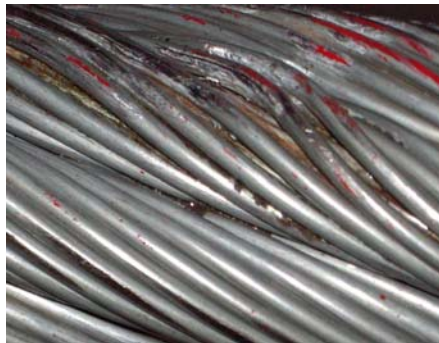
FIGURE 6.

View of haul rope damage at 576 meters from splice

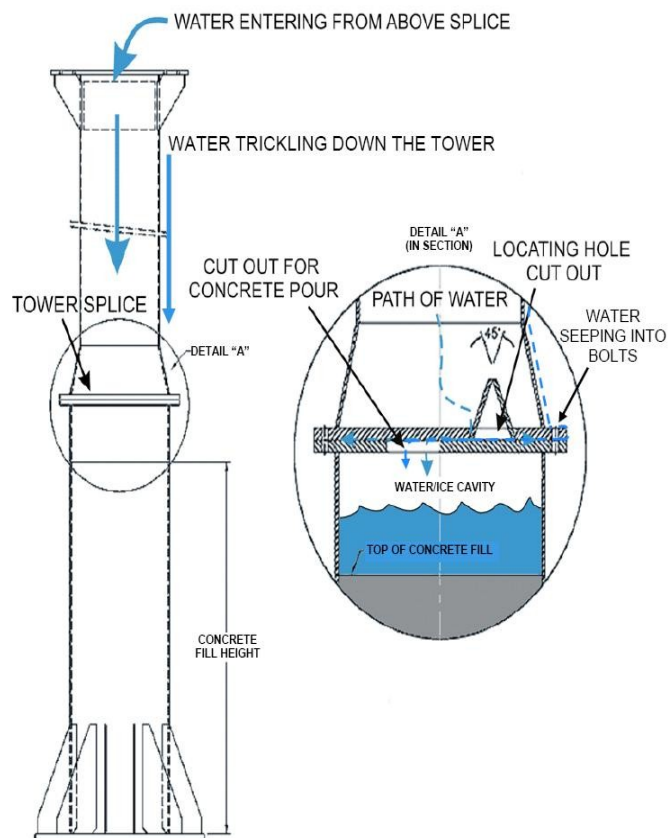
FIGURE 7.

37. As noted in paragraph 7, the original design of the Tower #4 structure was for the upper and lower sections to be sealed against the environment and more specifically against the ingress of water. The fact that a column or cylinder of ice some 1.9 meters in length was found in the tower immediately following its failure is evidence that at sometime within the fourteen years the tower was in-situ, water did find a way to enter and collect in the lower section of the tower structure. As depicted in Figure 7 it is believed that the water ingress into lower tower section was facilitated through a rectangular opening located in the splice coupling plate attached to the lower tower section. This opening in the splice coupling plate was provided to allow for the pouring of concrete into the lower section during construction. The filling of towers with concrete is a common practice of Doppelmayr CTEC for towers of this height (i.e. 16.7ms) to help stabilize the tower and prevent excessive movement or sway during operations. It was found that a bolt-hole on the splice coupling plate was flame cut during construction which may have created a path for water to enter between the upper and lower splice ring and into the rectangular hole in the lower plate. The flame cutting of the bolt hole was probably conducted during installation and erection of the tower to assist with aligning the bolt-holes on the splice coupling plates of the upper and lower tower sections.

Schematic of Tower #4

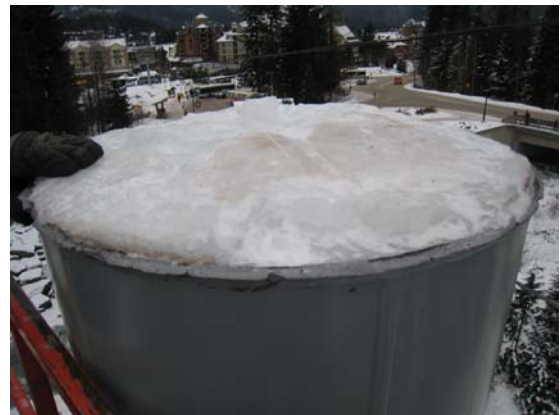
FIGURE 8.

39. These unusually cold temperatures contributed to the freezing of the water inside the tower structure as depicted in figure 8. The forces generated from the volumetric expansion of water due to freezing within the lower tower section are key factors contributing to the Tower #4 splice coupling failure. This phenomenon is also commonly referred to as 'ice jacking'. See Figure 8.

Top of Ice Column found in Tower #4 Lower Section Tube

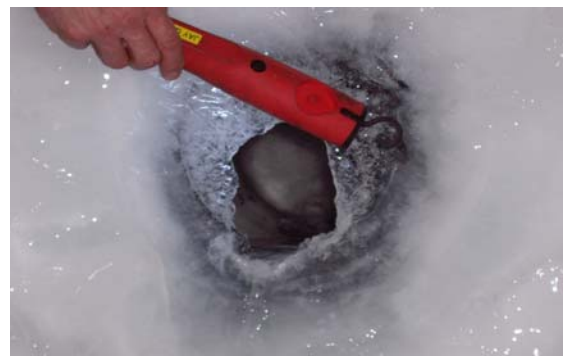
FIGURE 9.

40. Following the failure and prior to sending the failed section of Tower #4 to Acuren, the lower section of Tower #4 was taken to the Whistler Blackcomb Mountain maintenance shop where it was heated with propane torches to break free the ice column inside. The ice column that was removed measured 1.9 meters in length and is shown in Figure 9. The ice column was found to be still in liquid form near its center as sections of it were removed from the tower tube. This indicates the freezing process was not complete and that the column of ice was in a continued state of expansion. Below this ice column the rest of the lower section of the tower structure was filled with concrete to a height of 7.8 meters, which met the minimum level of 4 meters as per Doppelmayr's design specifications. See Figure 9.

Partially Frozen Ice Column Inside Tower #4 Lower Section Tube

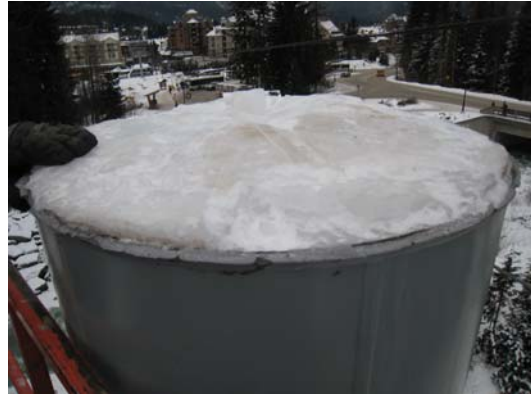
Figure 11.

View of ice protruding approximately 10 mm above failure point from within lower section of Tower #

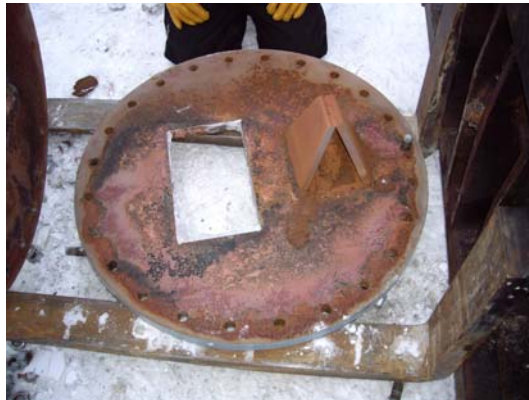
Figure 12.

View of Tower #4 lower section splice coupling plate with rectangular opening

62. The splice coupling plate on the lower section of Tower #4 was found to have a rectangular hole to facilitate the injection of concrete in to the lower tower tube. The splice coupling plate on the upper section was found to have a rectangular hole installed to receive two plates welded together to form a locator piece on the lower splice coupling plate for proper alignment of the two tower sections during construction. A bolt hole on the upper splice coupling plate was found to be flame cut which is a common practice used when installers are unable to align bolt holes between upper and lower plates during construction. These findings were the only possible paths for water ingress discovered during the investigation.

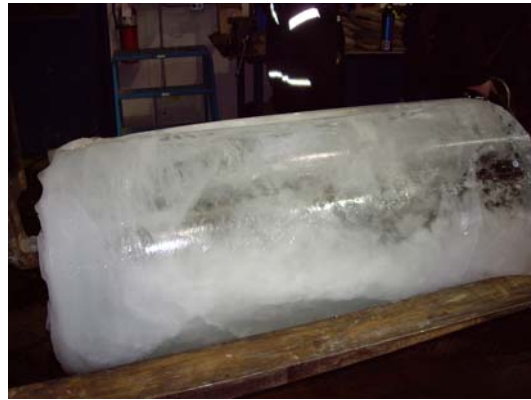
Figure 13.

View of ice column removed from lower section of Tower #4

63. When Tower #4 was removed from its site following the failure a cylinder of ice was found in the lower section of the tower above the 7.8 meters of concrete. This ice column filled the entire central portion of the lower tube cavity and was some 1.9 meters in length. The column of ice was not completely frozen at its center indicating that the ice was still forming and the column was a continued state of expansion.

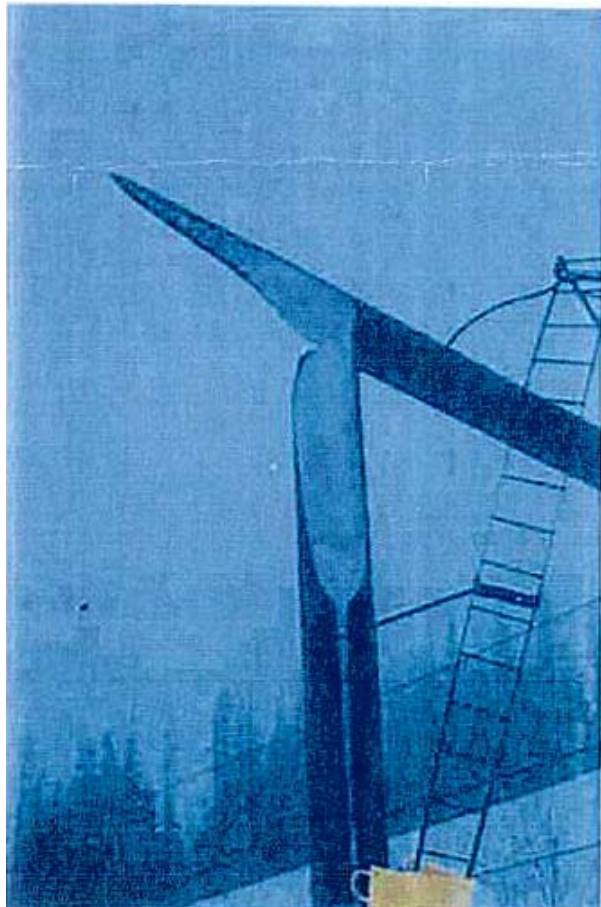
55. In December of 2006 Safety Alert bulletin SA-06-022 was issued to Doppelmayr customers. The document identified that it affected not just Doppelmayr installations but all installations that Doppelmayr took responsibility for as a manufacturer through company mergers and acquisitions. The safety alert identified an installation in Idaho that failed due to the formation of ice within the tower structure on a Von-Roll chairlift. The tower affected was of a two piece design but did not have the same construction details as Tower #4 on the Excalibur Gondola. The tower was 46 feet tall and the ice which formed within it was up to the 30 foot level. The tower split vertically from the base and then hinged at approximately 18.5 feet and fell towards the uphill side of the lift. The temperature at the time this incident occurred was approximately -18° C. This Safety Alert bulletin described for the first time the test referred to as a resonance test. Doppelmayr required that inspections of affected towers be completed within 30 days of the issuance of the bulletin if routine inspections had not been performed already on the installation. The bulletin also stated that holes to evacuate water could only be installed if the presence of water was detected. The bulletin did not address the fact that some towers may be filled with concrete. The tower failure identified in this bulletin is shown in Figure 14.

Idaho Tower Failure

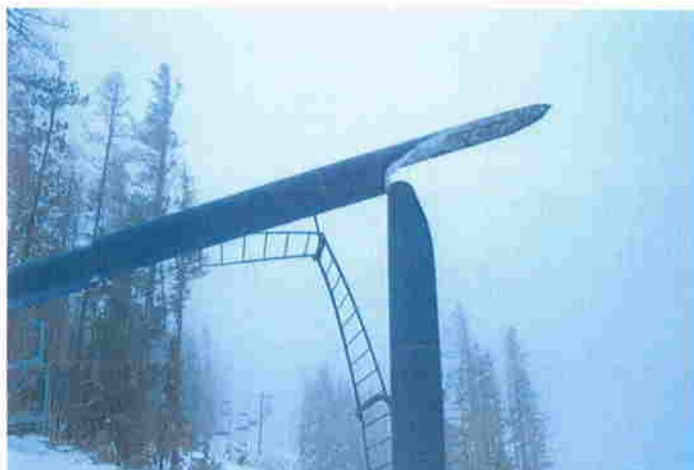
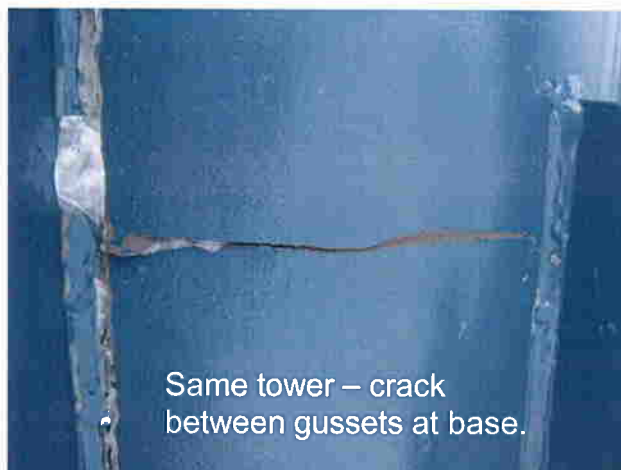
Tower: 6S/4S; 46' tall; 30' of 20" tube spliced to 16' of 16" tube. Ice filled to 30' position.

Weather conditions at failure:
Night; ~-5° F.; Wind ~ 57 mph.

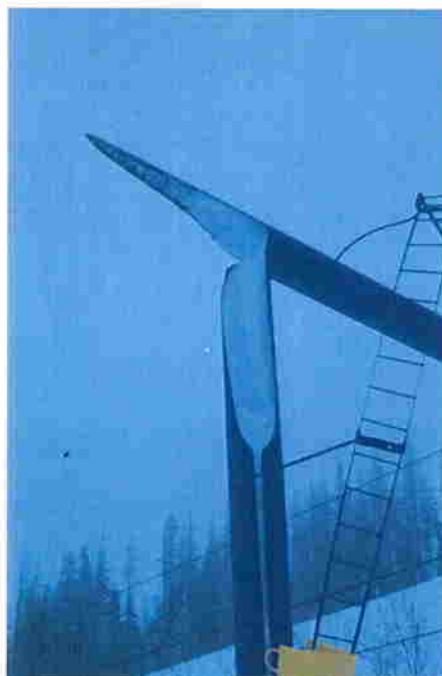
Haul rope was trapped on both HS & LS assemblies.

Horizontal tower base crack 10-1/2" long, 14" up from base.

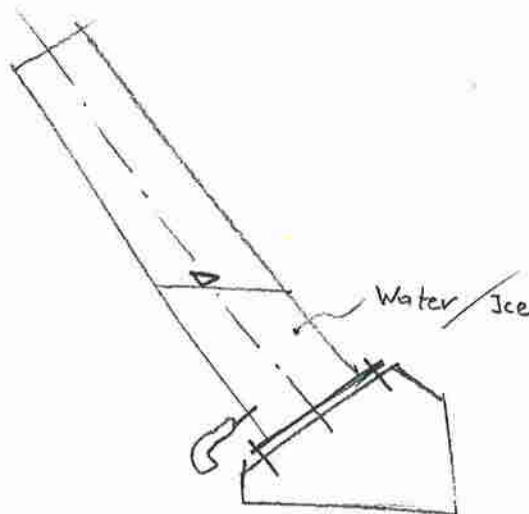
If with a resonance check, water/ice is found or suspected inside the tower within 4" (100 mm) of the top plate (see Section 3.1.2) **this shall be cause for immediate and continued closure of the lift to public transportation** and must be reported to the nearest Doppelmayr representation office for review and recommended repair procedures.

If with a resonance check, water/ice is suspected to be present within the tower but further than 4" (100 mm) from the top plate, a small hole 3/8" - 1/2" (10 - 12 mm) must be drilled near the tower base at the downhill side of the tower along the centerline of the lift 2" to 4" (50 - 100 mm) from the tower base to provide a pathway for water to escape. See illustration below.

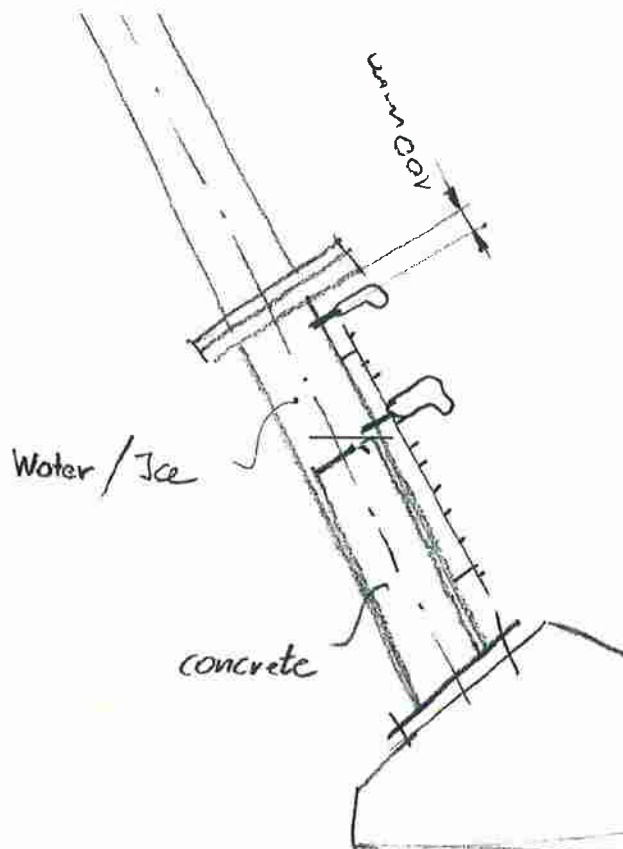
For tower shaft sections partially filled with concrete through the top plate, check the tower section with the hammer method as described previously. If water/ice is suspected, drill a small hole 3/8" - 1/2" (10 - 12 mm) approx. 2 inches (50 mm) below the top plate on the uphill side of the tower (behind the ladder). Tower shafts with a cover for concrete fill on the outside of the shaft already have a drain hole and the cover can be removed for inspection purposes. **If ice is found in this section, this shall be cause for immediate and continued closure of the lift to public transportation** and must be reported to the nearest Doppelmayr representation office for review and recommended repair procedures.

A small drain hole 3/8" - 1/2" (10 - 12 mm) is required to eliminate the water above the concrete level. See illustration below.

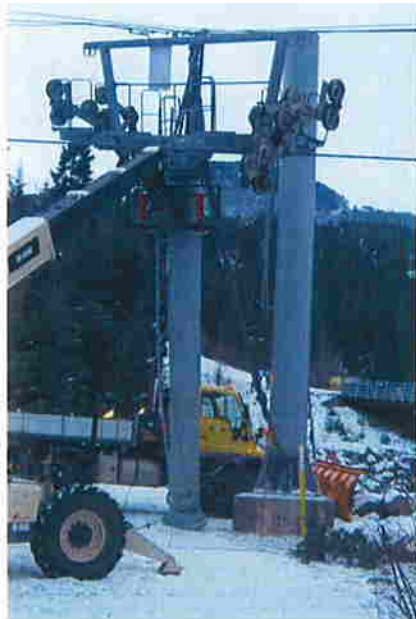
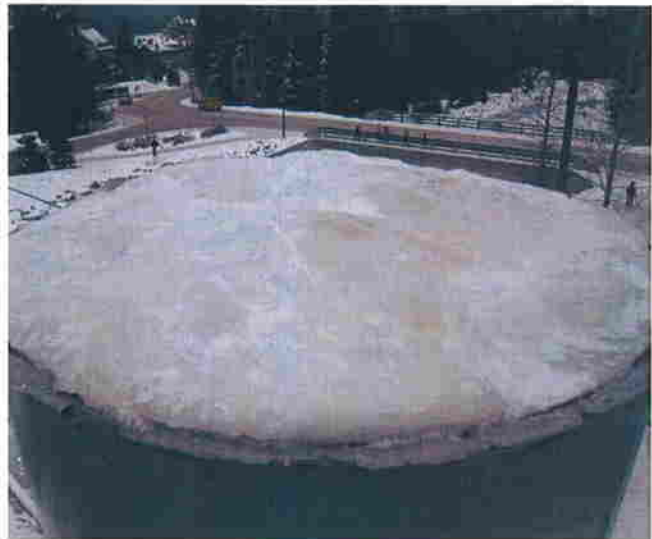
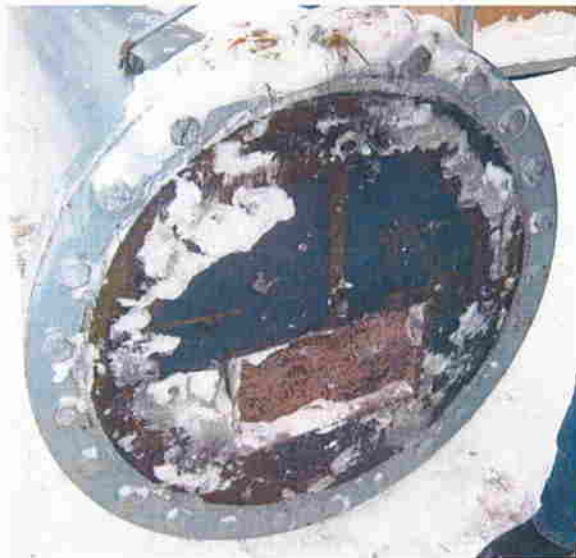
Tower with 2 x 6T/2FR assemblies;
16,7m tall; 9,7m of 30" tube spliced
to 7m of 24" tube.

Lower tower section filled approx.
5m with concrete, the remainder
with ice.

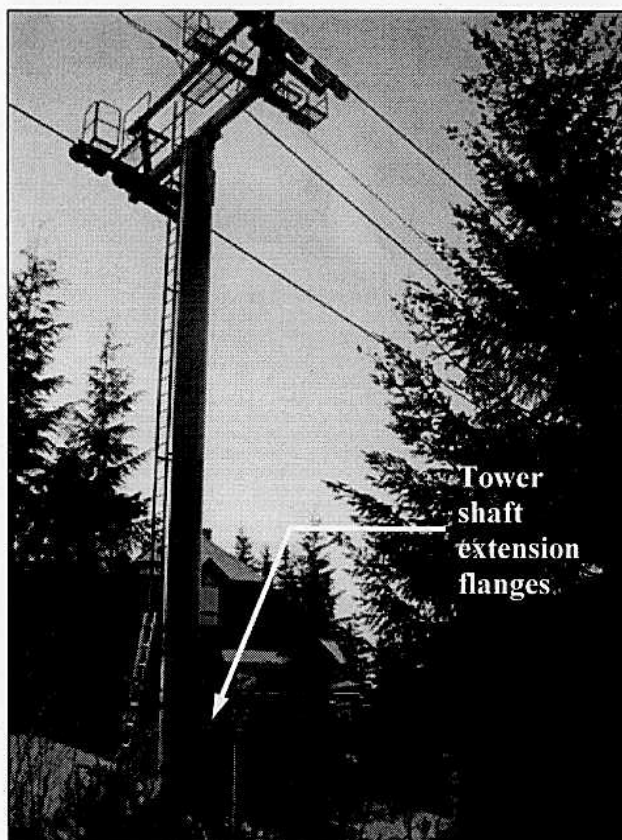
Photo 1:

General view of Excalibur tower #5.

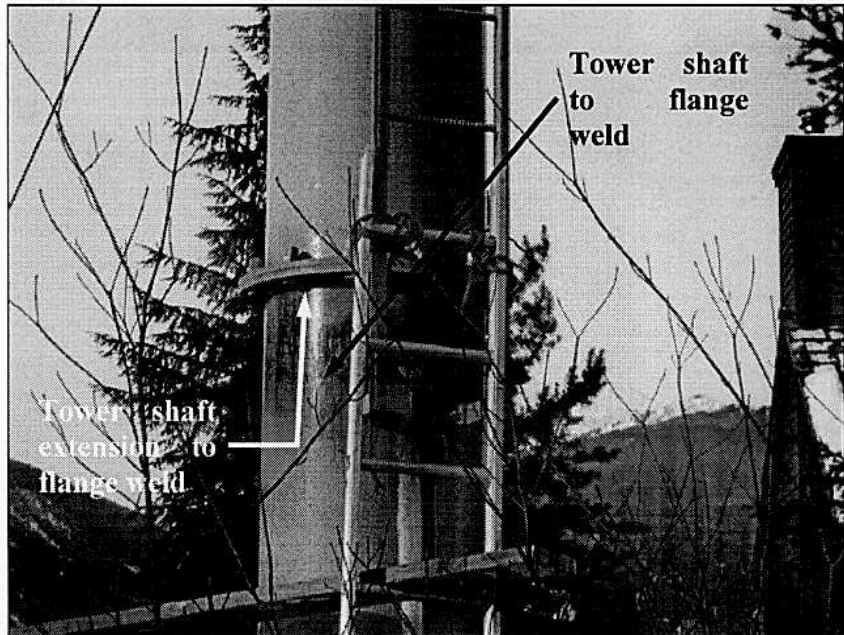
Photo 2:

Close up down hill view of the tower shaft extension and tower shaft to flange weld.

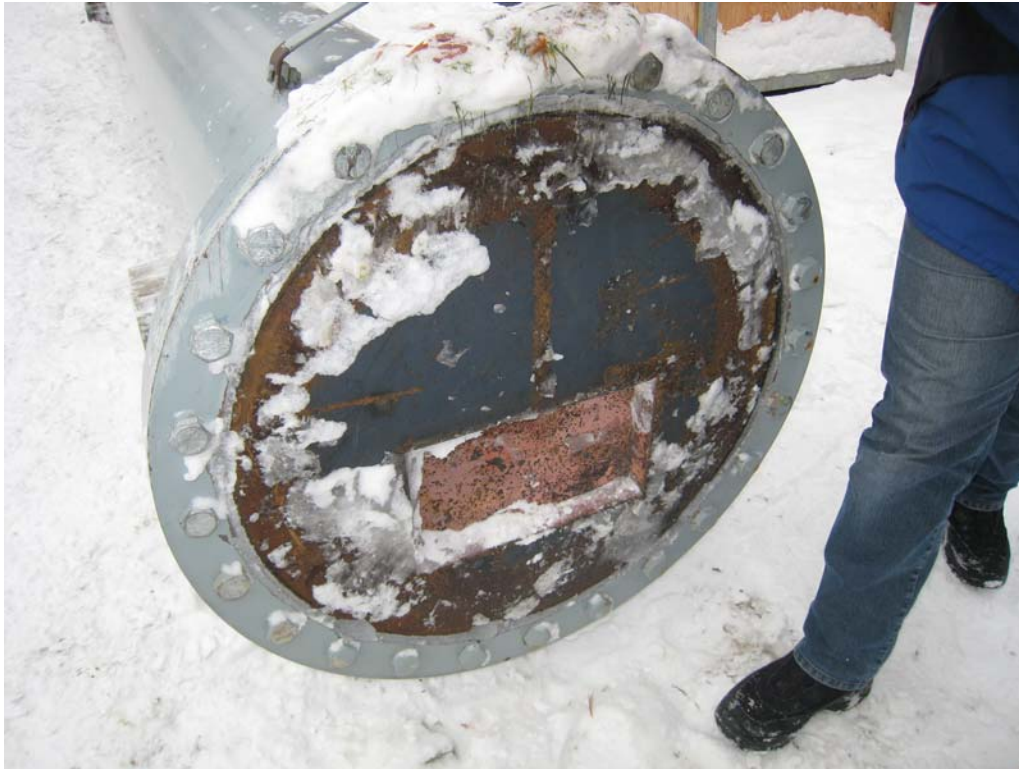
Lower Excalibur T4, underside of lower section cap plate, shiny weld surface shows brittle plate failure (i.e. plate tore away from the weld)

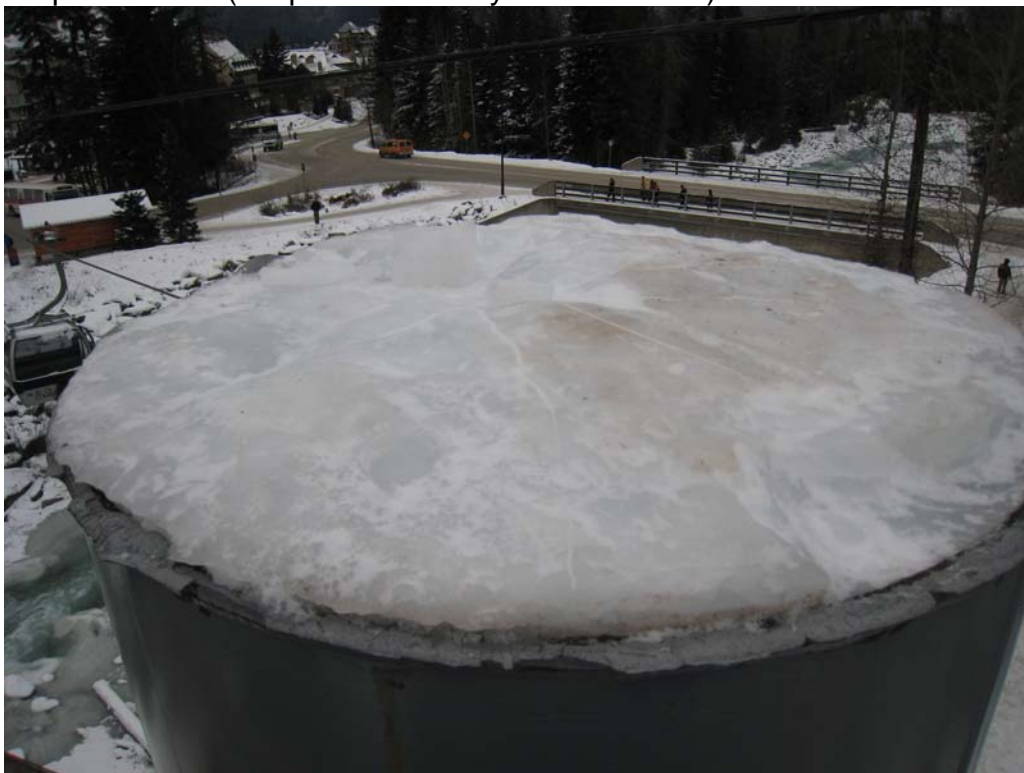
Lower Excalibur T4, Ice protruding above failed connection

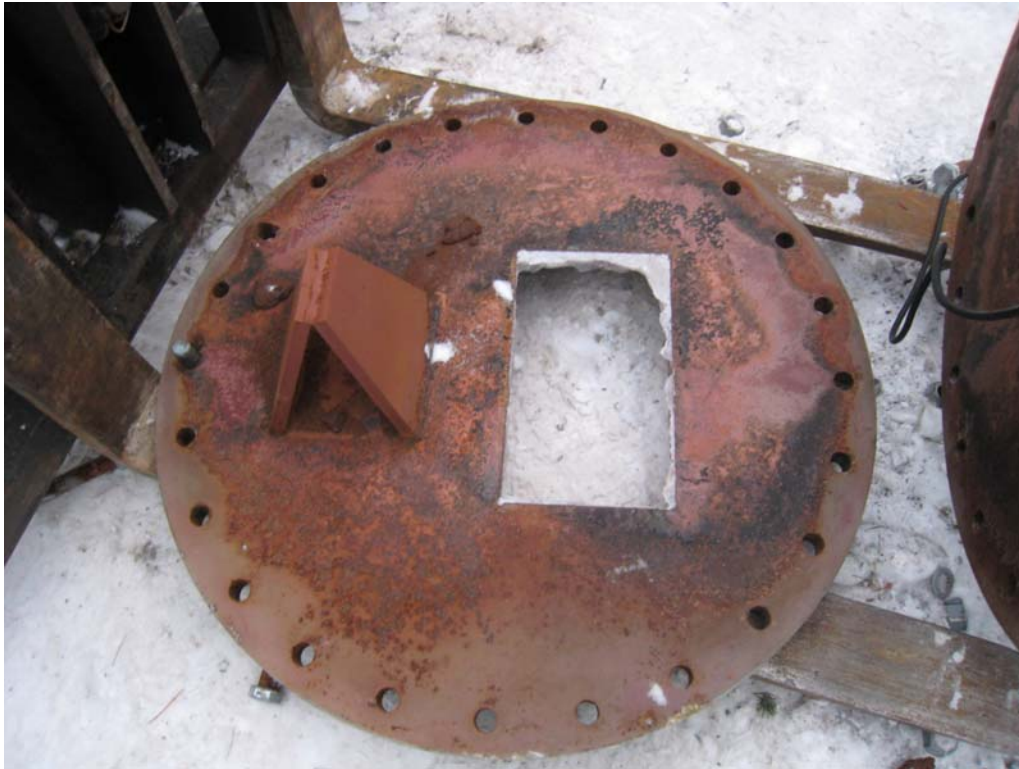
Lower Excalibur T4, top side of lower section cap plate

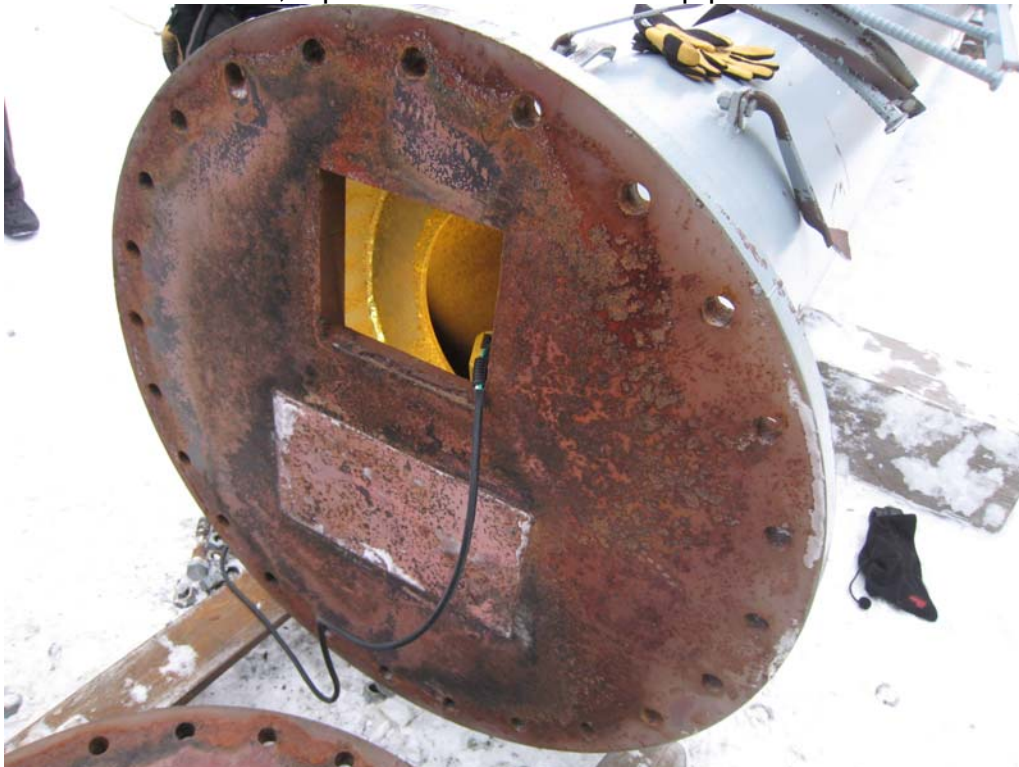
Lower Excalibur T4, lower side of upper section base plate

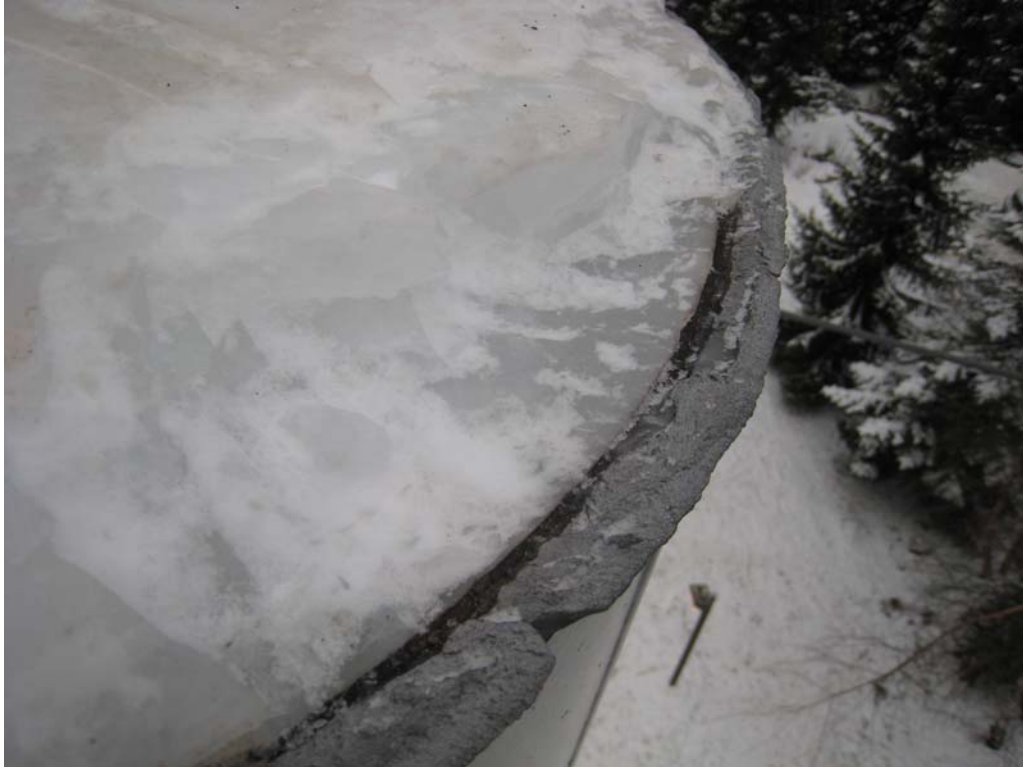
71. Acuren's examinations also identified a pre-existing crack within the weld where the crack of December 16 originated, as well as the fact that the weld was not a full penetration weld for 70% of the circumference. The Provincial Safety Manager is of the opinion that the lower splice coupling plate on Tower #4 was not designed for the forces developed by the expanding ice and therefore was unable to resist the forces generated from the continued expansion of ice. The Z98 standard in use at the time of the construction of the Excalibur Gondola and the current Z98 standard does not require manufacturers or designers to design a tower structure to resist this type of internal force

Lower Excalibur T4, incomplete penetration at lower section cap plate

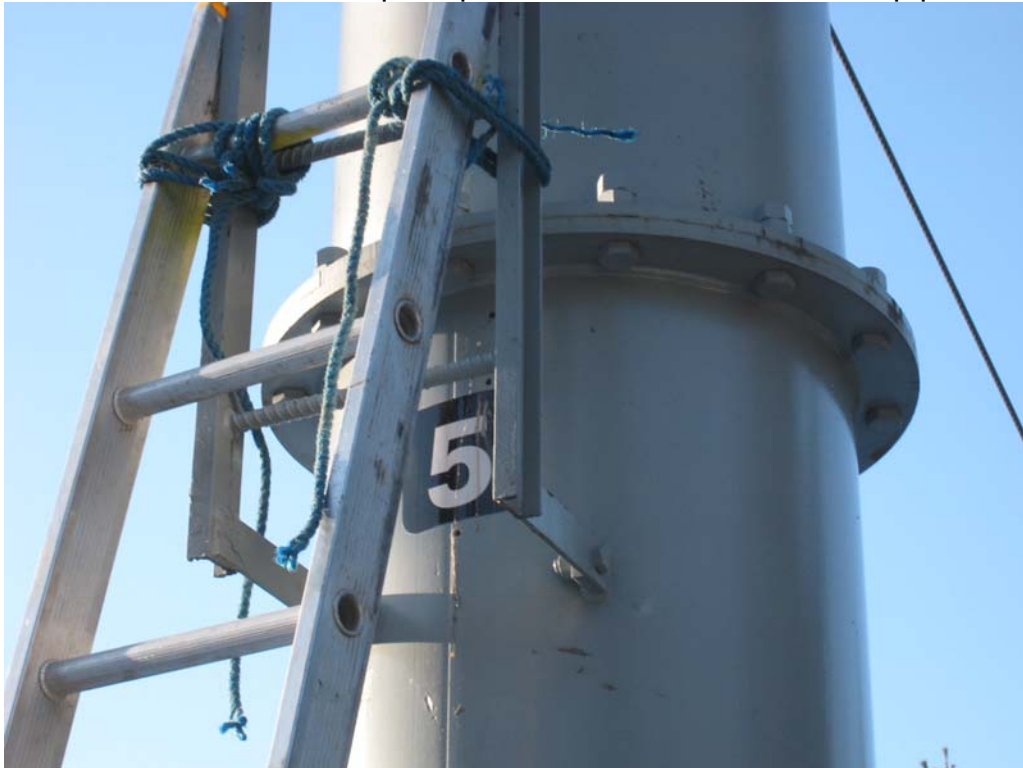
Lower Excalibur T5, pilot holes to determine concrete/ice interface

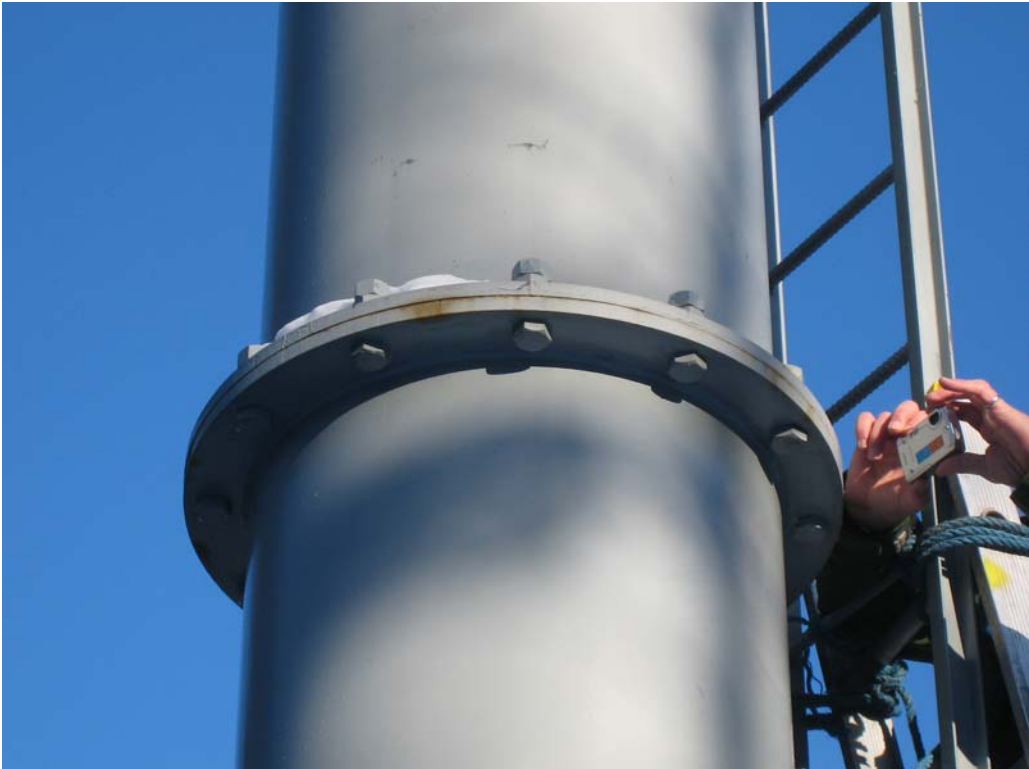
Lower Excalibur T5, rusted lower flange from water leakage

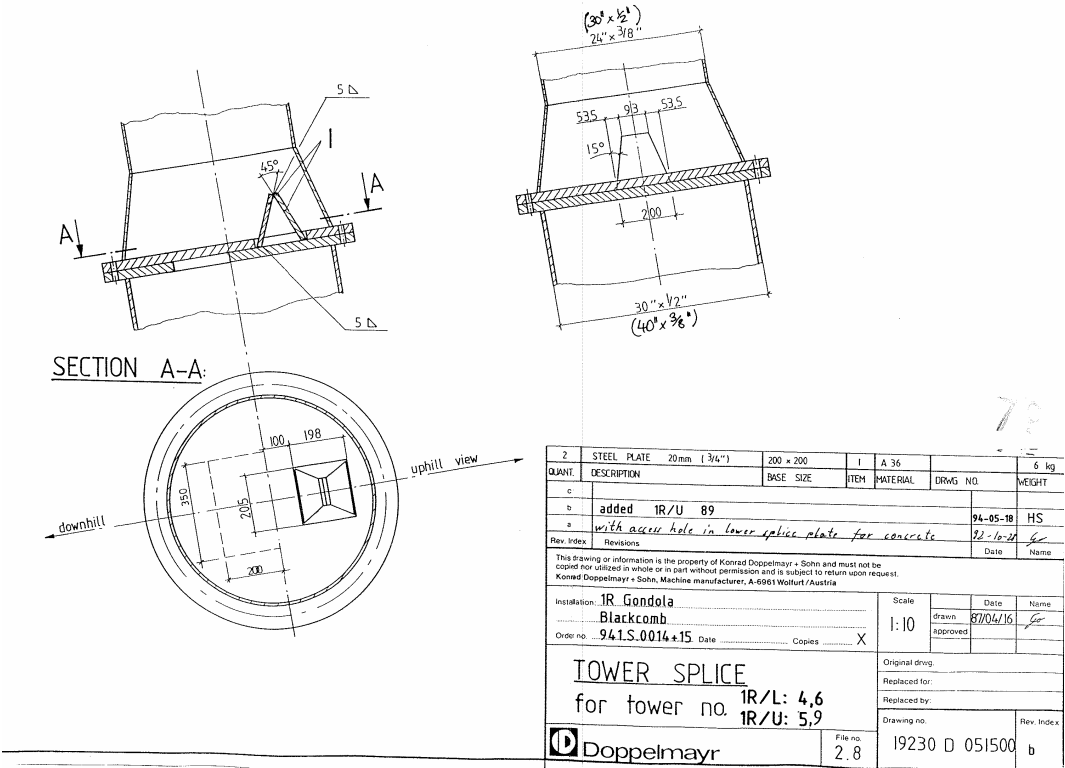
Lower Excalibur T4, splice details
