## Infrared Thermography in the Process Gas Plant

*Randy Gates*

*Senior I&E, Lost Cabin Gas Plant, Burlington Resources*

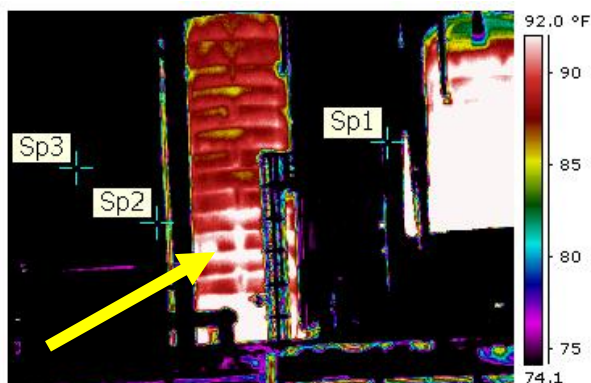
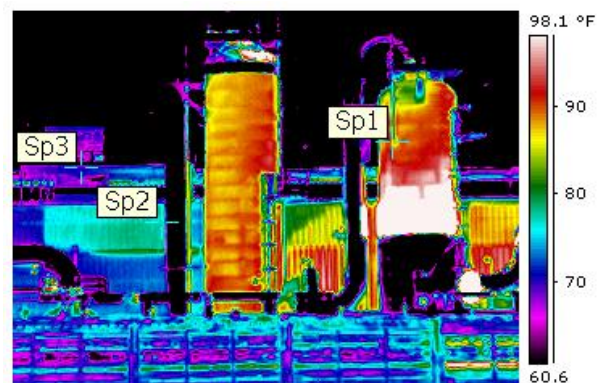
With the use of infrared camera technology, as shown in Figures 1A through 1C, there were no problems with the trays, but there were some blockages. We were able to determine that these could be corrected by an acid wash rather than a shutdown, due to the use of IR technology.

*Figure 1A. IR scan of absorber tower.*

*Figure 1B. IR scan of absorber tower using a different palette.*

*In the above pictures you can see the channeling in the lower part of the tower due to blockage from sludge and buildup that created uneven solvent distribution. You can also see that all of the trays are intact.*

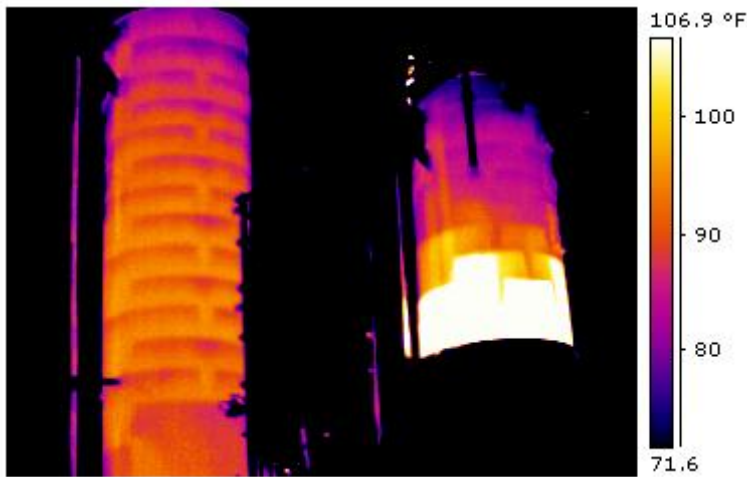
*Figure 1C. This is a thermal image of the absorber tower following the acid wash. The buildup and sludge are gone and the flow through the tower was back to normal. This image also proves that the trays remained in place during the wash, saving many man hours.*

The acid wash took 48 hours and we were able to complete it by only a slight flow reduction through the plant. The cost savings are as follows and these are very conservative estimates: revenue attributed to our plant is approximately \$750,000 per day and of that Plant Three accounts for \$500,000 of that. A ten day turnaround from lost production would cost us approximately \$5,000,000 in lost revenue. We are in a very remote location so the mobilization for a shut down and to bring crews and added man power costs an addition \$500,000. There could be more variables factored into this equation and more saving realized, but example clearly shows the impact of the use of the infrared camera.

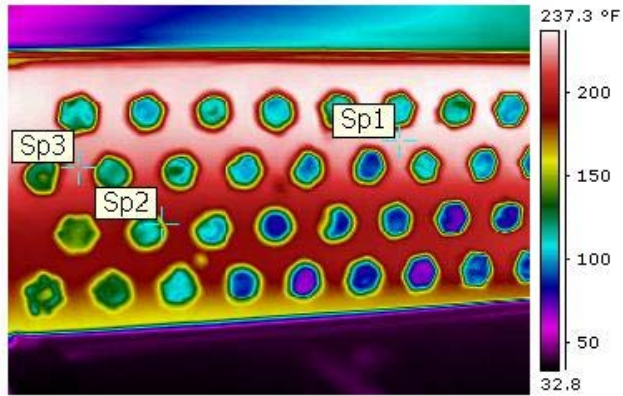
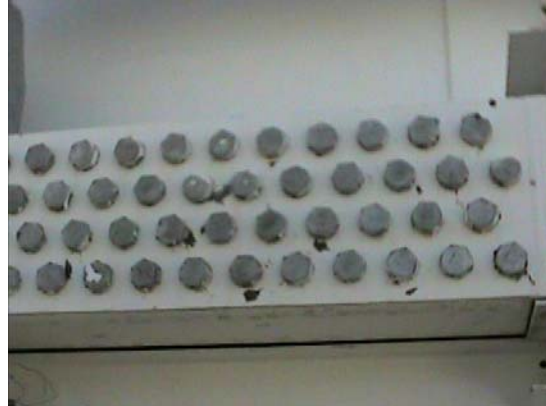
Figure 2A. IR scan of aerial cooler header box.

Figure 2B. Digital shot of aerial cooler header box.

Infrared scanning has made it possible to readily detect cooling tubes that are getting corroded. It has also given us a record of which tubes have failed and been taken out of service, thus not having to rely on memory of which tubes have gone bad (Figures 2A&B).

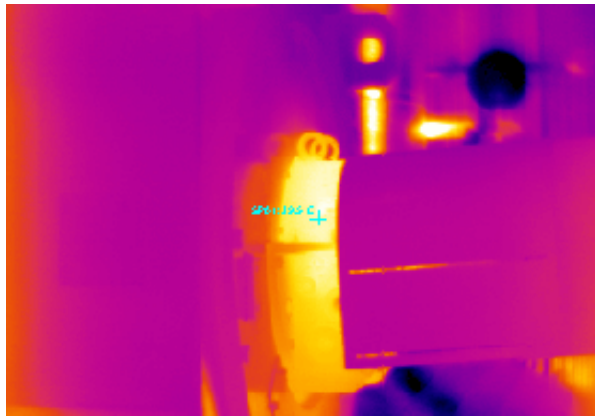
Figure 3A. Hot bearing on incinerator blower

Monitoring bearing temperatures along with our newly implemented vibration program has helped immensely by reducing unscheduled downtime (Figures 3A&B).

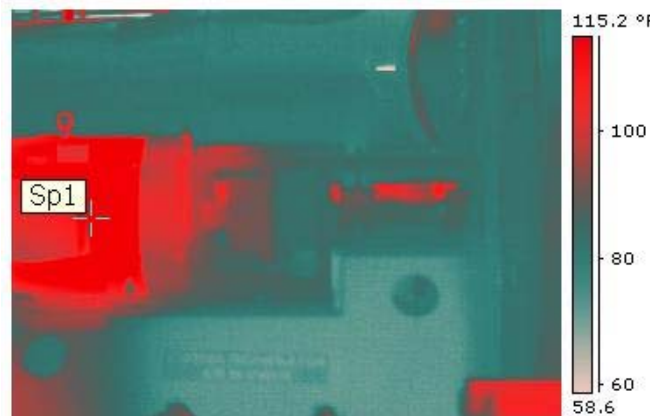
Figure 3B. Slight misalignment of coupling on incinerator blower

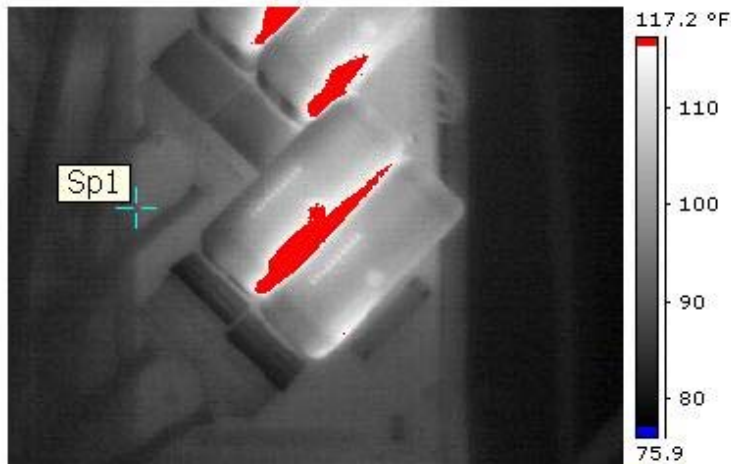
*Figure 4. H1 cards on our digital control system*

We have started monitoring the H1 cards on our digital control system to predict if temperature will let us know when the cards are going to fail. We have not compiled enough data to know the temperature when the cards fail, but we will have this soon. New cards do not show signs of excessive heat like the card shown above. We will monitor these and watch for a rise in temperature (Figure 4).

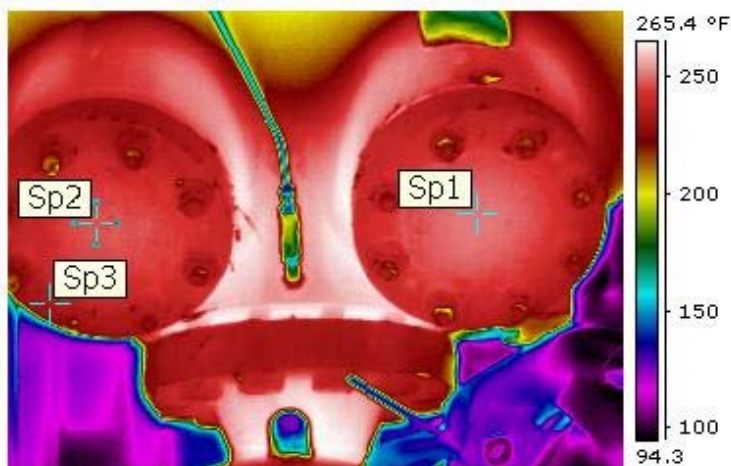
*Figure 5: Compressor valves*

Figure 5 is an infrared image of valves on our large compressors used for processing gas at our plant. We use the IR camera to monitor temperature changes between the valves. When there is a 10°F temperature difference or more, experience has shown us that the internal valves are letting gas flow back through, which causes overheating. The valve is then replaced prior to failure, thus eliminating costly unscheduled downtime.

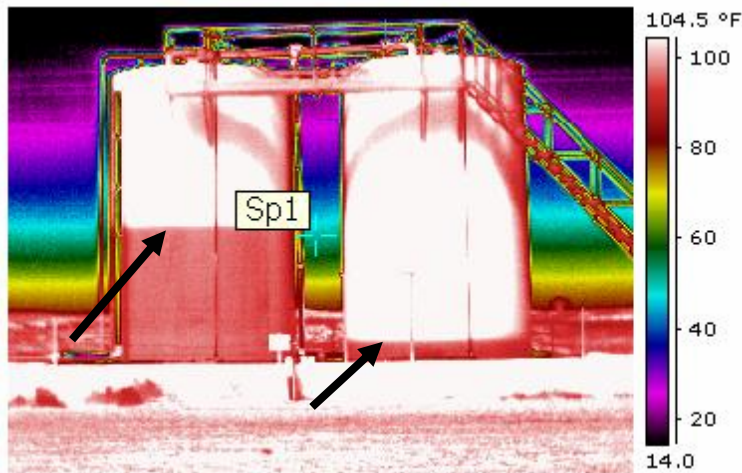
*Figure 6: Condensate tank levels*

Figure 6 depicts condensate tanks that need their levels checked to prevent overflow and spillage, as this would require contacting environmental agencies and possible fines. This particular tank's level indicator was not working and showed a 2-foot level. We were able to scan the tank and correct the problem with the level indicator prior to any environmental impact.

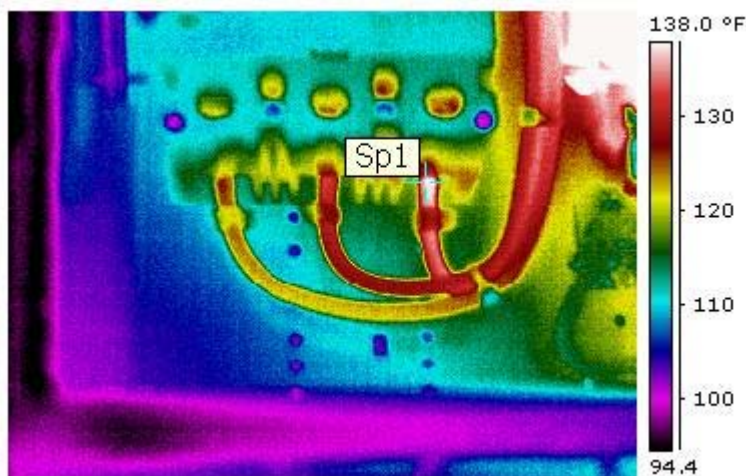
*Figure 7: Electrical connection heating*

Figure 7 shows electrical connections for our main boiler feedwater pump. The amperage was high and on further examination it was discovered there were loose connections and overheating in the electrical bucket in the main motor control center. The connections were tightened and the problem was corrected.

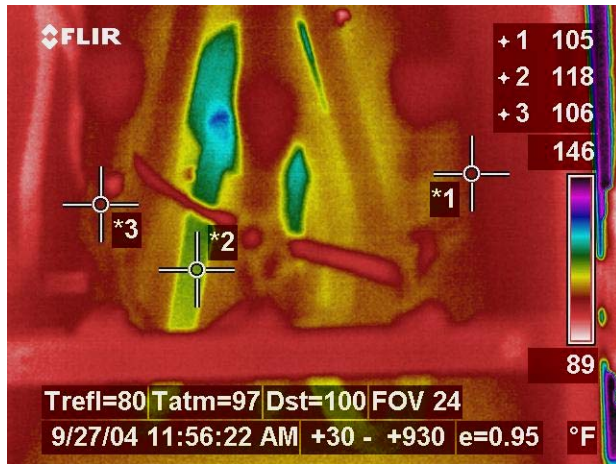
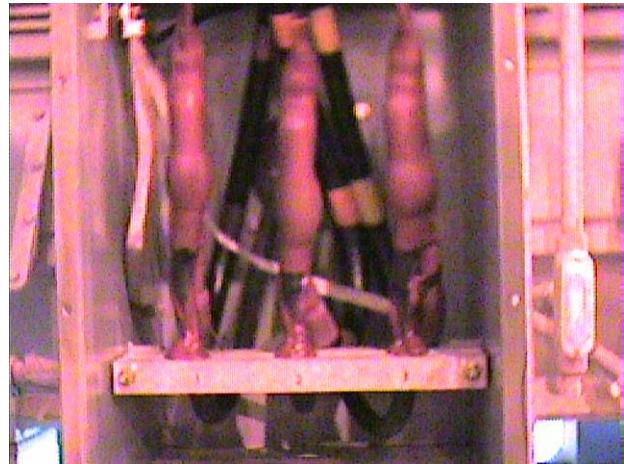
Figure 8A. IR scan of loose high-voltage terminations

Figure 8B. Digital image of same terminations

Figures 8A and 8B show infrared and digital pictures of the leads on one of our compressors. The compressor was tripping offline due to over-current. We located the hot leads in the motor termination box and discovered that the terminations were loose on two phases. We re-terminated the problem leads and the amperage returned to normal for what the full load current should have been.
