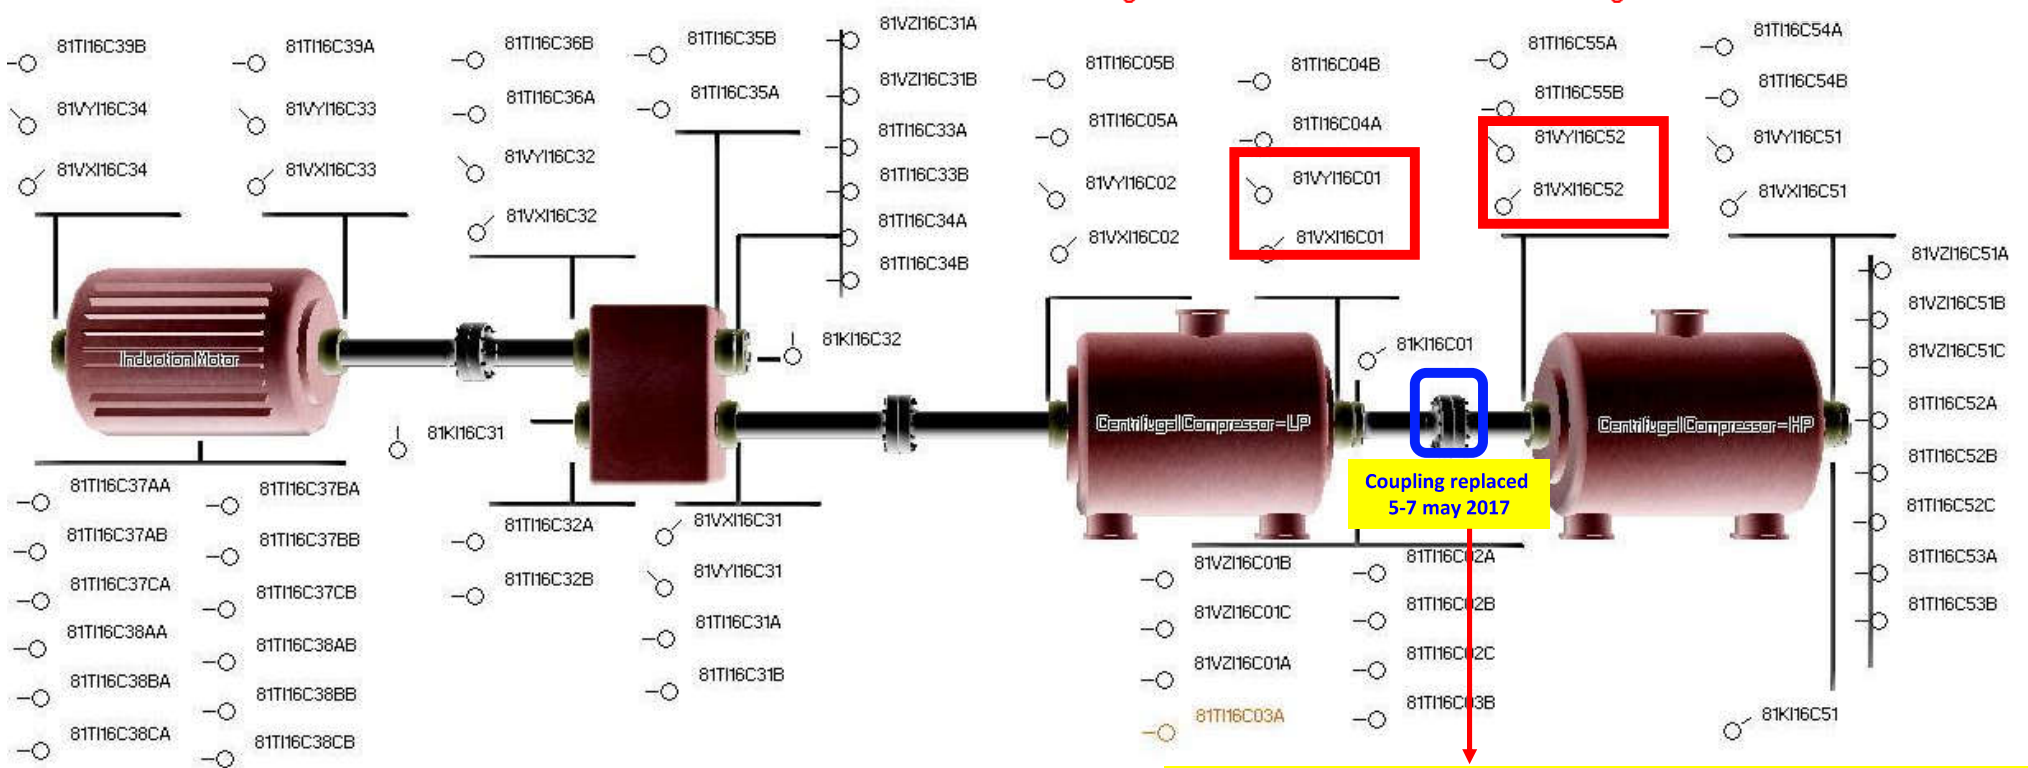
Based on previous failure pattern, the present data indicates, change in the coupling balance condition and most probably by breaking of the shim pack elements.
