Case Study: 1 - Loose coils cause harmonics of $2*LF$

Plant Application: Condensate Pump Motors

Machine Description: 4000 hp, 1200 rpm, 13.2kv vertical motors built by Parsons Peebles in late-70's/early-80's

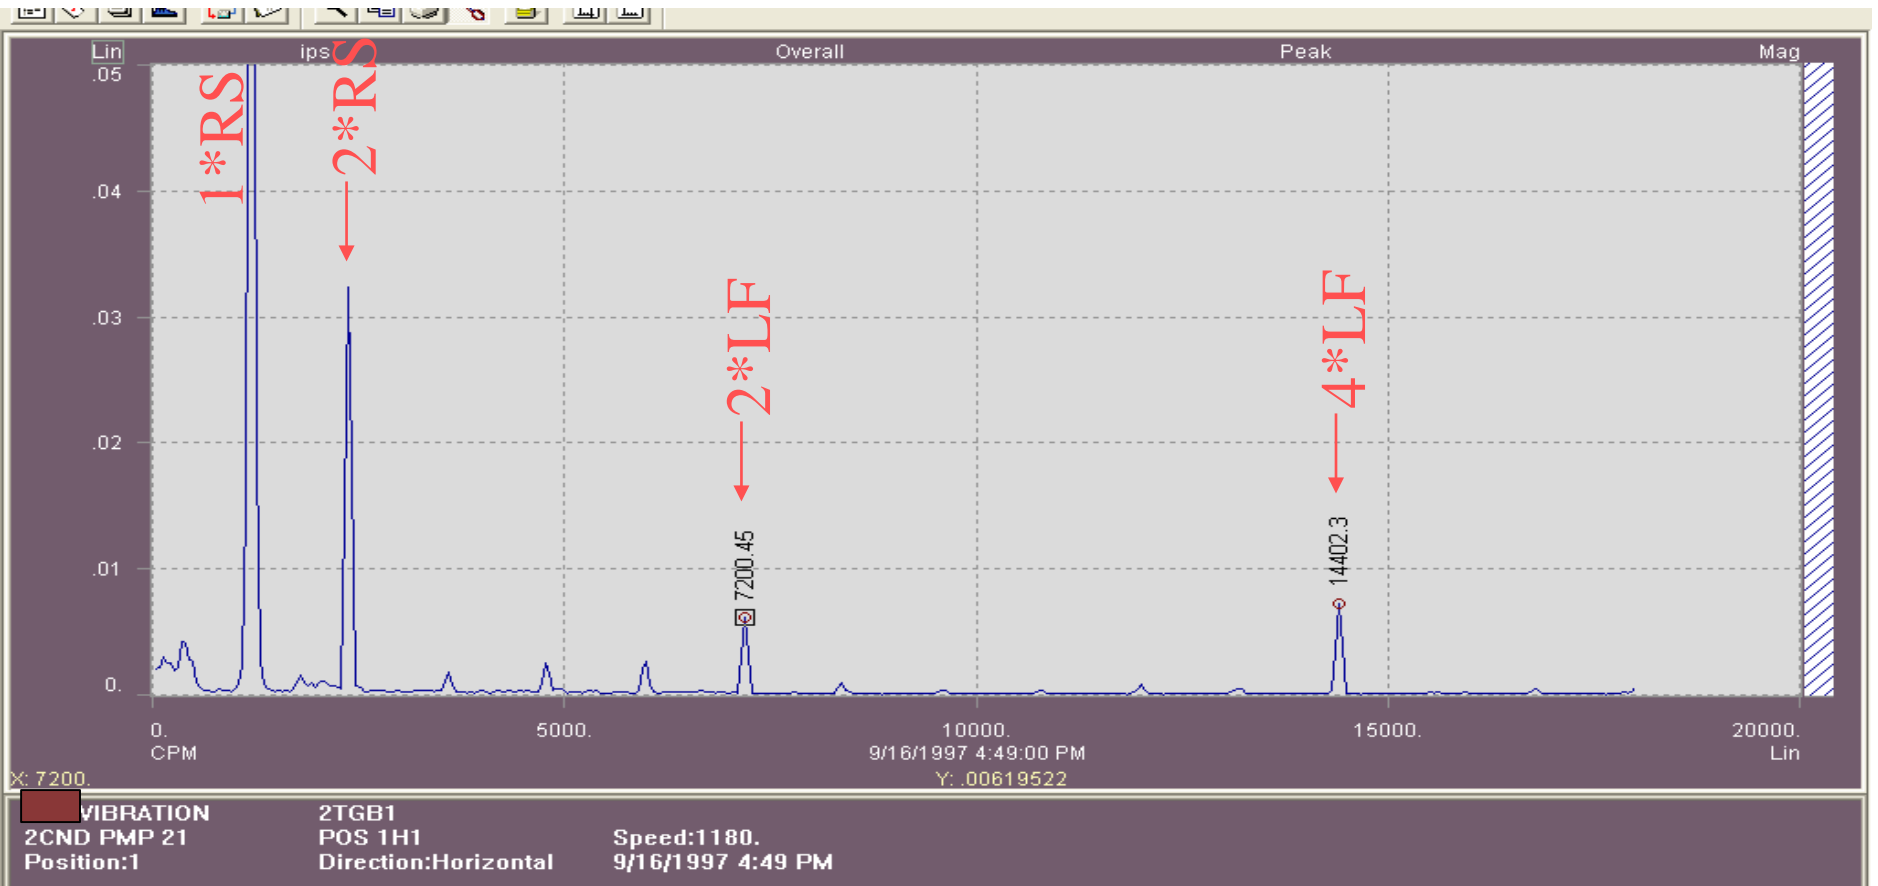
CD21 Spectrum - just before failed DC step voltage test.

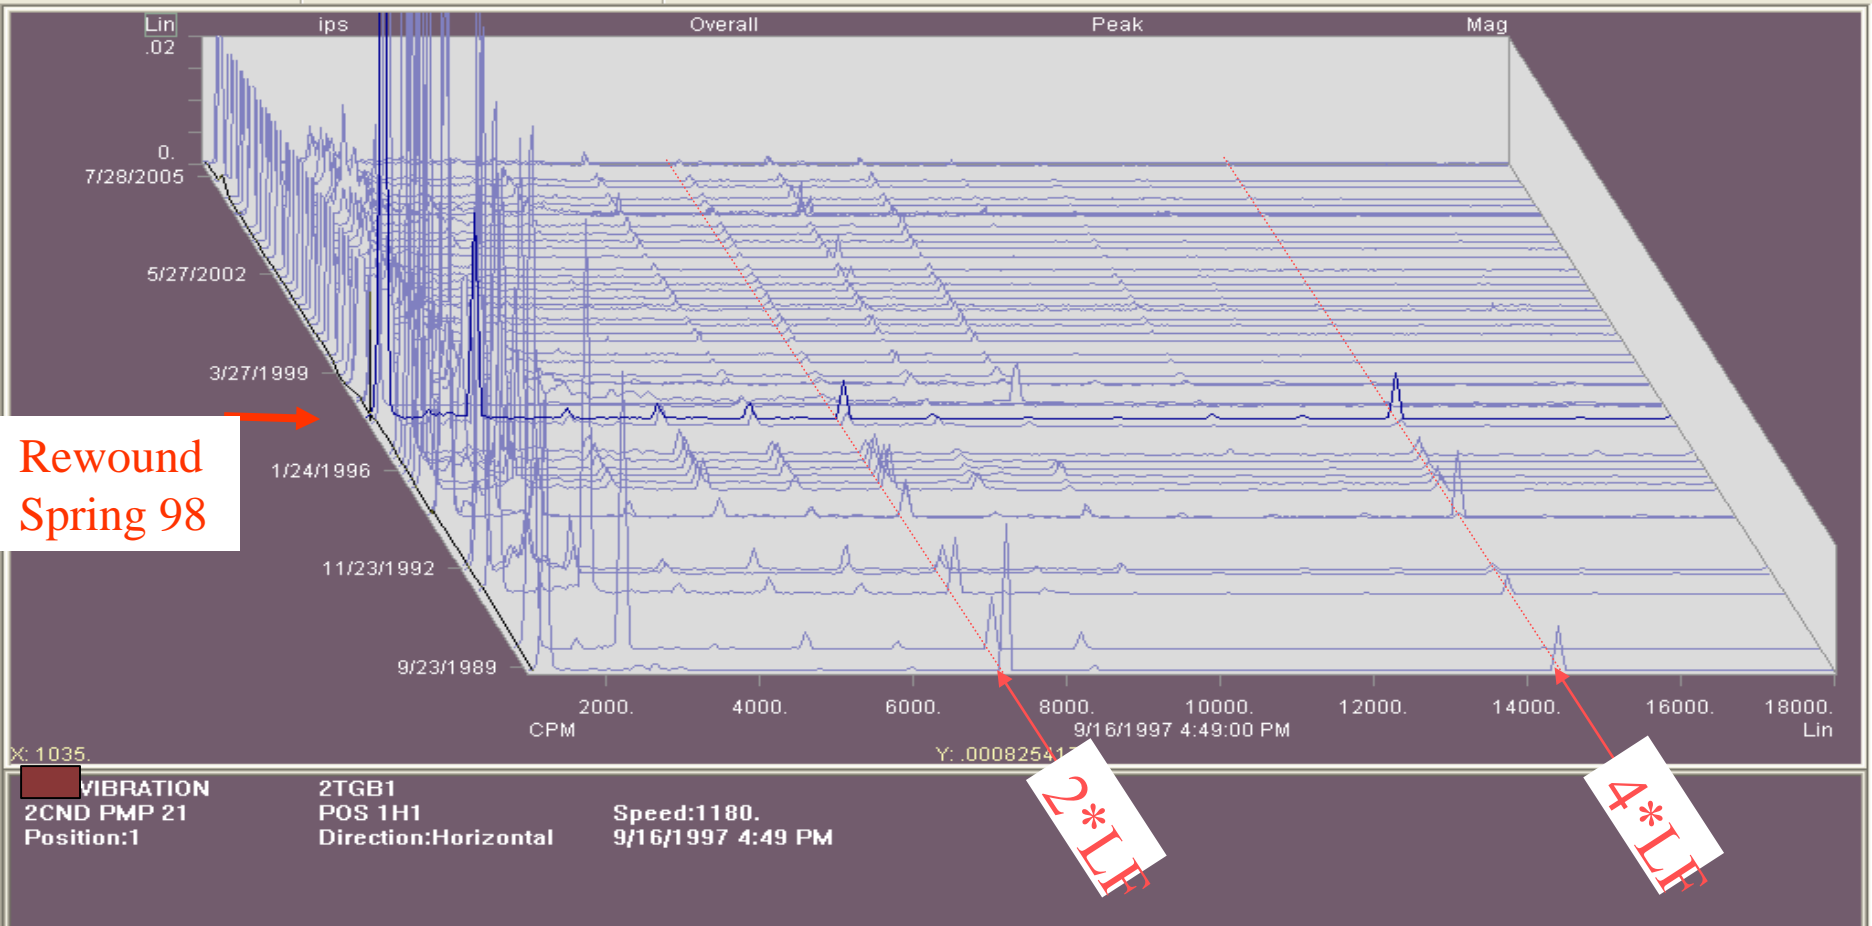
CD21 – 4LF disappeared upon rewind.
(Scale for CD21 is the highest ...0 - 0.02 ips)

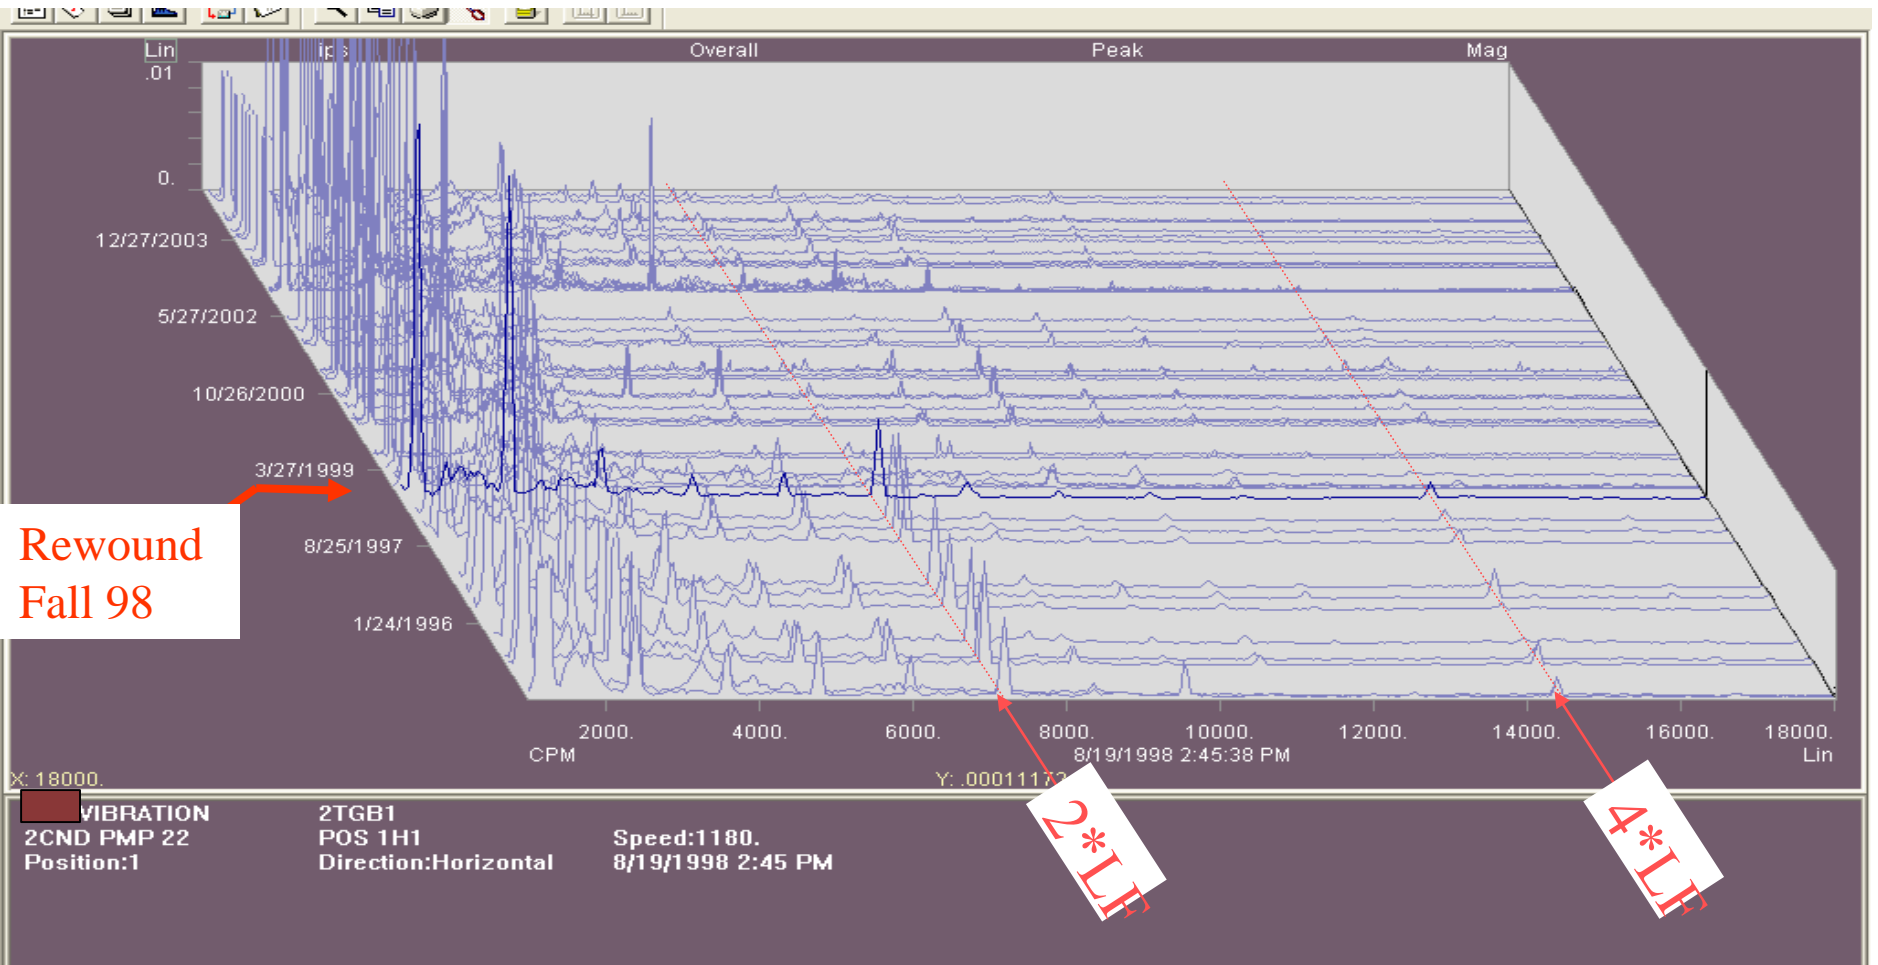
CD22 – 4LF disappeared on rewind.

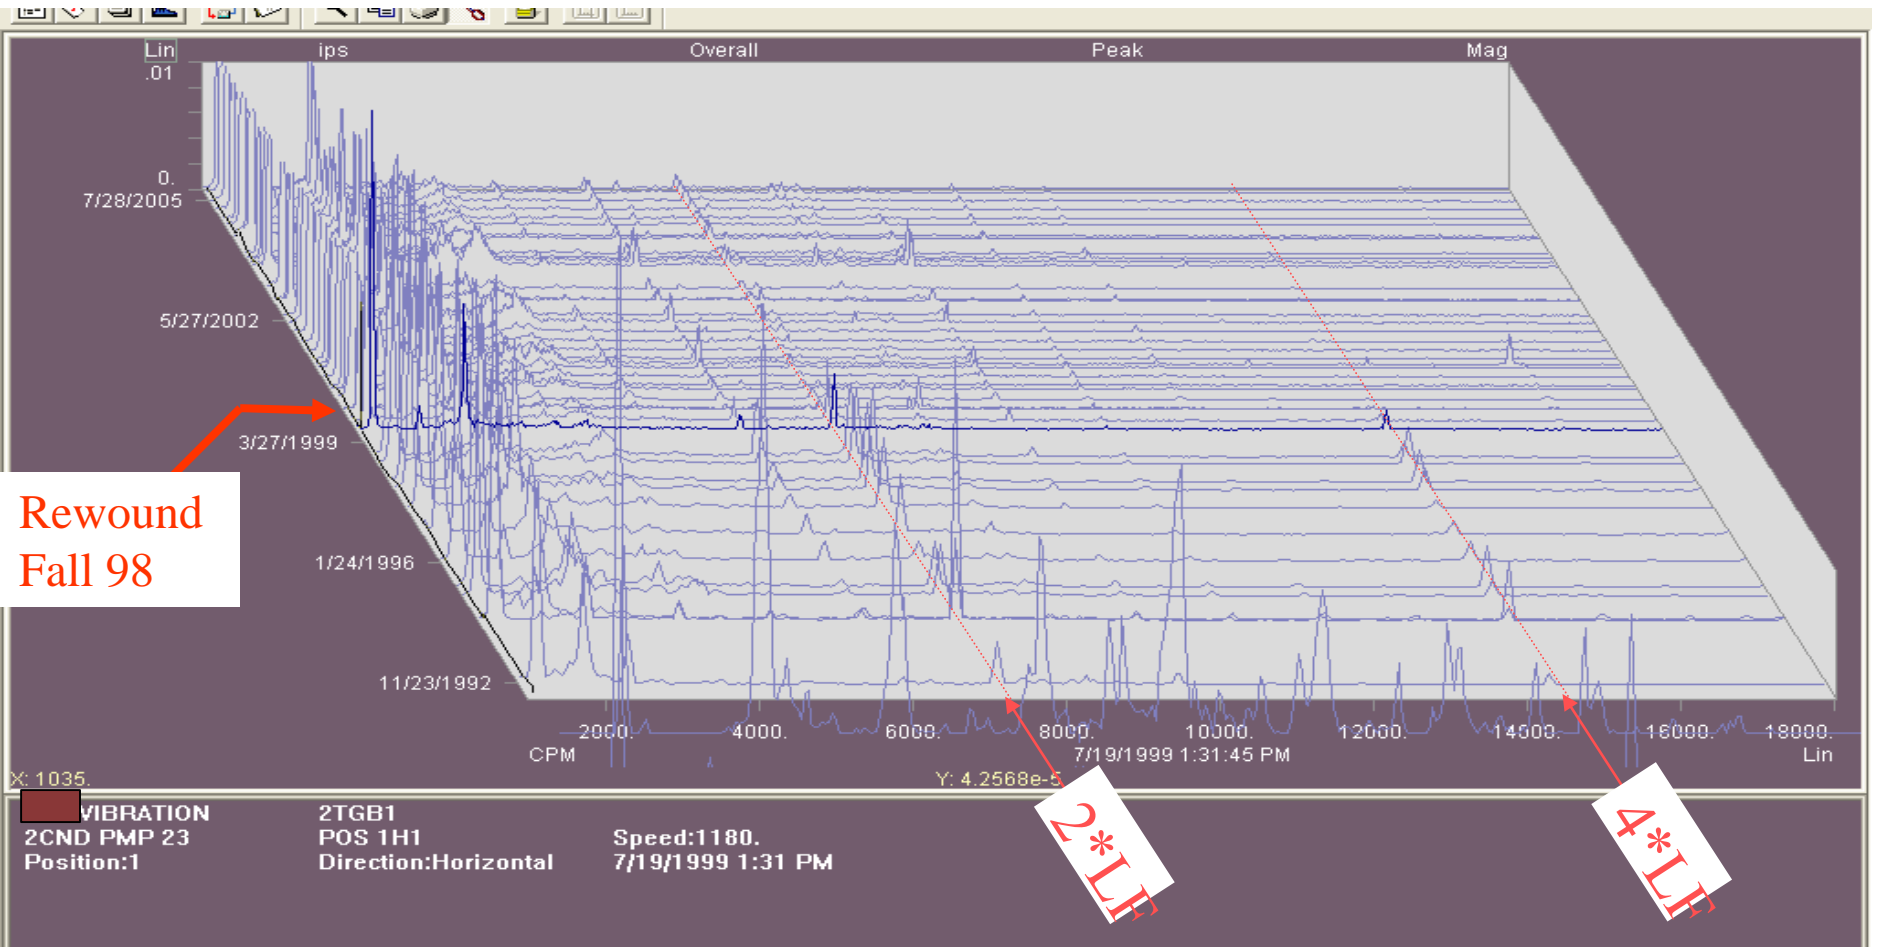
CD23 – 4LF disappeared upon rewind

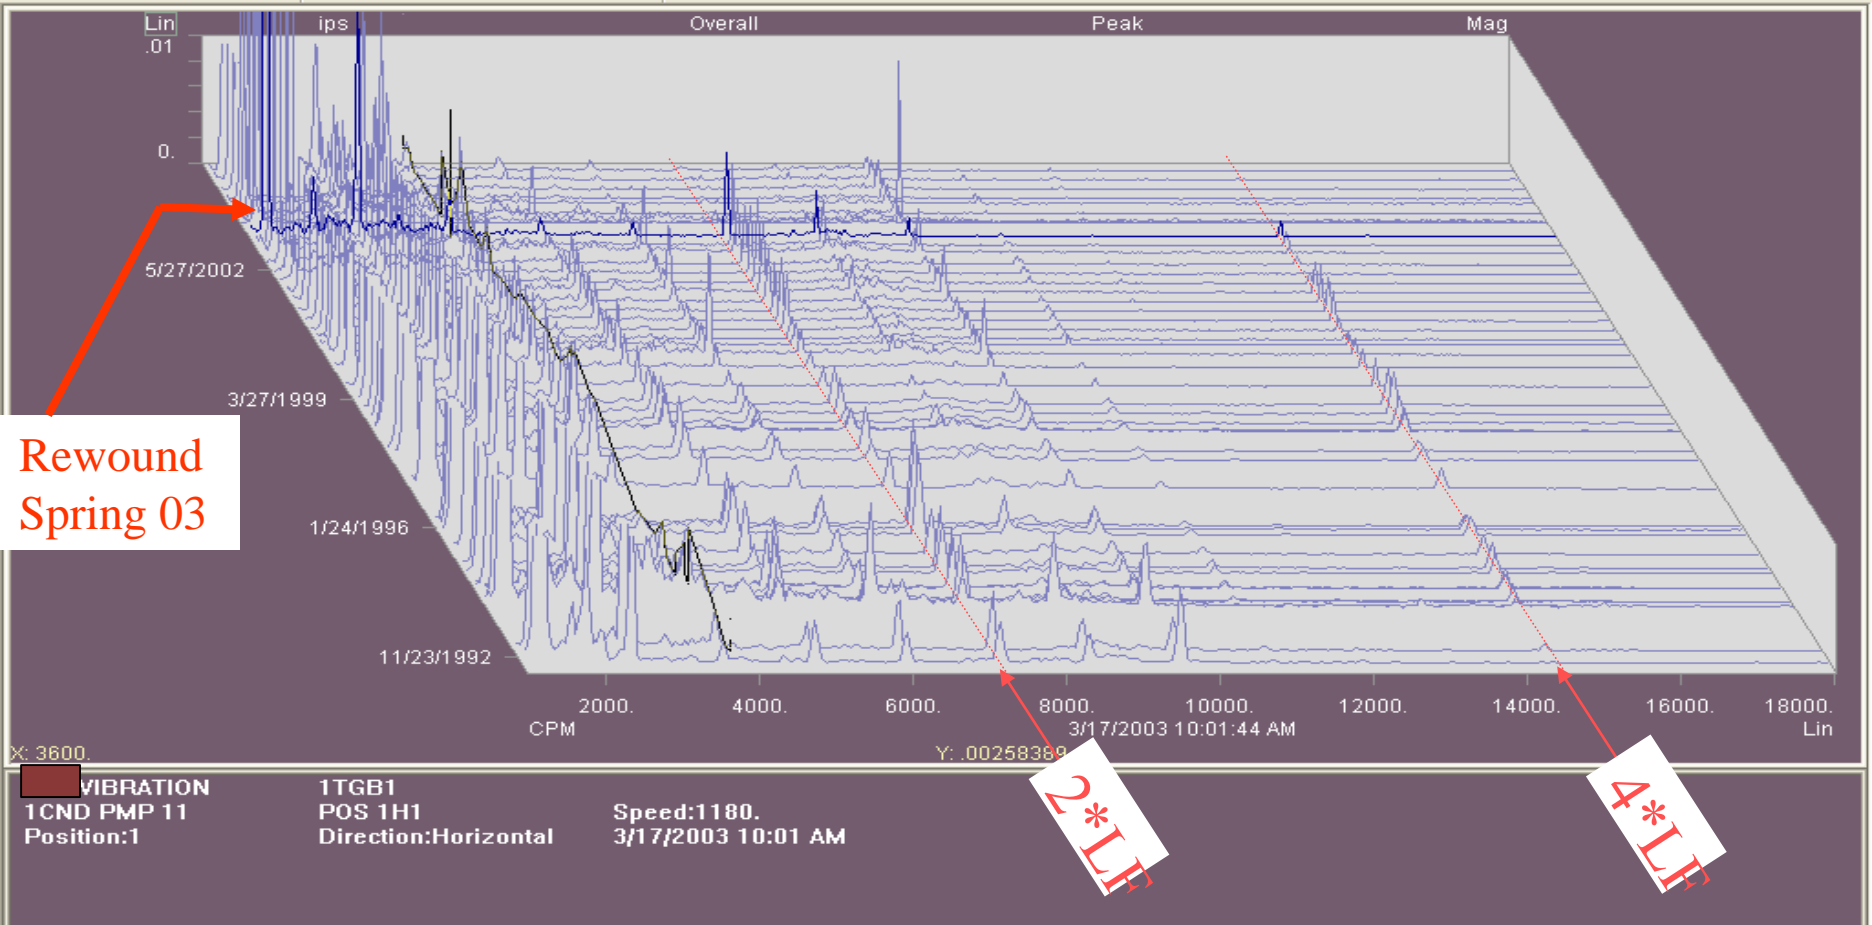
CD11 – 4LF disappeared on rewind

Rewound
Spring 03

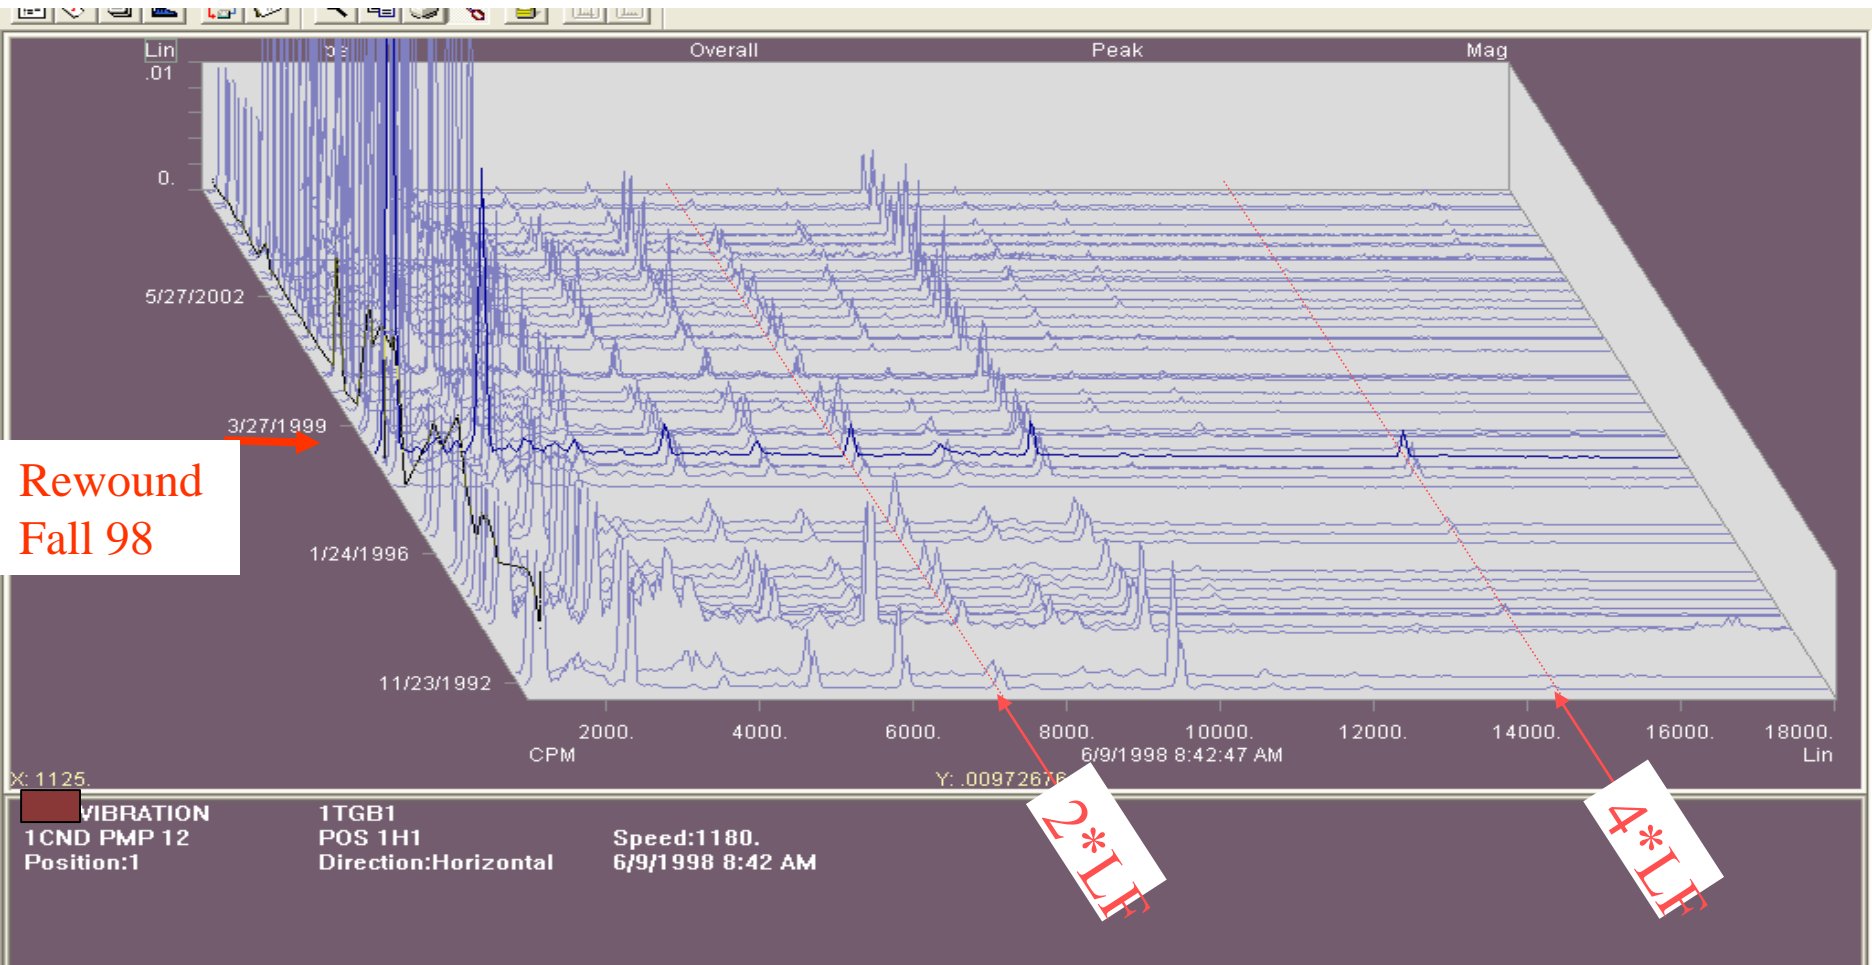
CD12 – 4LF disappeared upon rewind

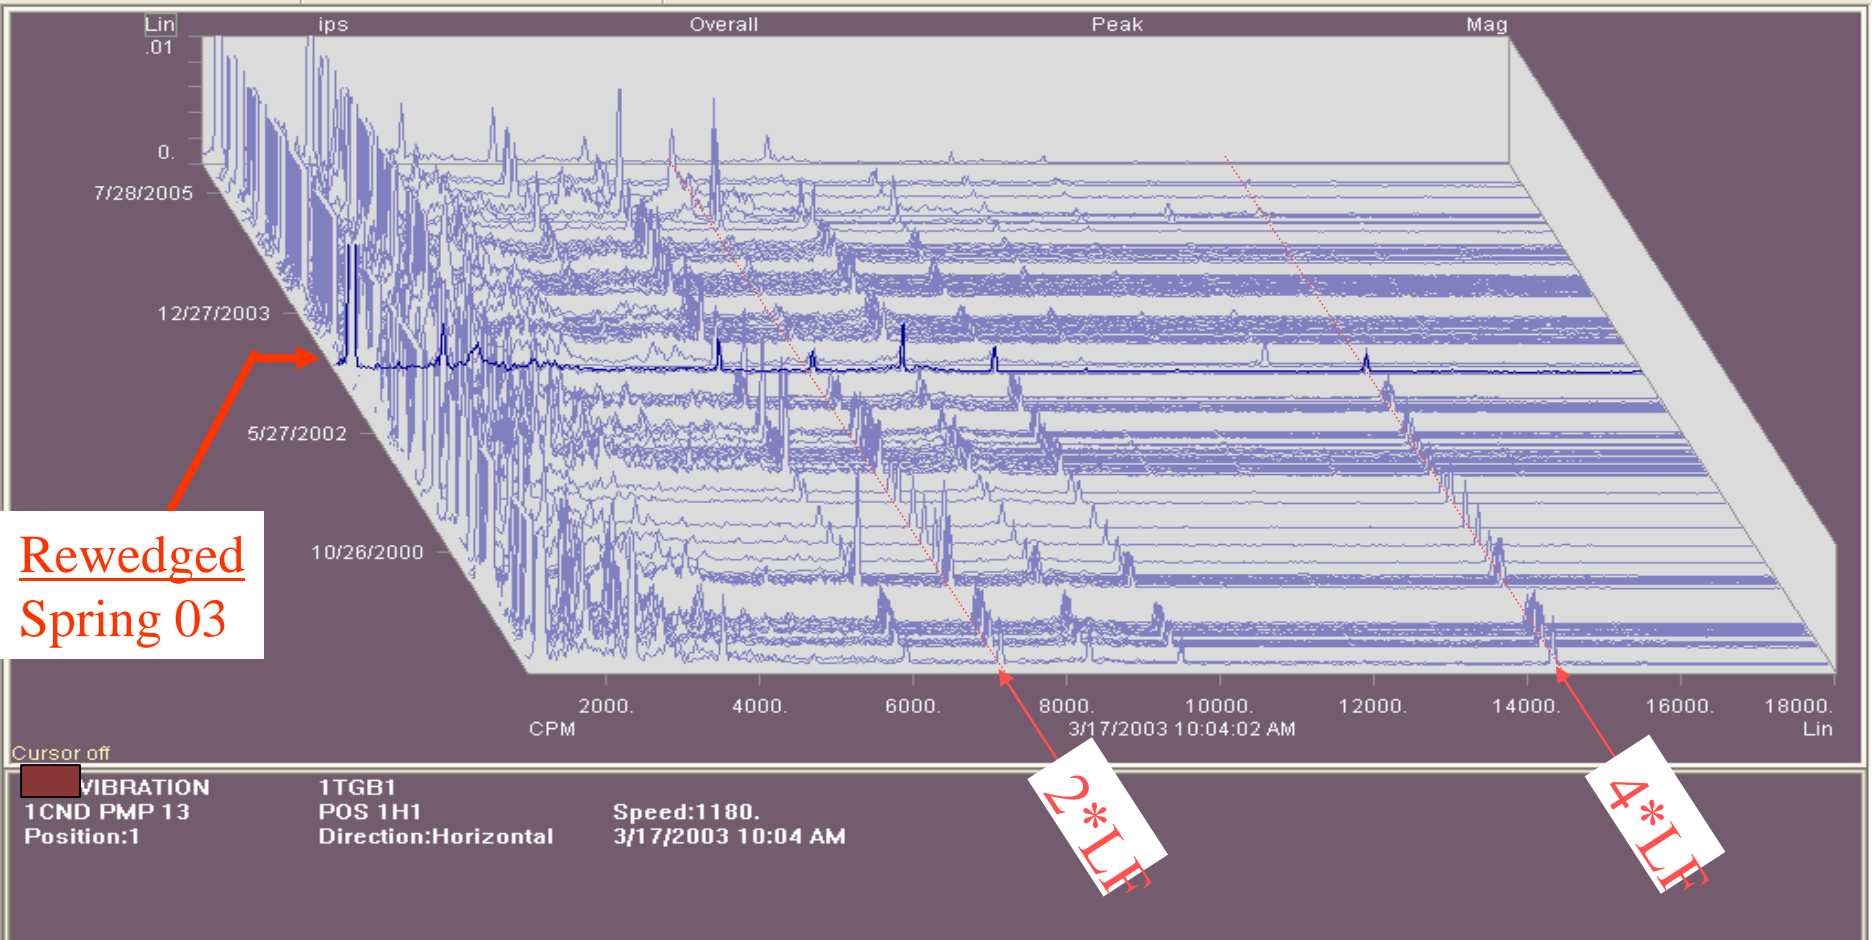
CD13 – 4*LF disappeared when REWEDGED

Rewedged
Spring 03

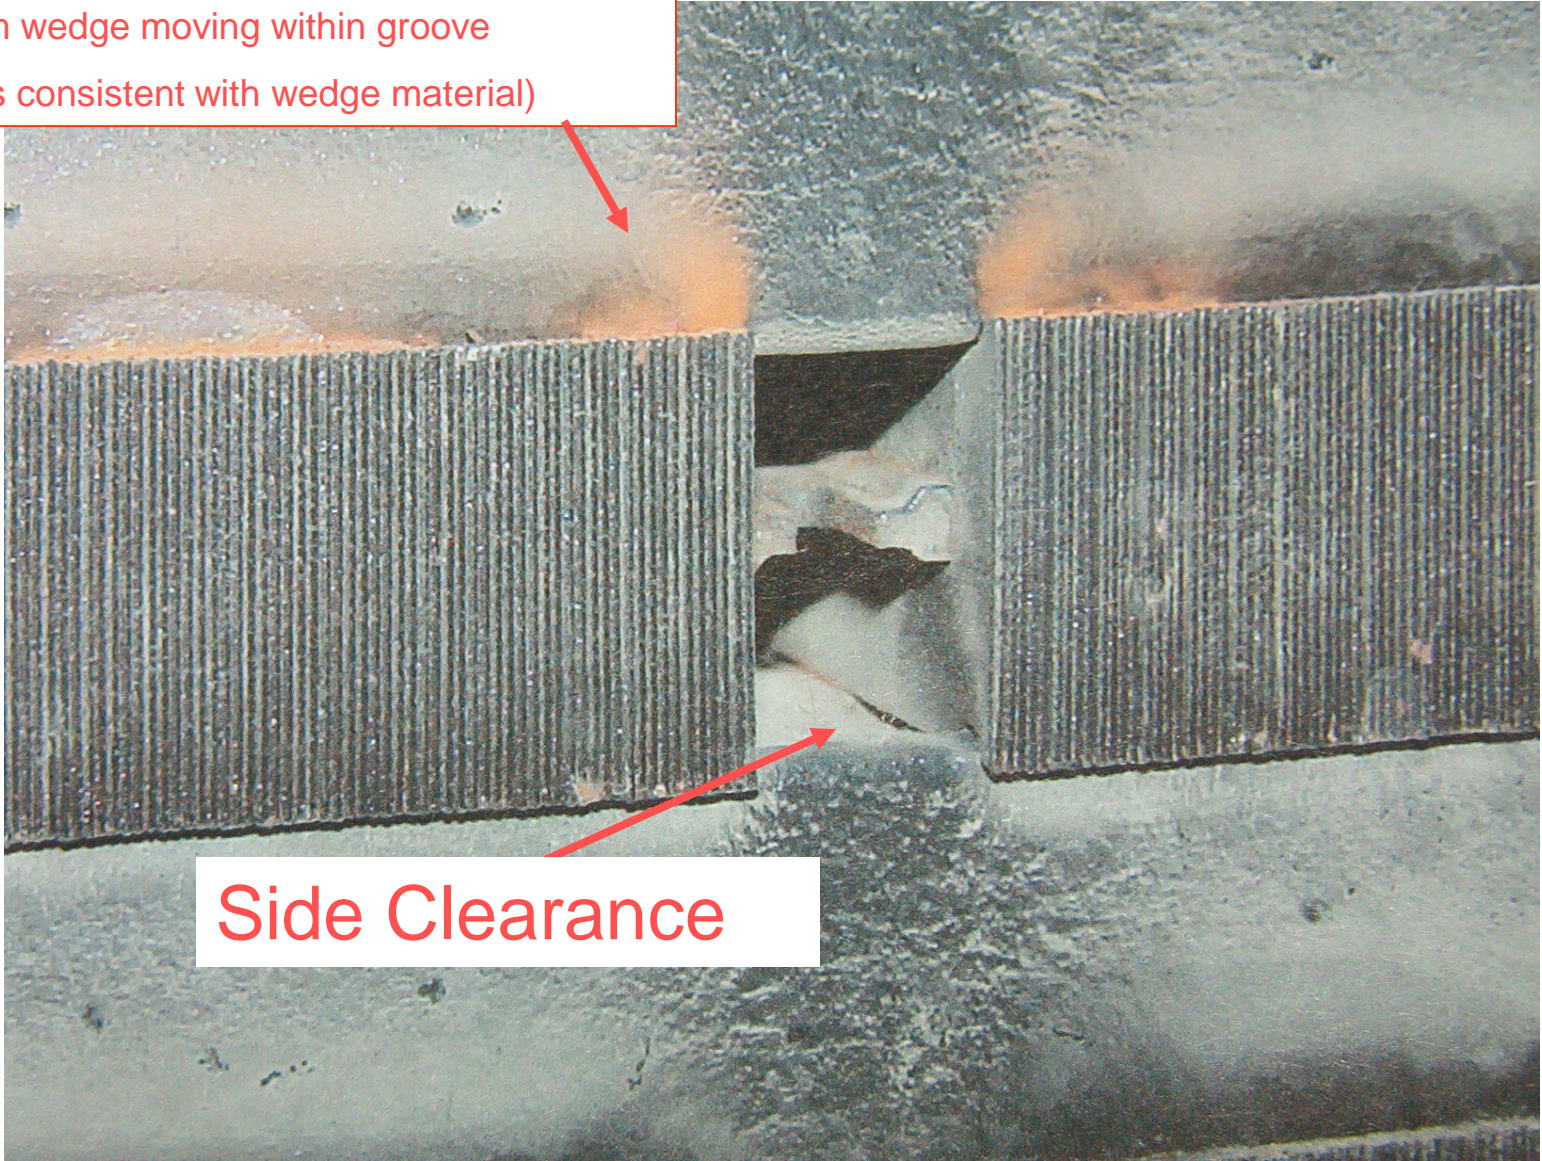
Side clearance visible through air duct (from another family of Parsons Peebles machines)

Powder from wedge moving within groove
(lab analysis consistent with wedge material)

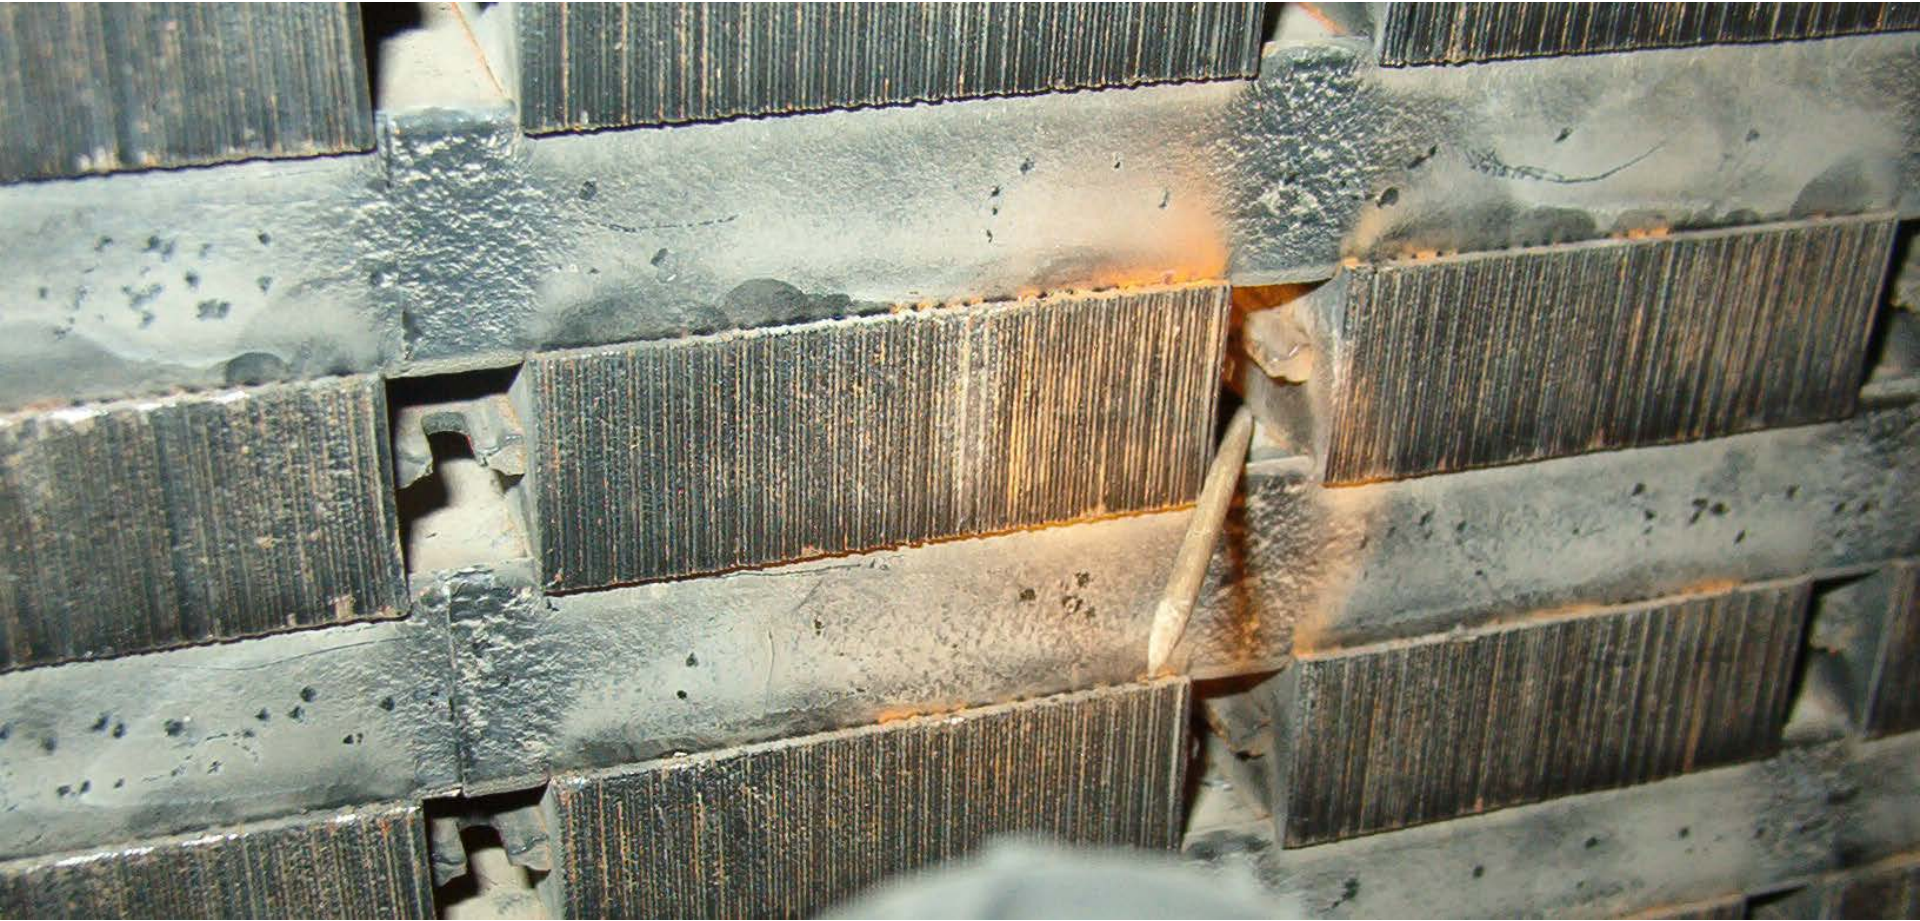
Side Clearance

...Enough clearance to hold a toothpick

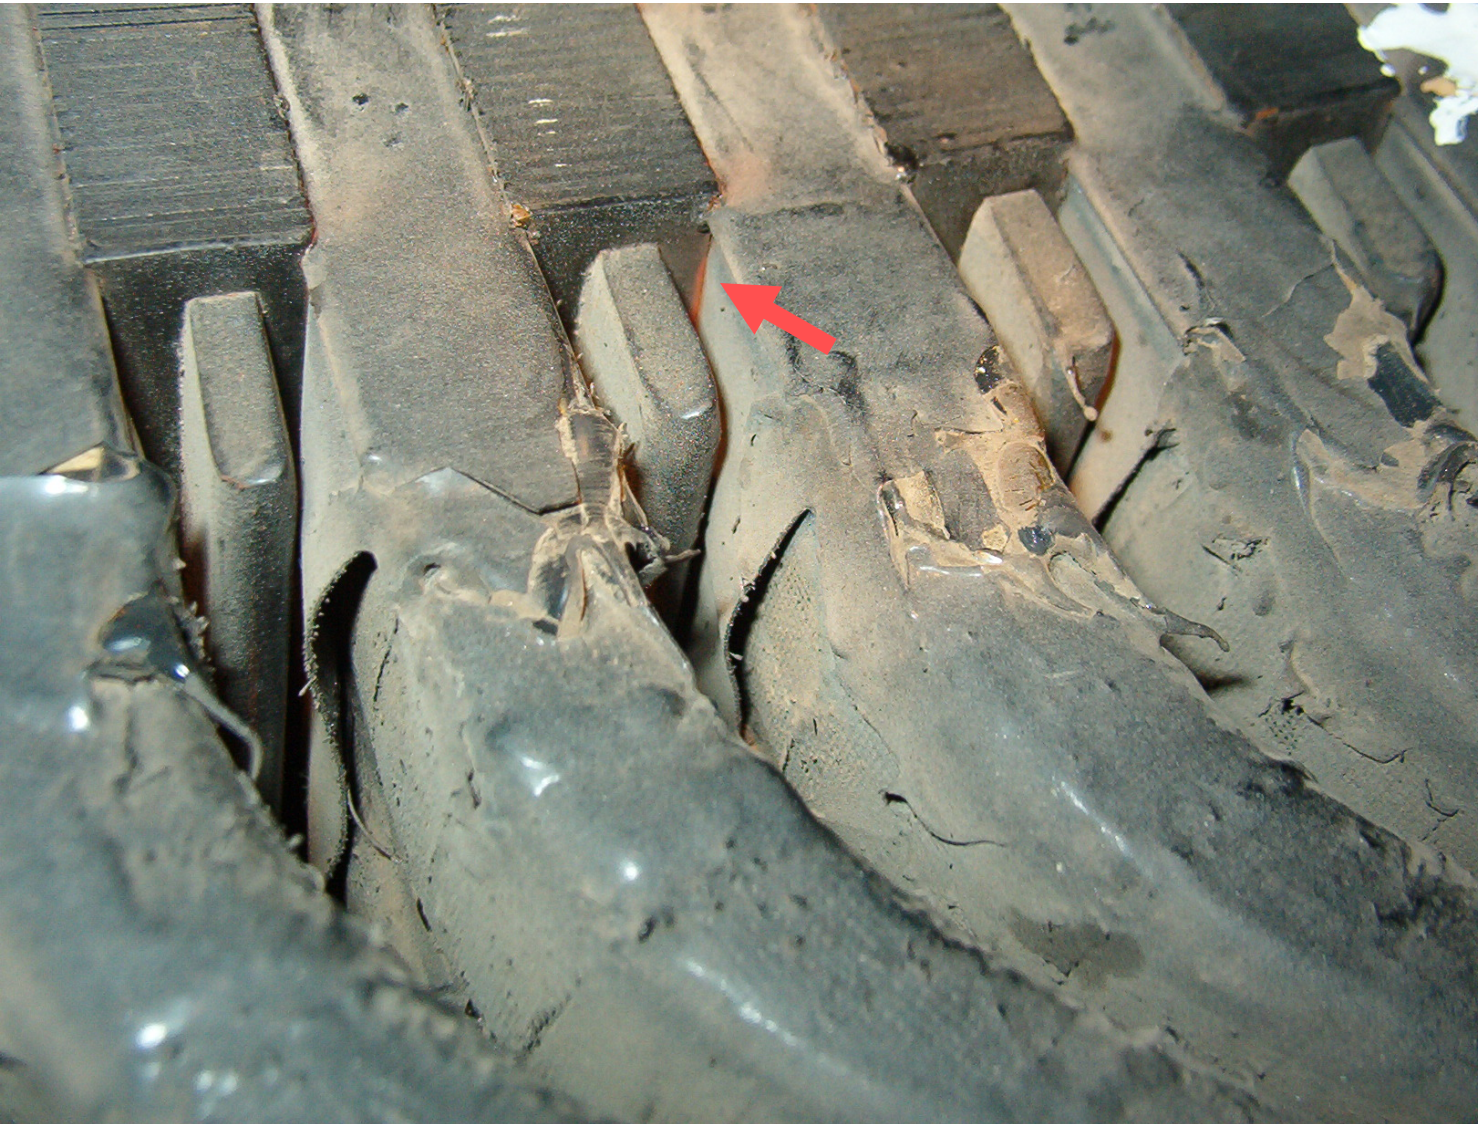
Signs of abrasion at slot exit

Tap test and other inspections confirm loose wedges
