Event Report

FHWA Office of Bridges and Structures

Subject: Closure of I-276 Delaware River Bridge (PA Turnpike and NJ Turnpike)

Date of Event: January 20, 2017

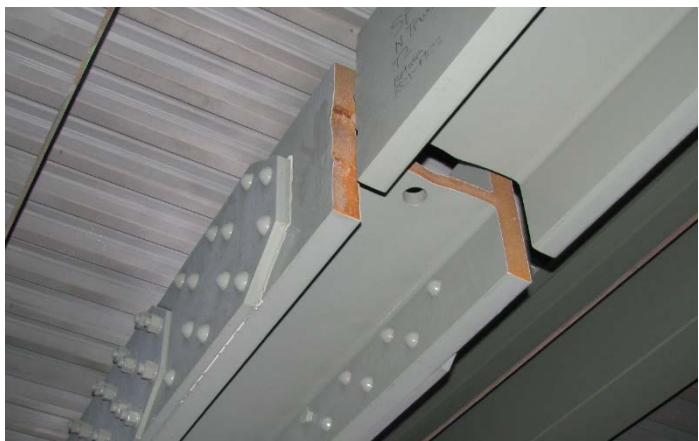
The fracture occurred on the north truss face, on the 16th span, just prior to panel point 19'. The member is designated U19-19' and is a rolled 14WF314 that is weak axis oriented. Figure 3 shows the fracture in the field.

Figure 3 Fracture of U19-19', North Truss, Looking South and East at Panel Point 19', prior to any material sampling. (HNTB)

The only definitive conclusion so far is that this was a brittle fracture, which initiated in the heat affected steel around the partially weld-filled holes.

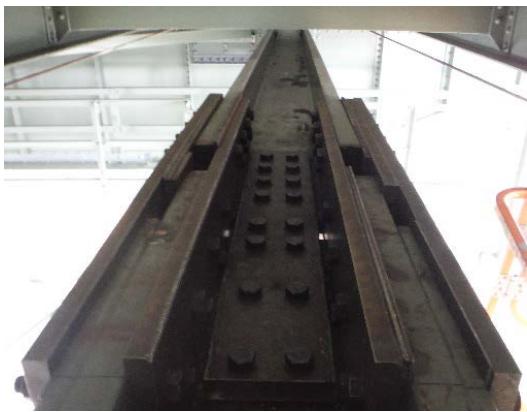
Figure 4 Splice plates on U19-19', looking west from panel point 19'. (HNTB)

At the site of the fracture, the consultant measured approximately 1" of lateral misalignment, 0.75" of vertical misalignment and 2.5" of longitudinal displacement. The contractor shimmed the splice plate to make a flush connection, not attempting to bend the member or otherwise restore geometry. Samples were torch cut from each fracture face for metallurgical analysis by Lehigh University.

remove the paint tarps, suspended platforms, and any stored materials from this and adjacent spans, to reduce potential wind loading. In order to provide some member continuity and establish a comfort level with safe worker access, the consultant designed and fitted temporary web and flange splice plates over the fractured member. The splicing operation was completed early Sunday morning. The splice is shown in Figure 4.

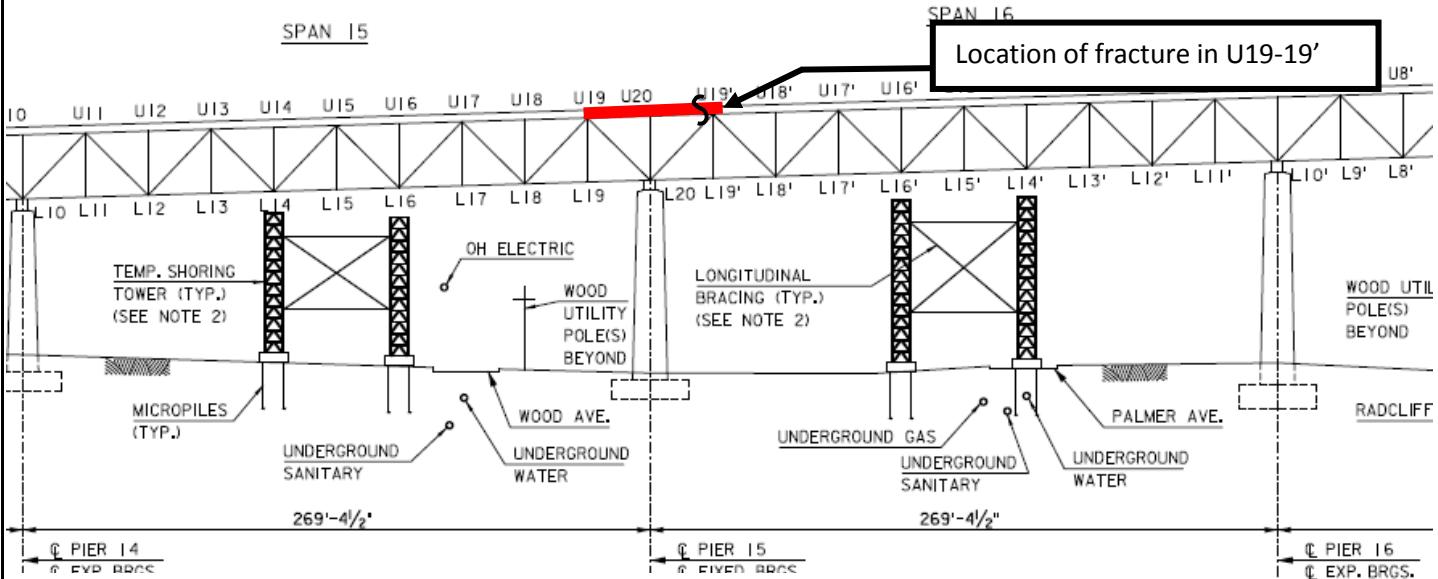
Figure 5 Shoring Tower locations, elevation looking north (HNTB)

The consultants also began designing shoring towers, to be placed in positive moment locations on either side of the pier, as shown in Figure 5. The lower chord of the truss is about 80' off the ground at this pier. They were designed to serve as a catch should the truss fail, but also provide a platform for potential jacking during the repair. A typical section is shown in Figure 6.

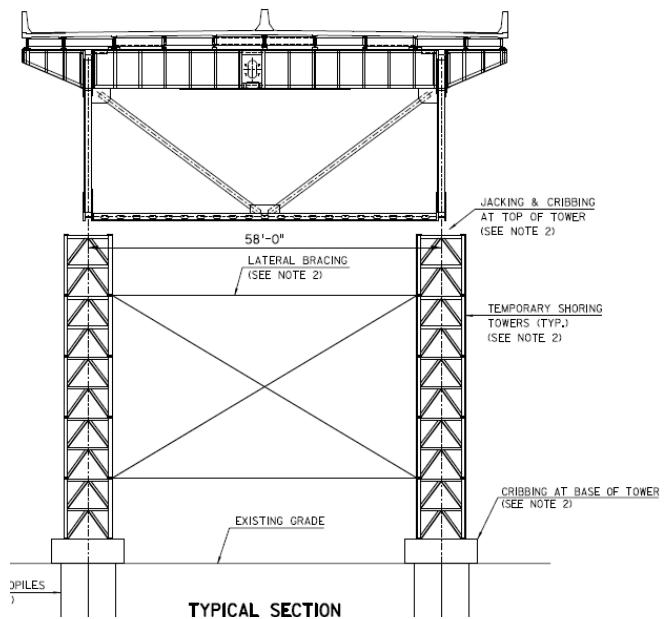
Figure 6 Shoring Tower typical section, looking east

The towers are founded on 2x3 arrays of 12.75" micropiles. Micropiles were selected for expediency, since the NJTA had a contractor with drill rigs and materials ready to go. The micropile design accommodates the bridge dead loads as well as loads induced by the jacking operation.

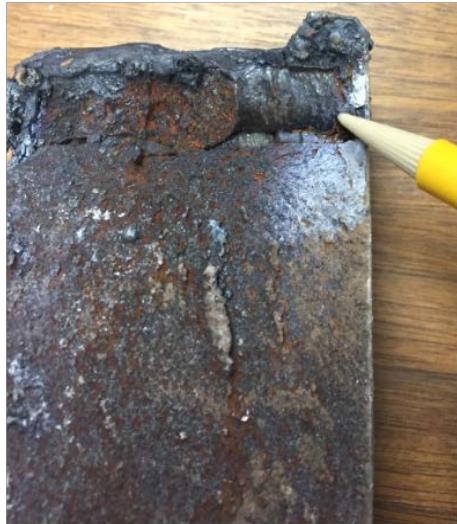
Initial visual assessment by Lehigh University indicated that the north flange of the failed member has two additional shop-reamed holes that are not present in the south flange, just past the edge of the adjacent cover plate. The holes line up with the cover plate rivet lines, so the current thought is that these holes are a fabrication error. It appears the holes had weld material placed in them and ground smooth at the surface. The weld material inside the hole did not really penetrate the surrounding steel, but is likely that the steel properties around the holes were affected by the heat of the weld material. The fracture initiated at the site of these holes and was brittle in nature, with no indication of fatigue. These holes have been called plug welds, but we note a more accurate descriptor would be weld-filled holes.

Figure 7 Sample taken from North Flange fracture surface. (HNTB)

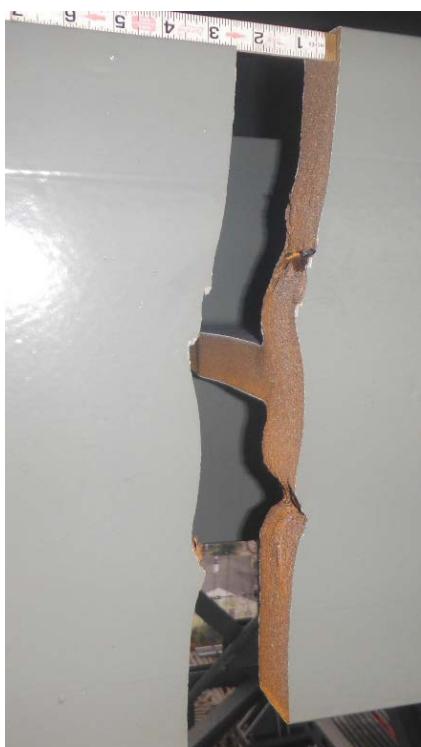
Charpy v-notch tests were run at 40 degrees and 0 degrees F, with 40 degree results averaging 21 ft-lbs and 0 degree results averaging 7 ft-lbs. These results are low compared to modern steel; however, there was no specification for Charpy toughness at the time the bridge was constructed. Yield strength was

Figure 8 Close-up of north flange fracture face. (HNTB)

Early indication from microscopy is that the material is highly variable and has high inclusion contents, which is expected for such a large and thick rolled shape from this era.

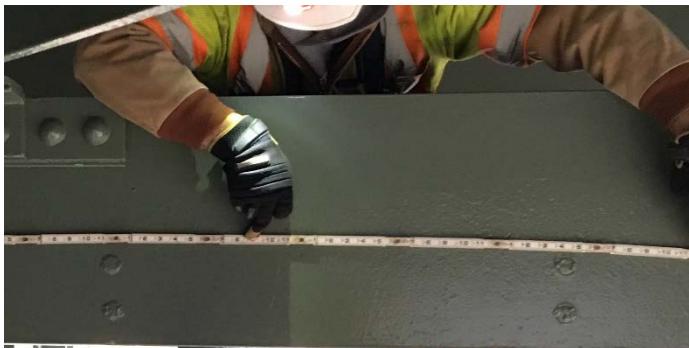
Figure 9 Tack-welded rivet shanks, member U19-19', near PP20 (HNTB)

Some locations have been discovered on the top chord on both approaches where there are holes in the inside flange with rivet shanks filling the holes, as shown in Figure 9. The rivet heads have been removed and the top of the rivet tack welded over. It's unknown what the purpose was of these holes, if they are further fabrication errors or erection holes, or something else. These defects were not noted on the 2014 FC inspection, despite being in the FC top chord. These locations will be repaired prior to opening the bridge, by drilling out the rivet shanks, overdrilling the hole to remove the heat affected steel, then painting.

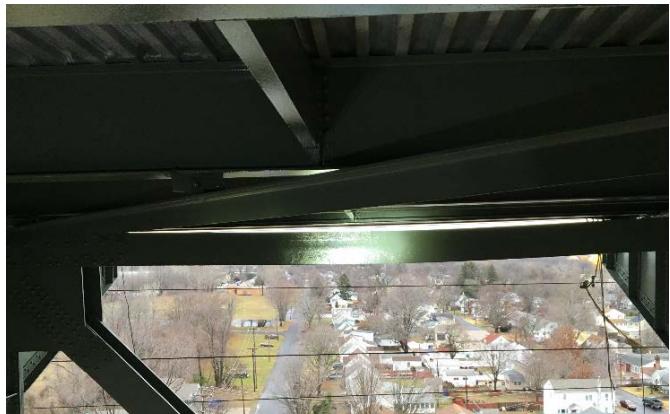
In the next span beyond the fractured member, the top chord U19'-17' has an elastic buckle or bow, as shown in

Figure 10 Elastic bowing in U19'-17', between panel points U19' and U18'. (HNTB)
