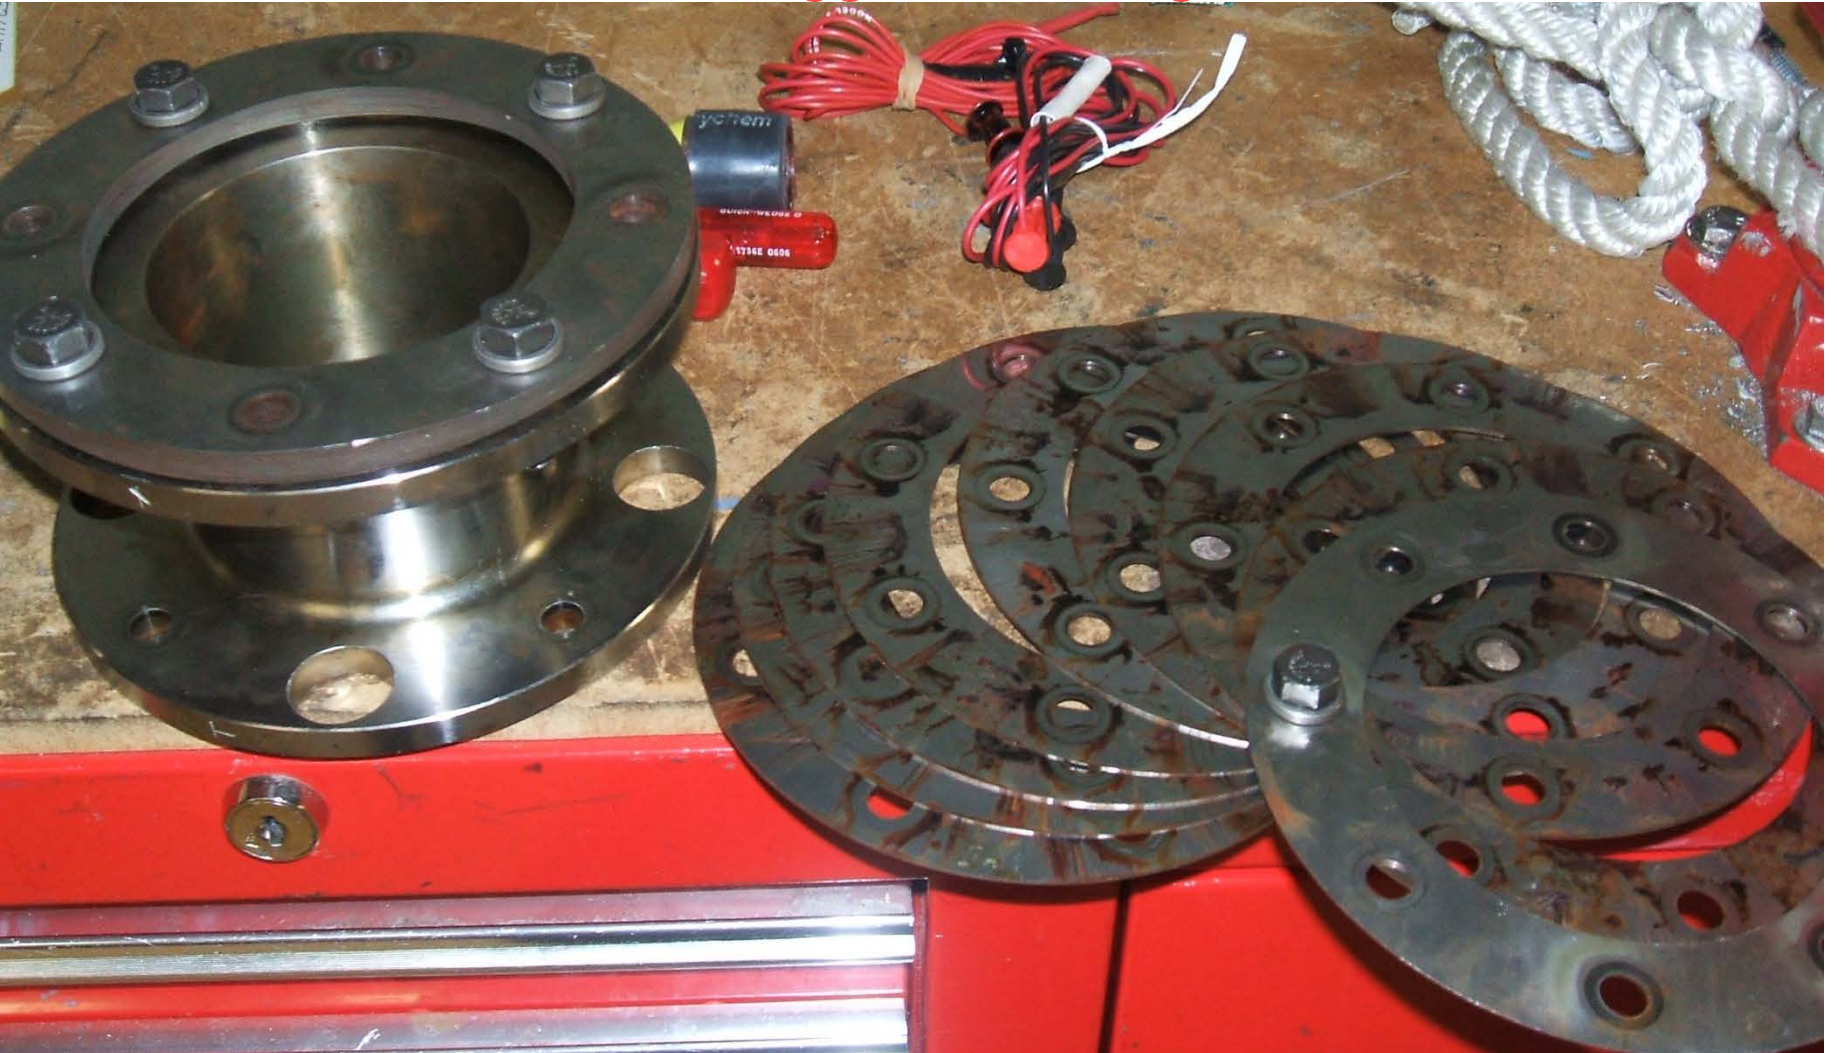
As-found, One pack disassembled, one not. Both had same pattern when later disassembled (shows on inner surfaces of shims, not outer surface). They felt greasy. Note the only place the pattern does not occur is the outer surface of outer shims-> suggests fretting

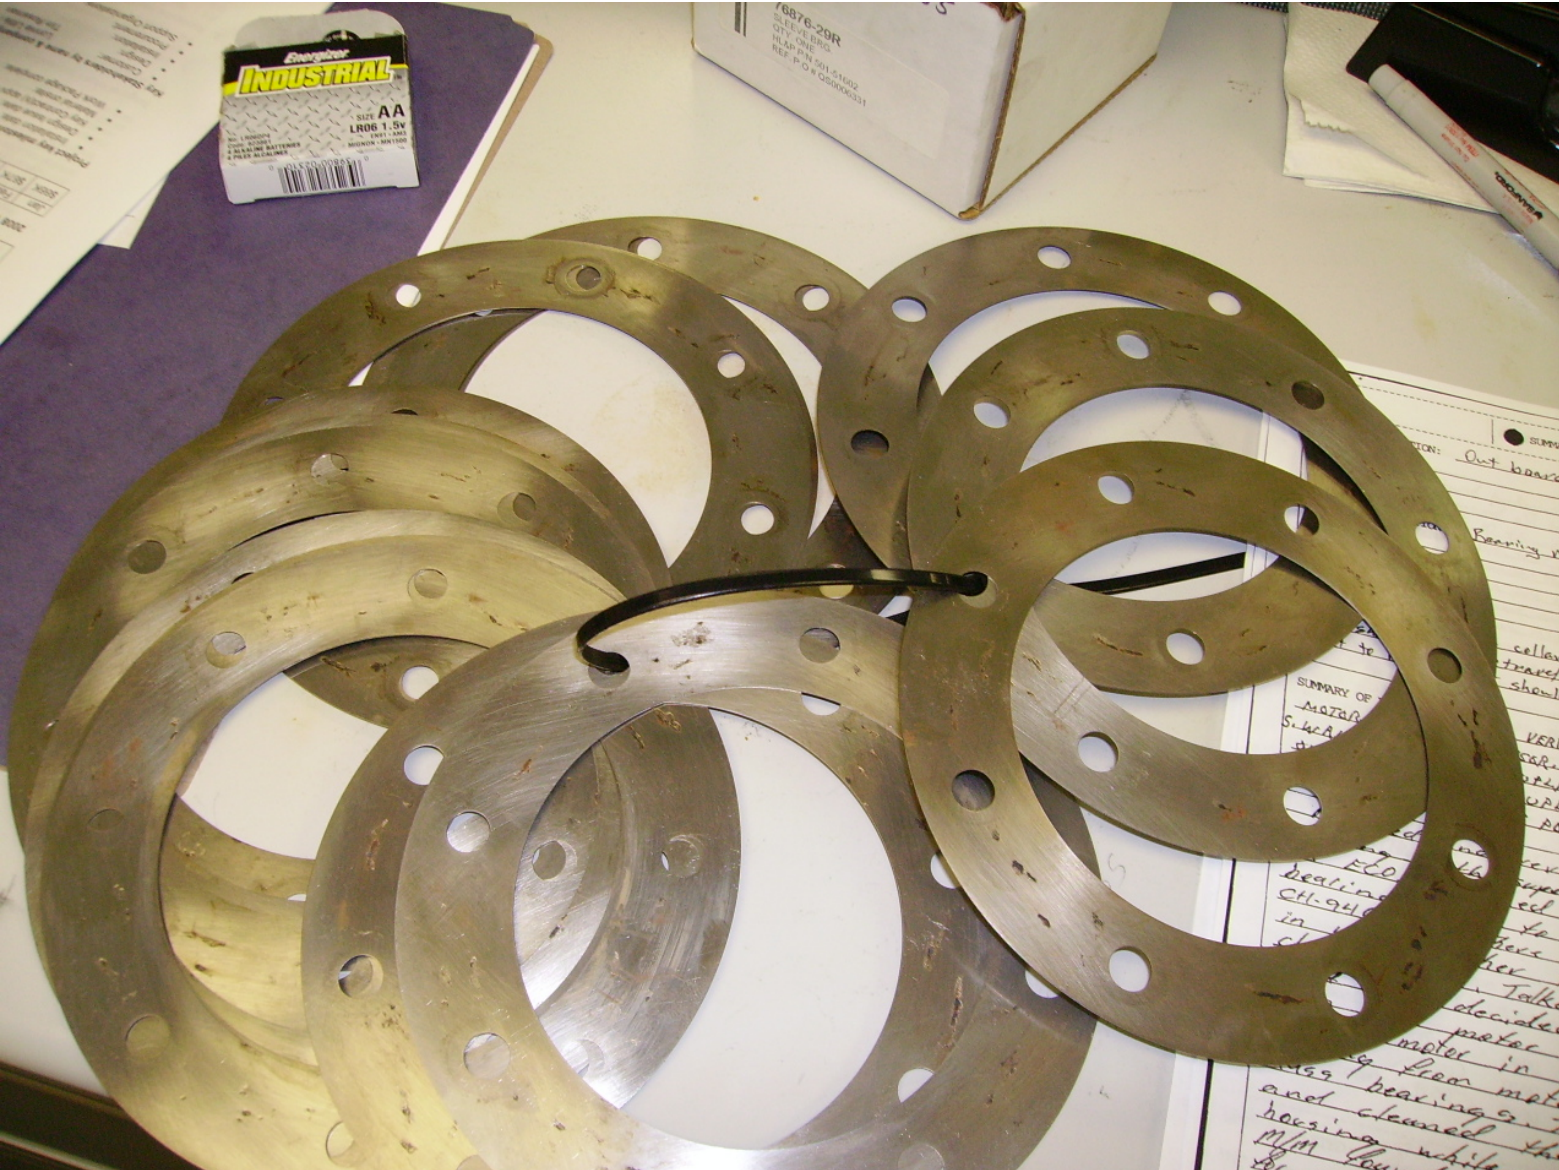
After cleaning – photos note shims were replaced, not re-used)

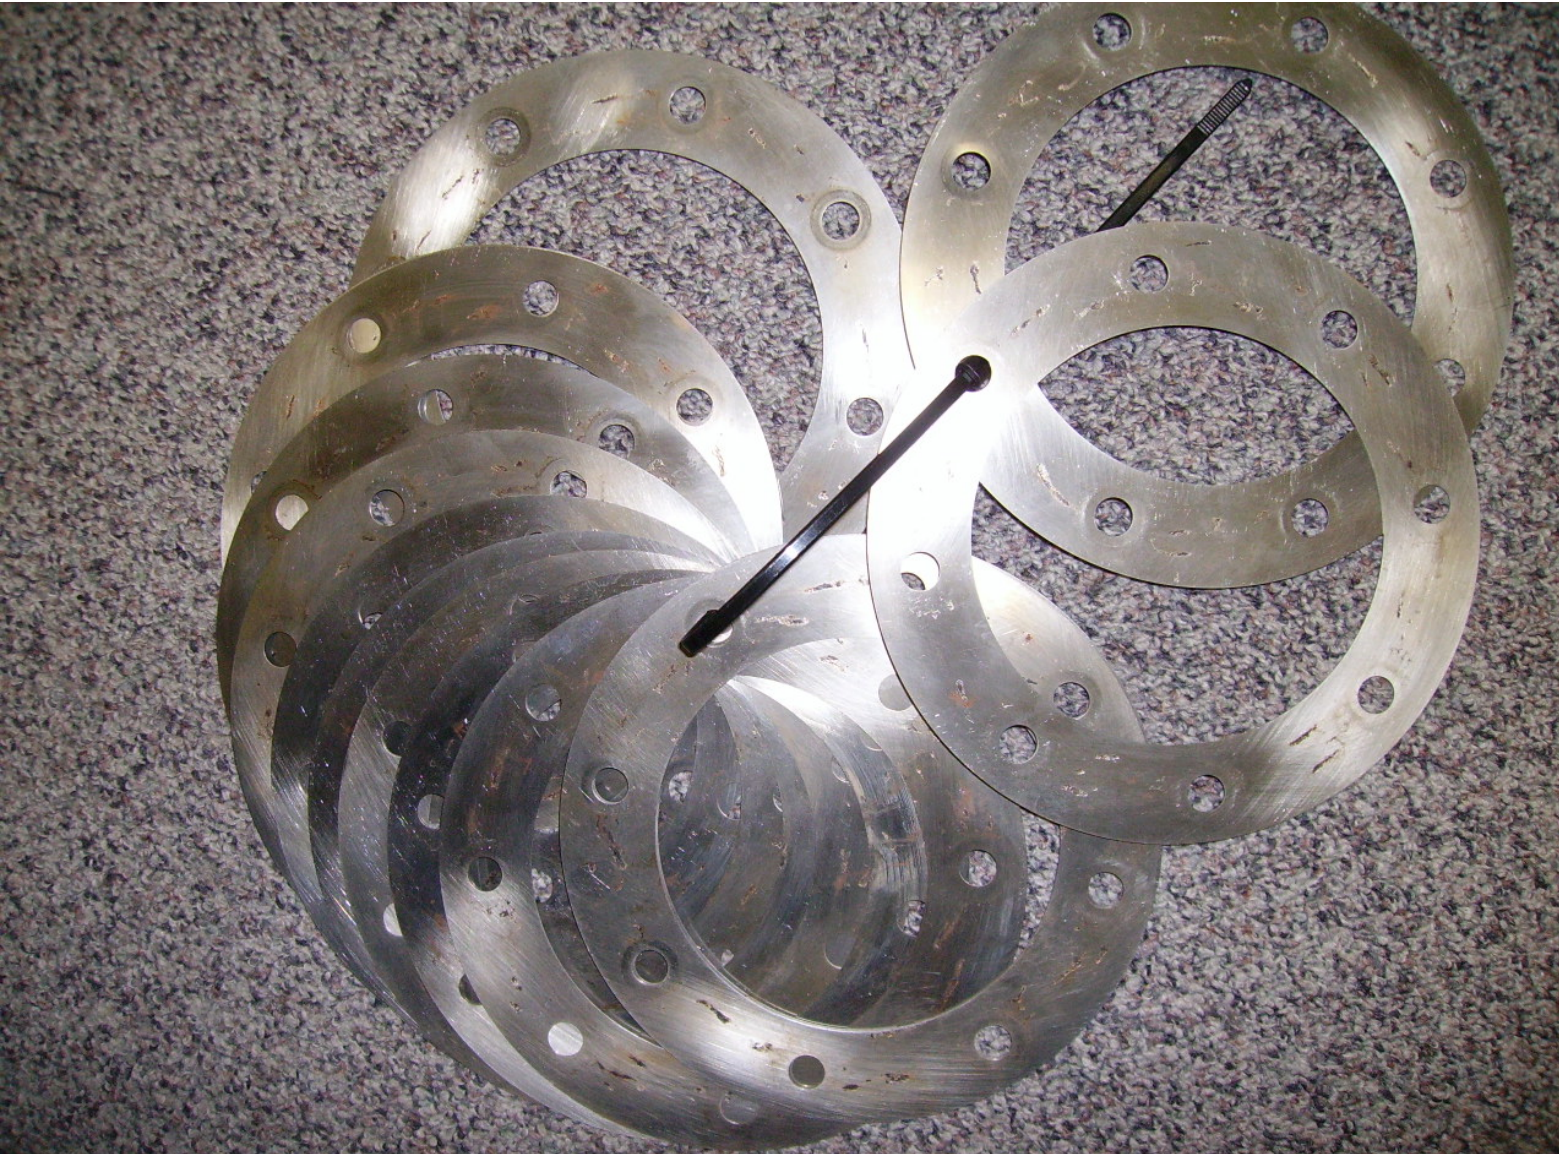
More after-cleaning photos

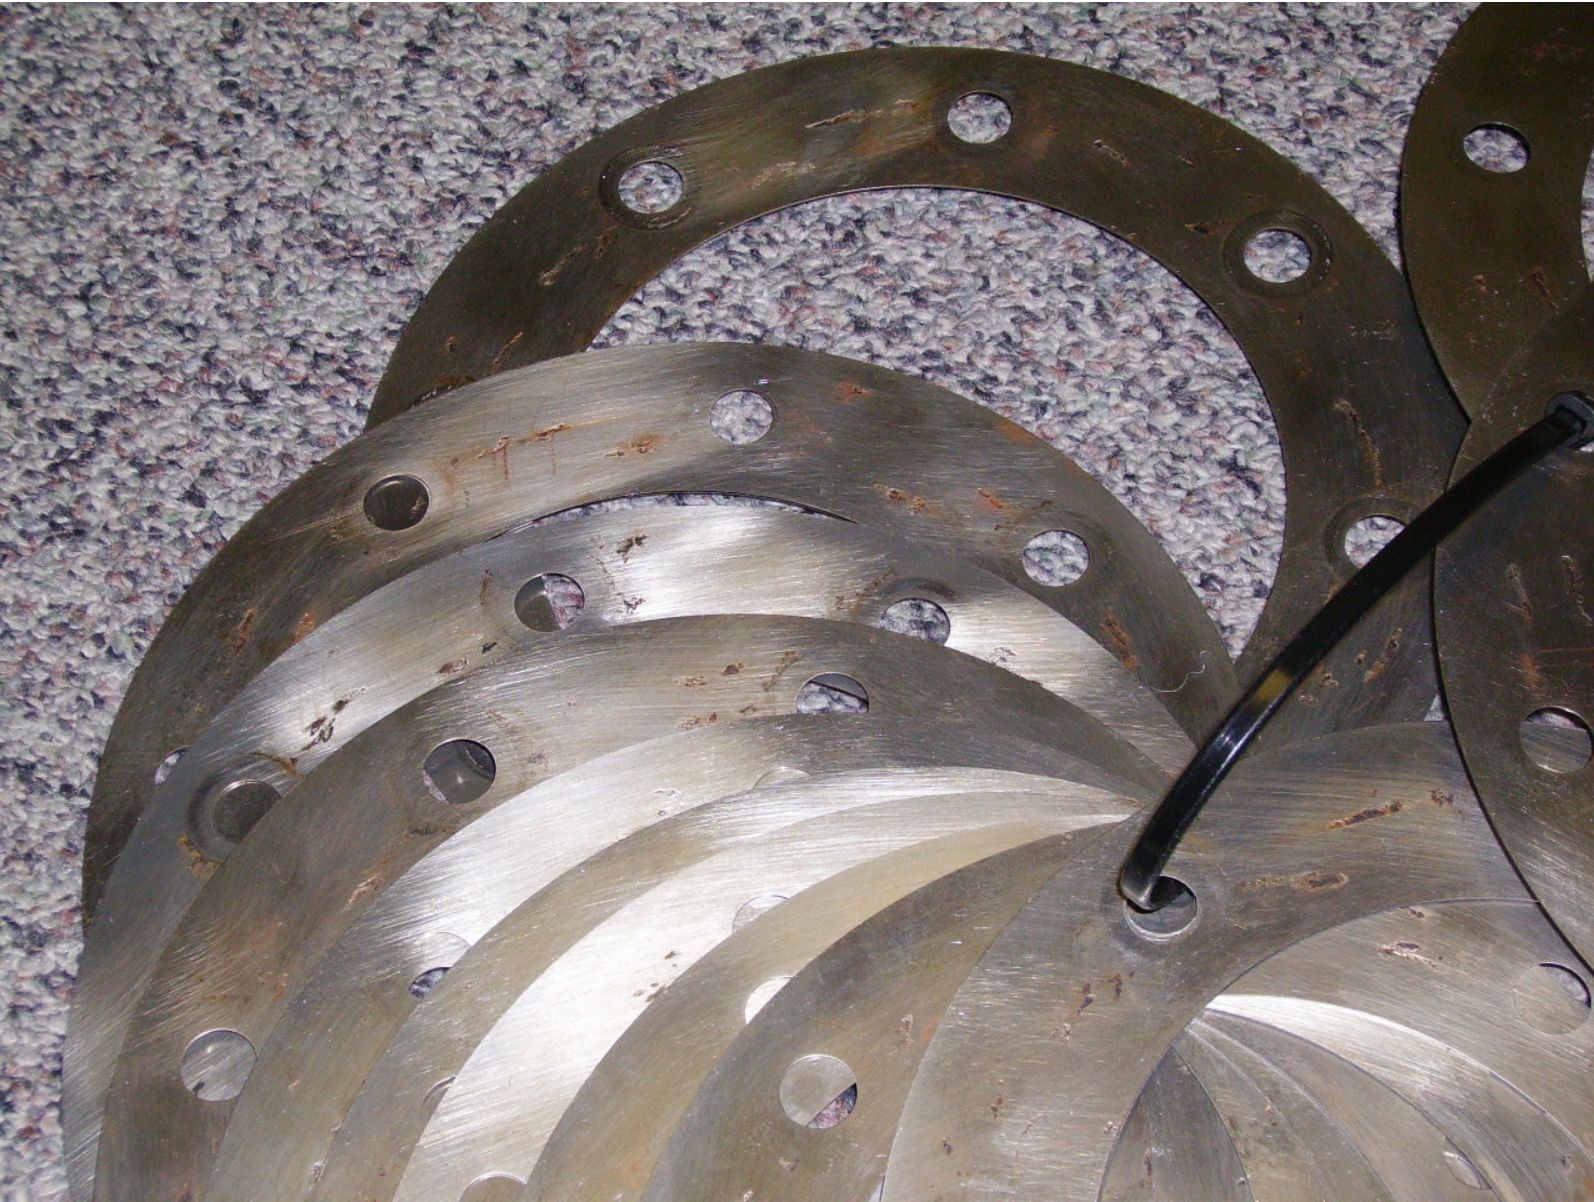
More after-cleaning photos

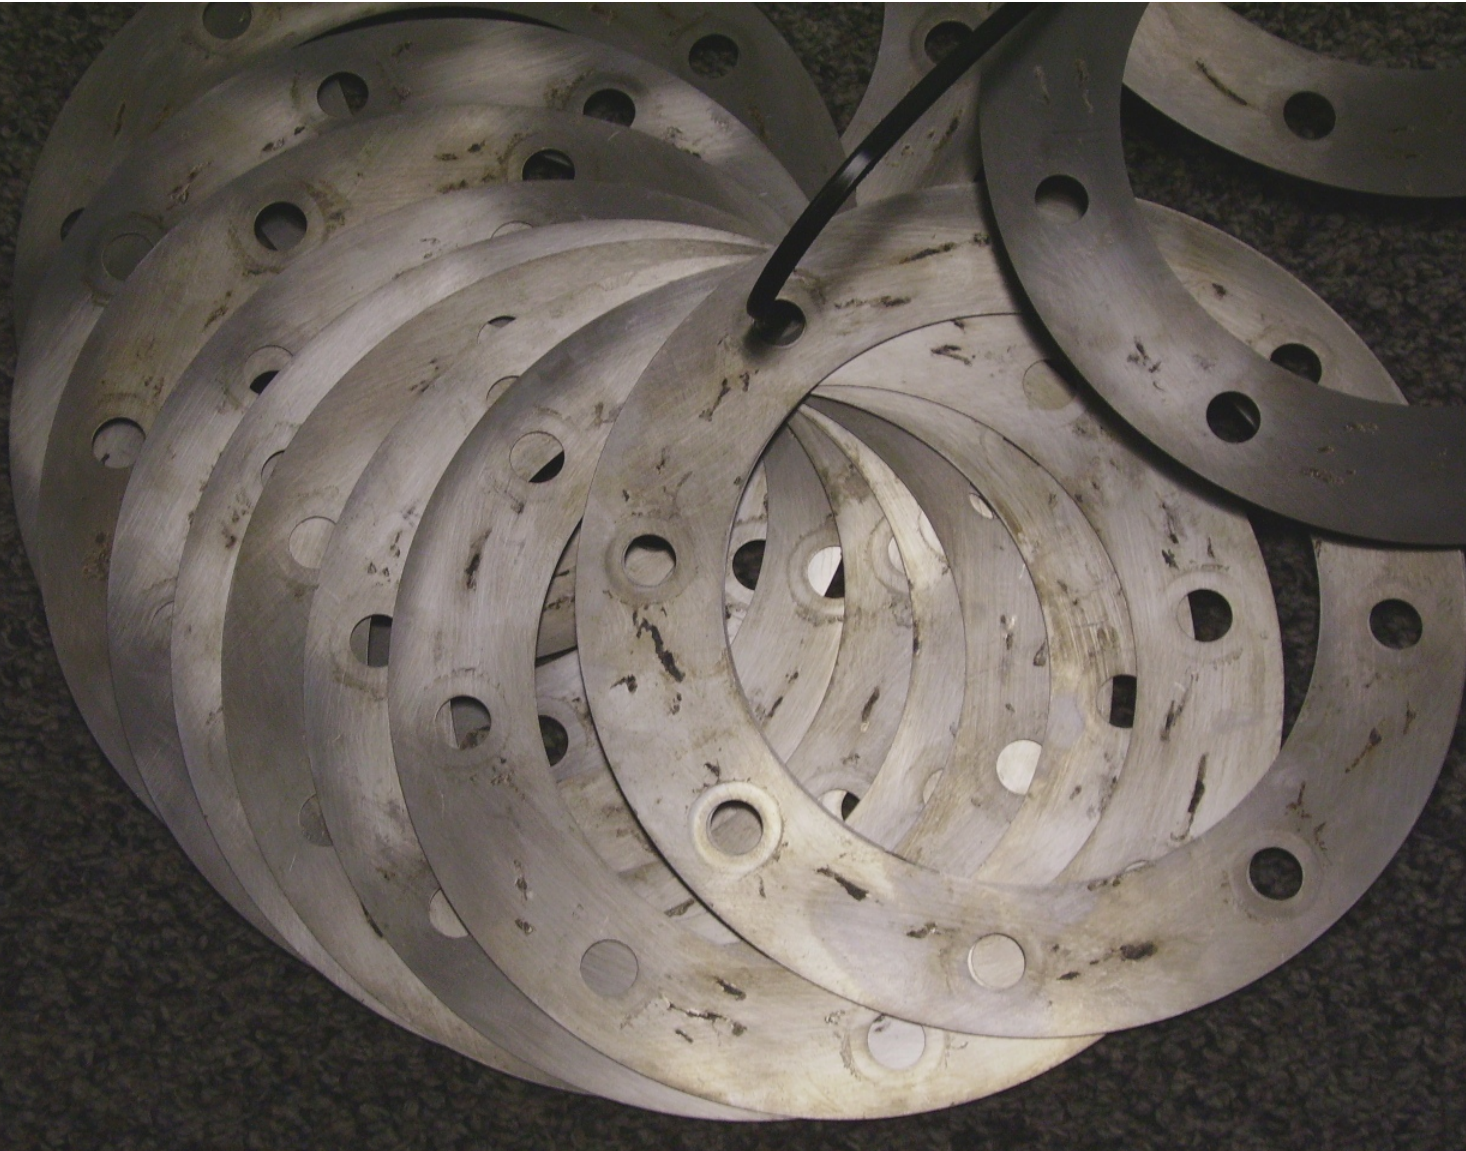
More after-cleaning photos

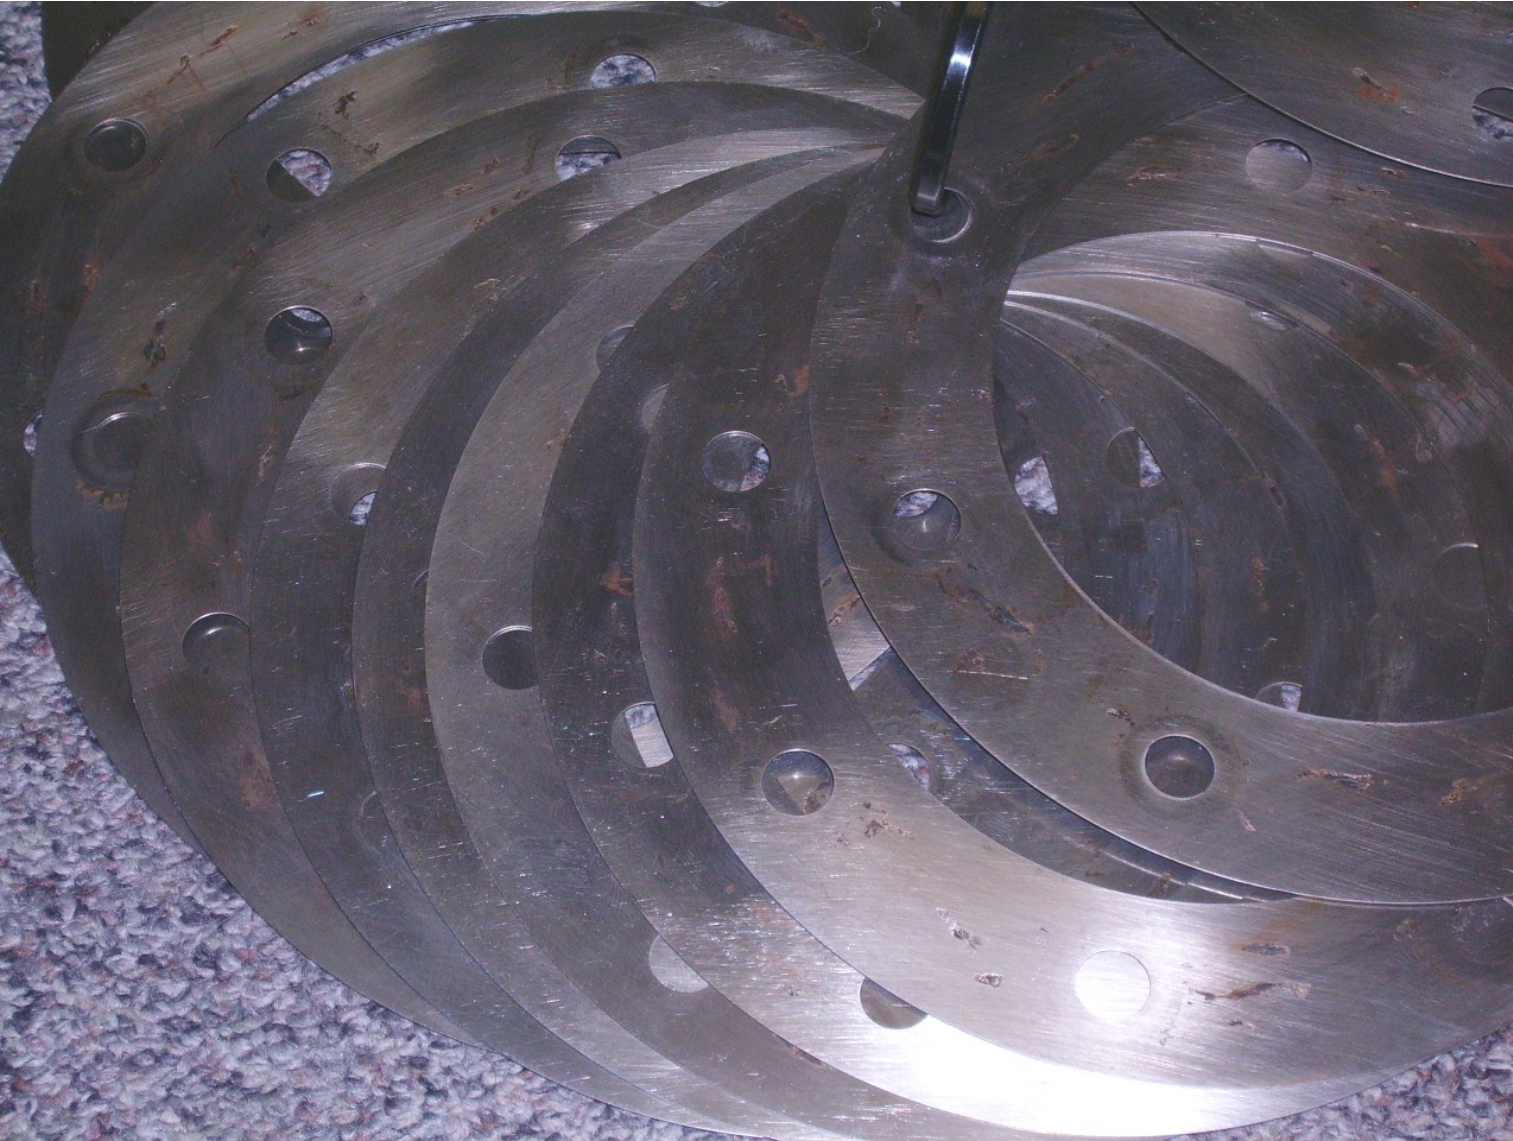
More after-cleaning photos
