# TUBE DAMAGE LOCATION AND STATUS

Location : Drain Nozzle (2ND Baffle from Tube Sheet)  
At 3 Pass and 4Pass Area

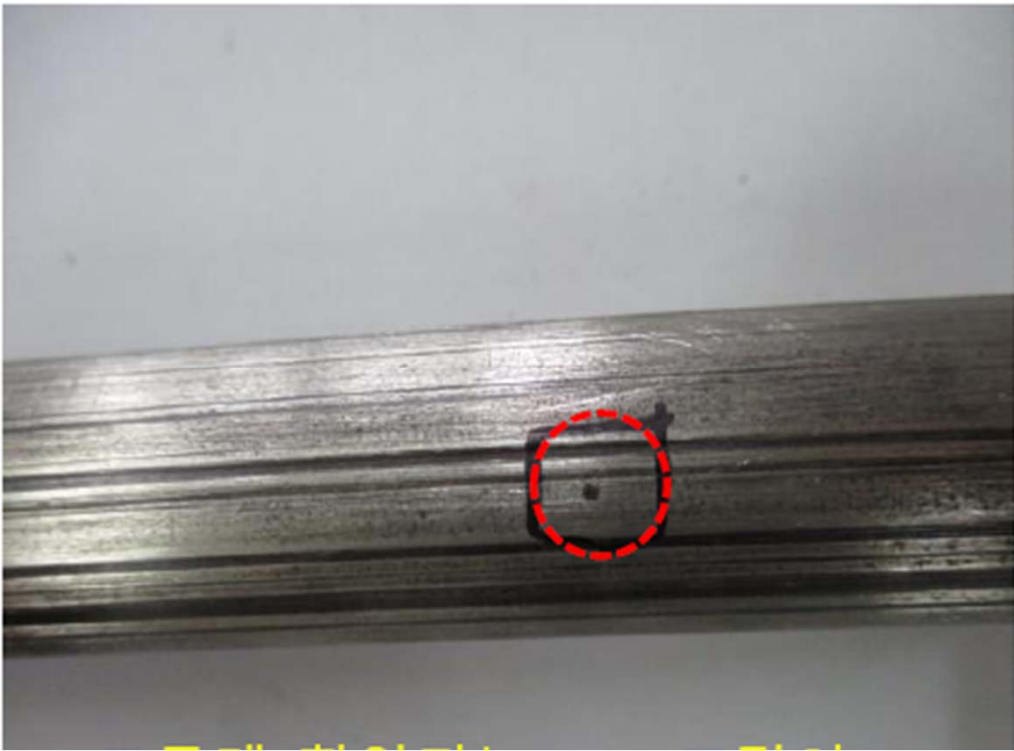
1. Tube Surface Pitting

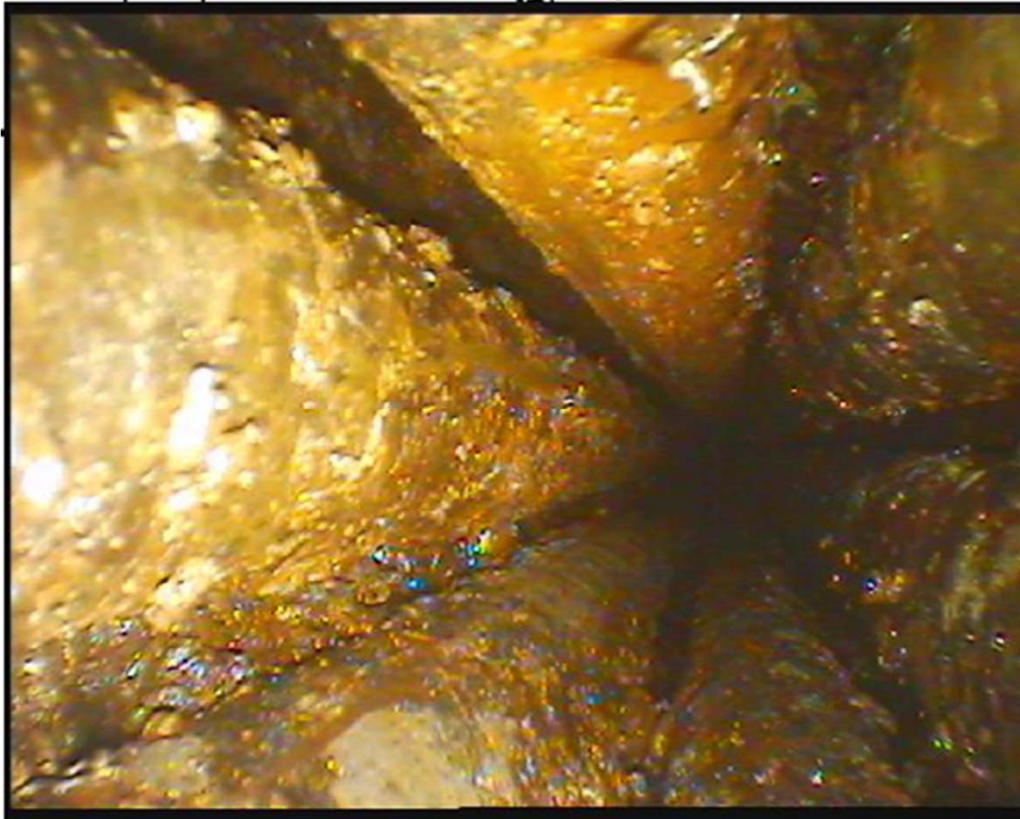
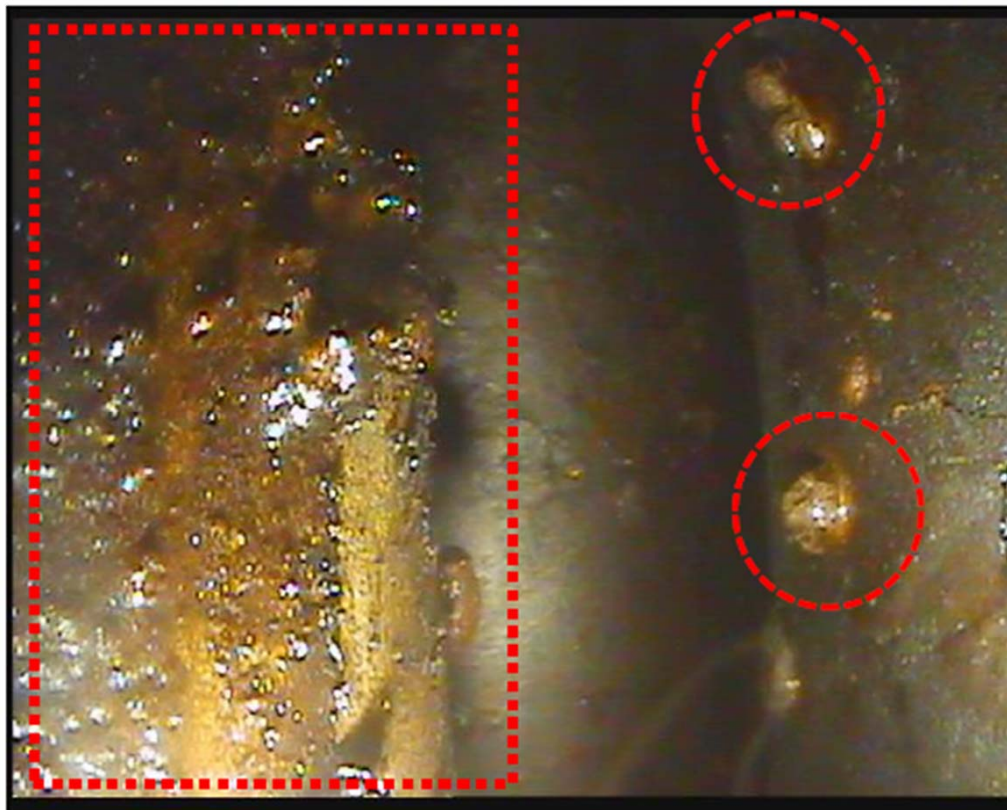
4. Tube Surface near by Tube Sheet

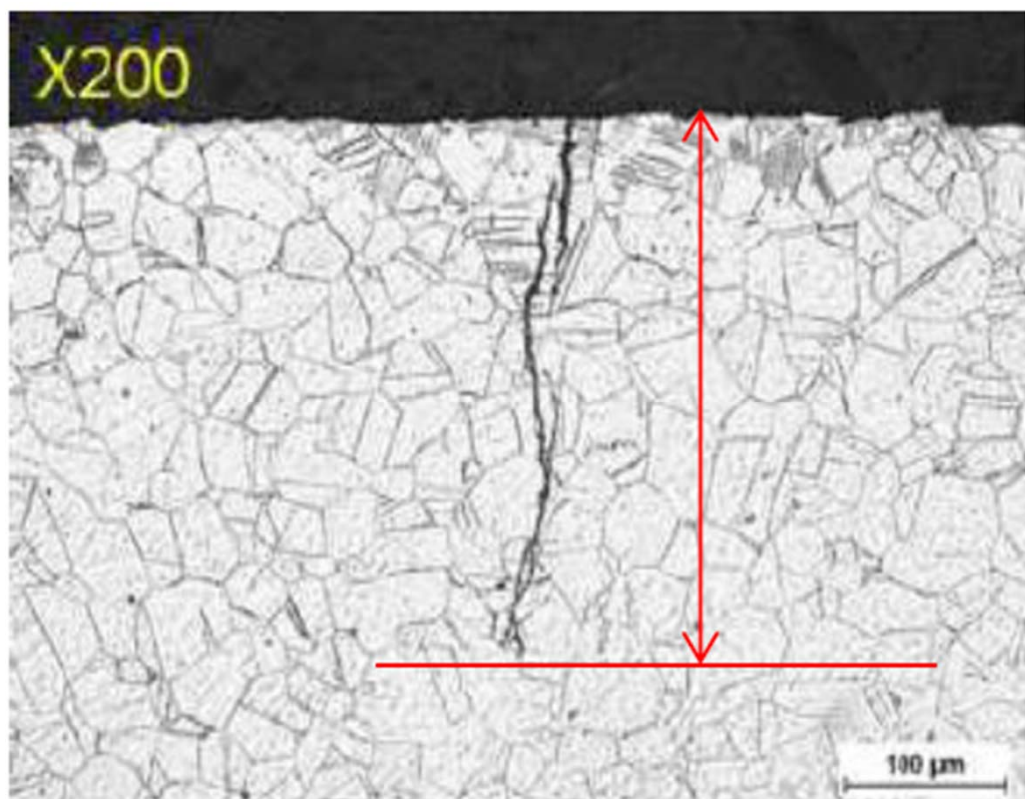
5. Micro Crack (Max. 1.1mm)
