Background

Cracking of Water Jacket in Service

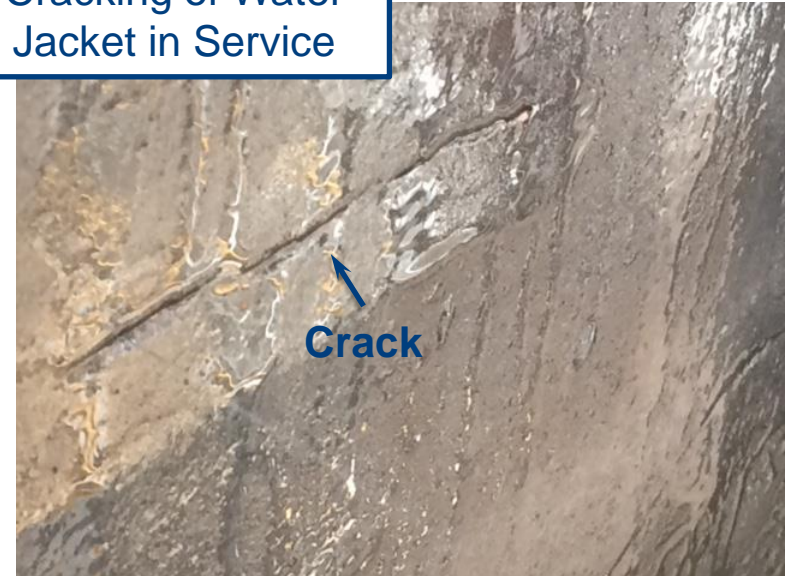
- Material is carbon steel A516 – Grade 70.
- Horizontal cracking 2-3 ft below a stiffener ring almost in line with nozzle L2.
 - Pinhole observed near the corner of the baffle weld.
 - Additional cracks forming.

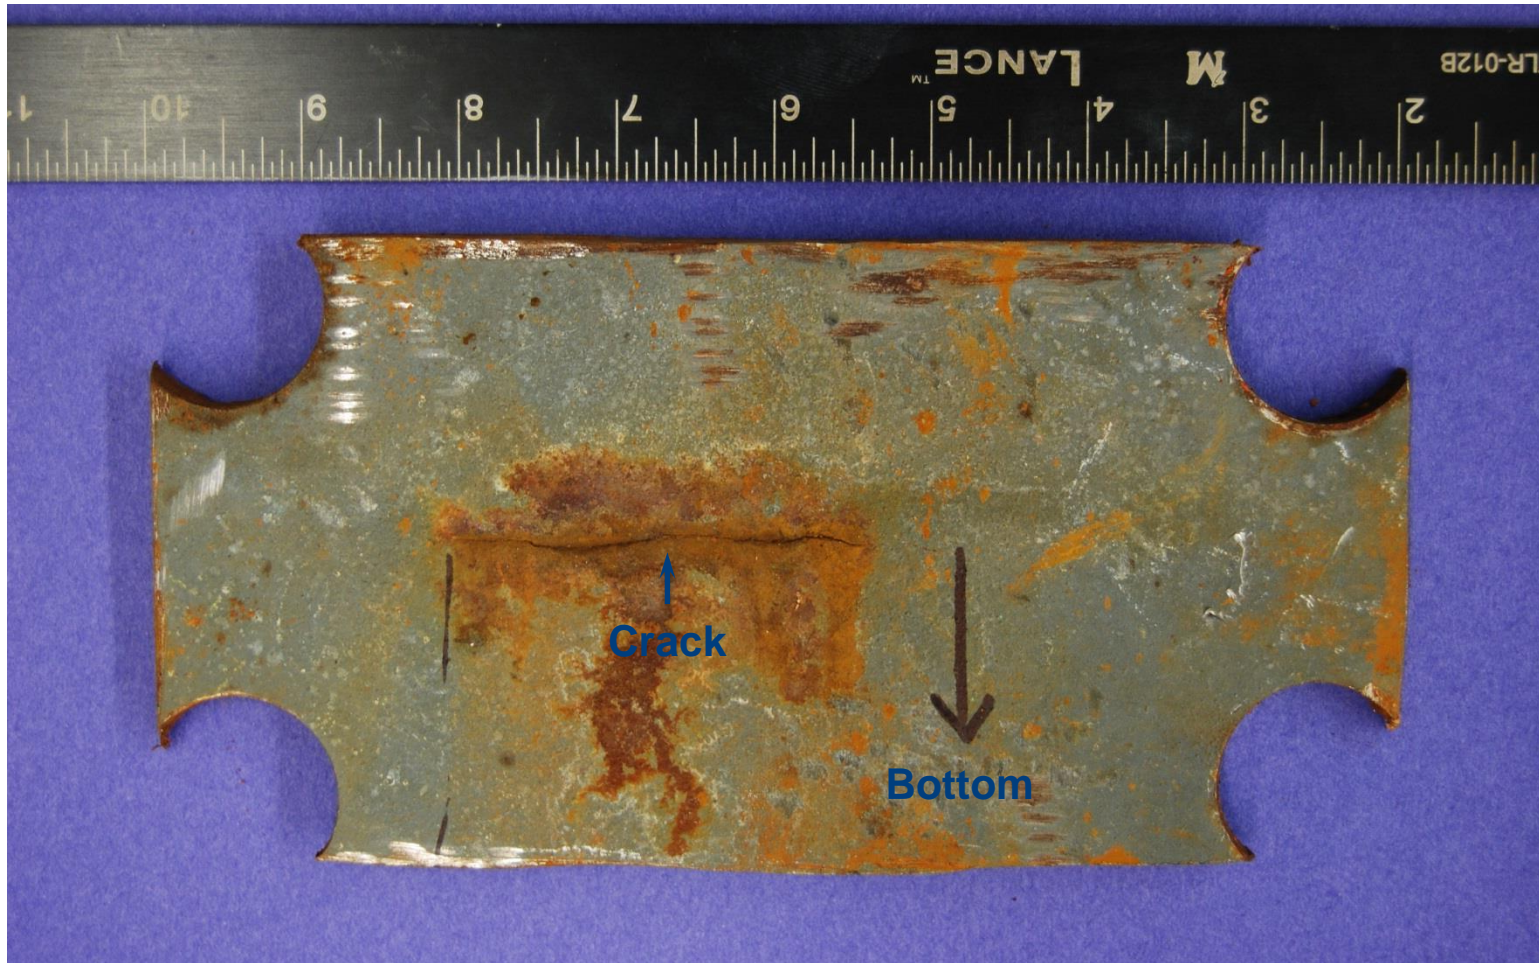
As-Received Section of the Water Jacket

As-received jacket wall section showing through wall crack. Arrow indicates the “top” of the vessel.

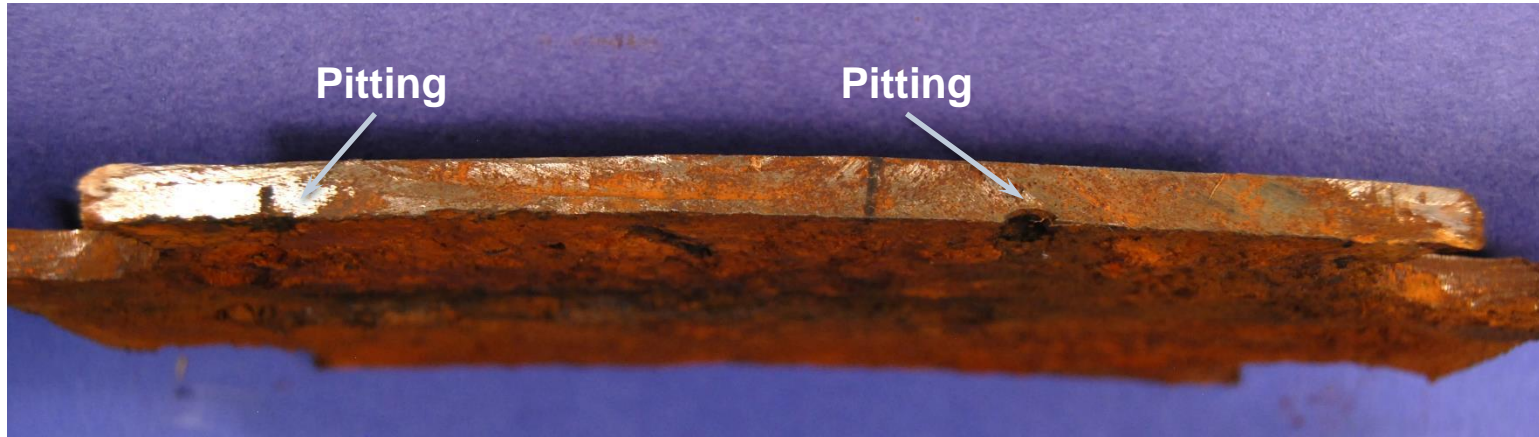
As-Received Section of the Water Jacket

1	2	3	4	5	6
Thickness (in)	0.25	0.23	0.25	0.26	0.25	0.25
Thickness (mm)	6.35	5.84	6.35	6.60	6.35	6.35

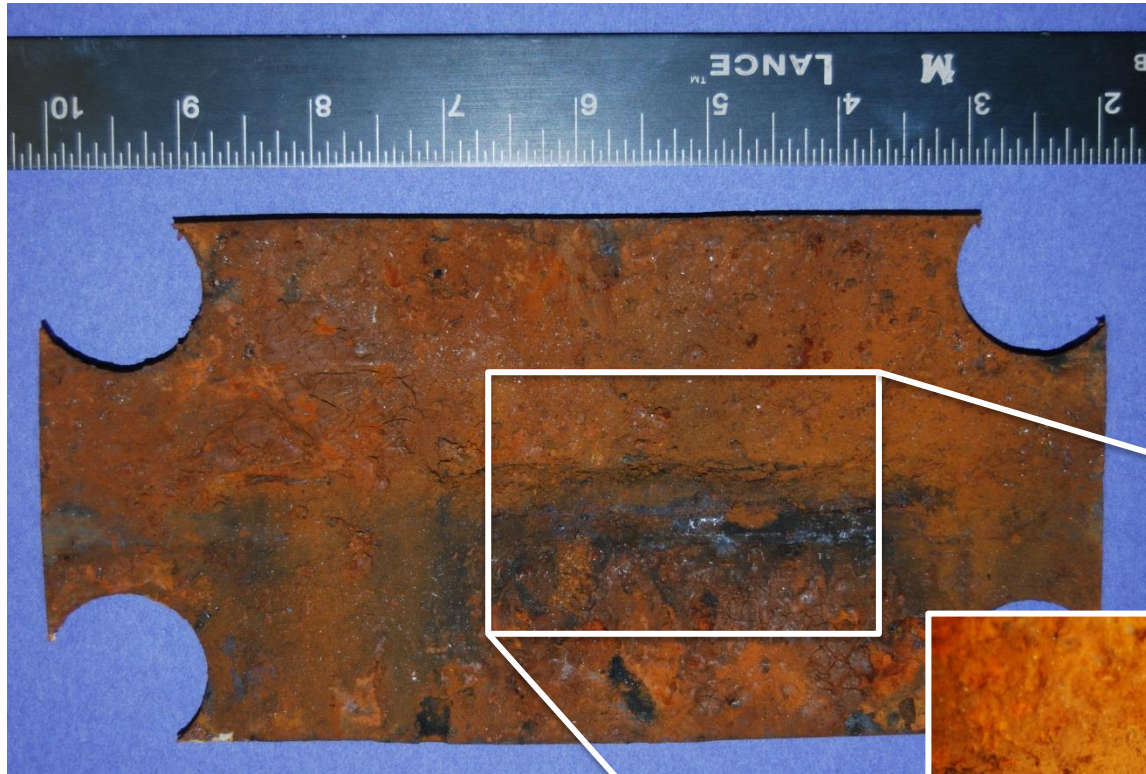
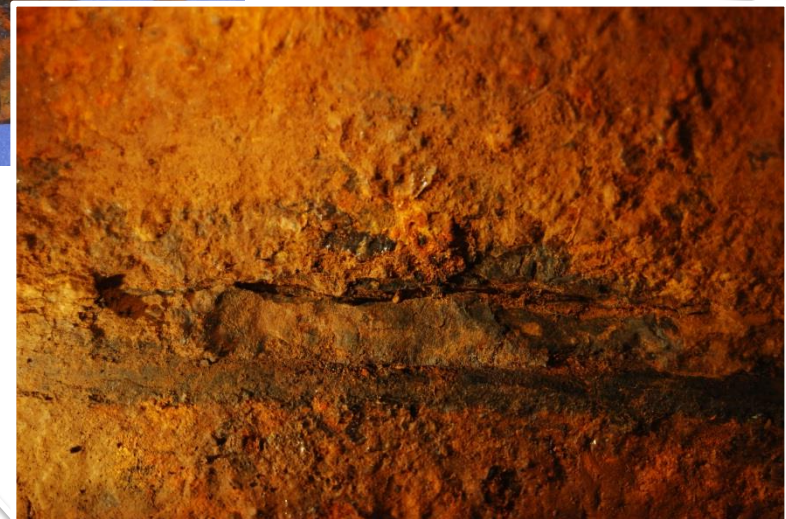
Inside Surface of the Water Jacket Section Post Partial Cleaning

Cracking occurred near stitch weld.

Metal thinning (grooving) observed at cracked location.

Additional corrosion and metal thinning observed.

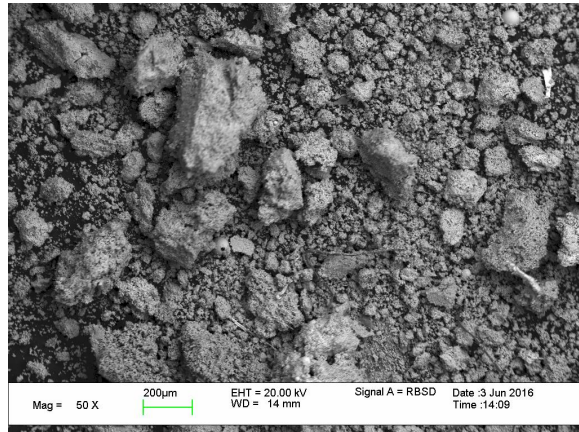
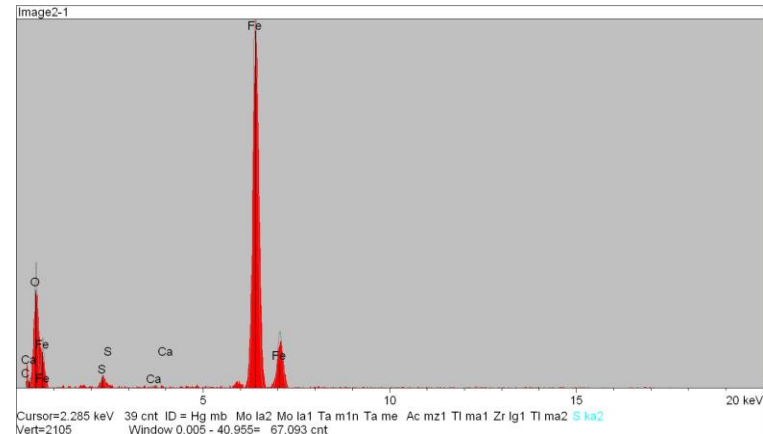
EDS Characterization of Scale

Analysis of scale product removed from the interior surface of the water jacket showed that the scale was mostly iron oxide (Fe_2O_3) with minor concentration of molybdenum (Mo)—should be noted that sulfur (S) and Mo peaks overlap in the EDS spectrum and if S is present is difficult to differentiate the species.

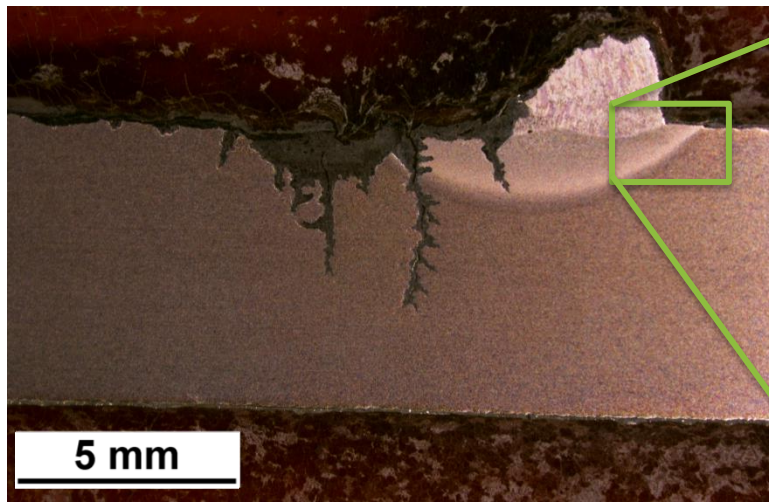
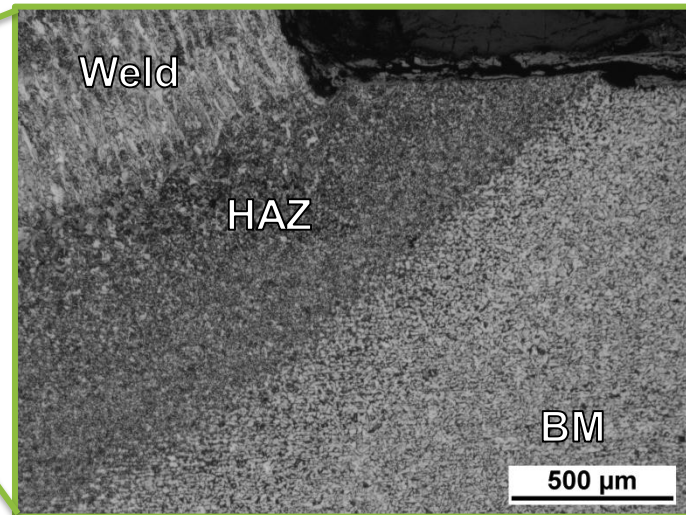
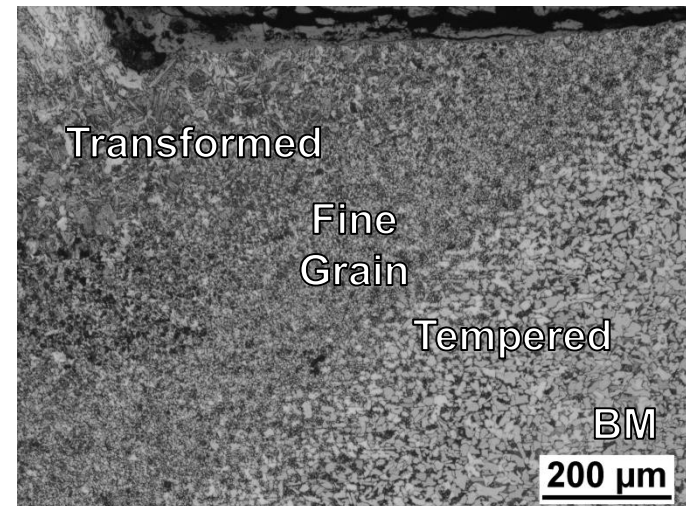
Metallography

Etched cross-section taken at the location where cracking was present, near the baffle welds.

Microstructure of the base metal (BM) plate is ferrite and pearlite. The weld heat affected zone (HAZ) showed microstructure typical of as-welded material.

Cracking was not localized within the HAZ of the weld.

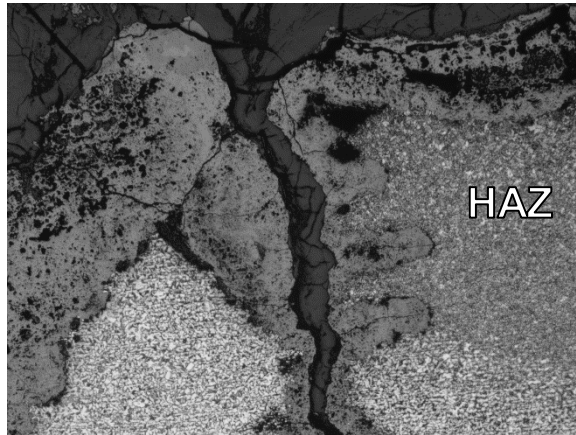
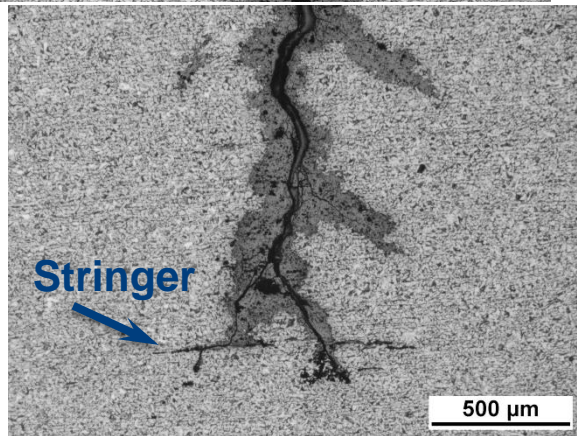
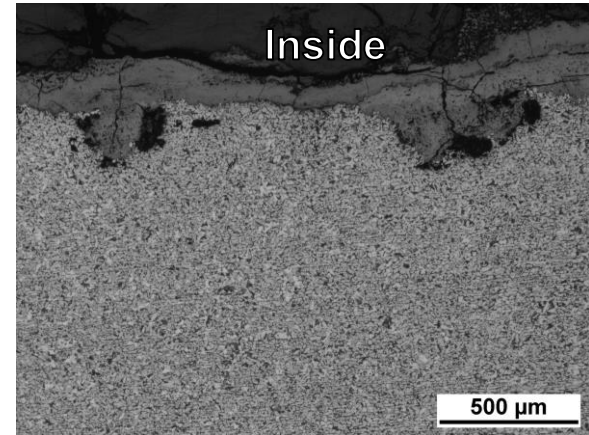
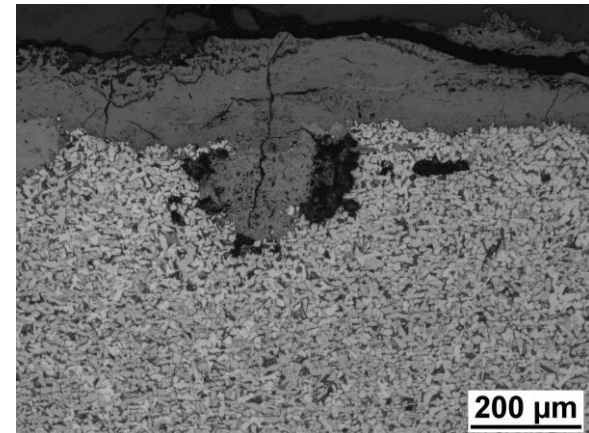
Metallography

Cracks were branched and transgranular with initiation at corrosion pits on the surface of the plate. Crack extension is preceded by corrosion of exposed metal and formation of a thick corrosion scale.

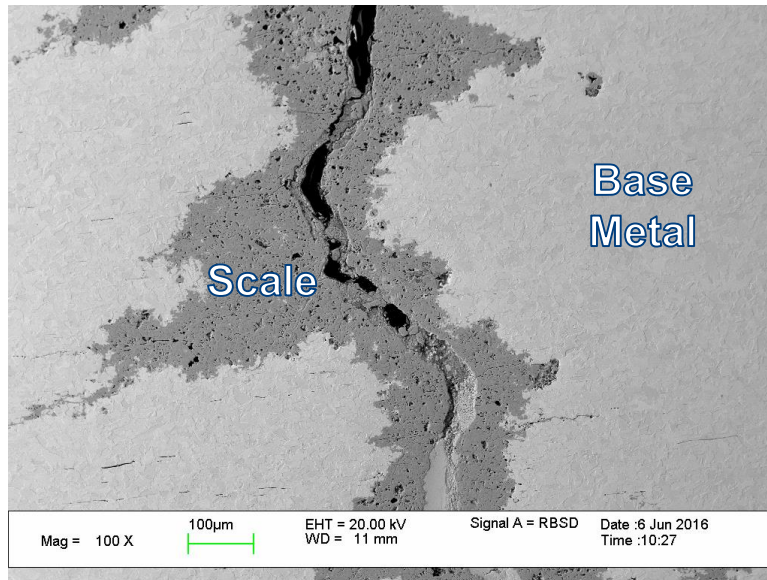
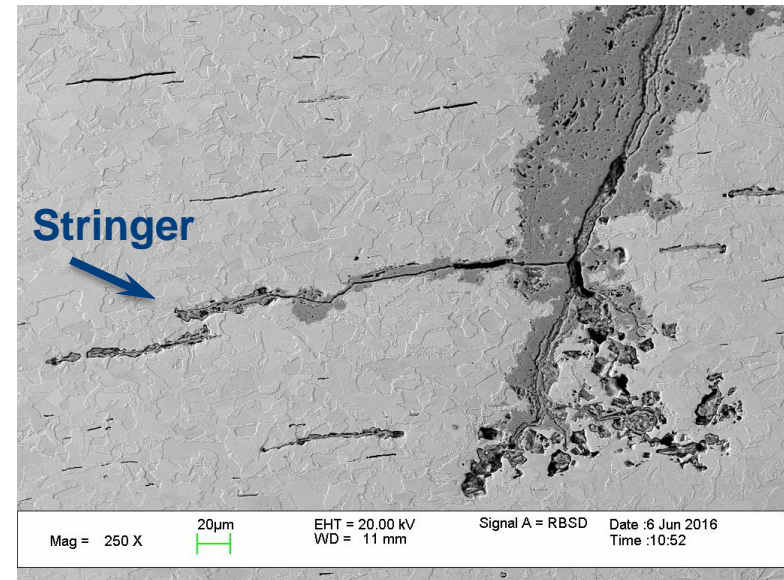
Characterization of Scale

- Scanning electron micrographs of a crack near the baffle weld showing corrosion of the crack surface as the crack propagated into the base metal.
- Crack branching is observed at location of manganese sulfide inclusion, which are typically susceptible to corrosion due to lower corrosion potential.

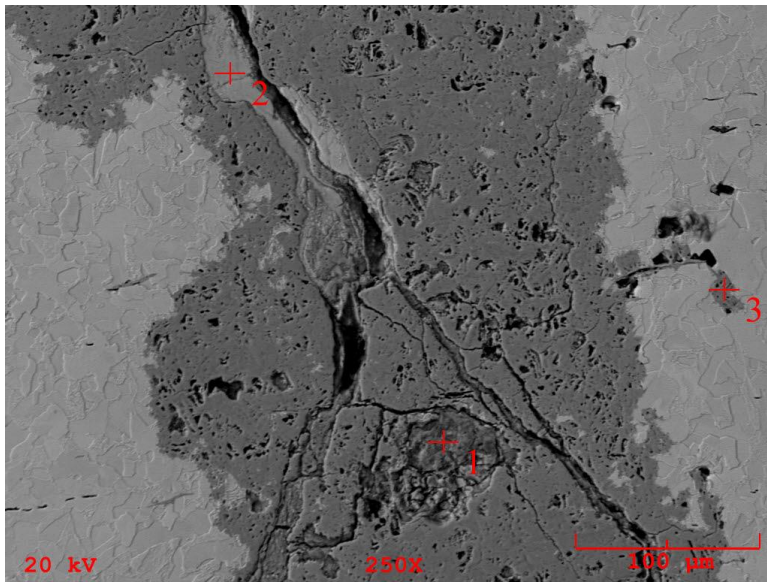
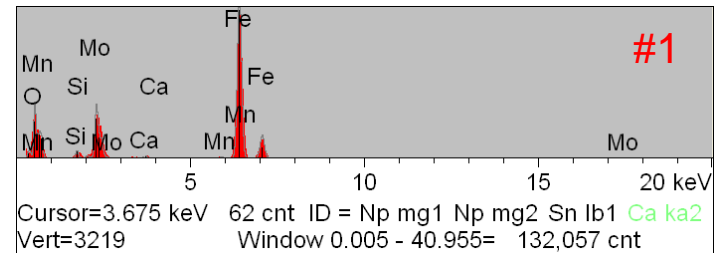
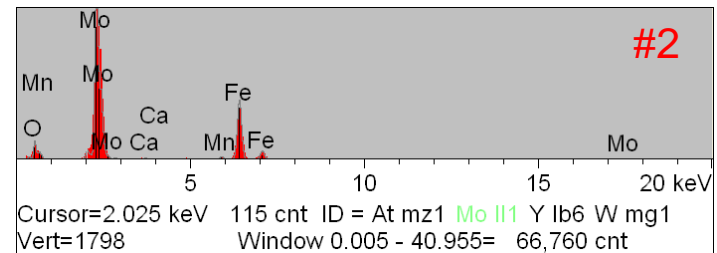
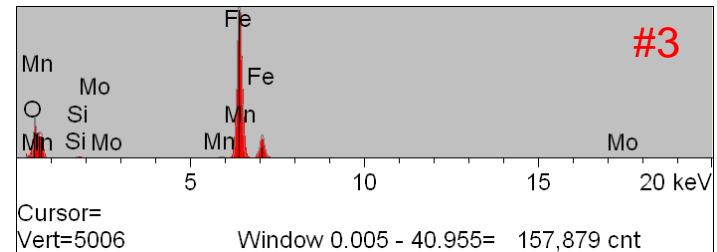
EDS Characterization of Scale

Corrosion scale on crack surface showed characteristic energy peaks for Mo, Fe, Mn, and O. Additional peaks for Ca and Si observed. Location #1 showed peaks for Mo, Fe, and O likely due to the formation of FeMoO_4 . Location #2 showed high concentration of Mo coated on the surface due to absorption into the corrosion product.

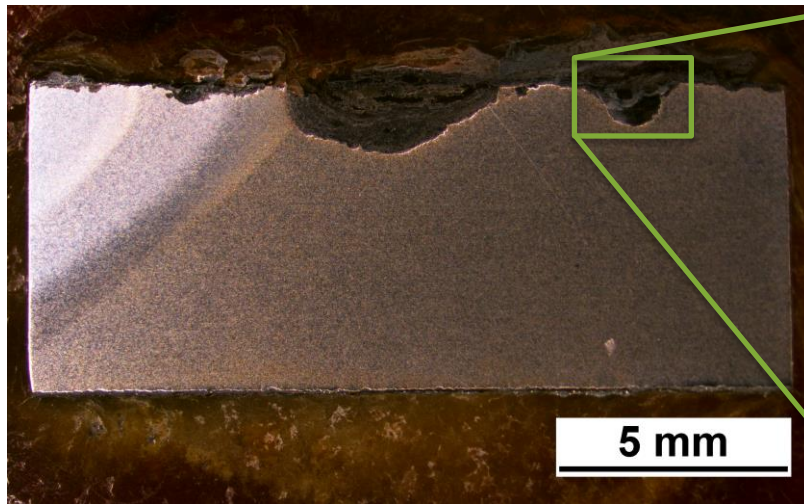
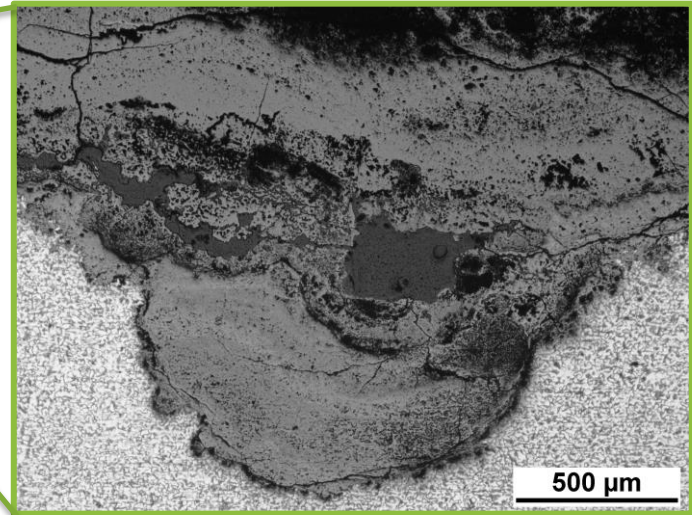
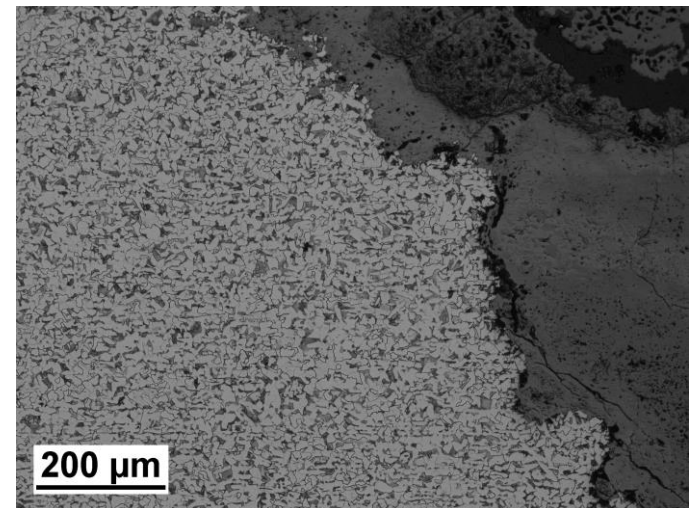
Metallography

Etched cross-section taken away from the location where cracking was present but showing corrosion pits.

Thick porous scale filled the cavity of the pit.

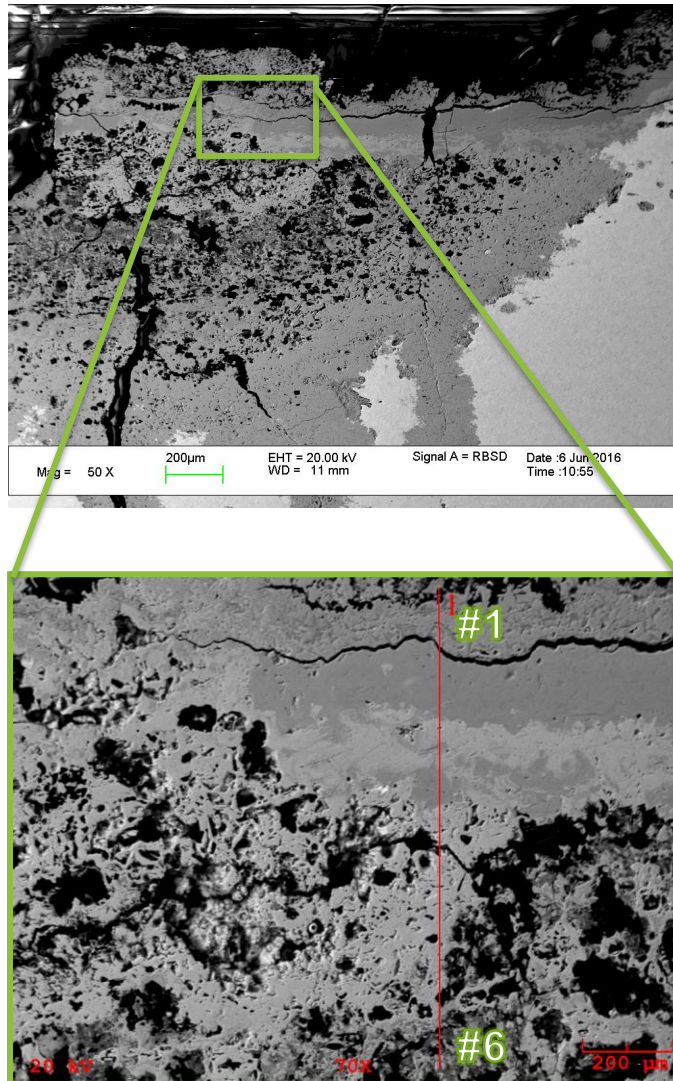
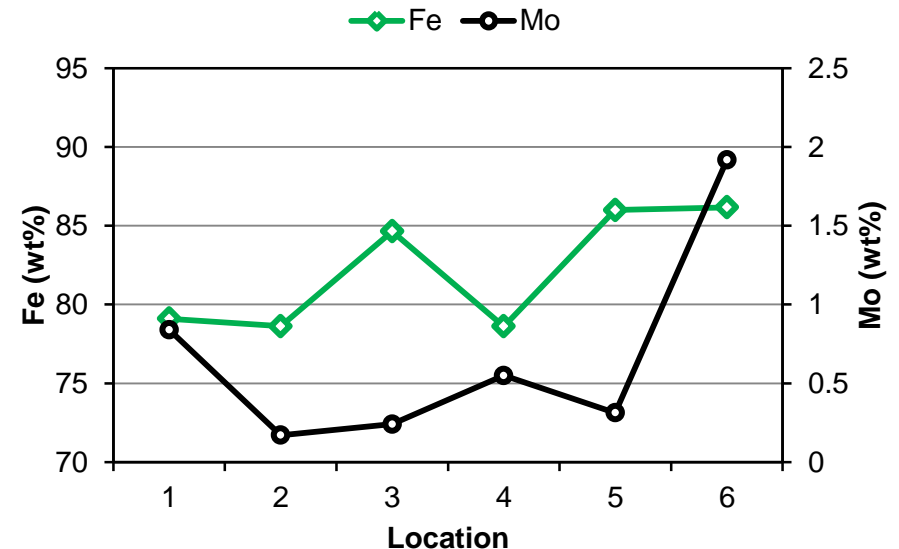
EDS Characterization of Scale

➤ Increased Mo content observed in the porous regions of the scale (Locations #1 & #6).

- Mo content increased towards the base metal, where protective molybdenum oxide formation is promoted.
- Element concentration measure by EDS.
