Appendix A – Coupling Images

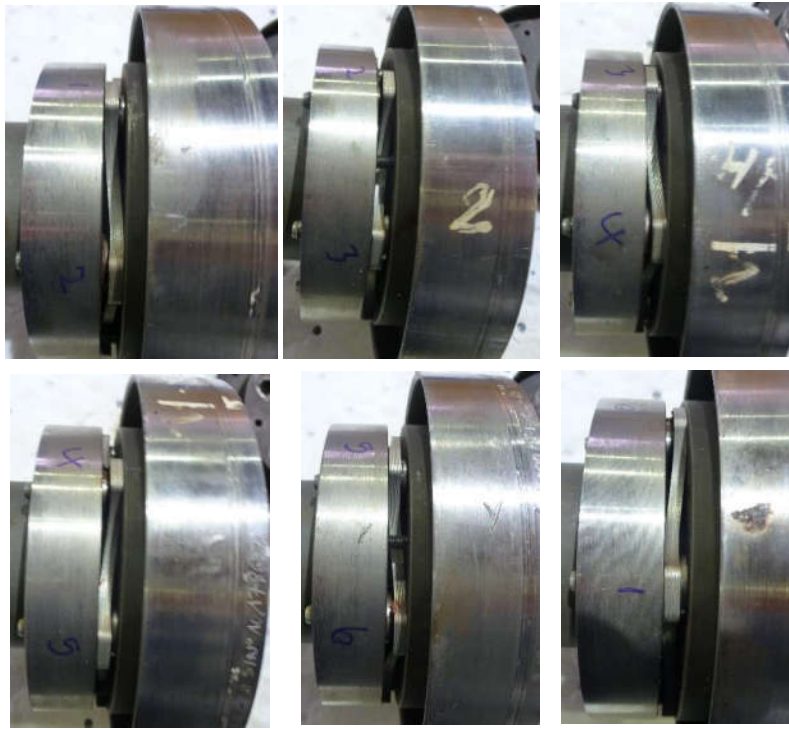
Figure 1 - HPC Guard ring as received

membrane pack was found to be overtightened using gagging bolts

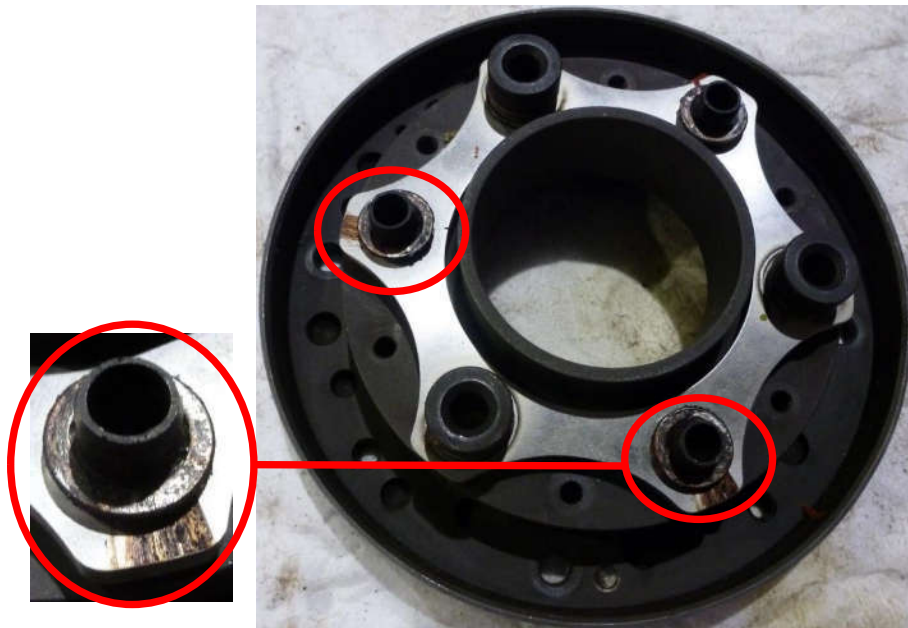
Figure 2 - HPC side membranes still attached to guard ring, fretting residue is seen on the two marked positions and the washers are worn

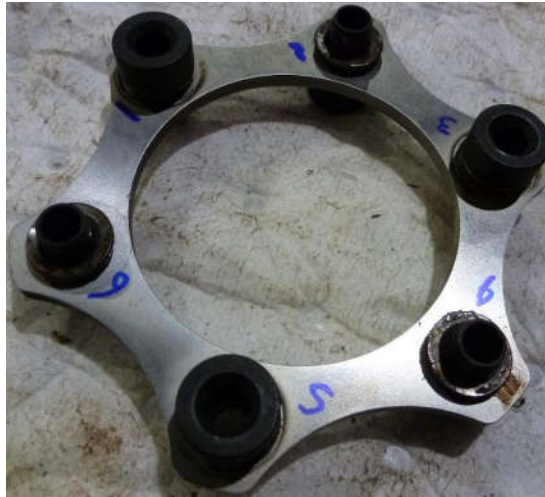
Figure 3 - membrane pack showing fretting residue around the membrane pack but with an overall good condition and no noticeable bowing

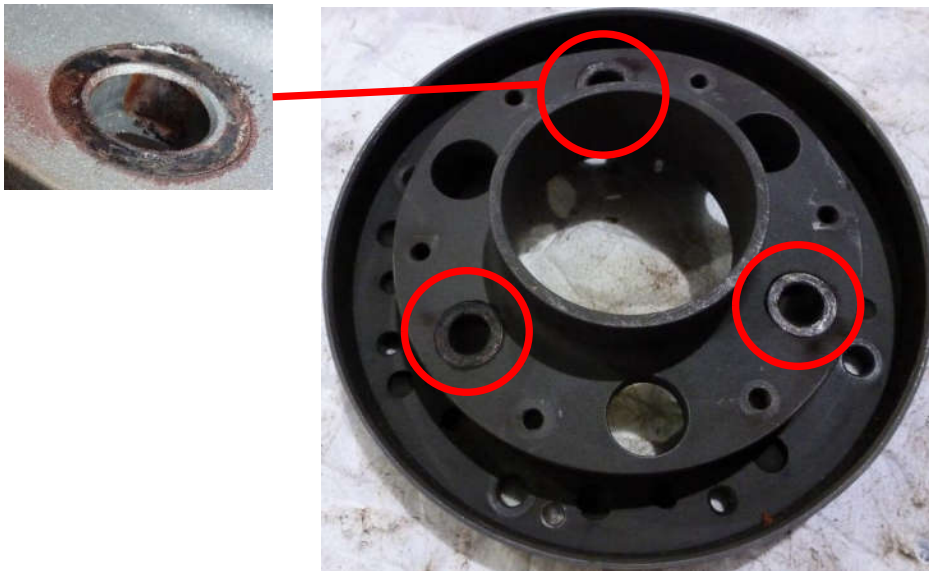
Figure 4 - Guard ring showing signs of wear around the bolt hole washers which grooved the surface

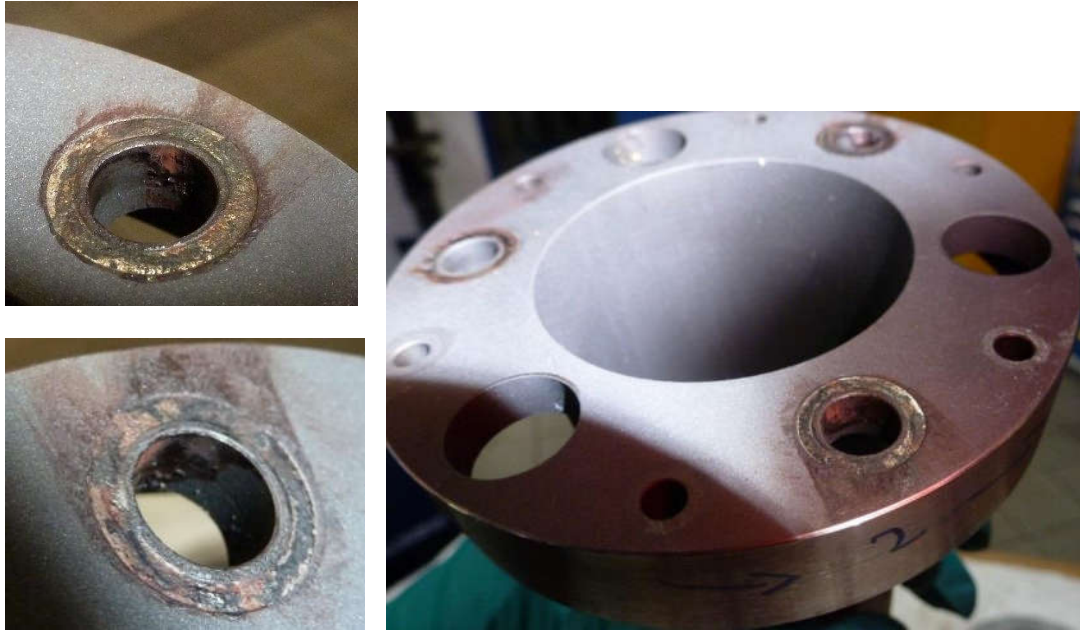
Figure 5 - Spacer HPC side condition with damage around the bolt holes

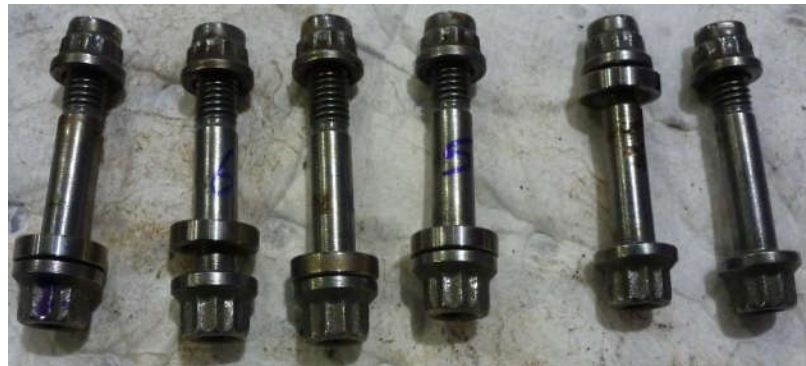
Figure 6 - HPC side bolts with an overall good condition with minor fretting on some of the bolts shank

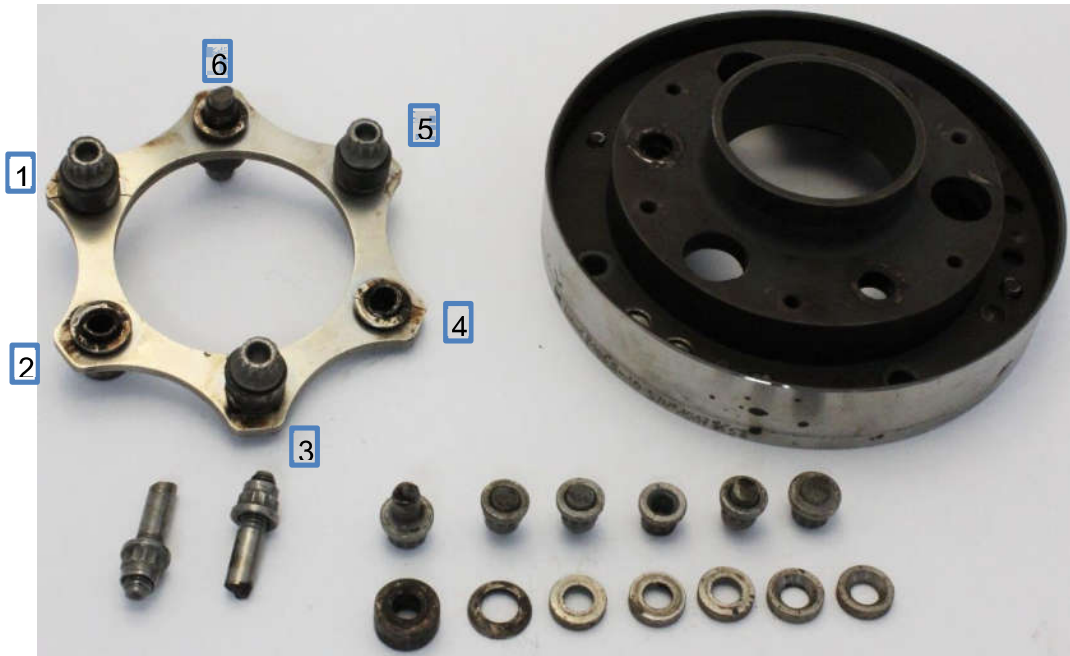
Figure 7 - Driver side with damaged components as received from

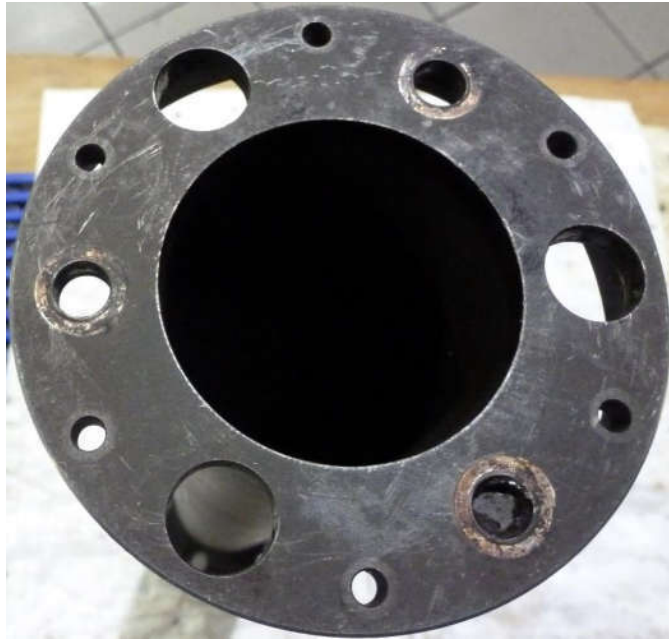
Figure 9 - Spacer from LP compressor side, with damage at the bolt holes

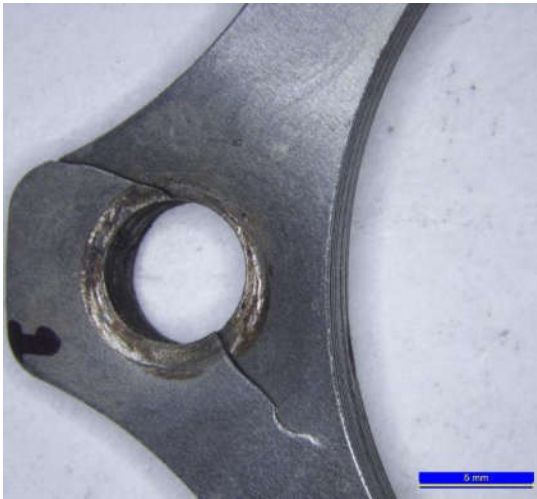
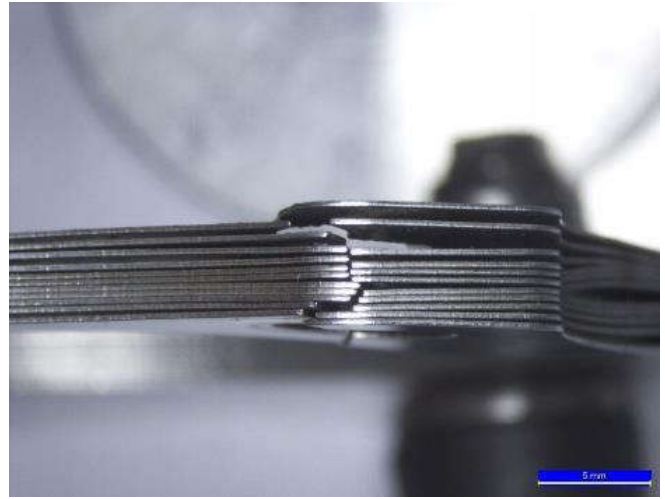
Figure 10 - membrane hole with fretting damage around the hole and crack propagating from the bolt hole and failure across of the membranes

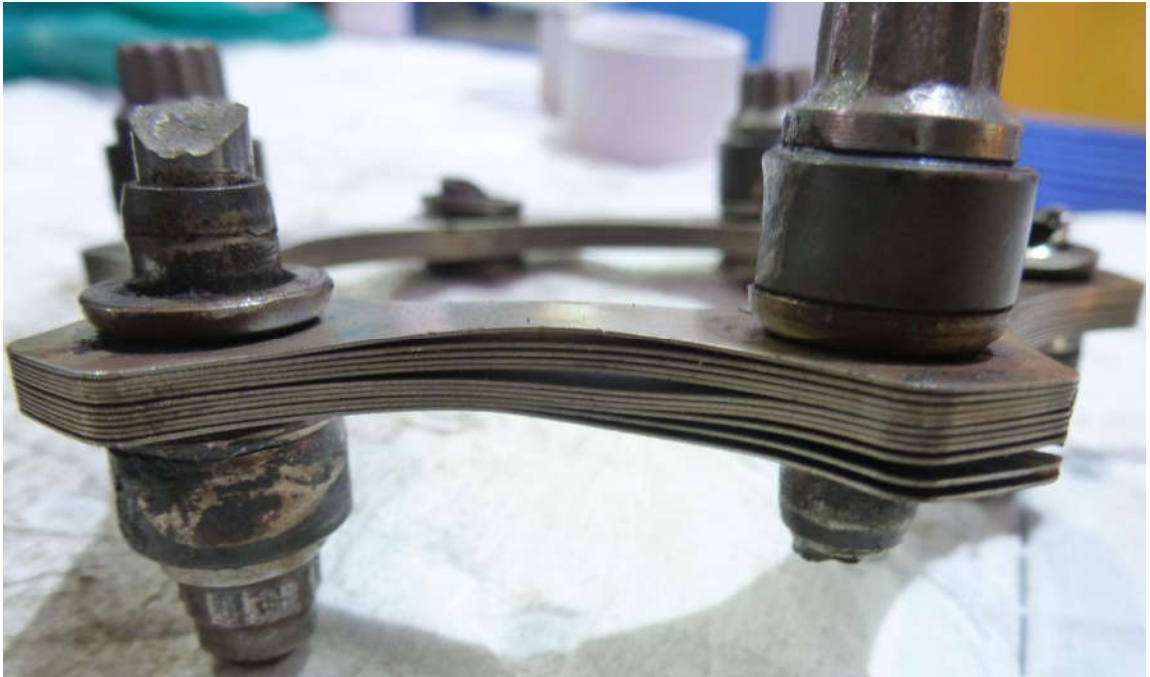
Figure 11 - LPC membrane pack with wear damage on overload collars

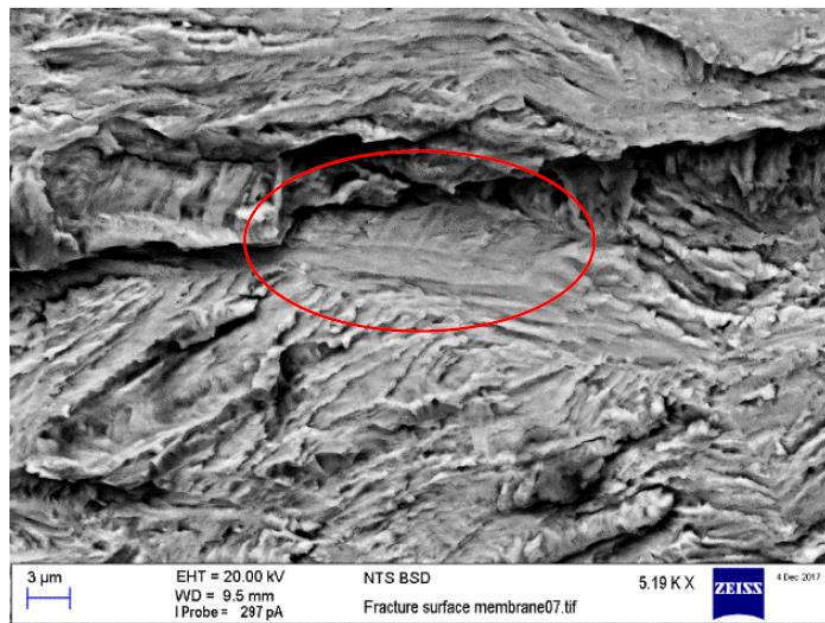
Figure 12 - SEM BSD micrograph showing general view of fracture surfaces from membranes, highlighting fatigue striations (red circle) within the microstructure

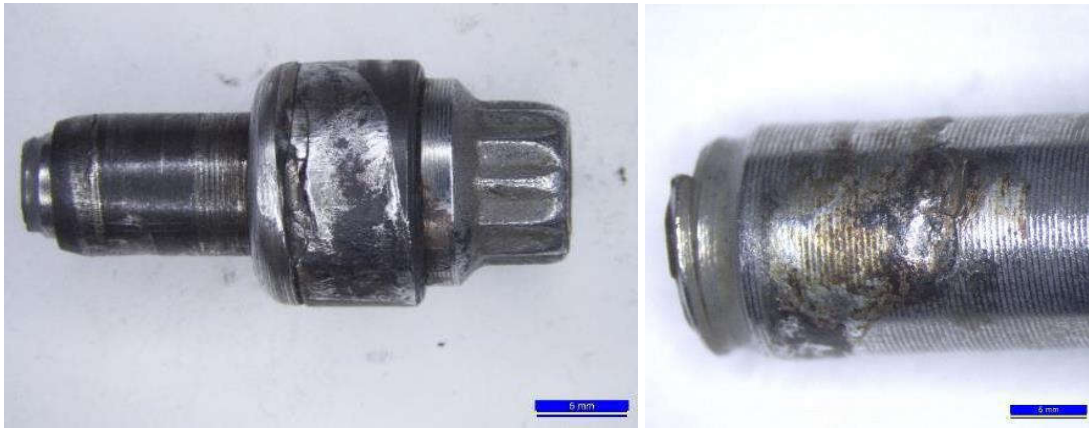
Figure 13 - Mechanical damage and cracking of the bolt collar (left) and fretting damage along the shank of the bolt (right)

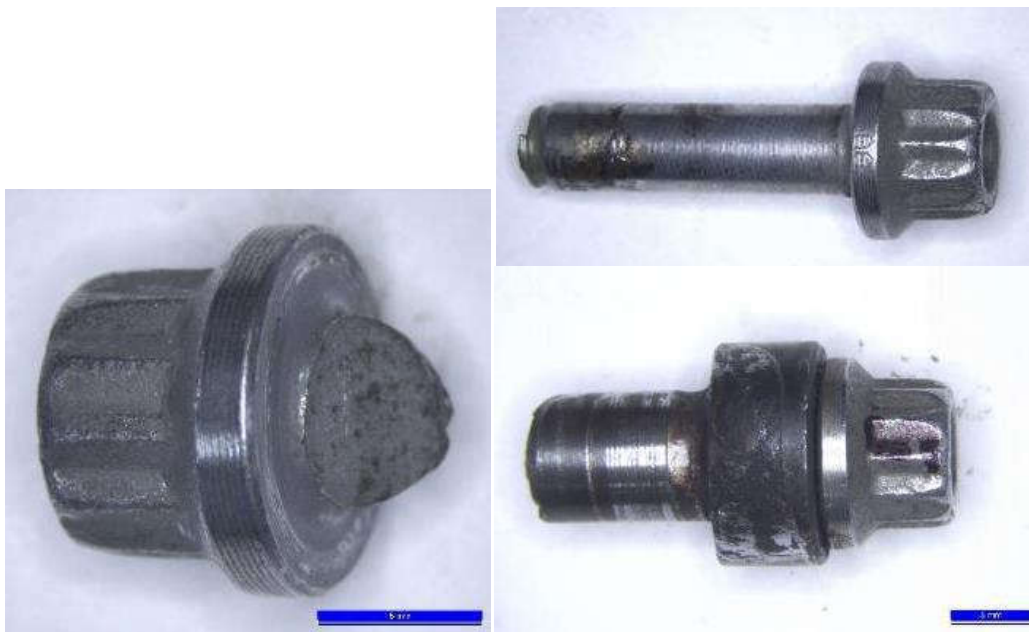
Figure 14 - Failed bolts, highlighting the location of failure i.e. fillet radius (left), threads (middle) and shank (right)

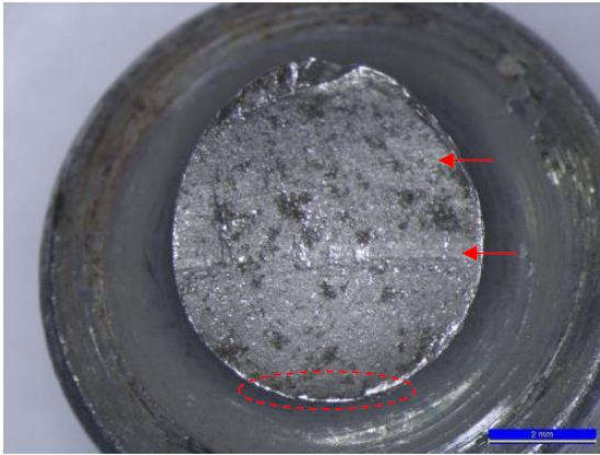
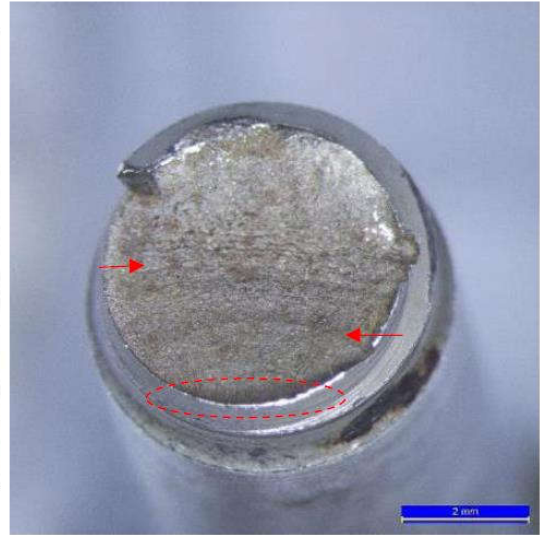
Figure 15 - Drive bolts located at no. 1 and 3 on the membrane pack, highlighting clamshell marks (red arrows) and the area of initiation (red circle).

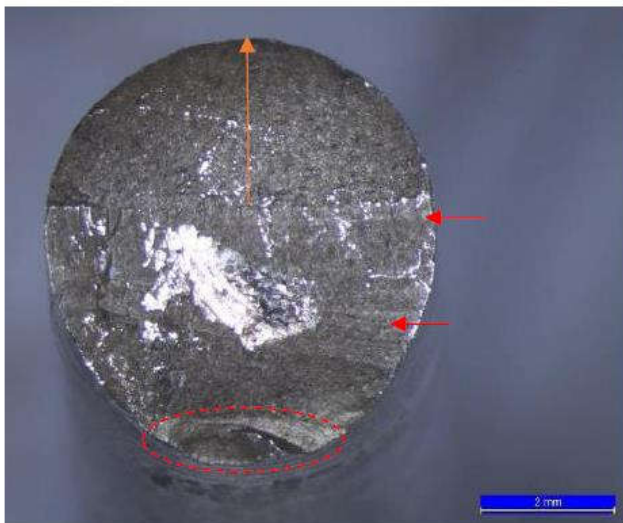
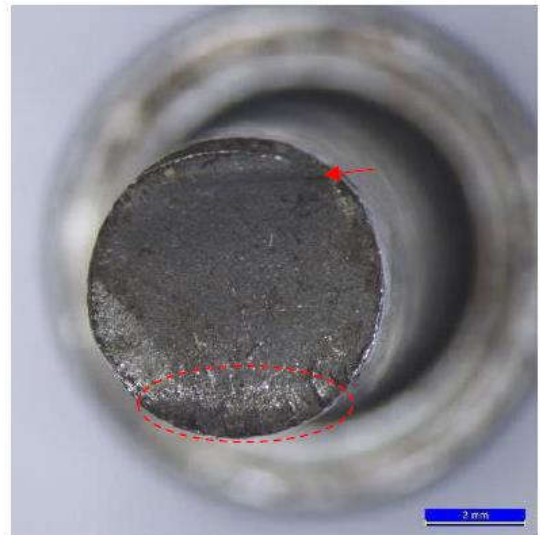
Figure 16 - drive bolts located at no. 2 and 5 on the membrane pack, highlighting the area of crack initiation (red circle) and clamshell marks (red arrows) which indicate fatigue crack propagation.

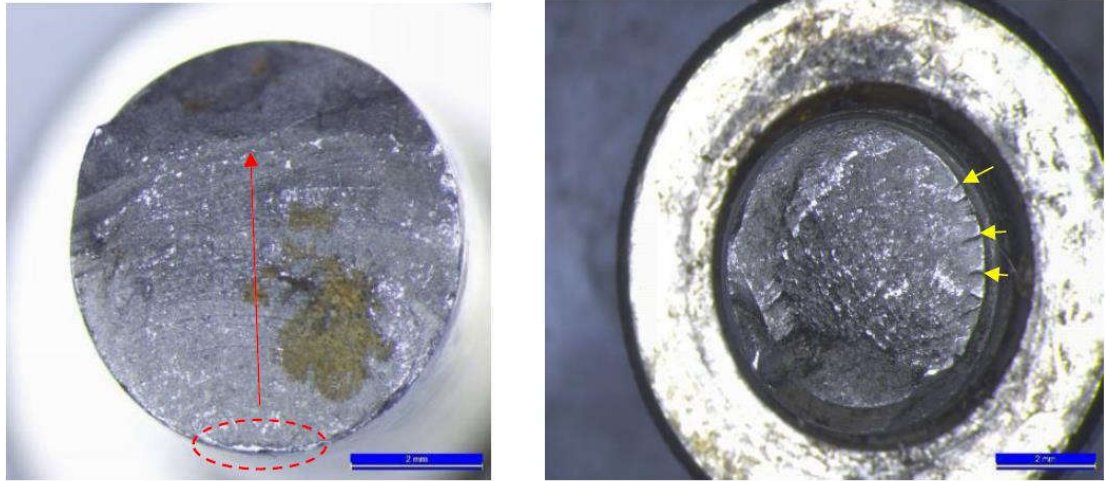
Figure 17 - Fracture surfaces of the failed bolts, highlighting i) fatigue crack propagation across the fracture surface and initiation area (red circle) and ii) ratchet marks (yellow arrows) indicative of high stresses at time of failure lab]
