What prompted the collapse of the Chirajara Bridge ?

Ing. JAIME SUAREZ DIAZ

**Why the pylon (tower)
failed at Chirajara?**

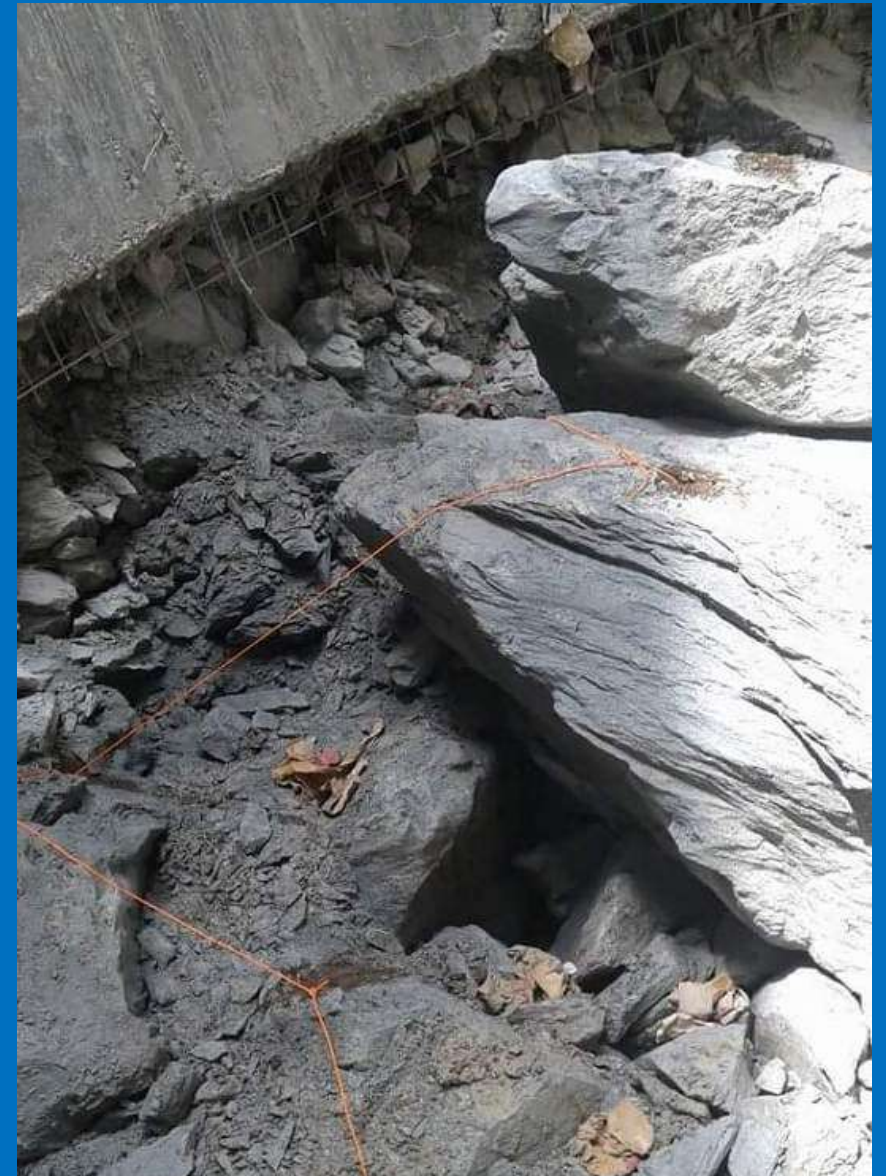
Phyllites and quartzite fractured and layered schists.

Colluvium Deposit 20 meters thick.

At the site of the right tower (the one that collapsed) exists a Colluvium deposit 20 meters thick.

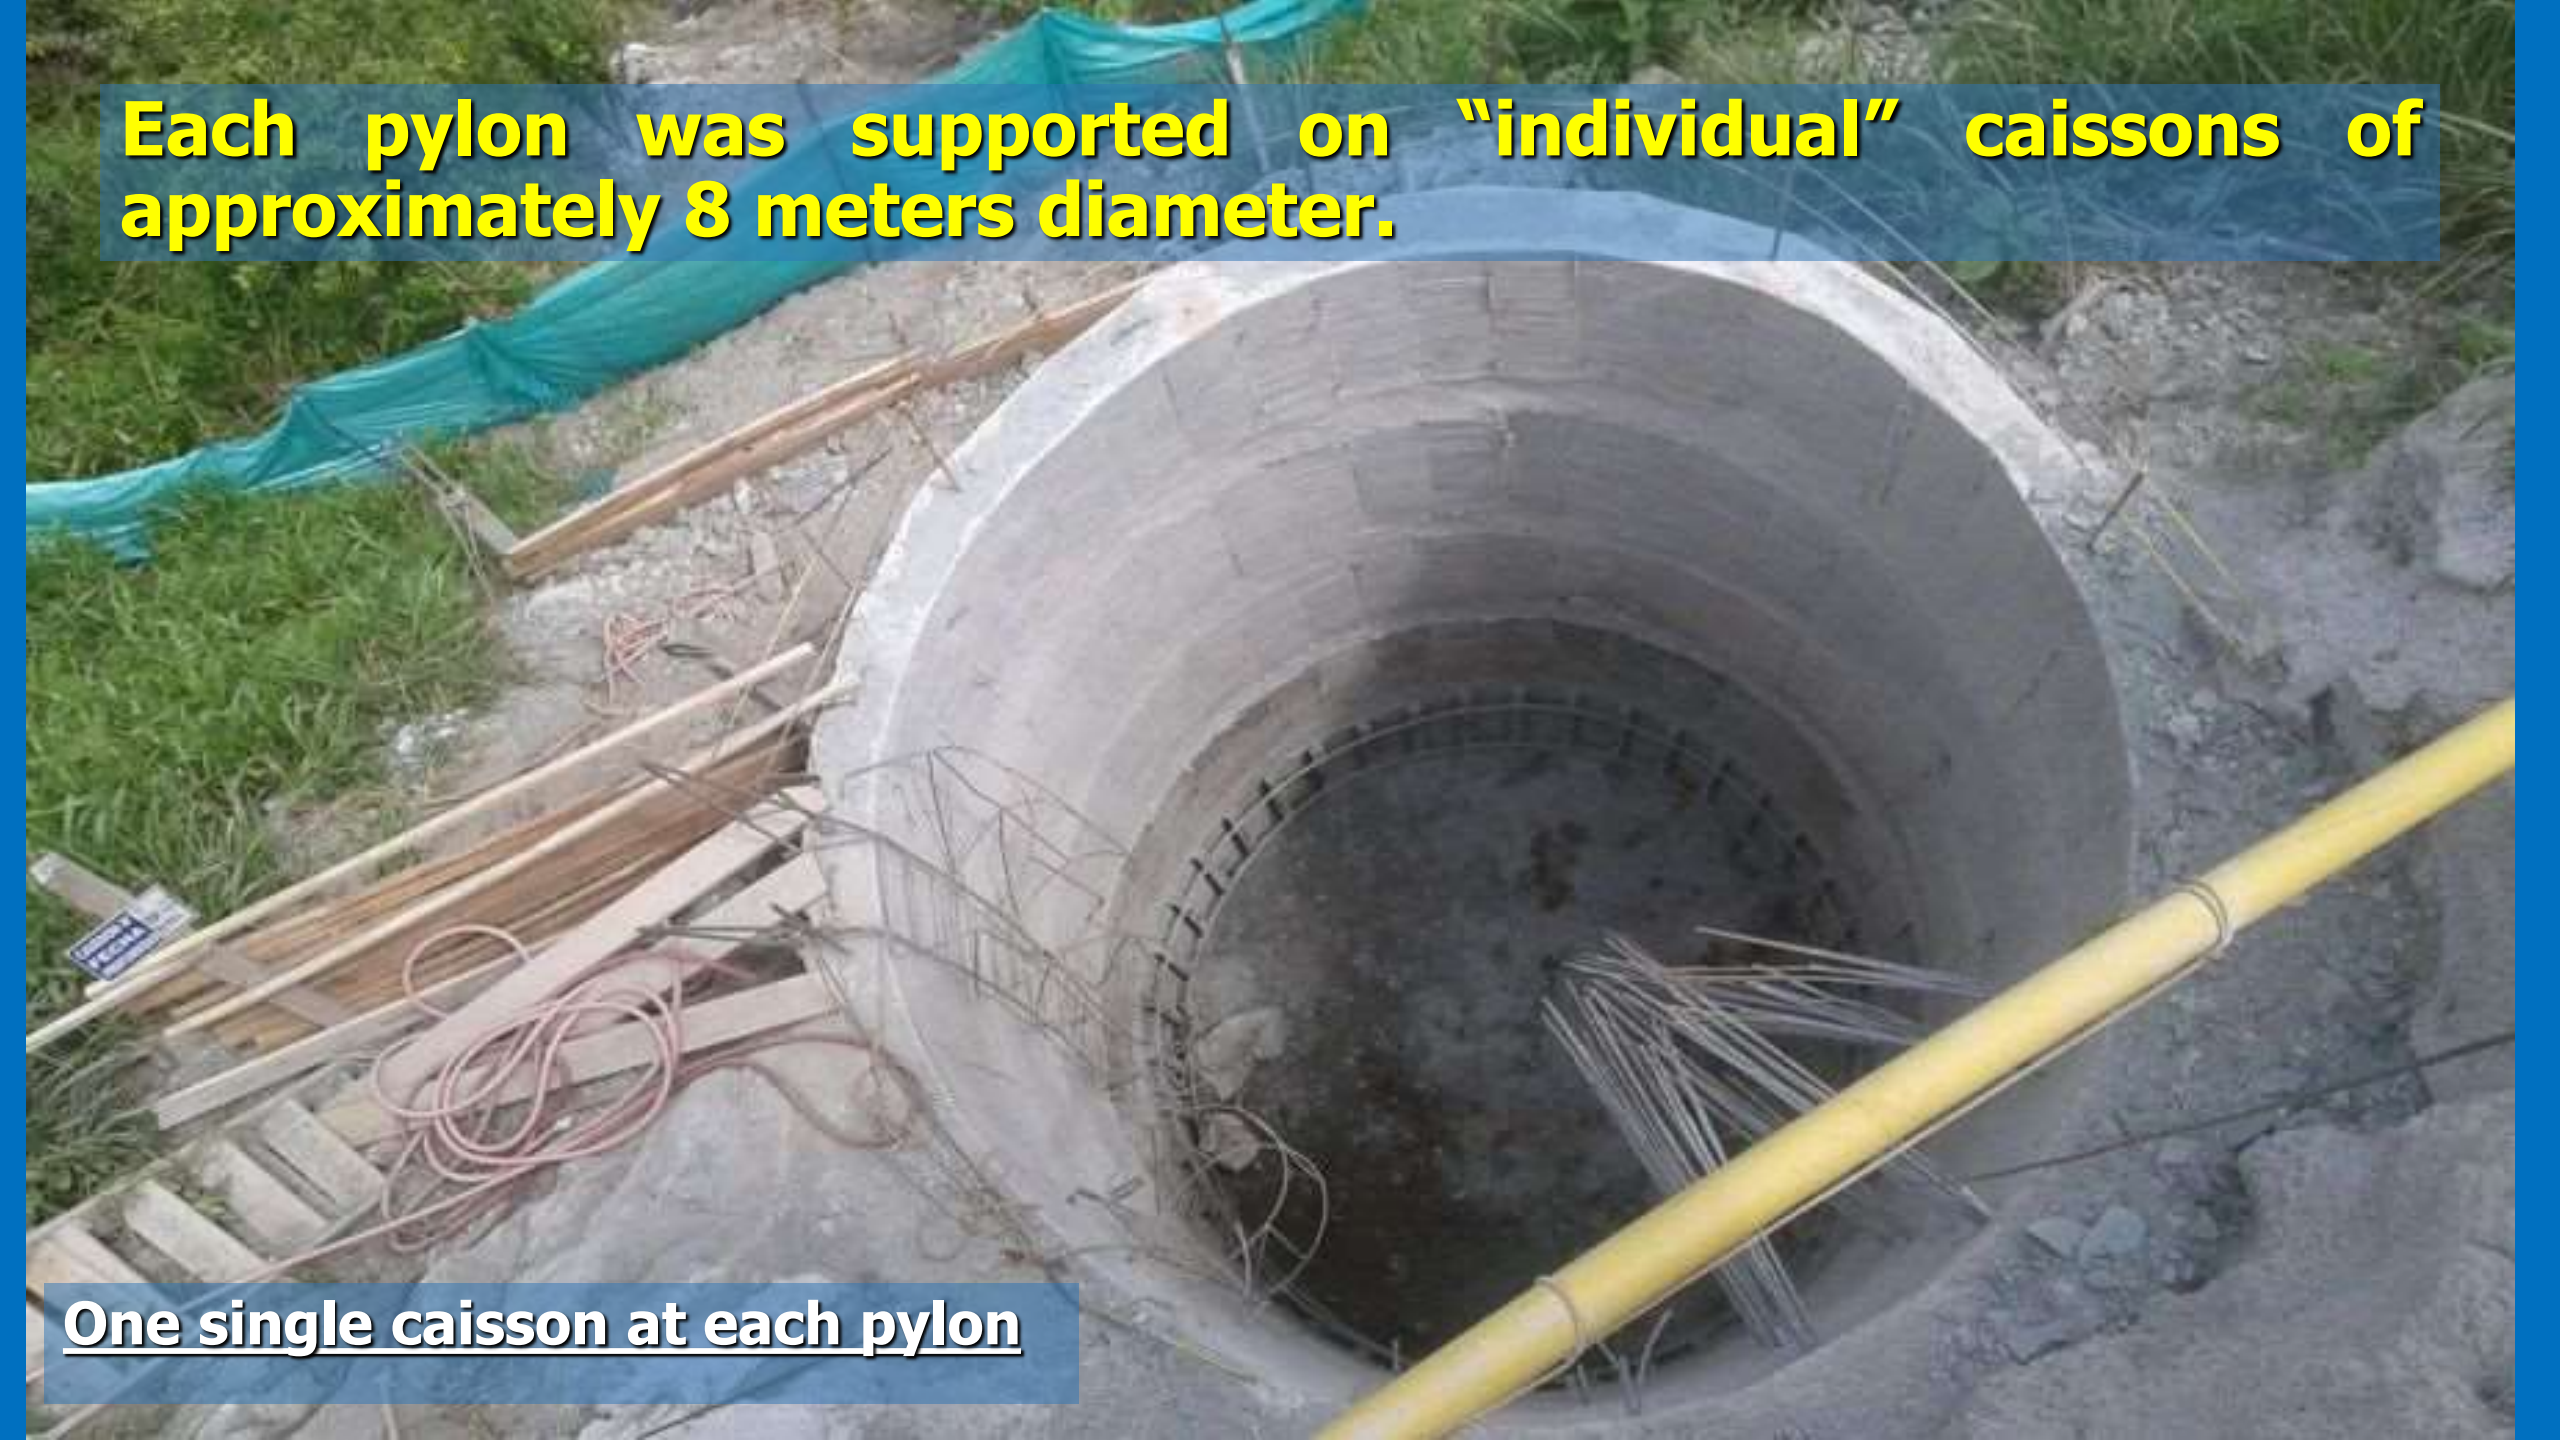
Each pylon was supported on "individual" caissons of approximately 8 meters diameter.

One single caisson at each pylon

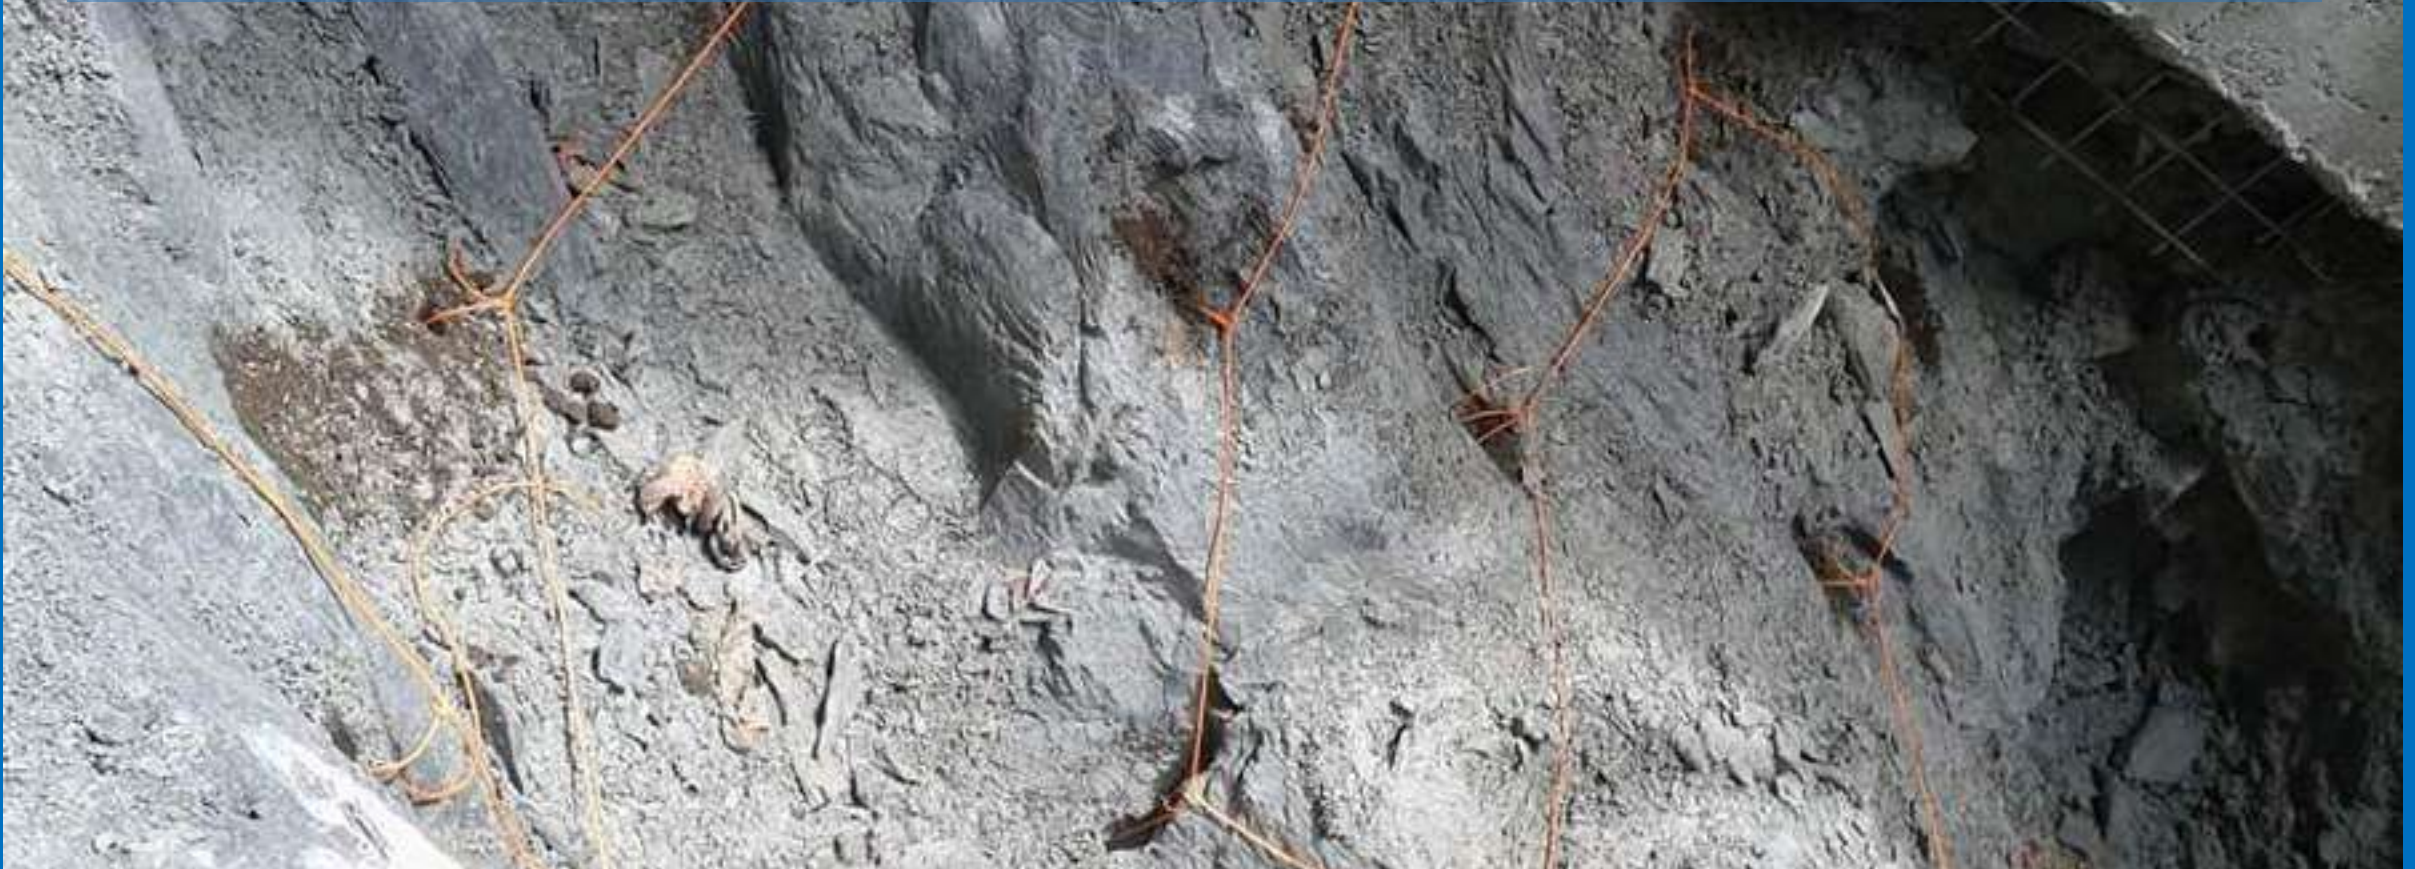
Explosives were used to advance the excavation of the caisson.

¿Could the use of explosives have affected the integrity of the phyllites and quartzites or the colluvium in the foundation?

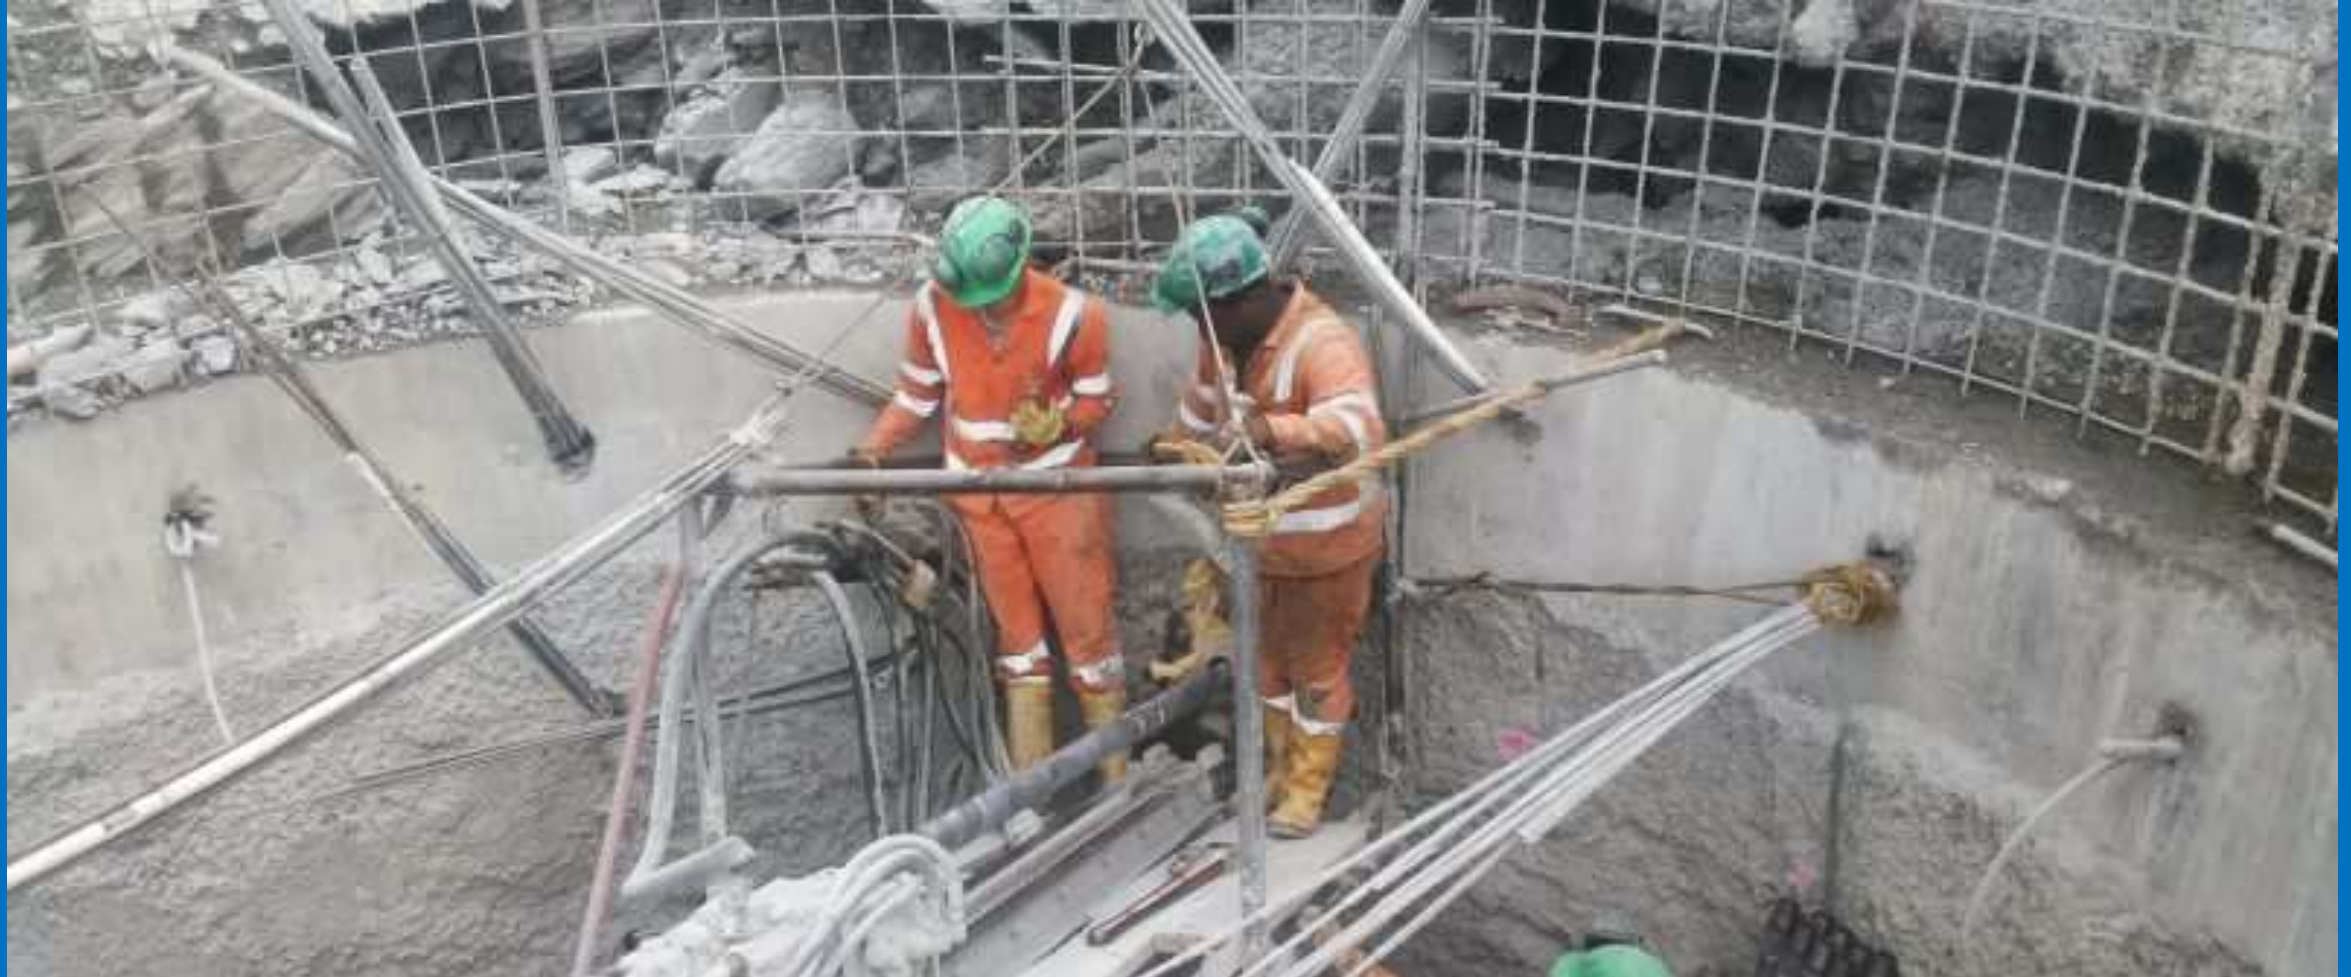
Tie-backs were installed at the top of the caisson into the hill slope.

To counteract the effect of the colluvium against the caisson 9 tiers of 50 tons nominal load/anchor, tie-backs were installed over the top 20 meters of the 32 meters deep hollow caisson.

The caisson works as a tie-back anchored bulkhead to retain the colluvium.

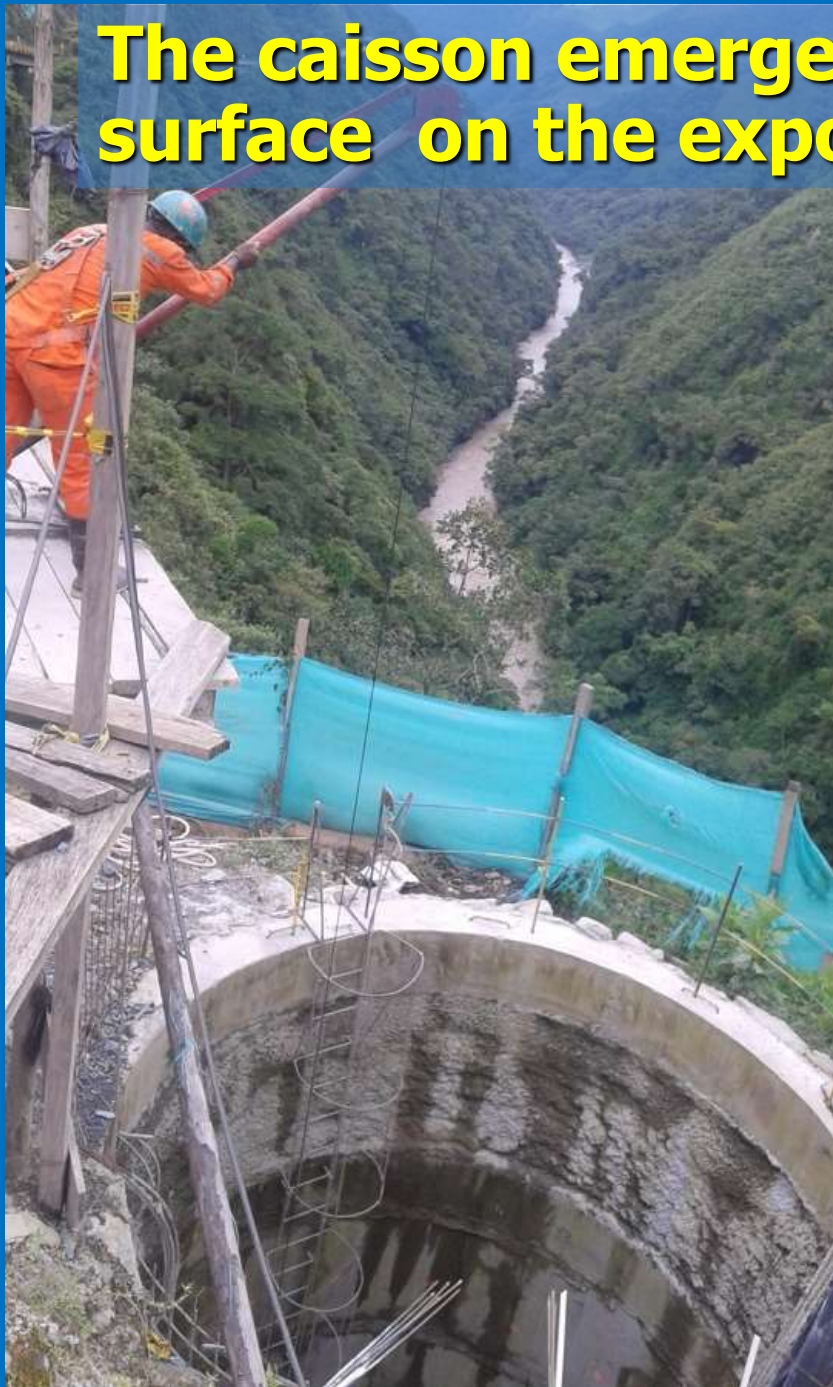
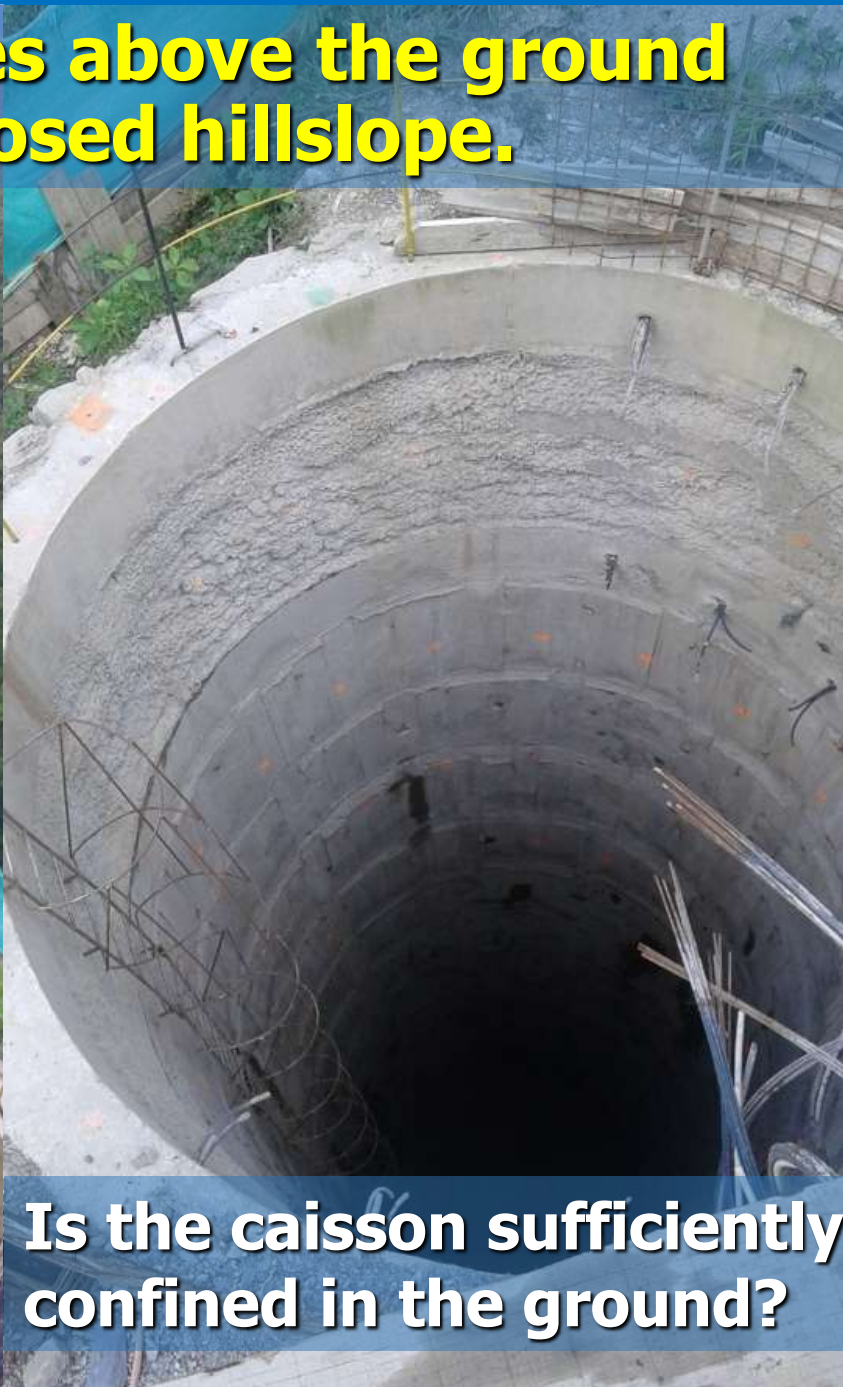
The caisson emerges above the ground surface on the exposed hillslope.

Is the caisson sufficiently confined in the ground?

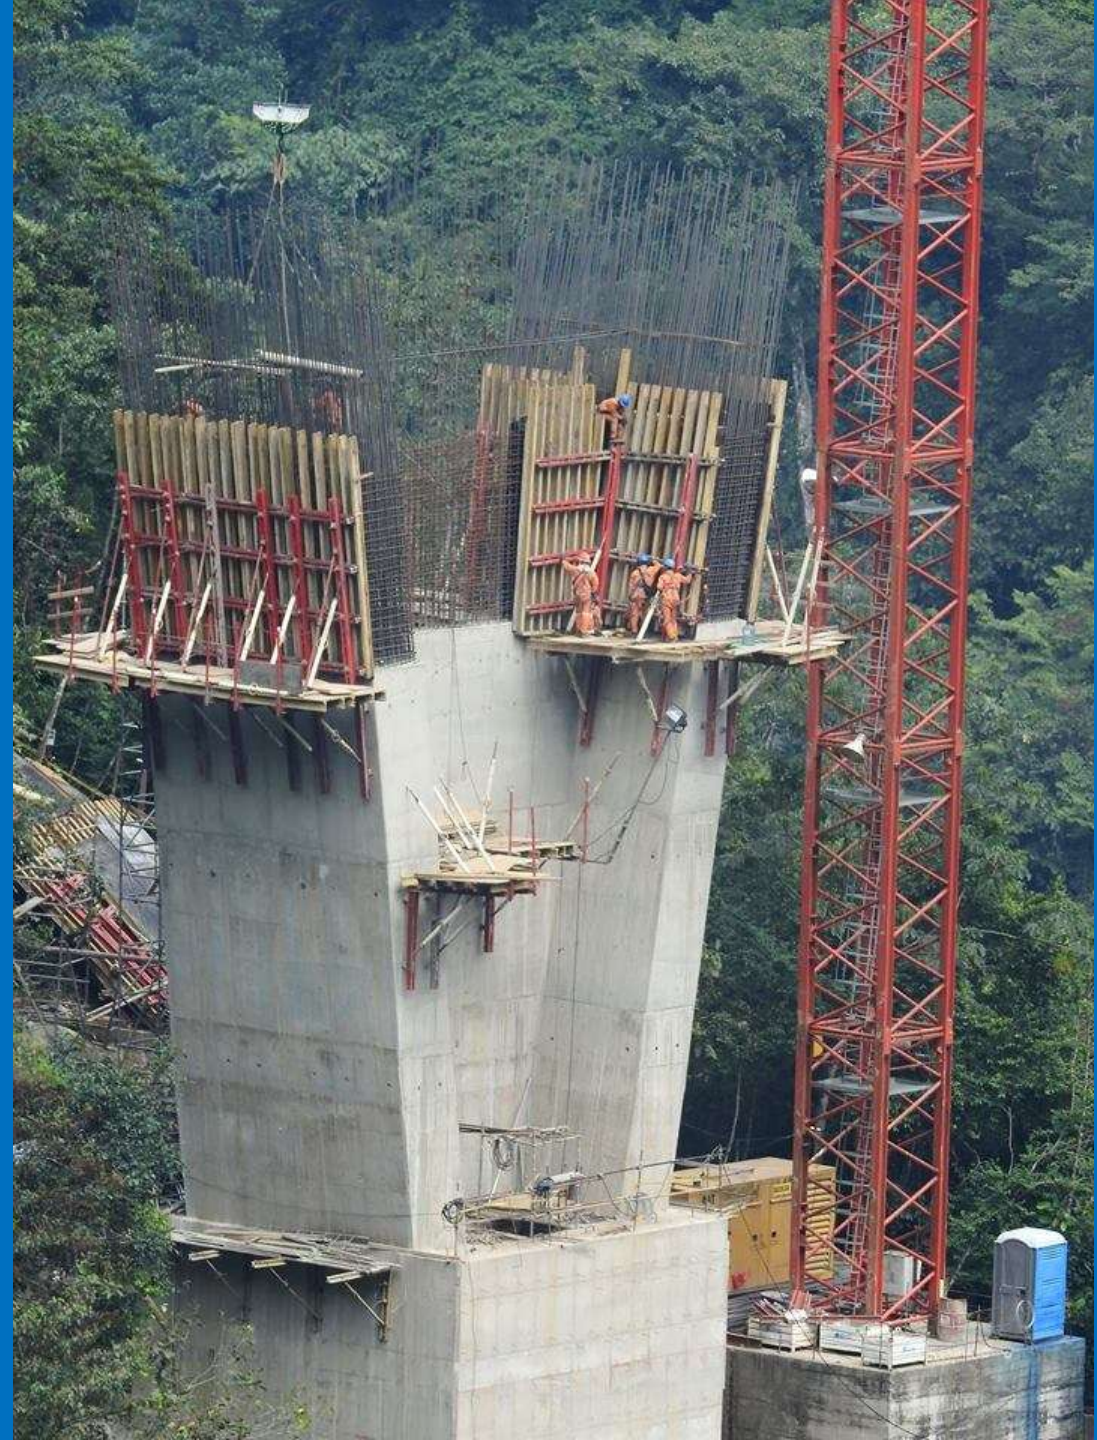
The individual caisson was capped with a cube block and a diamond and pencil tip shaped pylon.

The cube cap of the single caisson was built unconfined above the ground surface.

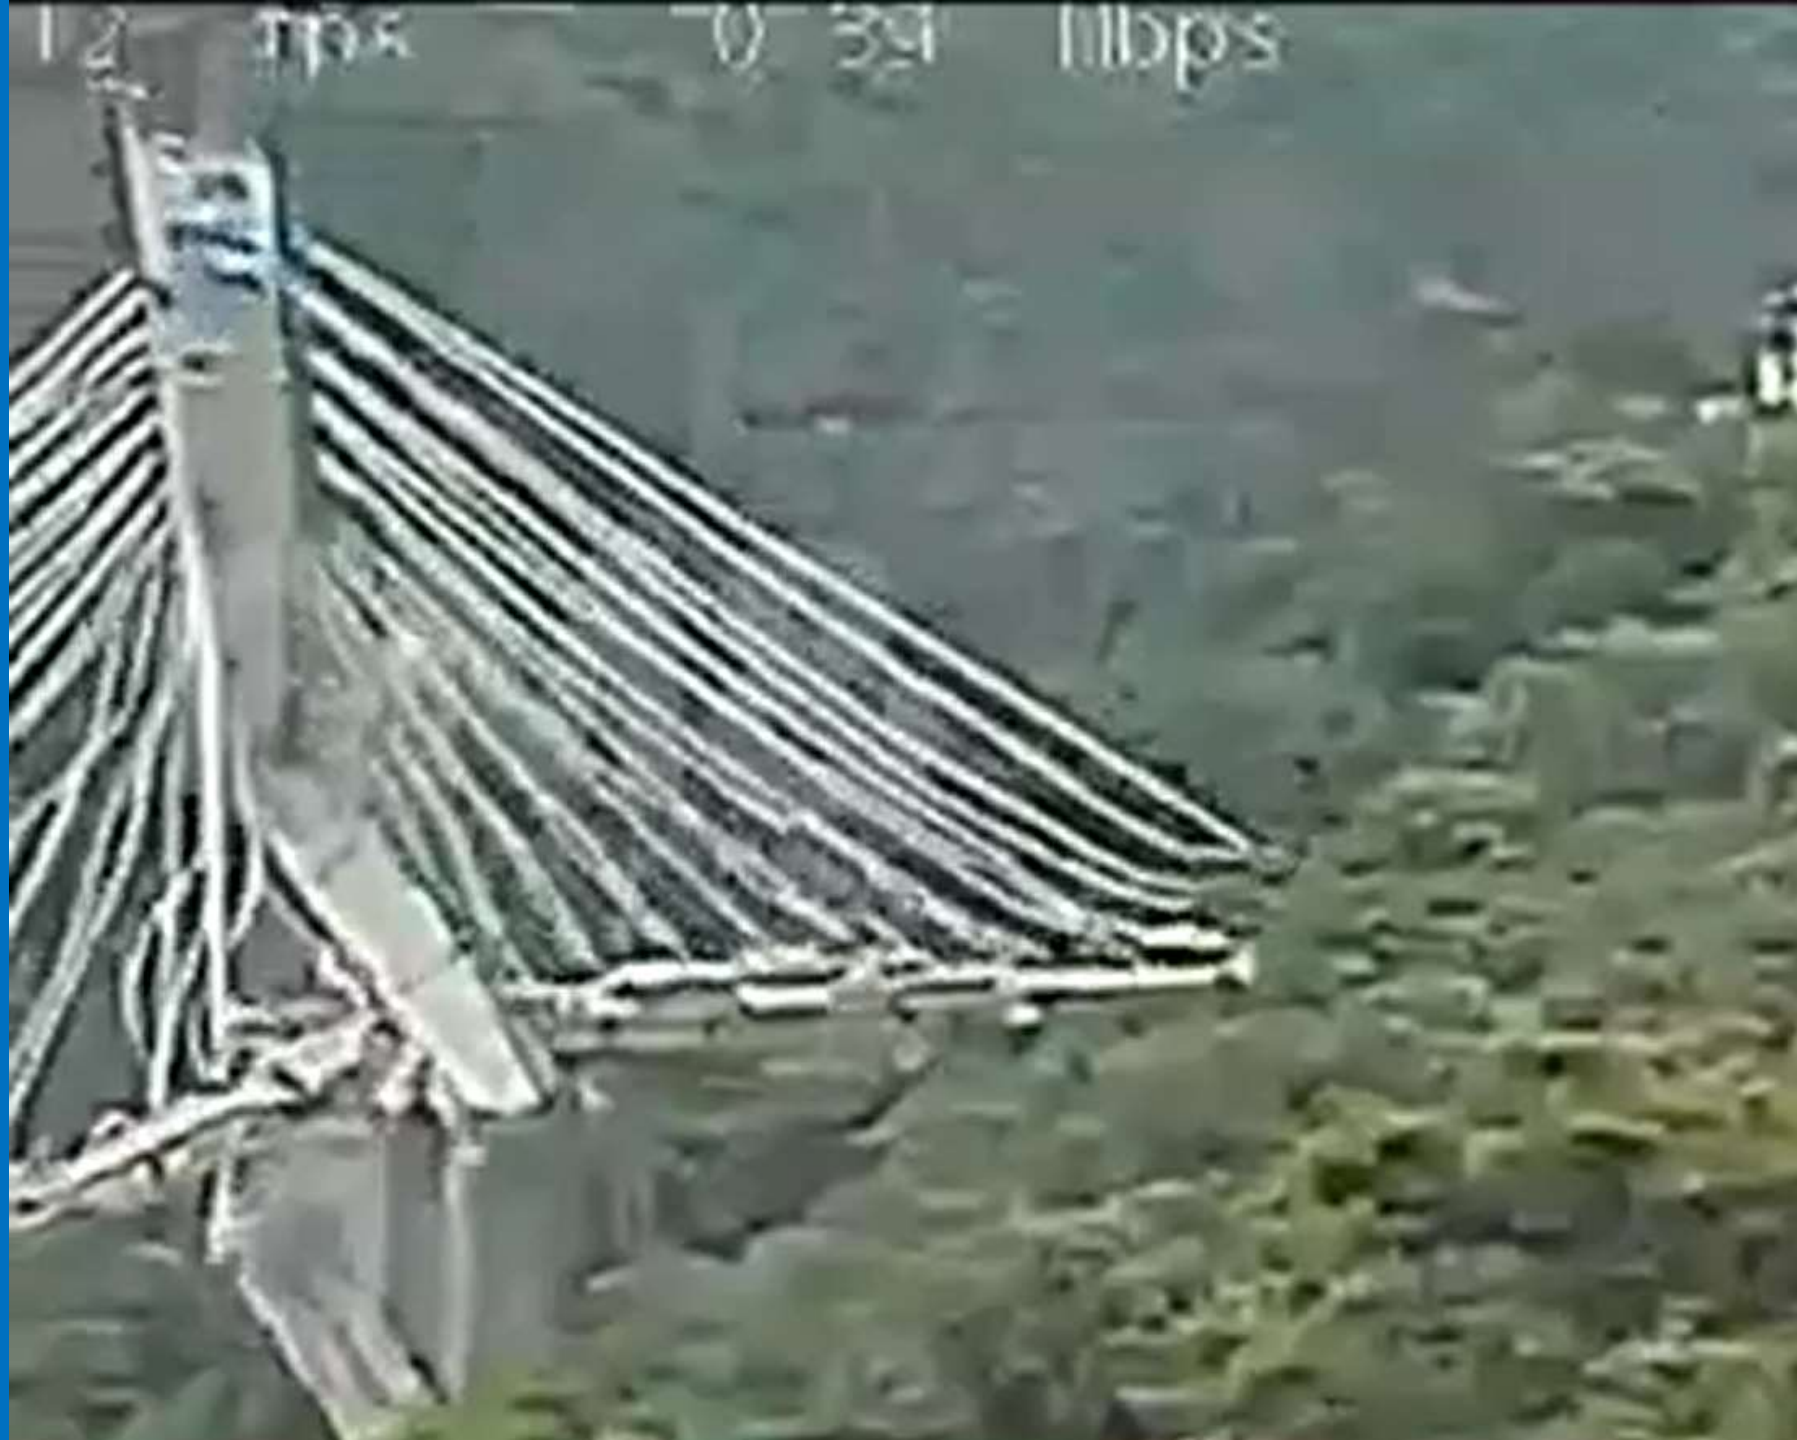
Bending moment failure at the joint between the column and the cube caisson cap.

Failure point at the toe of the pylon.

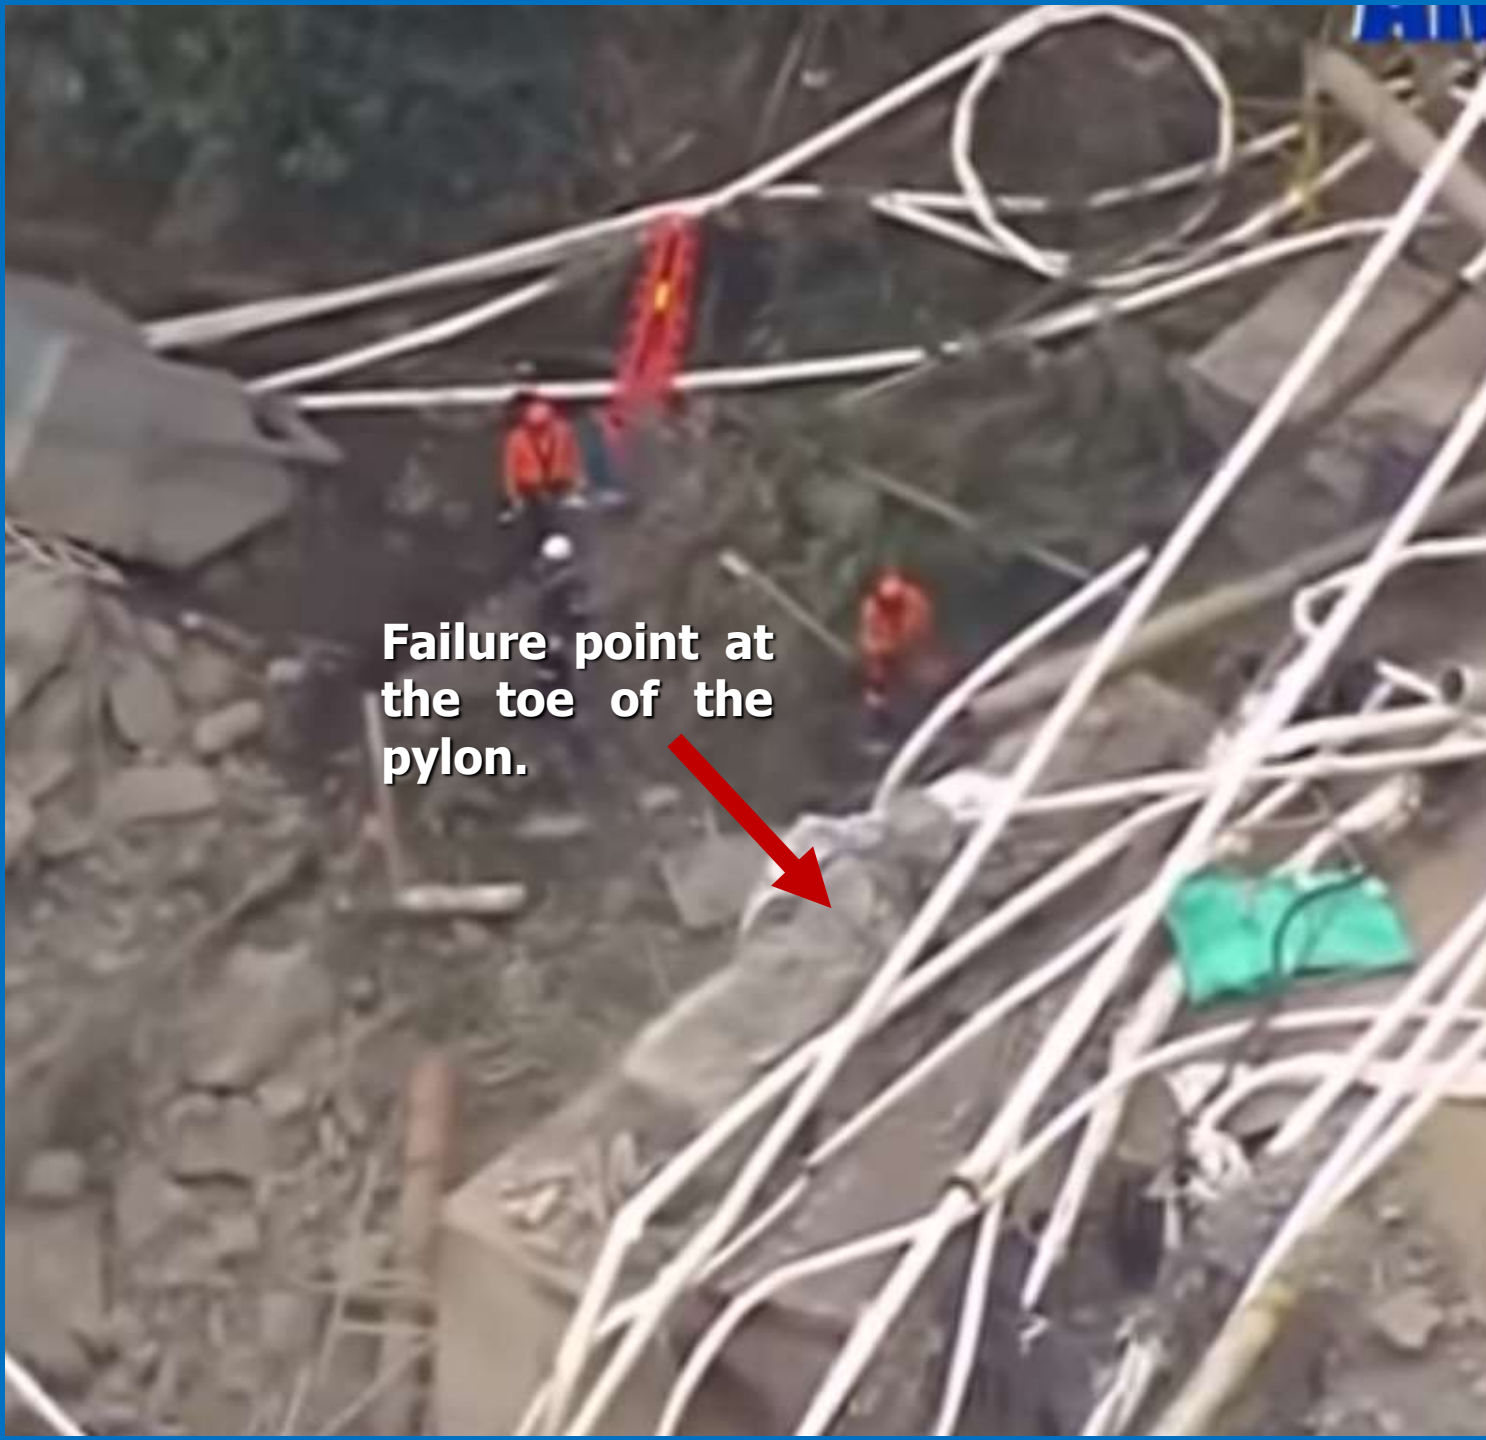
**Failure point at
the toe of the
pylon.**

**There is no visual
evidence of any
movement of the
foundation. However,
it is not known if any
displacement of a few
centimeters may have
occurred.**

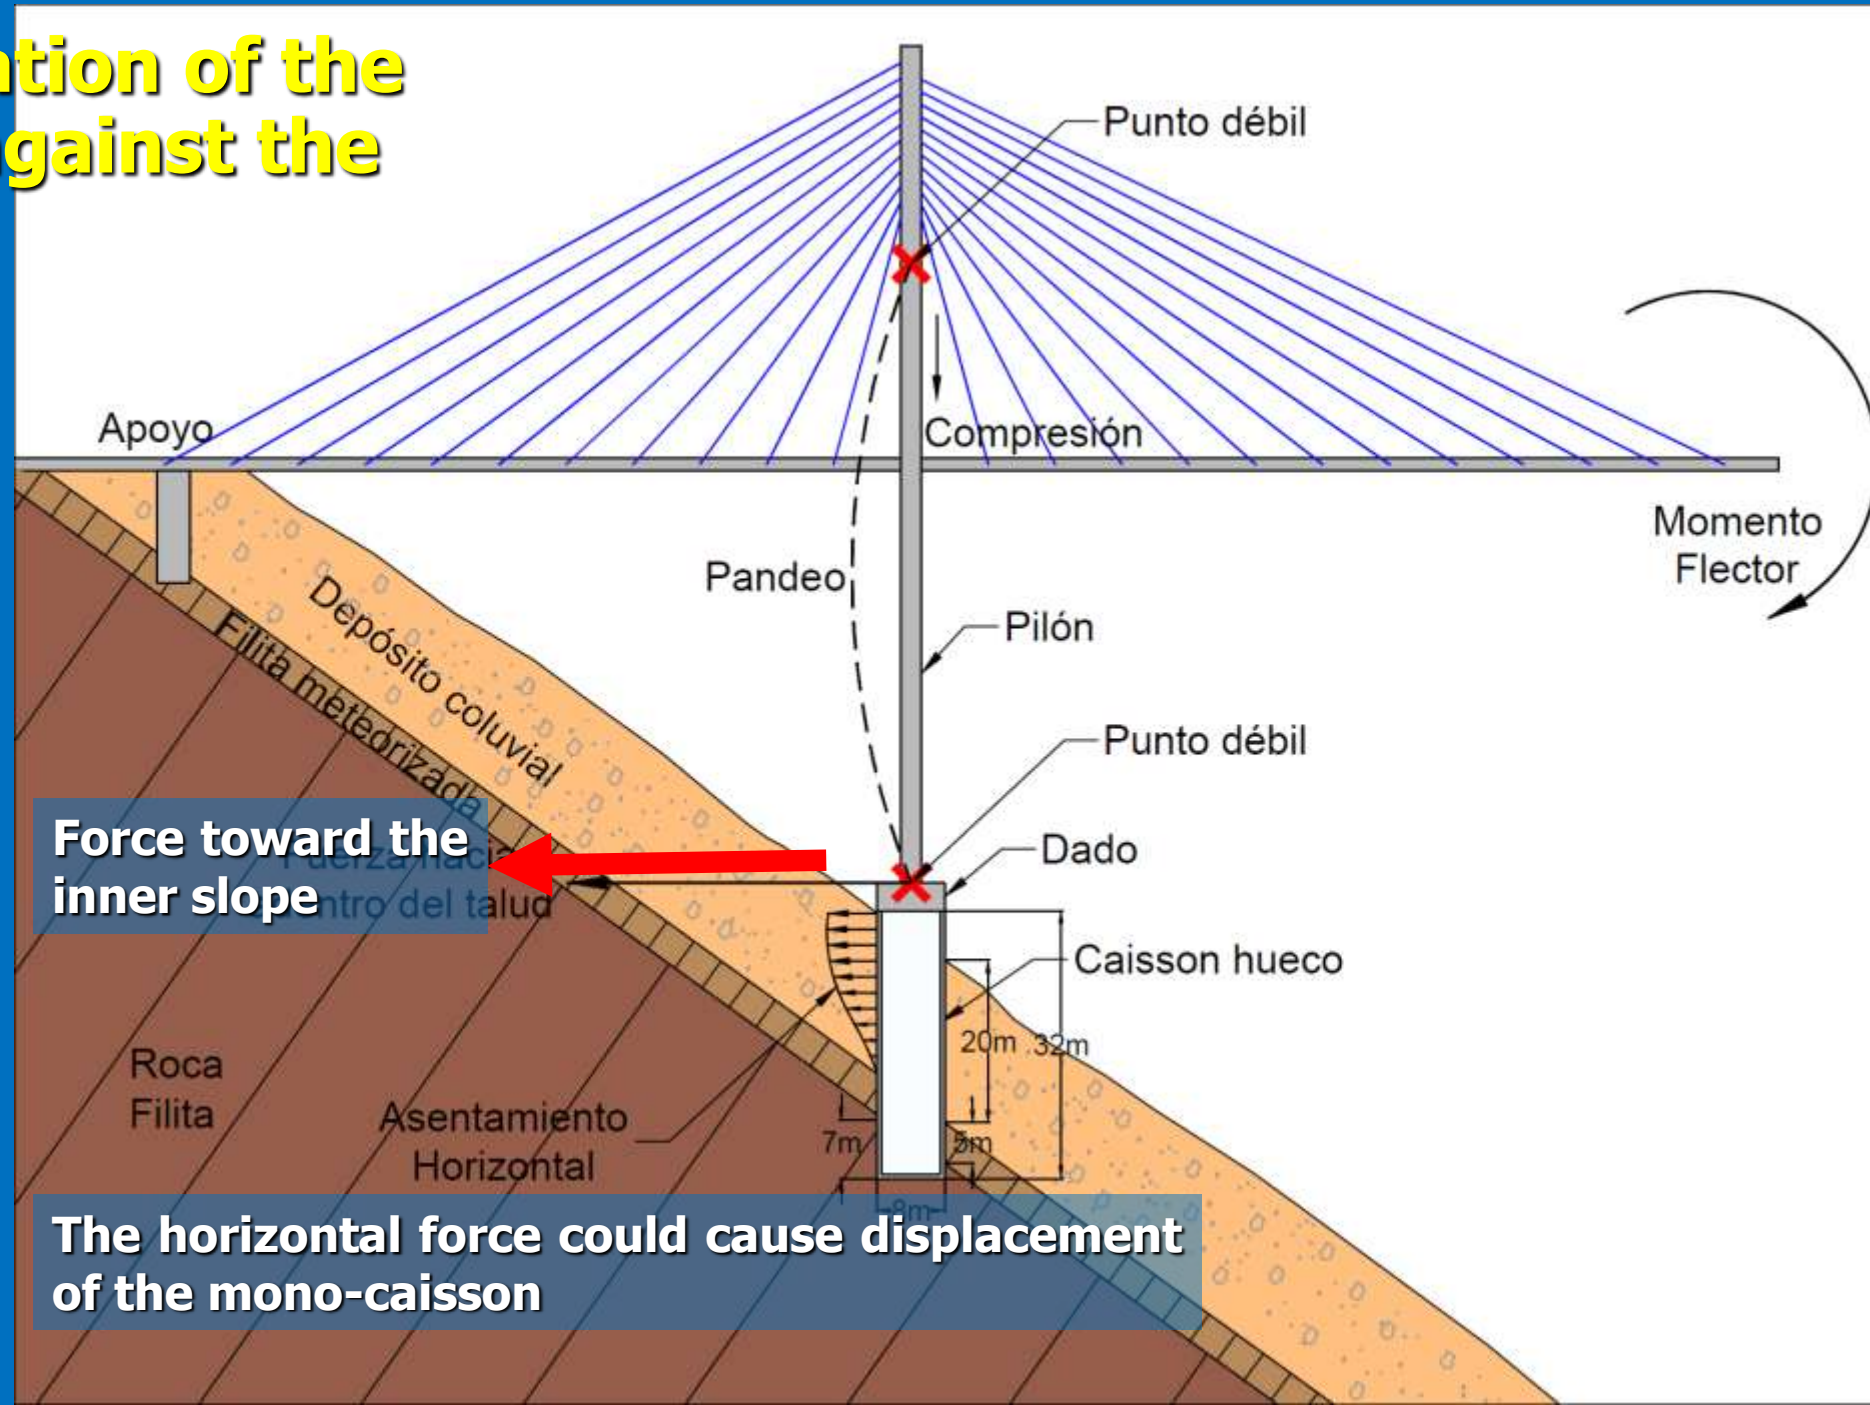
The bending moment generates a horizontal force at the semi-rigid point of the joint between the pylon and the foundation

Force toward the inner slope

The horizontal force could cause displacement of the mono-caisson

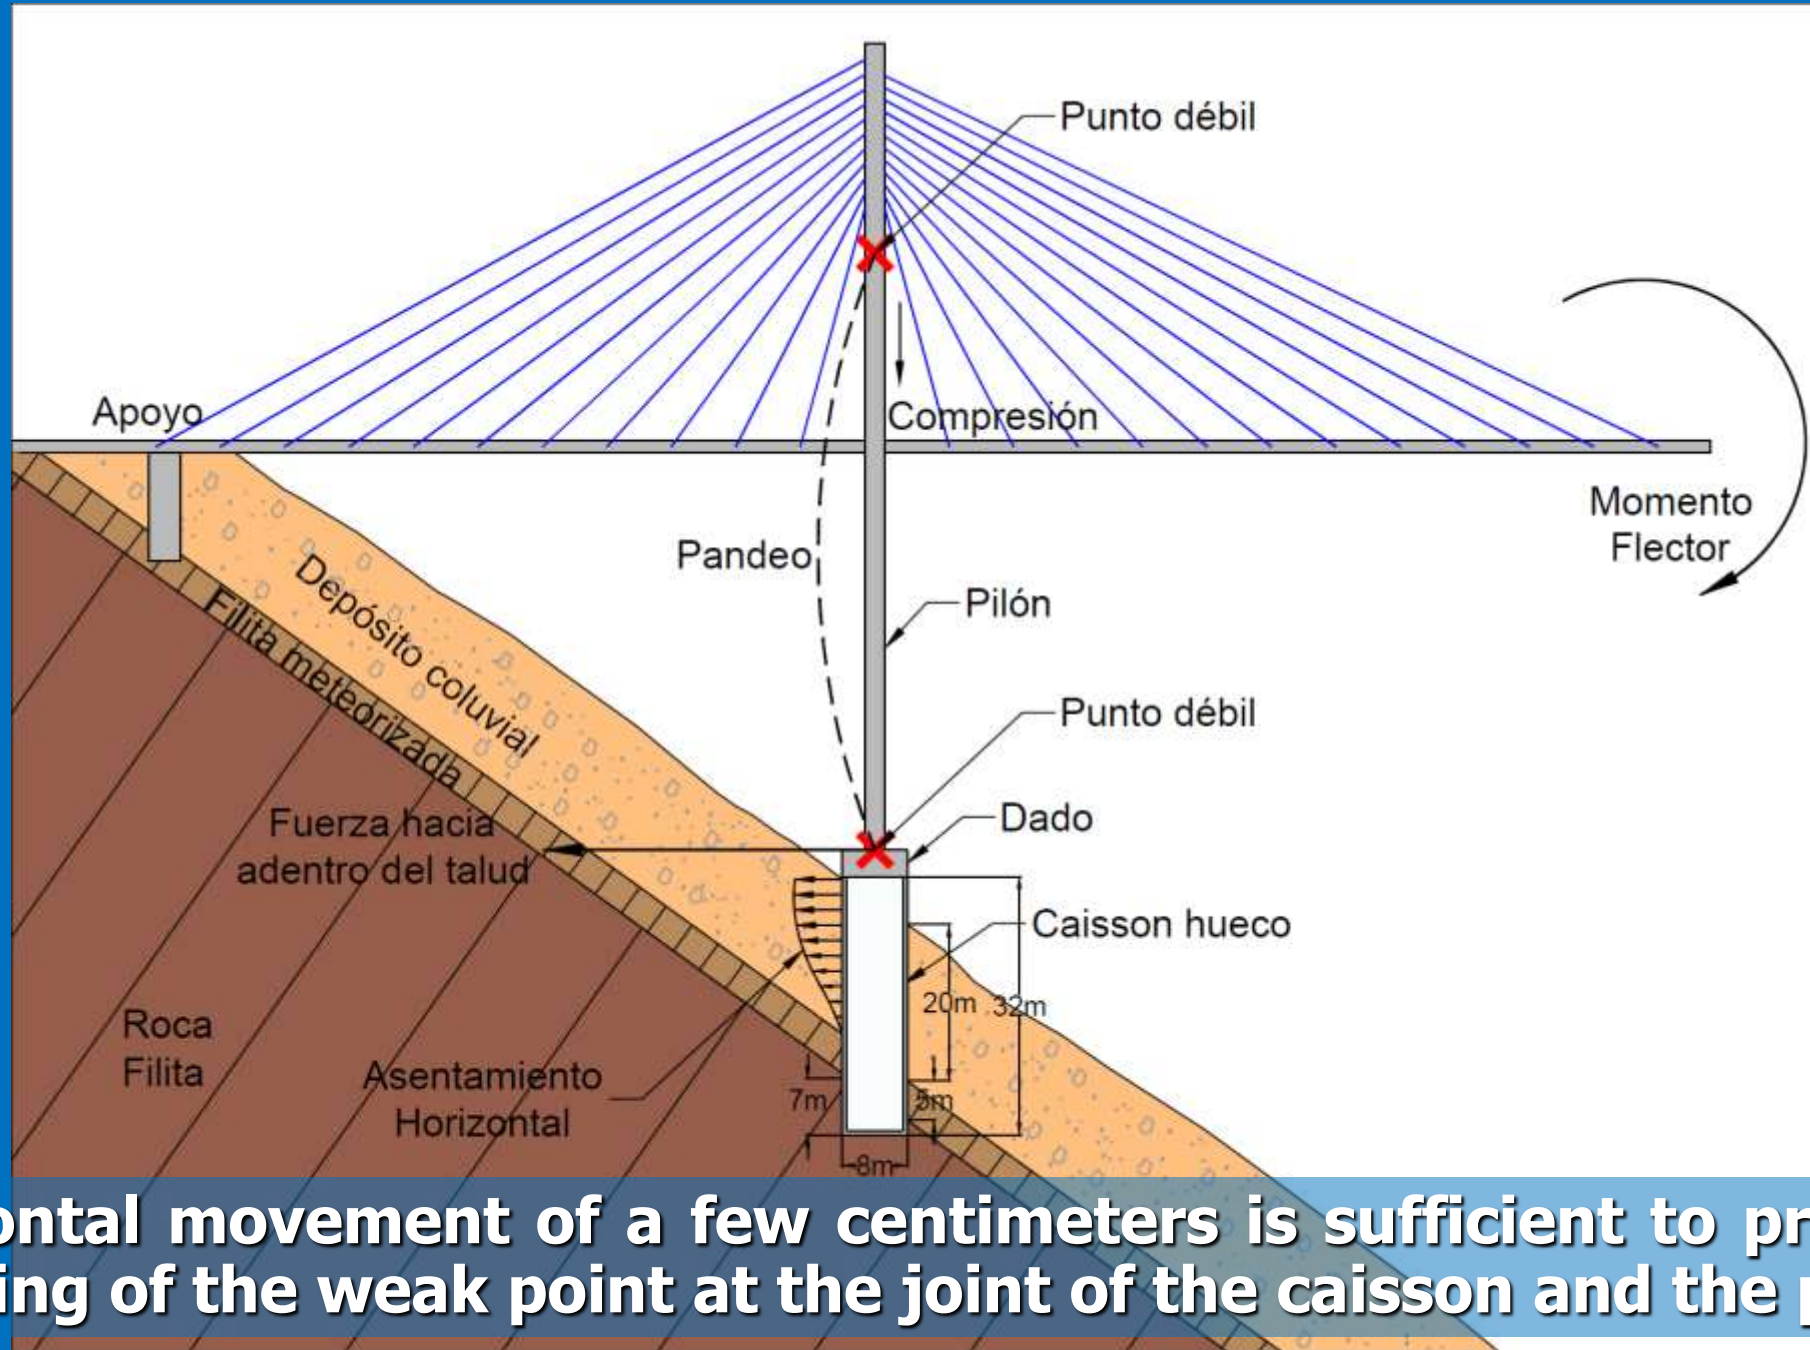
Horizontal movement of a few centimeters is sufficient to produce the breaking of the weak point at the joint of the caisson and the pylon.

The assumption of a possible movement of the foundation could be challenged or confirmed if an investigation of the top tiers of tie-backs indicates loss of tension.
