What prompted the collapse of the Chirajara Bridge ?

Ing. JAIME SUAREZ DIAZ

**Why the pylon (tower)
failed at Chirajara?**

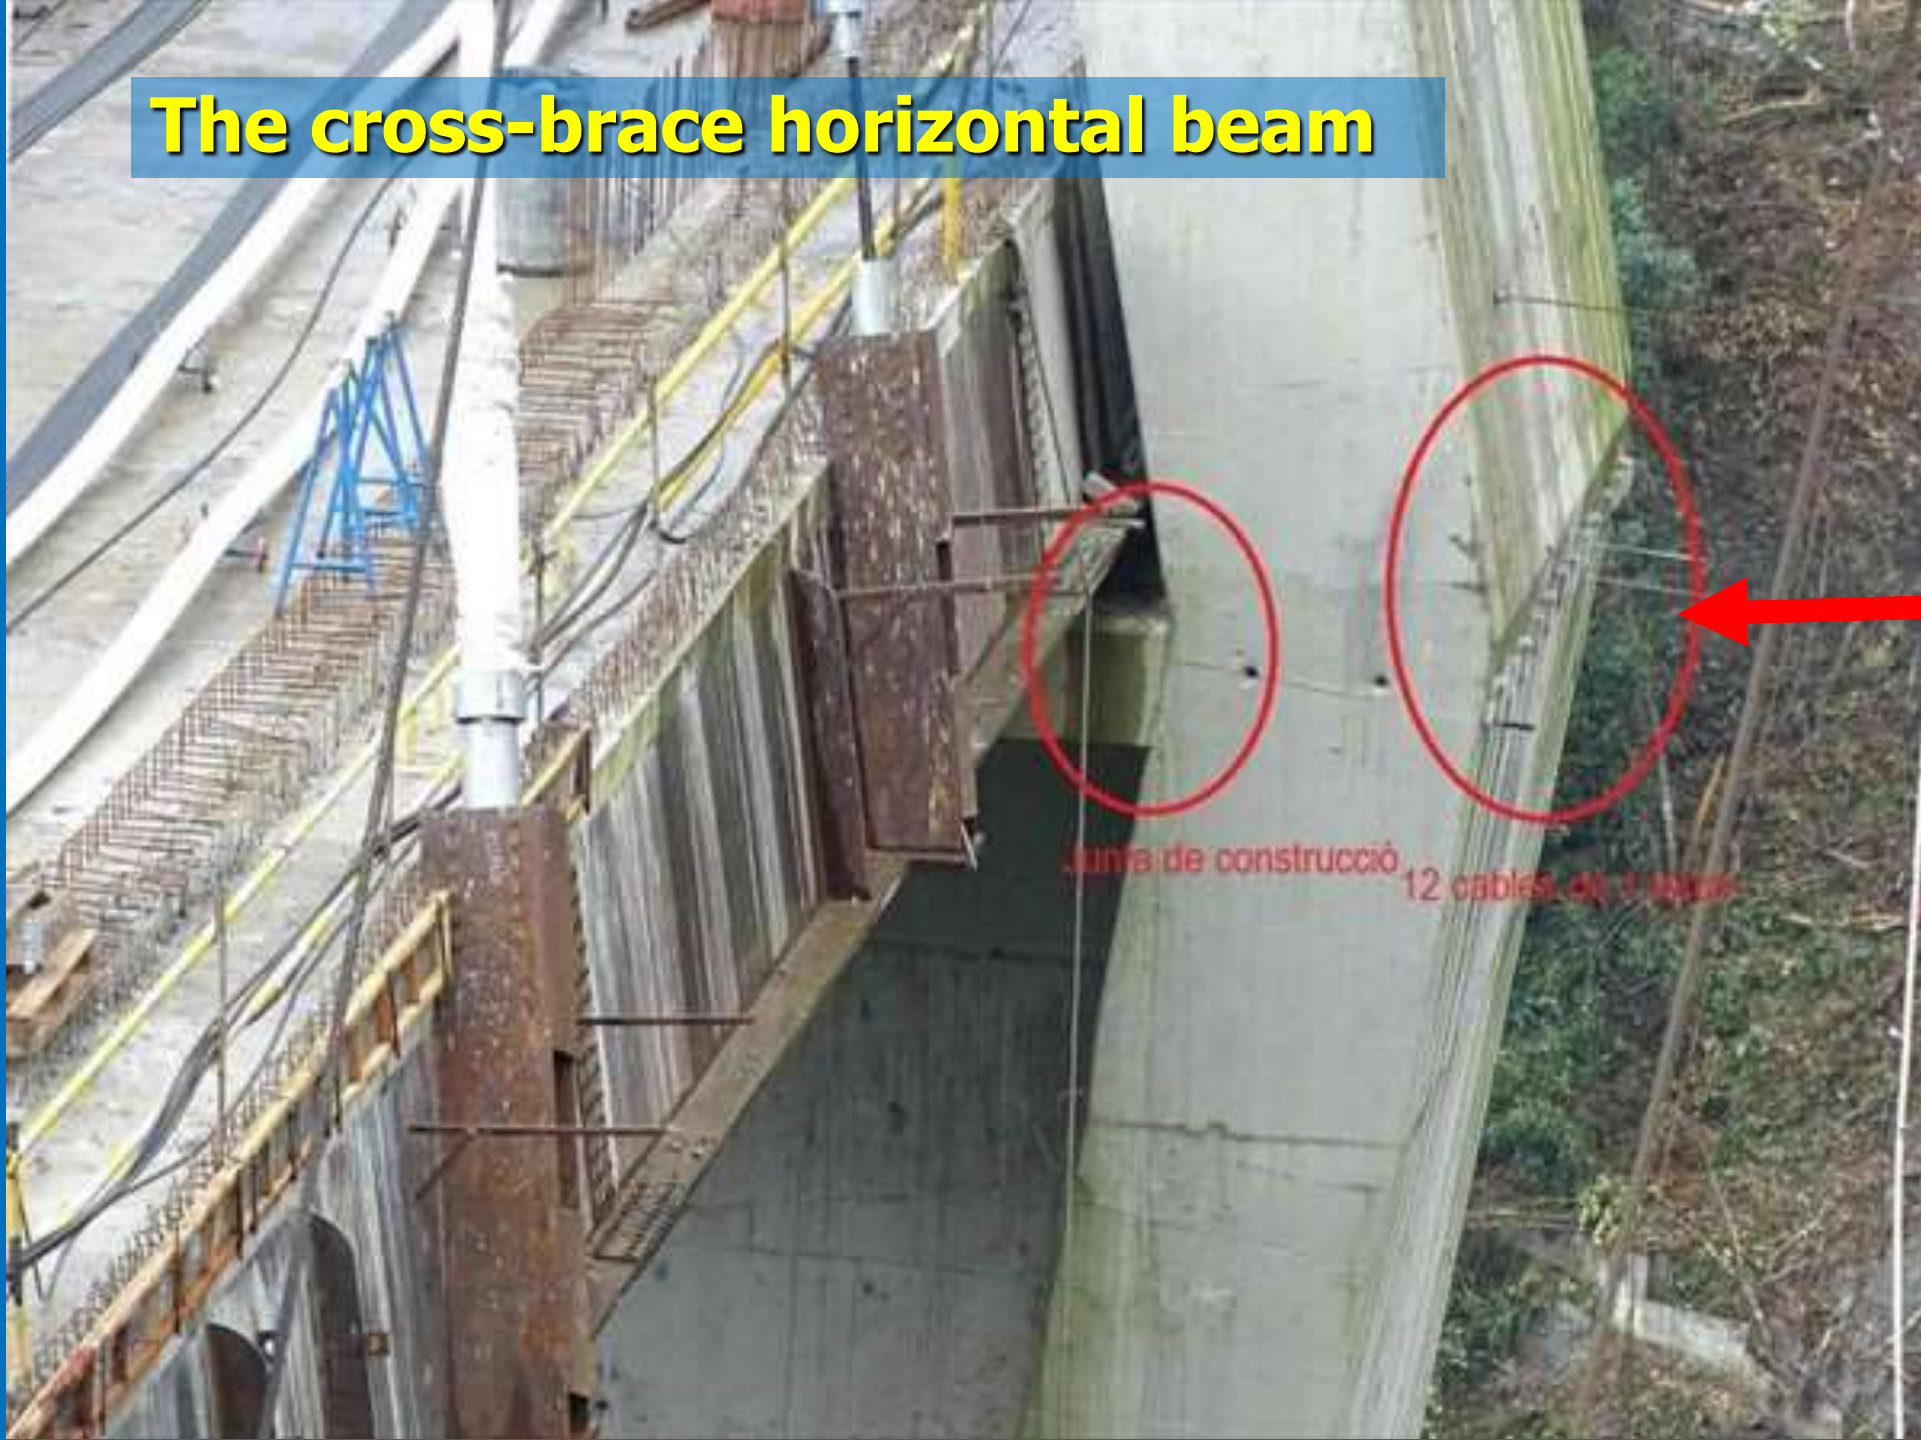
The cross-brace horizontal beam

Horizontal reinforcement cables

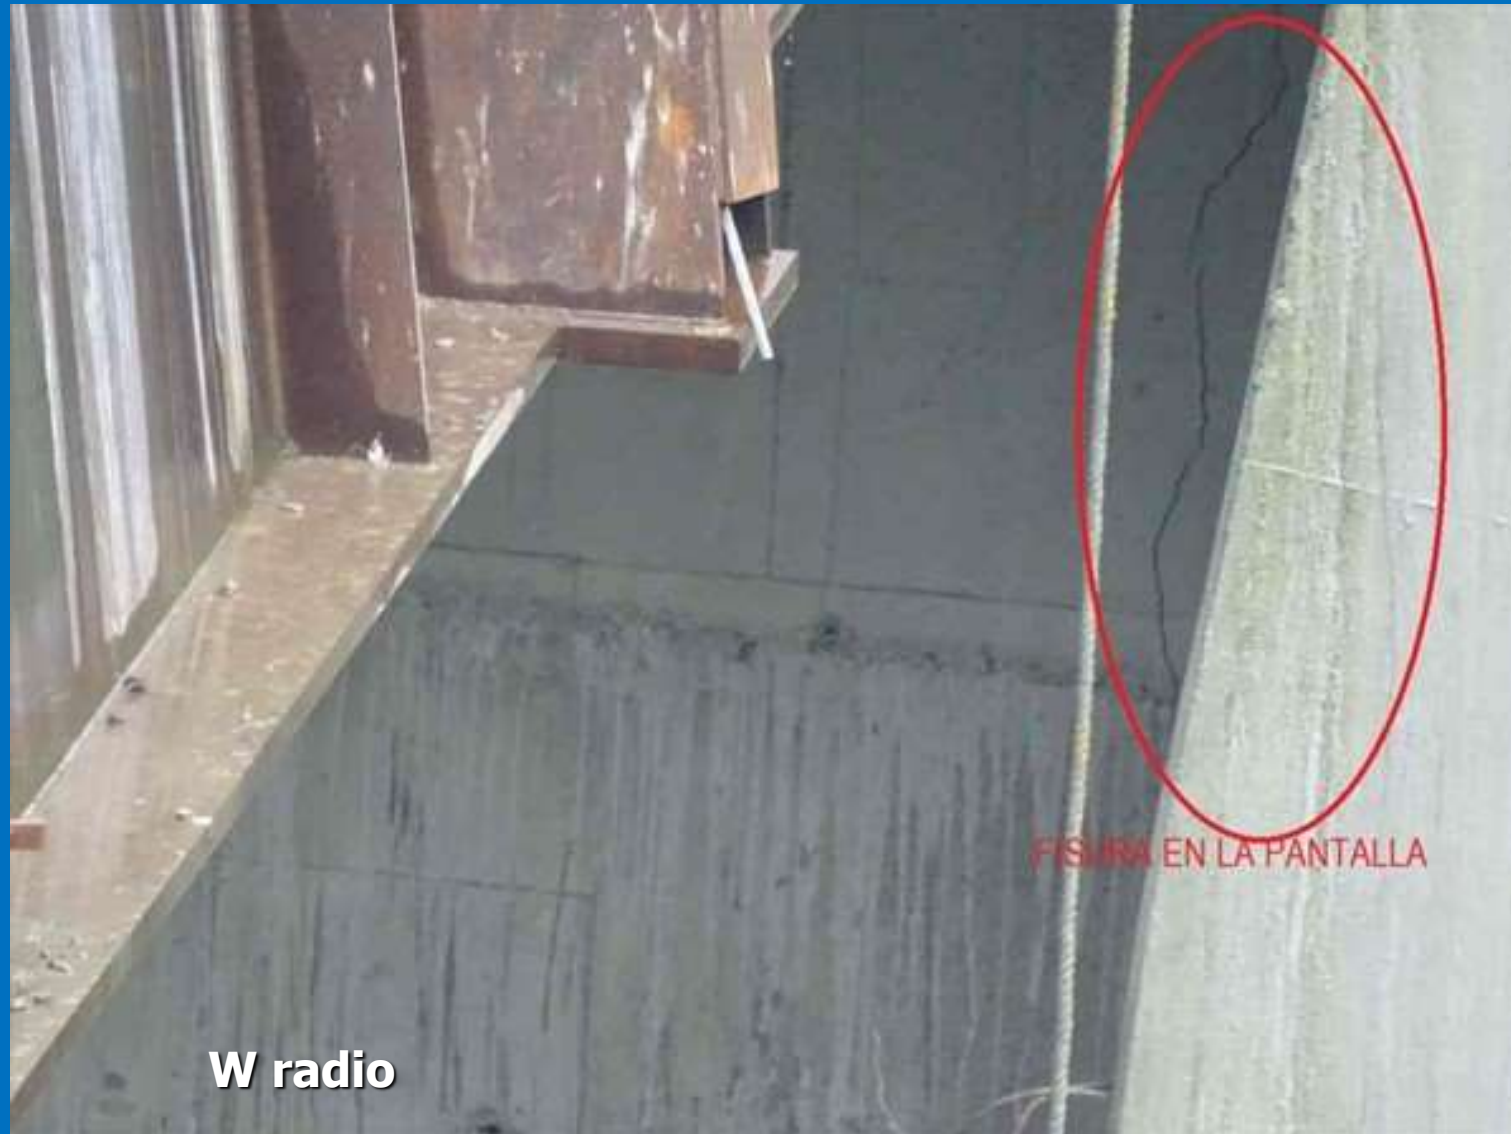
Fracture in the vertical diaphragm wall of the existing pylon

FISURA EN LA PANTALLA
