# Why Do CPVC Pipes Fail?

*By Dr. Duane Priddy, Plastic Failure Labs, Midland, MI*

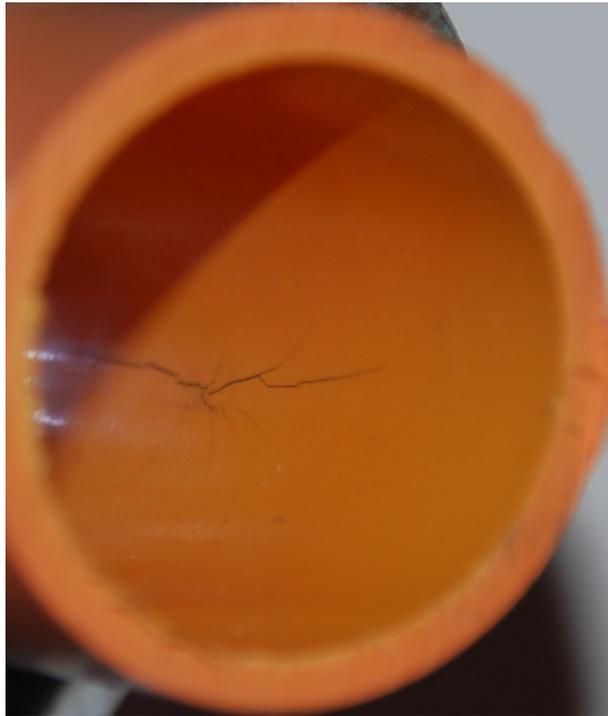
**Figure 1.** Environmental stress-cracks on inside of CPVC pipe

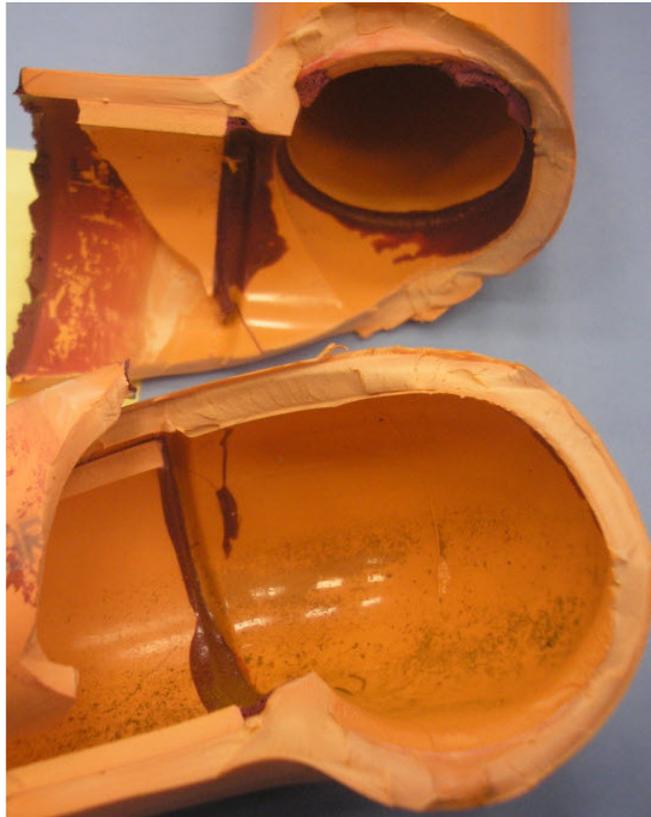
**Figure 2.** Disintegrated CPVC elbow caused by over-pressurization.

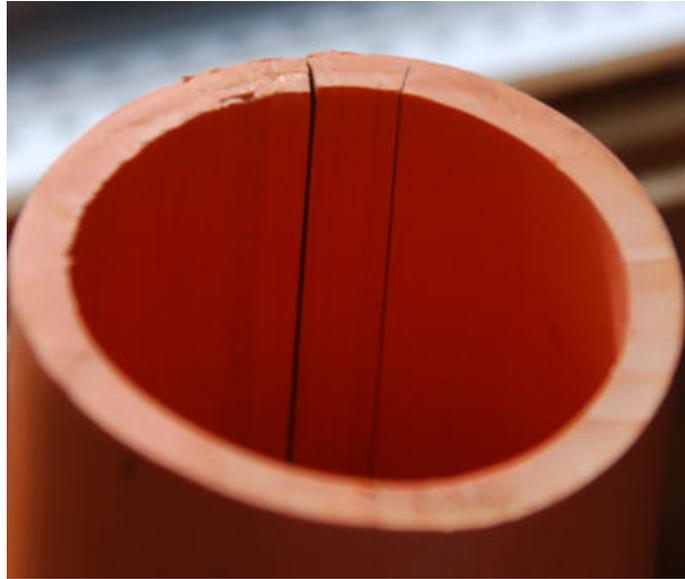
environmental stress cracking (ESC). Cracks originating from the knit lines appear as straight-line cracks running longitudinally and parallel down the pipe (Figure 3) and they display no single initiation point.

**Figure 3.** Weak extrusion knit-lines on the inside surface of a CPVC sprinkler system pipe resulting in the formation of perfectly parallel straight line cracks upon exposure to contaminants

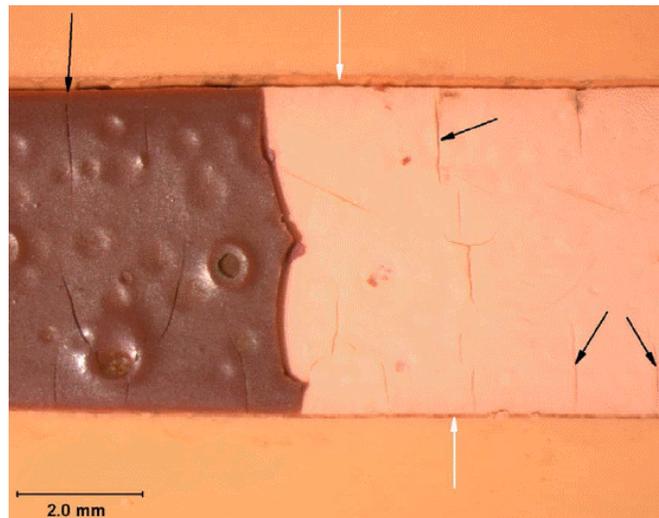
dribble is a spongy material and it serves as a place where contaminants can be absorbed and trapped underneath. Peeling back the glue often reveals hairline cracks underneath (Figure 4).

When excessive glue is used on the outside of pipe it is not as much of a problem as on the inside. This is because, on the outside, the organic solvents quickly evaporate. However, on the inside of the pipe, the organic solvents are trapped allowing more exposure time of the plastic to the solvent. Also, the glue dribble is porous and acts like a sponge providing a place where trace hydrocarbon contaminants can be absorbed from the water inside the pipes. The hydrocarbon laden glue dribble is in constant contact with the inside pipe surface providing the perfect site for crack initiation (Figure 4).

**Figure 4.** Glue dribble on inside of CPVC pipe with hairline cracks found underneath the dribble.

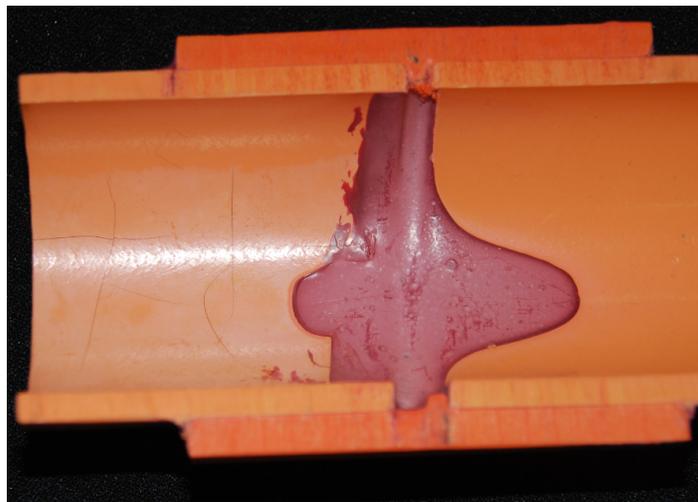
**Figure 5.** Pooling of excess glue inside of fitting. Notice mud cracking of the inside surface to left of glue.

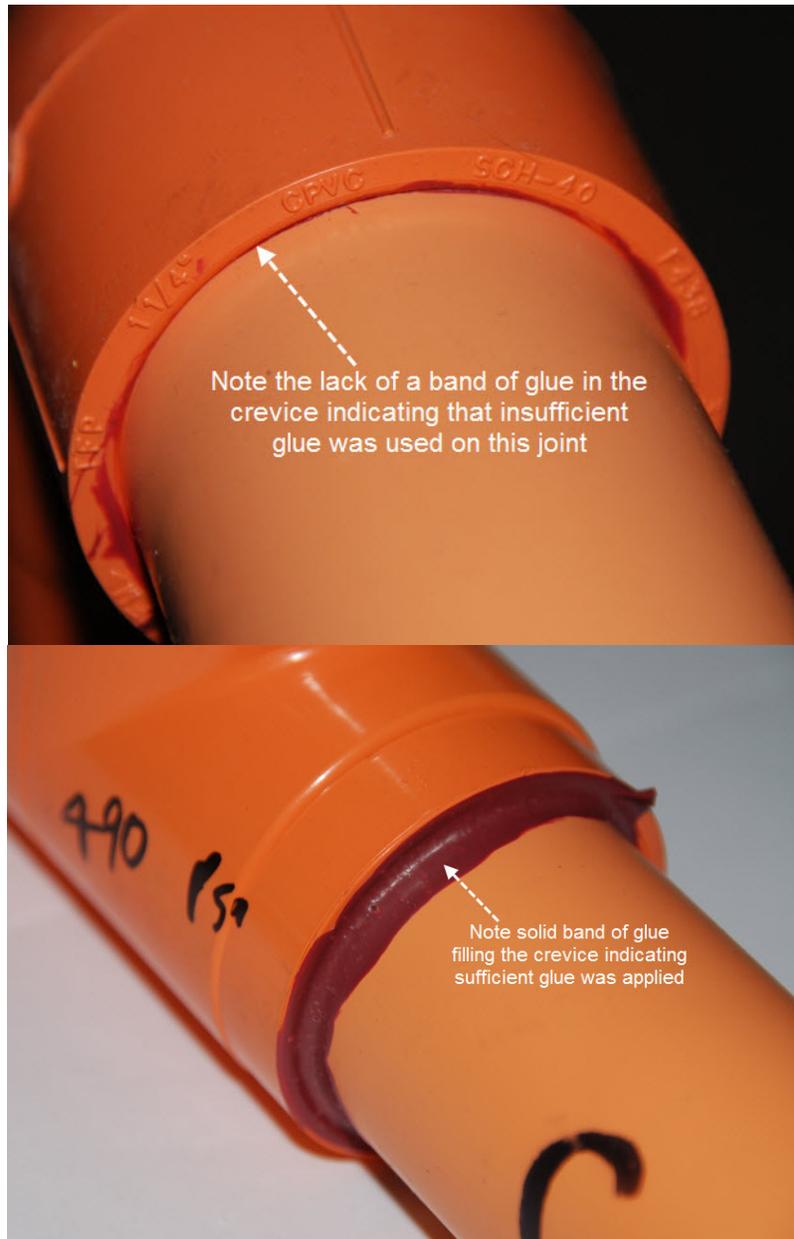
**Figure 6.** Photos showing the external appearance of a bad (top) and a good (bottom) joints.

It is alright to end up with excess glue on the outside of a pipe/fitting but it is not alright to end up with excess glue on the inside of the pipe/fitting. By applying the excess glue to the end of the pipe, but not the fitting, when the pipe is inserted into the fitting, the excess glue is pushed down the outside of the pipe. If excess glue is applied to the inside of the fitting, the excess ends up remaining in the fitting and either pools inside the fitting (Figure 5) or else runs down the pipe (Figure 4). It is generally quite easy to spot whether a fitting was assembled using sufficient glue versus an insufficient amount of glue as shown in Figure 6.

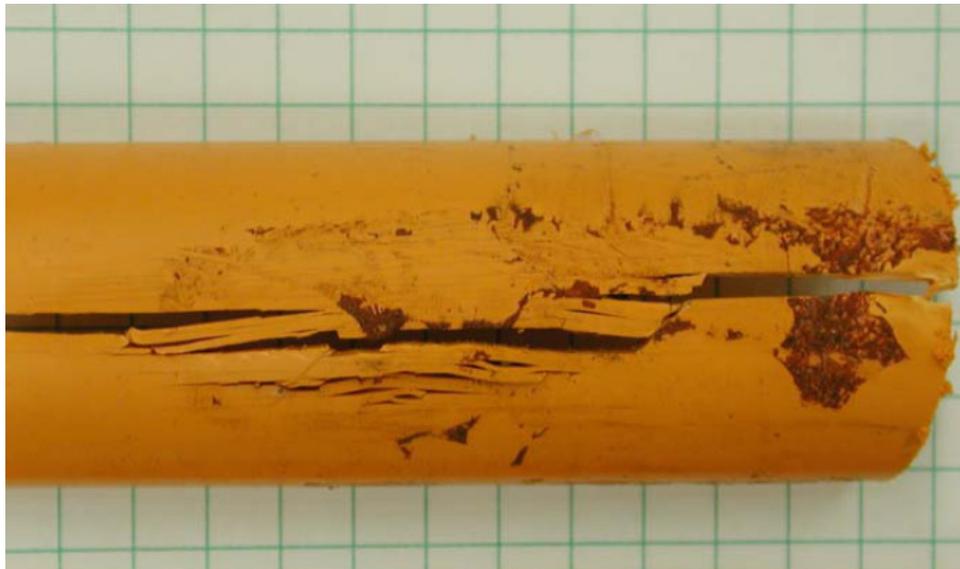
Contamination - Exterior: Care must be taken not to allow CPVC pipes to contact other non-metallic materials. Figures 7 and 8 show examples of failure due to contact of CPVC with other materials that contain plasticizers. Figure 7 was a condominium where a worker sealed all of the openings in walls using a fire caulk. A drop of excess fire caulk fell down onto a CPVC fire sprinkler pipe resulting in failure of the pipe underneath the fire caulk.

**Figure 7.** Failure of CPVC fire sprinkler pipe due to fire caulk contamination on the exterior surface of the pipe. The fire caulk contained phthalates and phosphate esters which migrated from the caulk and into the CPVC.

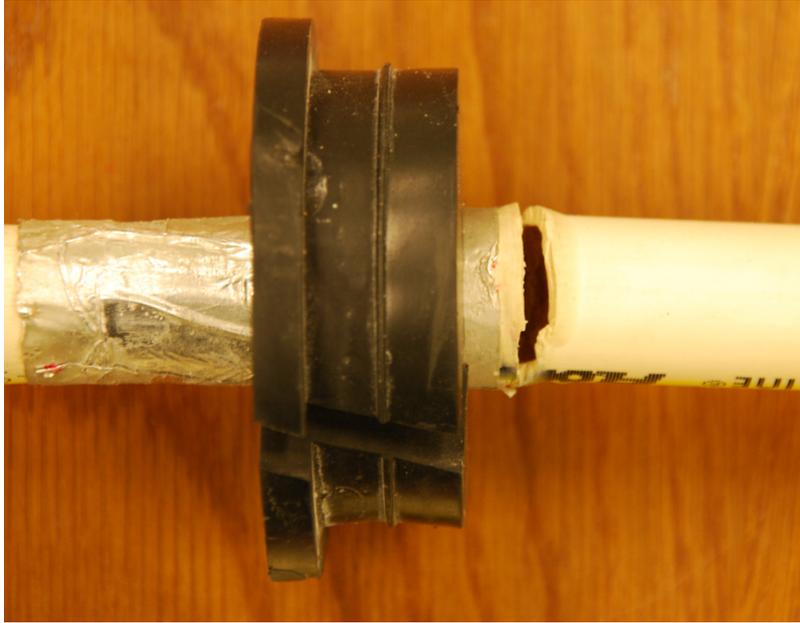
Figure 8 shows an example where a black grommet was used to seal the hole in the concrete floor through which a CPVC pipe ran. It was known that black grommets are not compatible with CPVC so metal foil tape was applied to the pipe to isolate the grommet from contacting the pipe surface. However, the phthalate plasticizers in the grommet migrated from the grommet down the tape and into the pipe resulting in softening of the pipe wall.

**Figure 8.** Failure of CPVC pipe due to migration of phthalate plasticizer from Proset grommet down metal foil tape used to isolate pipe. Phthalates were absorbed into the pipe resulting in softening and failure of the pipe wall.

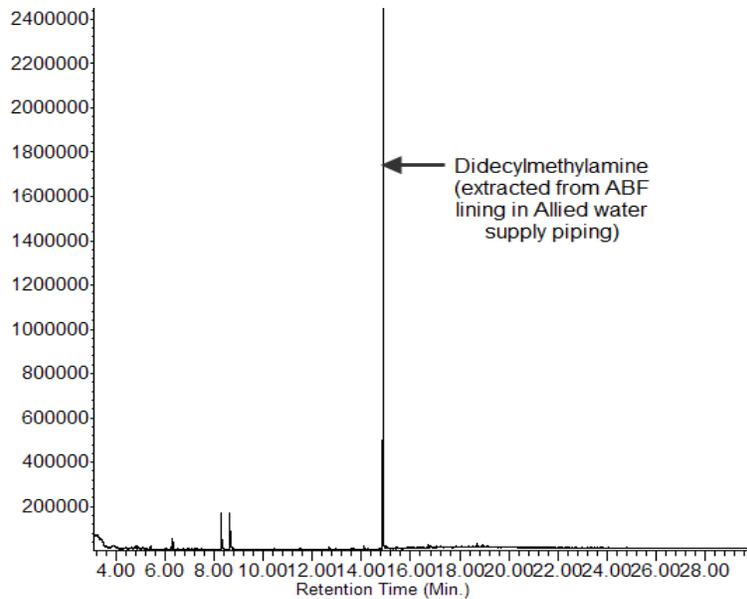
Figure 9 shows an example of a GC-MS analysis of a CPVC sprinkler pipe sample removed from a condominium. The pipe sample was found to contain didecylmethylamine. The amine was also identified in the hexane wash of the Allied ABF lined metal pipe that supplied the water to the CPVC sprinkler piping system.

**Figure 9.** GC-MS analysis of contaminants identified inside of a failed CPVC pipe. The contaminant found in highest concentration was didecylmethylamine which was extracted from the ABF lining in Allied pipe and deposited into the CPVC sprinkler pipe.

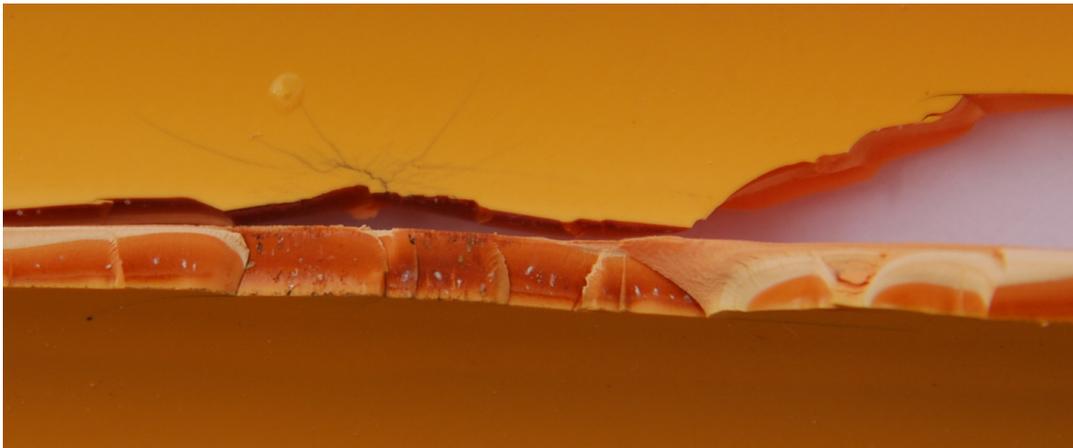
Diagnosing Failure Due to ESC/Contamination on Interior: Failure of CPVC piping by ESC is generally diagnosed by high magnification analysis of the crack surfaces by a professional experienced in fracture surface analysis. Figure 10 shows a fracture surface typically found in pipe samples that have failed due to contamination.

**Figure 10.** Fractographic analysis of the crack surfaces confirms failure due to ESC.
