# Grenfell: The Perfect Formula for Tragedy

*Christopher J. Wieczorek, Ph.D.*

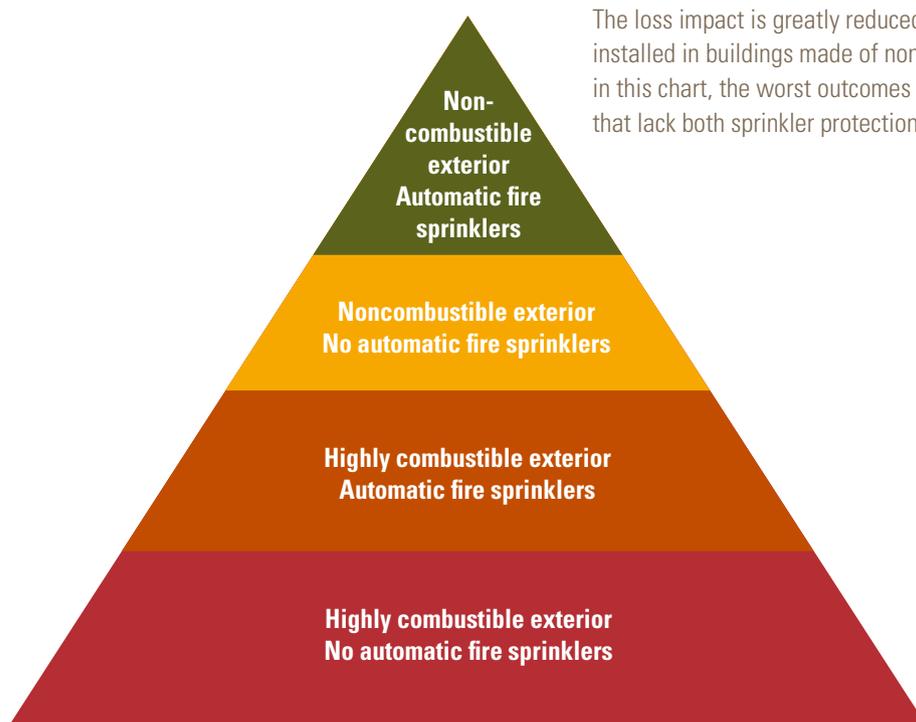
The loss impact is greatly reduced when automatic sprinklers are installed in buildings made of noncombustible construction. As shown in this chart, the worst outcomes are when fires begin in buildings that lack both sprinkler protection and the proper construction.
