## TUBE FAILURE STATUS

Since Heat Exchanger operation in 2001 year, for 15 years Tube failure occurred at 3, 4 pass area particularly as much as 8~10 tube leakage yearly.

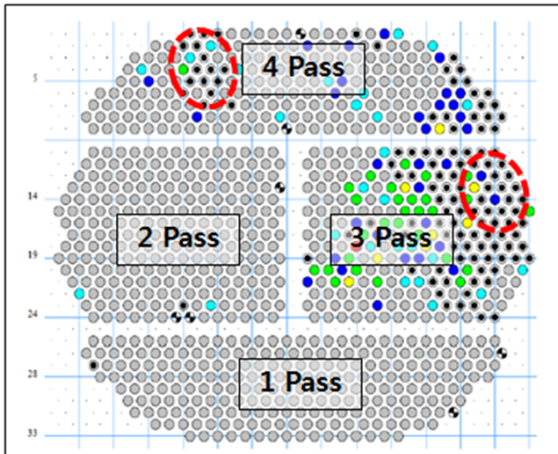
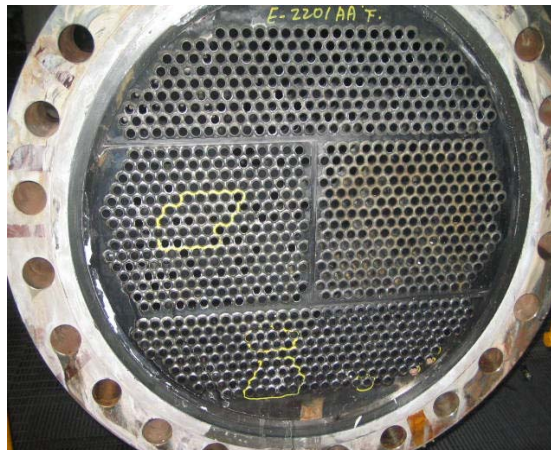
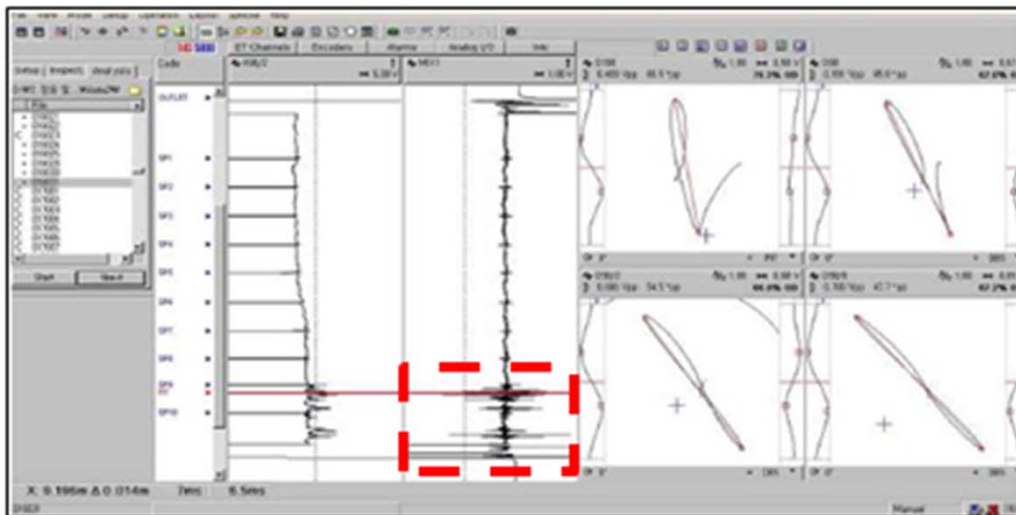
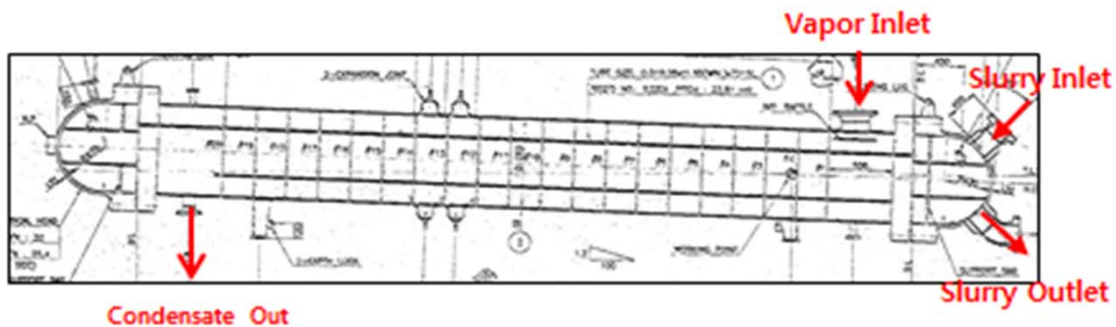
Currently total Tube Plugged q'ty is 127 of 932 tubes.

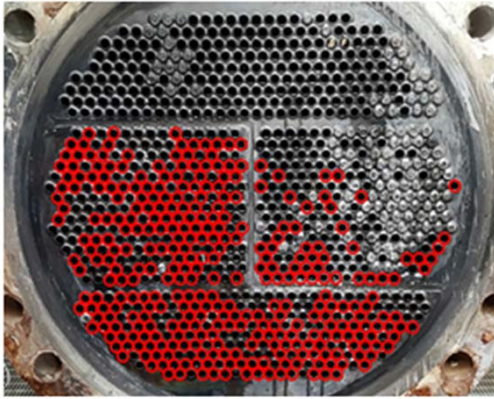
### 3) Tube Plugging Status for 3 months Operation

<1 Pass>  
 Tube : 232ea  
 Metal Plugged Tube : 1ea  
 T.A Plugging : 148 ea  
 <2 Pass>  
 Tube : 234ea  
 Metal Plugged Tube : 1 ea  
 T.A Plugging : 132 ea

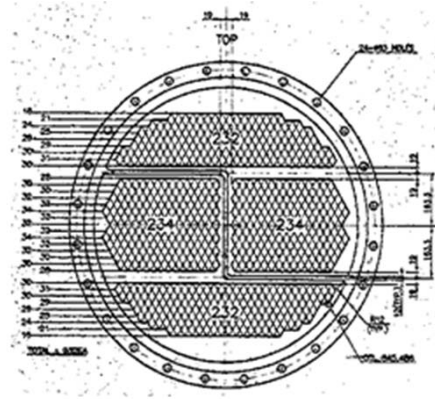
<3 Pass>  
 Tube : 234ea  
 Metal Plugged Tube : 91ea  
 T.A Plugging : 46 ea  
 <4 Pass>  
 Tube : 232ea  
 Metal Plugged Tube : 36 ea  
 T.A Plugging : 0 ea
