## TUBE FAILURE STATUS

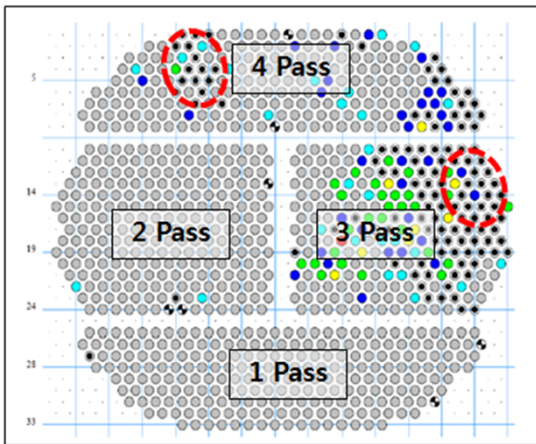
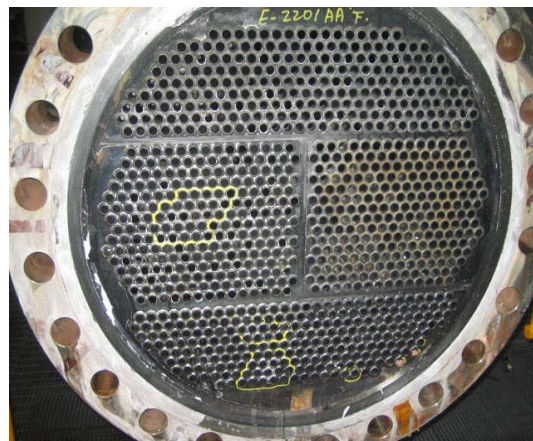
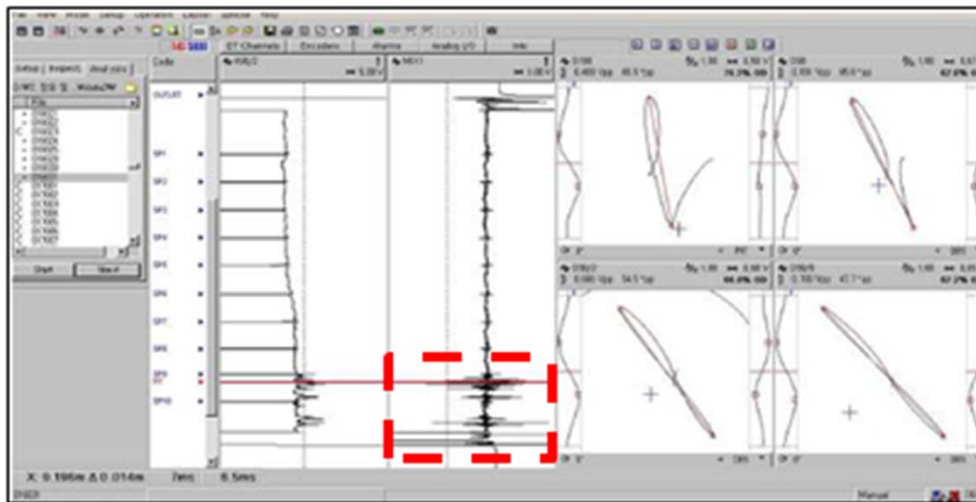
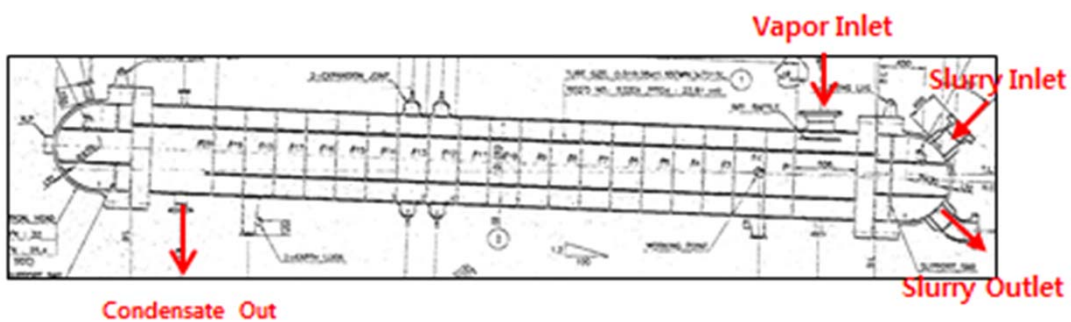
Since Heat Exchanger operation in 2001 year, for 15 years Tube failure occurred in drain outlet where located between Tube sheet and 2ND baffle at 3, 4 pass area particularly as much as 8~10 tube leakage yearly.

Currently total Tube Plugged q'ty is 127 of 932 tubes.

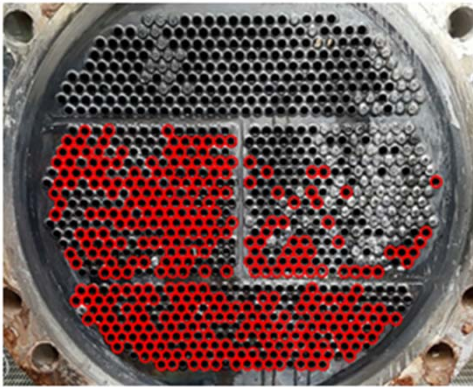
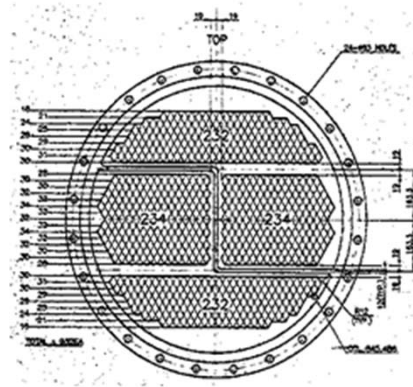
### 3) Tube Plugging Status for 3 months Operation

<1 Pass>

Tube : 232ea

Metal Plugged Tube : 1ea

T.A Plugging : 148 ea

<2 Pass>

Tube : 234ea

Metal Plugged Tube : 1 ea

T.A Plugging : 132 ea

<3 Pass>

Metal Plugged Tube : 91ea

T.A Plugging : 46 ea

<4 Pass>

Metal Plugged Tube : 36 ea

T.A Plugging : 0 ea

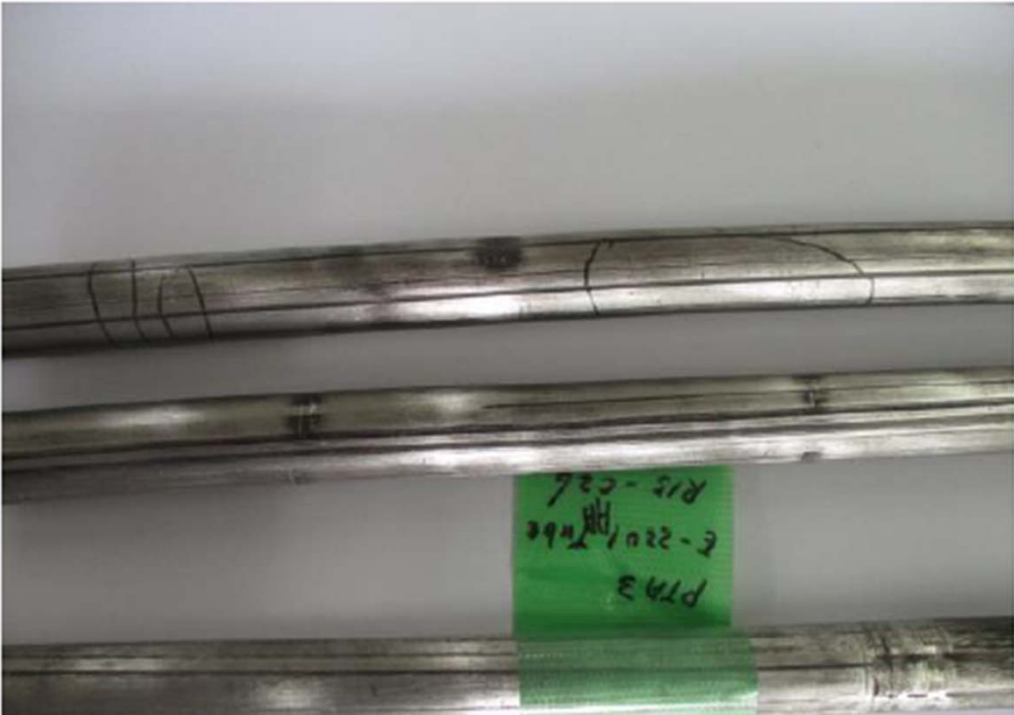
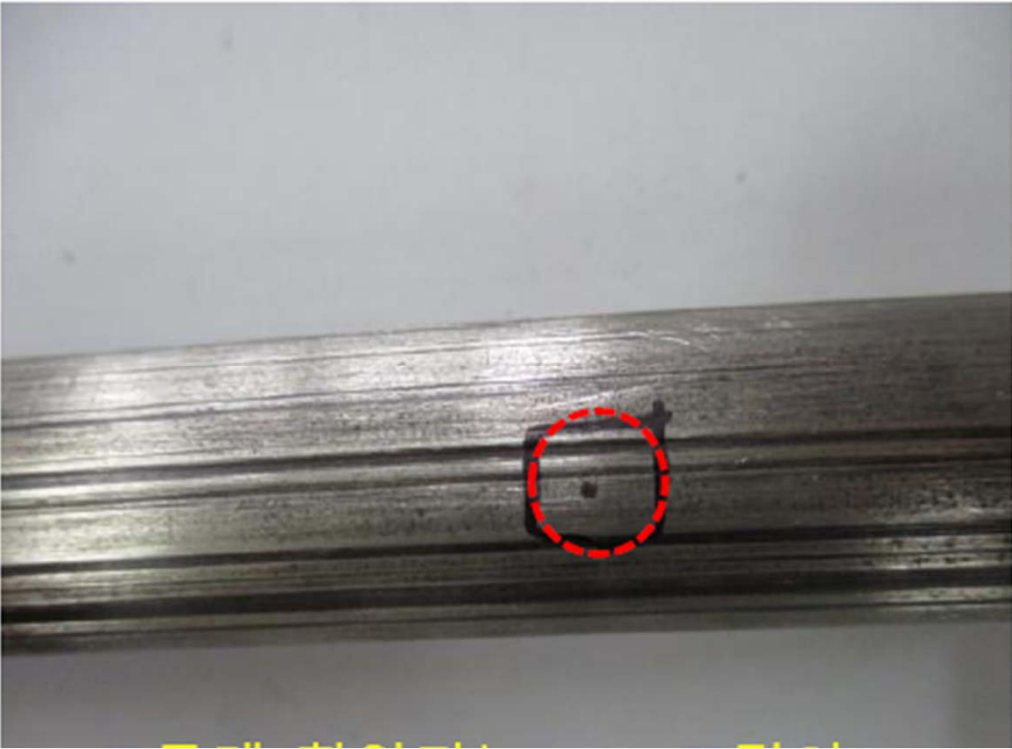
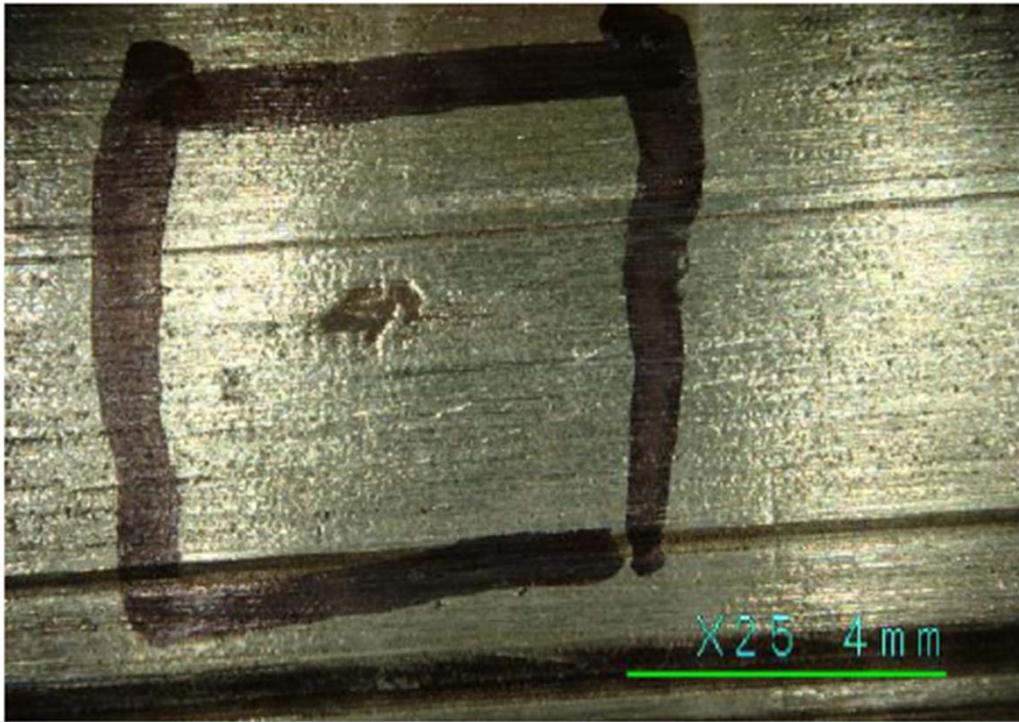
1. Tube Surface Pitting

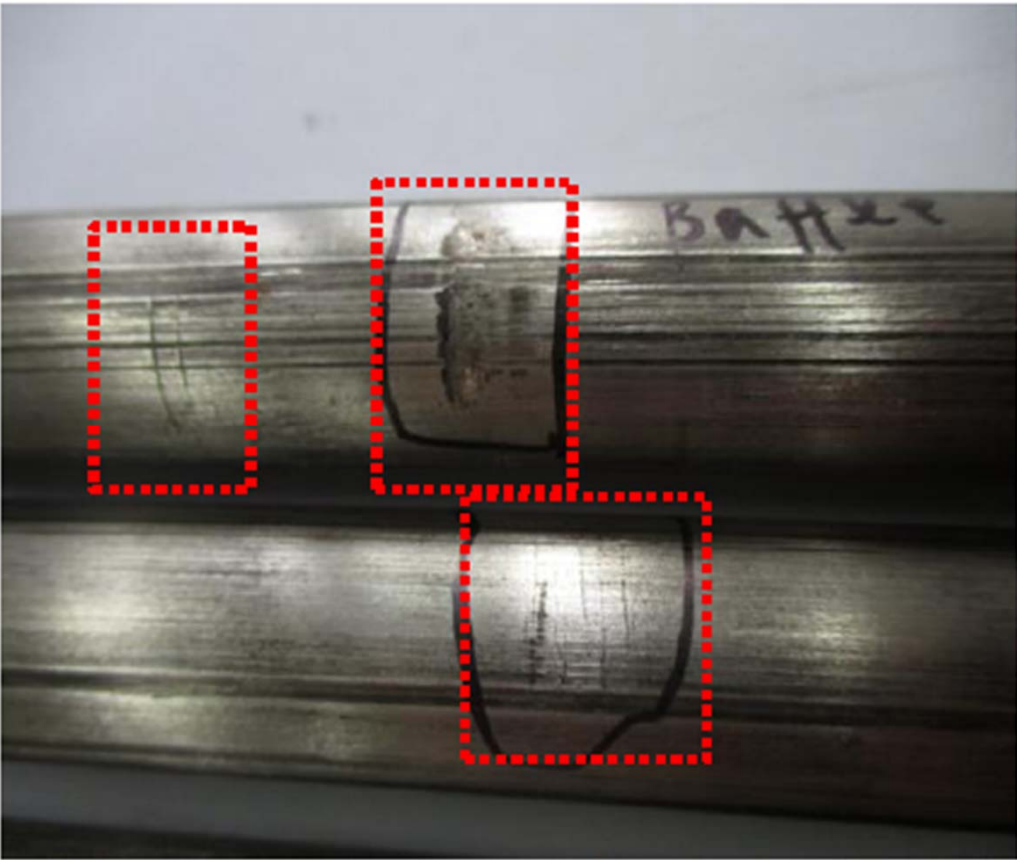
2. Friction Damage at Baffle

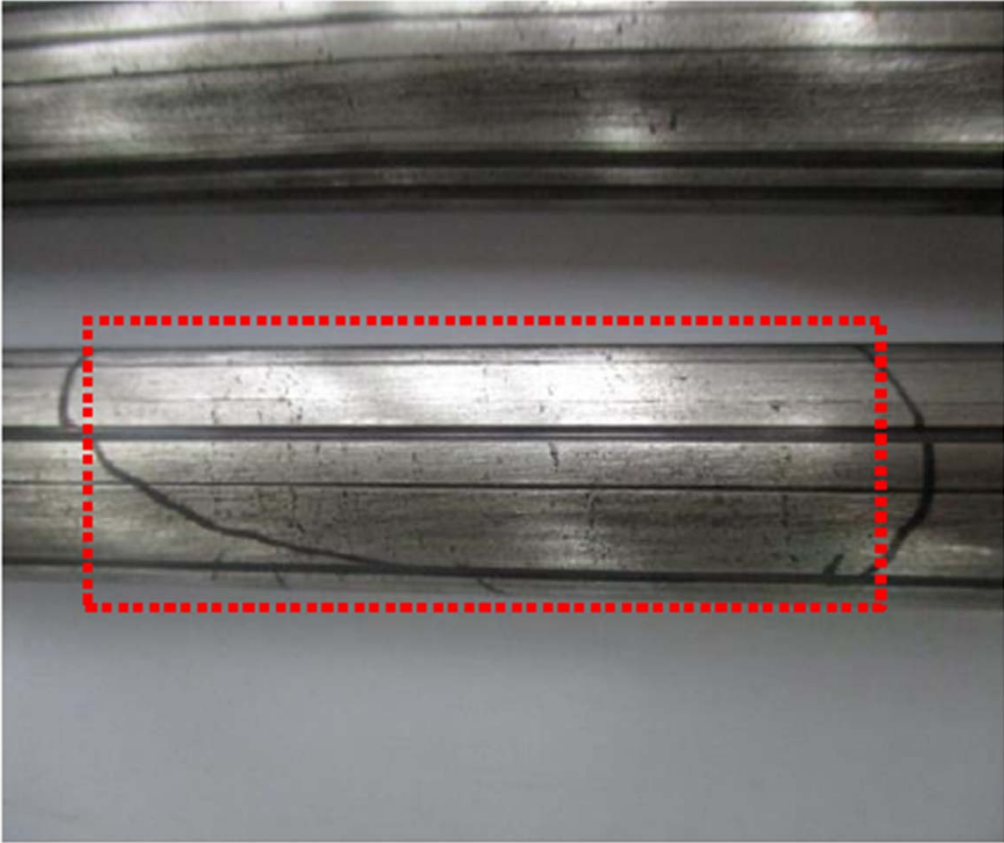
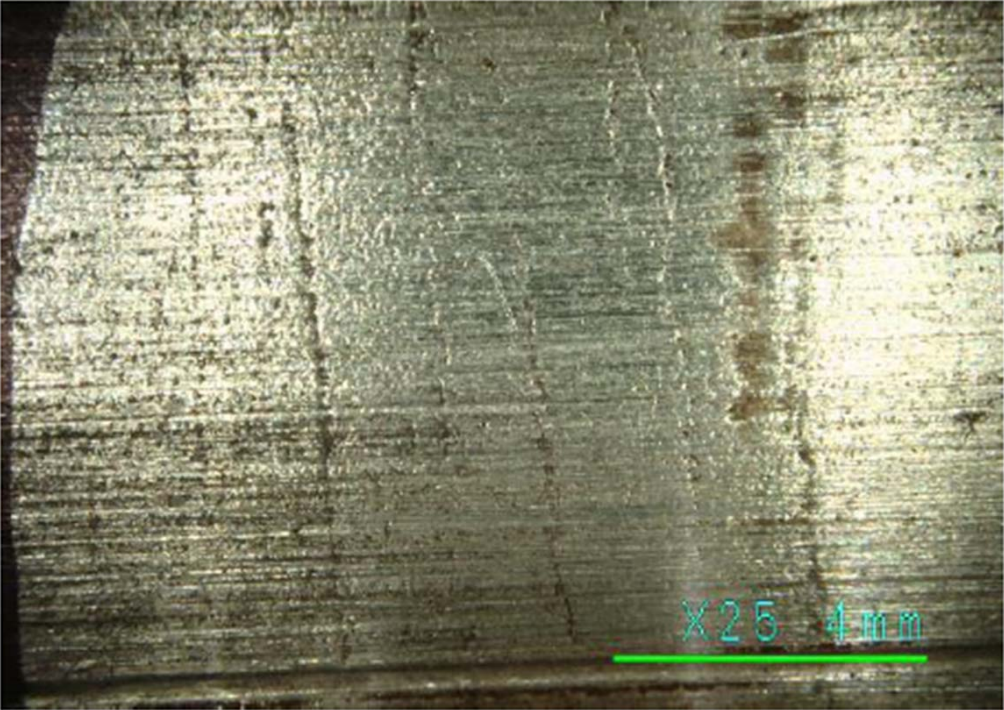
3. Tube Surface Pitting and Micro Crack

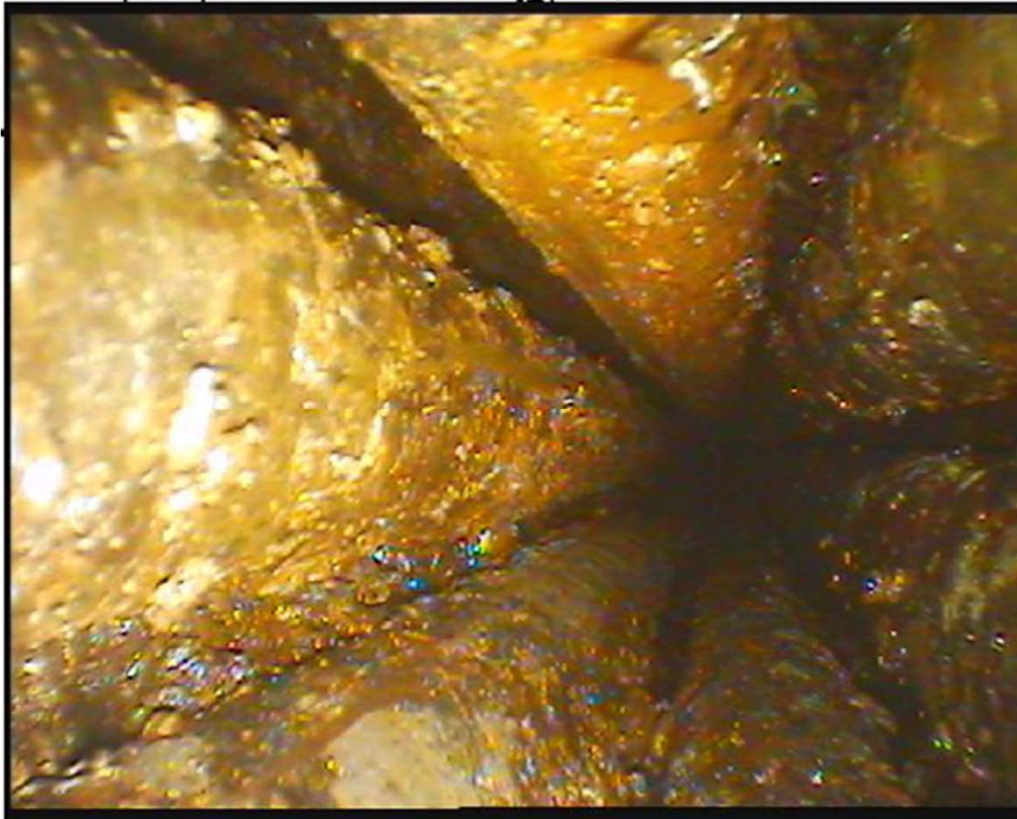
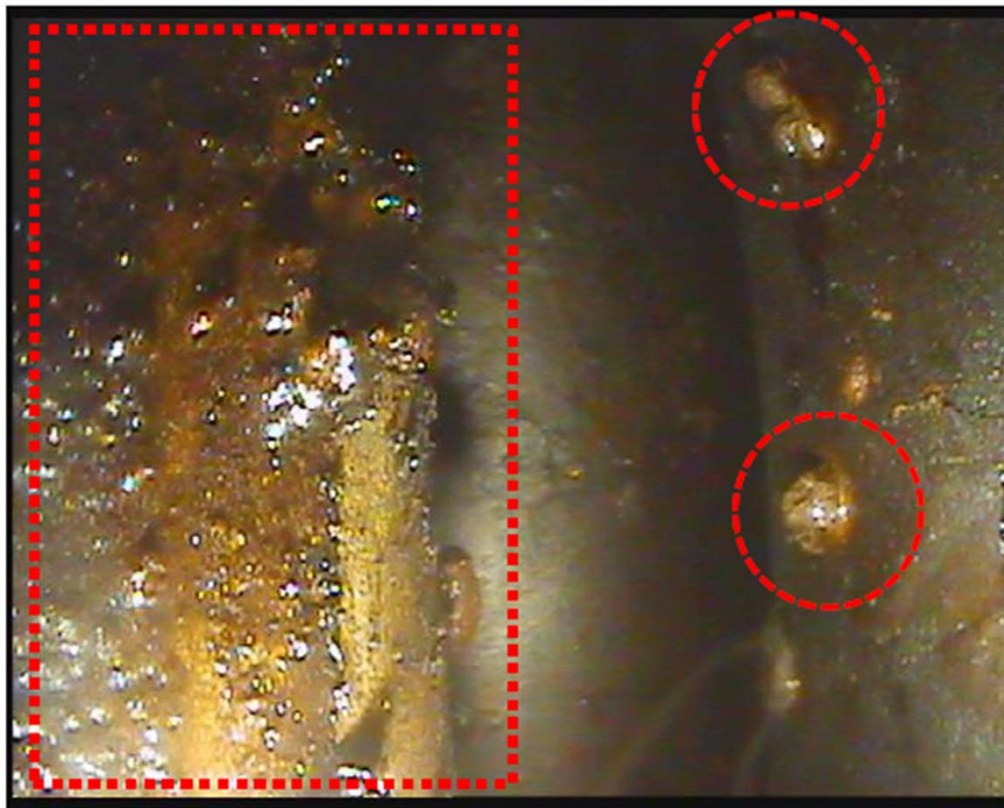
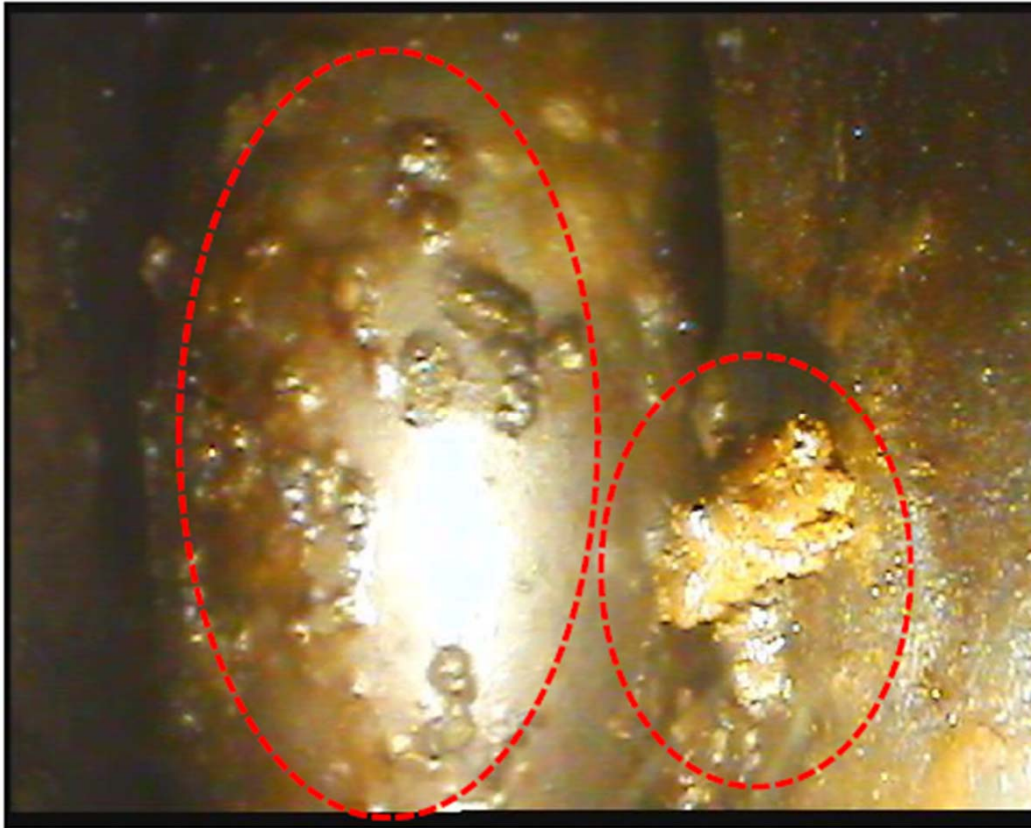
4. Tube Surface near by Tube Sheet

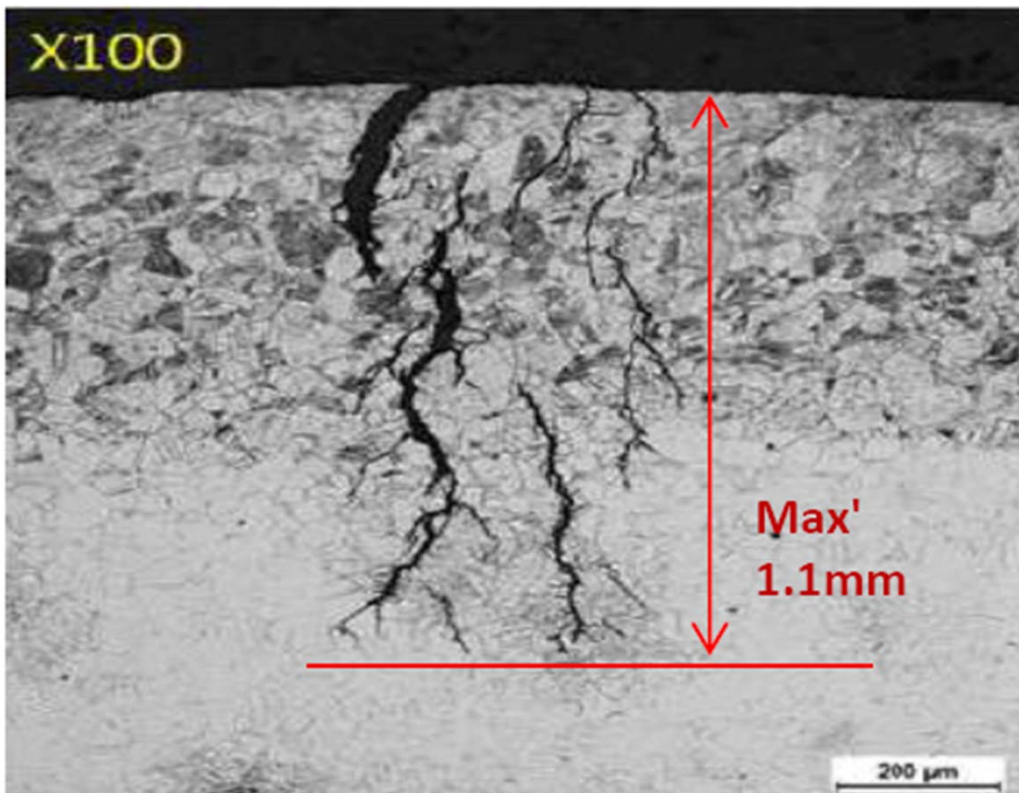
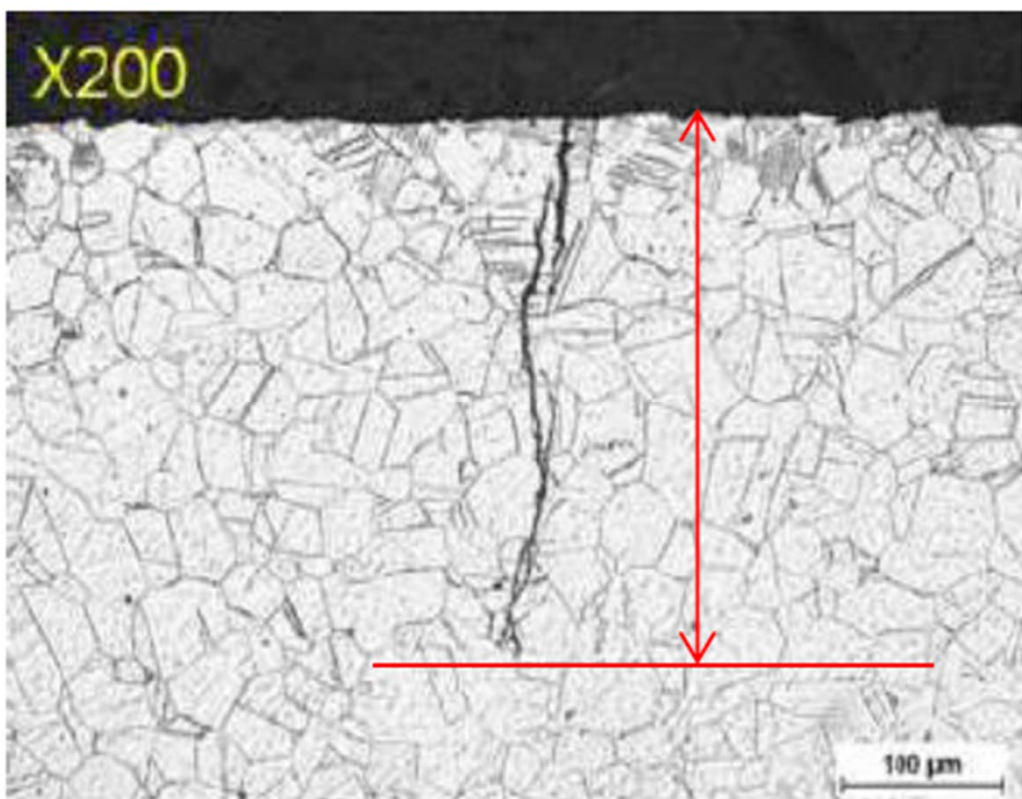
5. Micro Crack (Max. 1.1mm)
