Airworthiness Concern Sheet

Make: Mooney International Corporation

Model / Series: M20C, M20D, M20E, M20F, M20G

Fatigue cracks in control wheel shaft and/or attachment hub may lead to control wheel separation from the shaft.

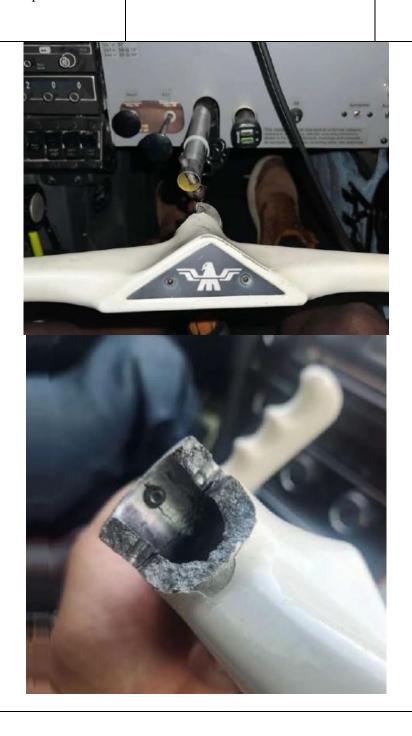
We have received reports of control wheel separations on Mooney M20C aircraft due to fatigue cracks in the control shaft and/or control wheel attachment hub.

Sample photos of the control wheel and shaft are on the following page.

We request that any operators of Mooney subject model aircraft perform a visual inspection of the control wheel and if signs of cracks are found to contact the FAA point of contact listed above with the aircraft model, aircraft serial number, part number control wheel, and hours TIS since installation. Also, please state the attachment method (tapered pin vs bolt) of the control wheel to the shaft.
