## Bridge Inspection Report

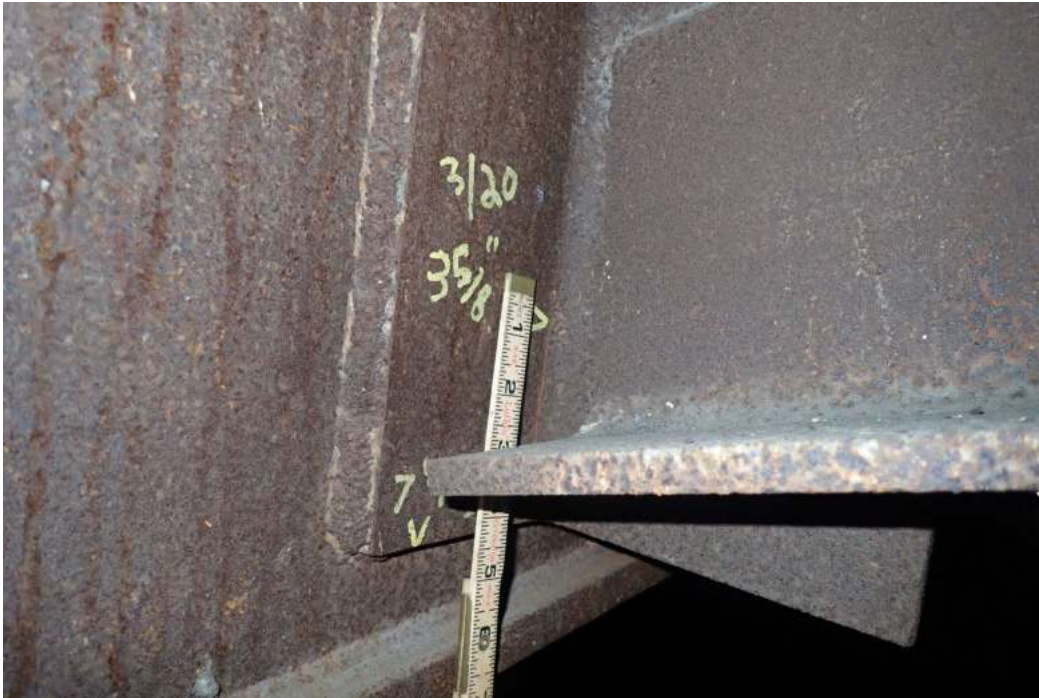
PHOTO 1 Recommended Maintenance Needs

Description 3 5/8" long crack in tee-section propagating from weld crack in wrap-around weld at the lower connection between the exterior erection diaphragm and the west web plate of Girder 2 at Bent 20, looking east.

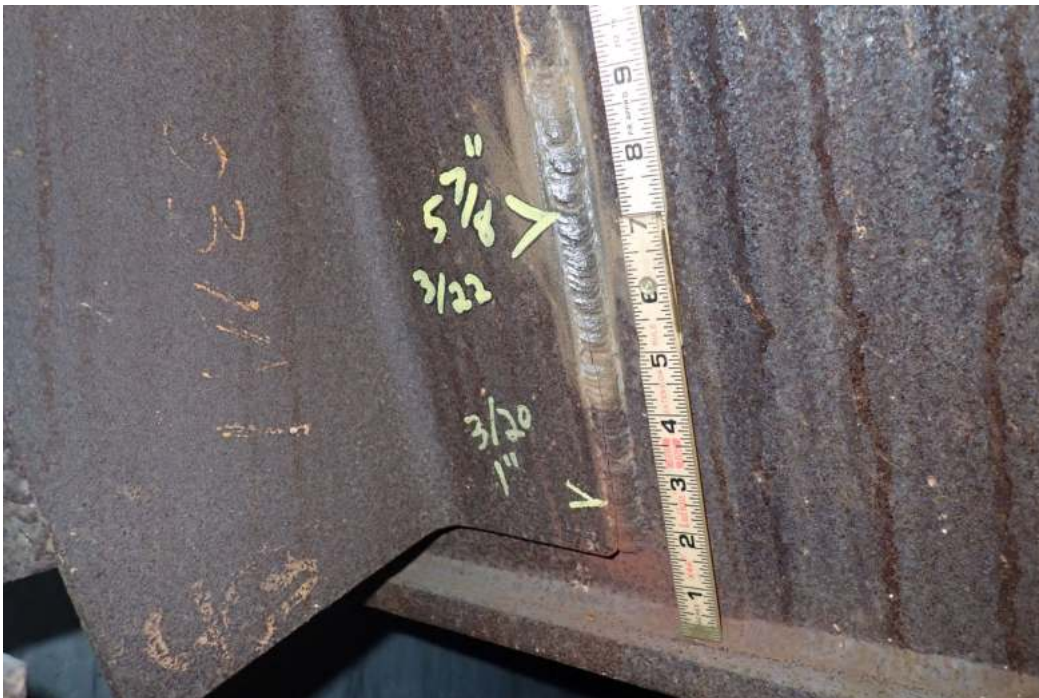
PHOTO 2 Recommended Maintenance Needs

Description 5 7/8" long vertical portion of crack in wrap-around weld at the lower connection between the exterior erection diaphragm and the west web plate of Girder 2 at Bent 20, looking northeast. Note 13 1/8" long total length of wrap-around crack.

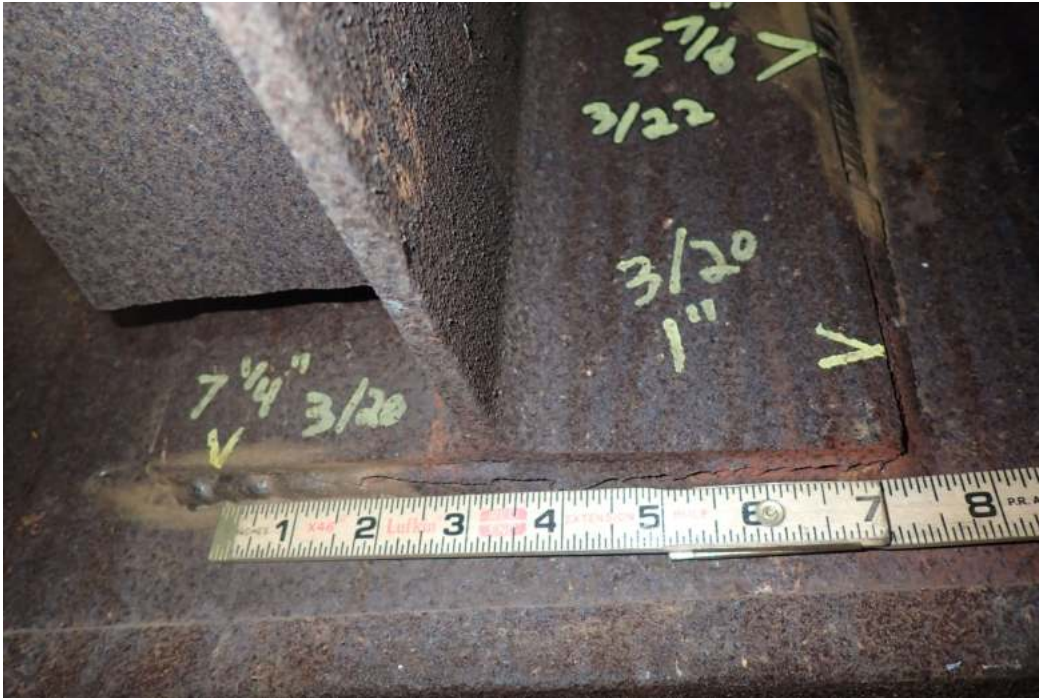
PHOTO 3 Recommended Maintenance Needs

Description 7 1/4" long horizontal portion of crack in wrap-around weld at the lower connection between the exterior erection diaphragm and the west web plate of Girder 2 at Bent 20, looking northeast.  
Note 13 1/8" long total length of wrap-around crack.

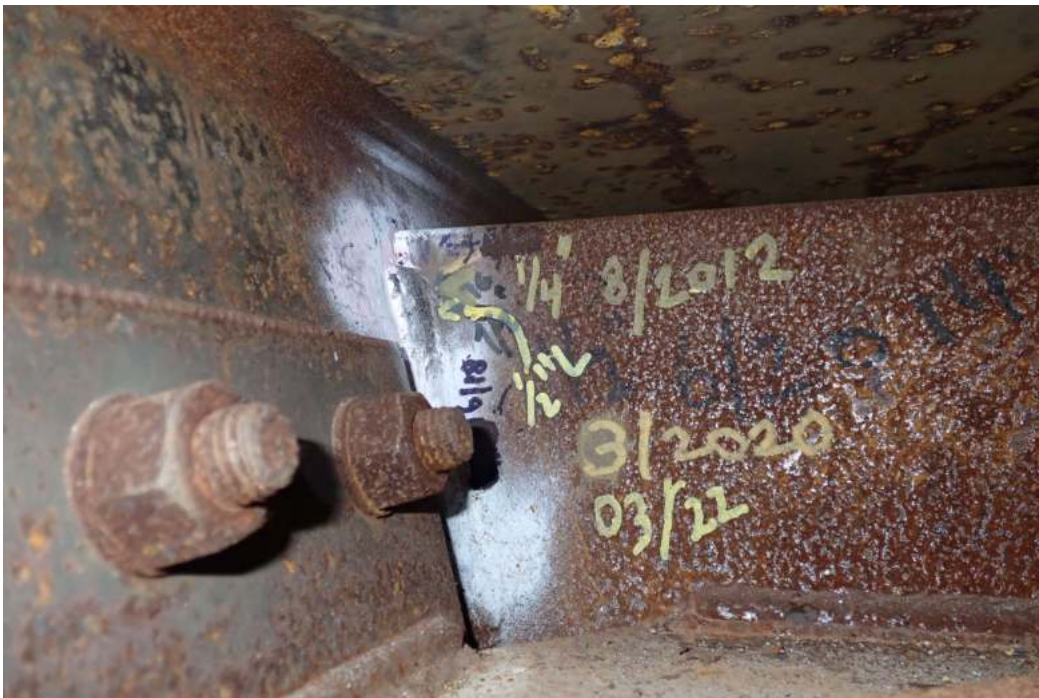
PHOTO 4 Recommended Maintenance Needs

Description 1/2" long crack in weld material between the west face of the interior diaphragm and the Girder 1 north web plate at Bent 14, looking northeast.

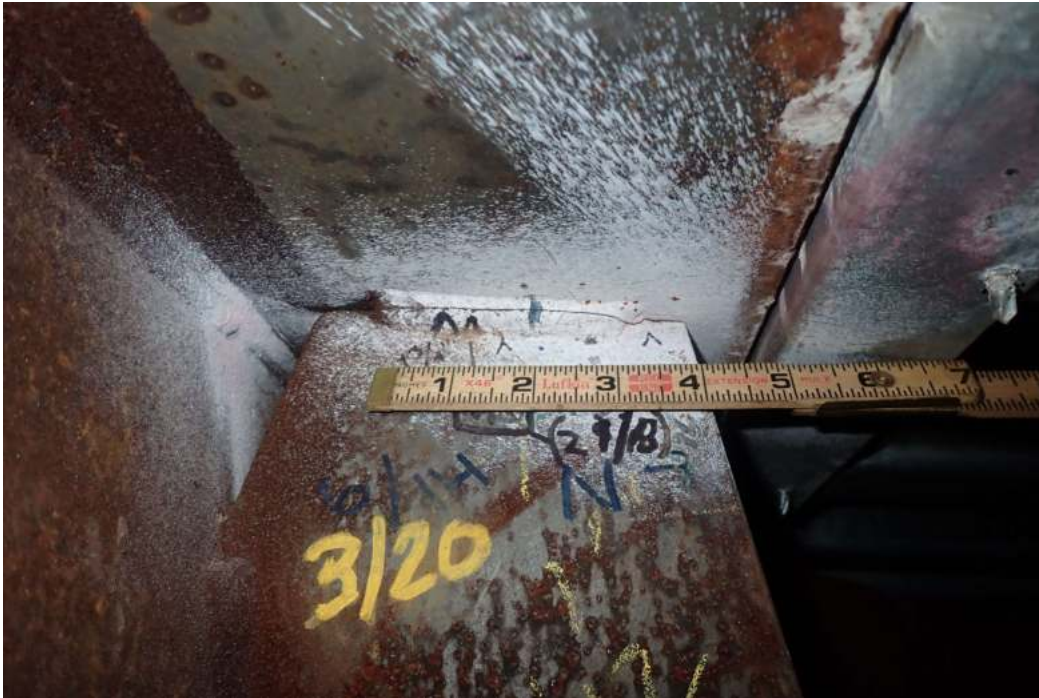
PHOTO 5 Recommended Maintenance Needs

Description Broken weld between east face of the transverse stiffener between Bays 2 and 3 and Girder 2 south top flange in Span 9, looking west. Note crack previously measured at 2 1/2" during prior inspection.

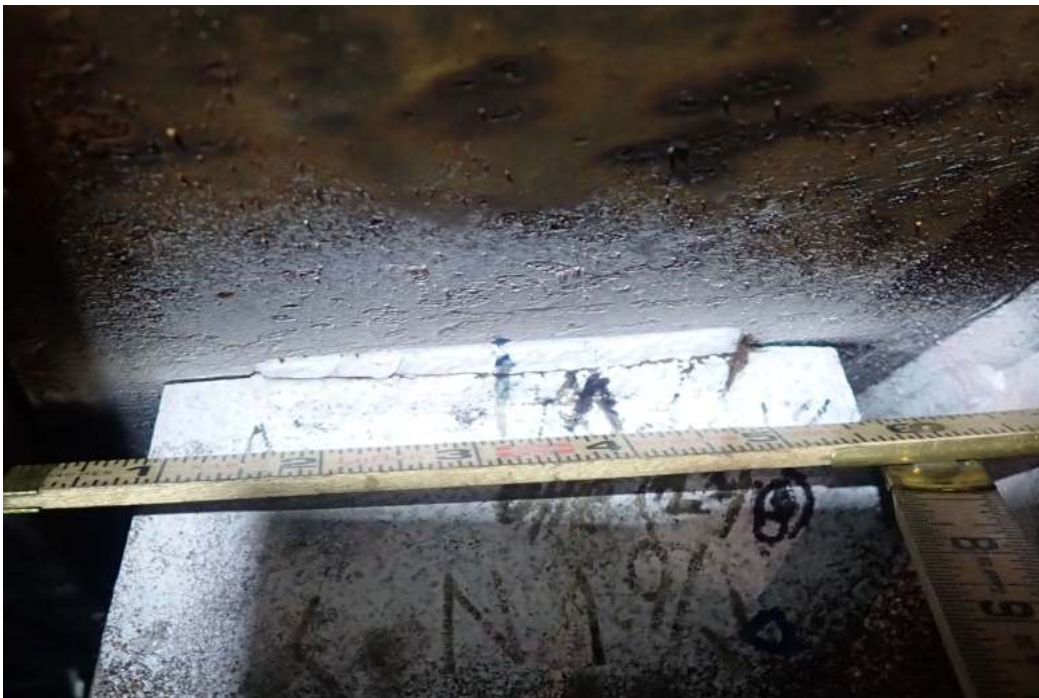
PHOTO 6 Recommended Maintenance Needs

Description Broken weld between the west face of the transverse stiffener between Bays 2 and 3 and Girder 2 south top flange in Span 9, looking east. Note crack previously measured at 2 3/8" during prior inspection.

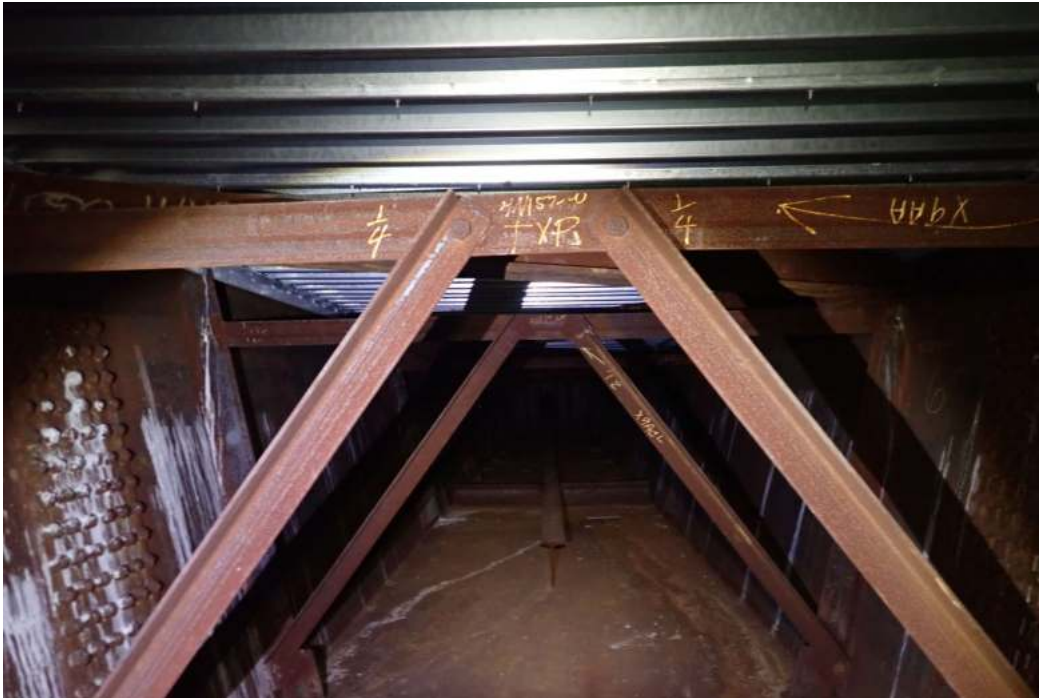
PHOTO 7 Recommended Maintenance Needs

Description 3/4" long crack in the north diagonal angle of Diaphragm 2 on interior of Girder 1 in Span 11, looking west.

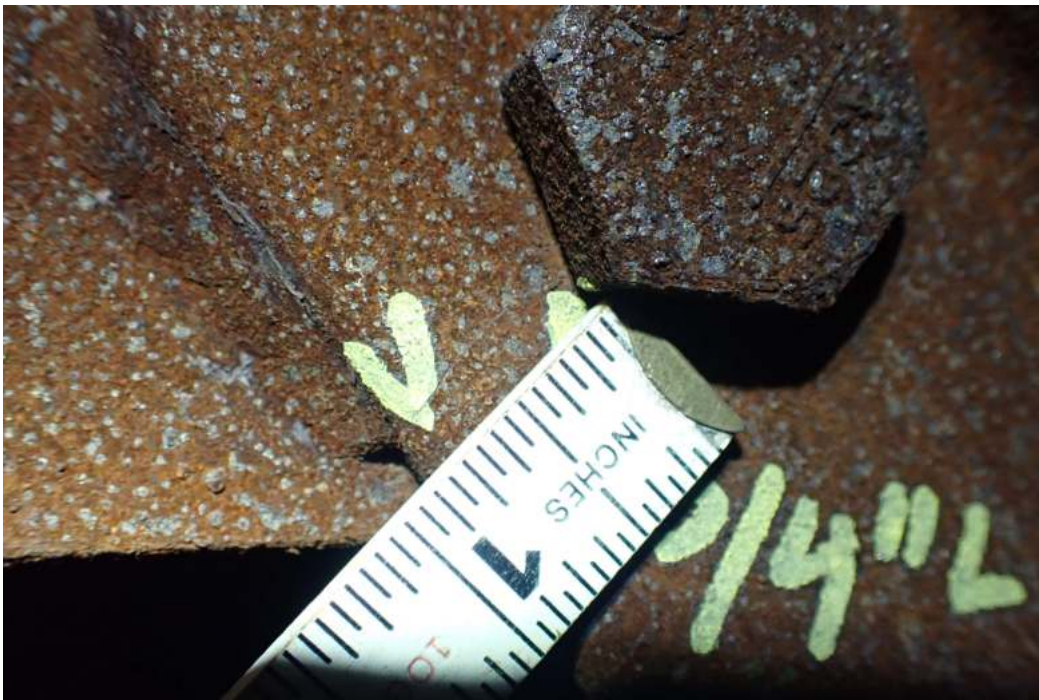
PHOTO 8 Recommended Maintenance Needs

Description 3/4" long crack in the north diagonal angle of Diaphragm 2 on interior of Girder 1 in Span 11, looking west.

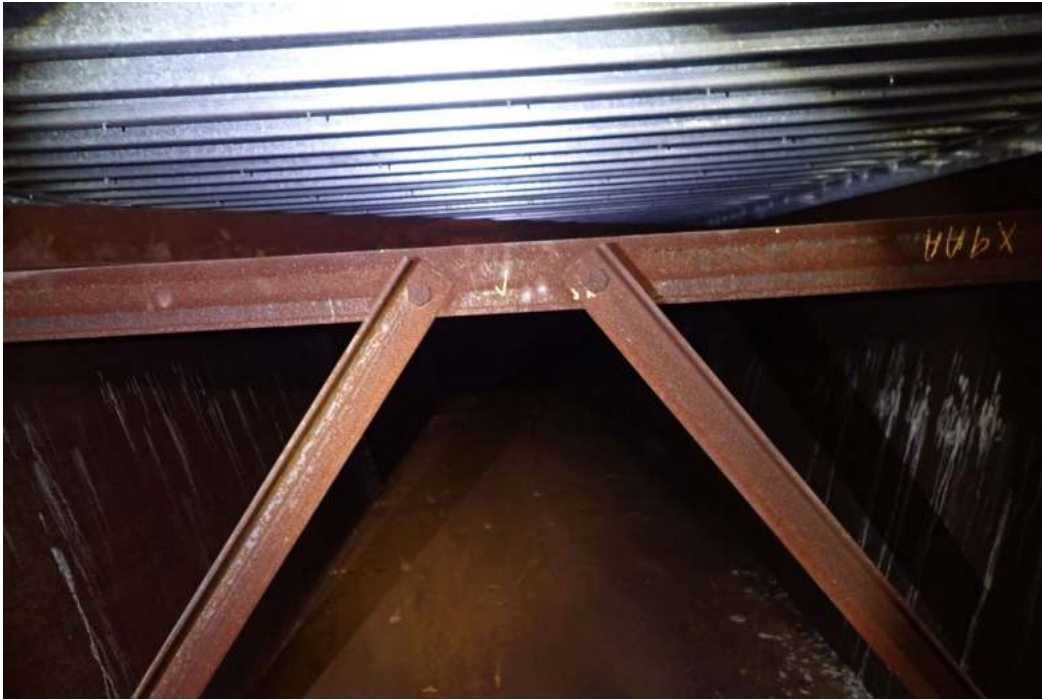
PHOTO 9 Recommended Maintenance Needs

Description 3/4" long crack in the north diagonal angle of Diaphragm 3 on interior of Girder 1 in Span 10, looking west.

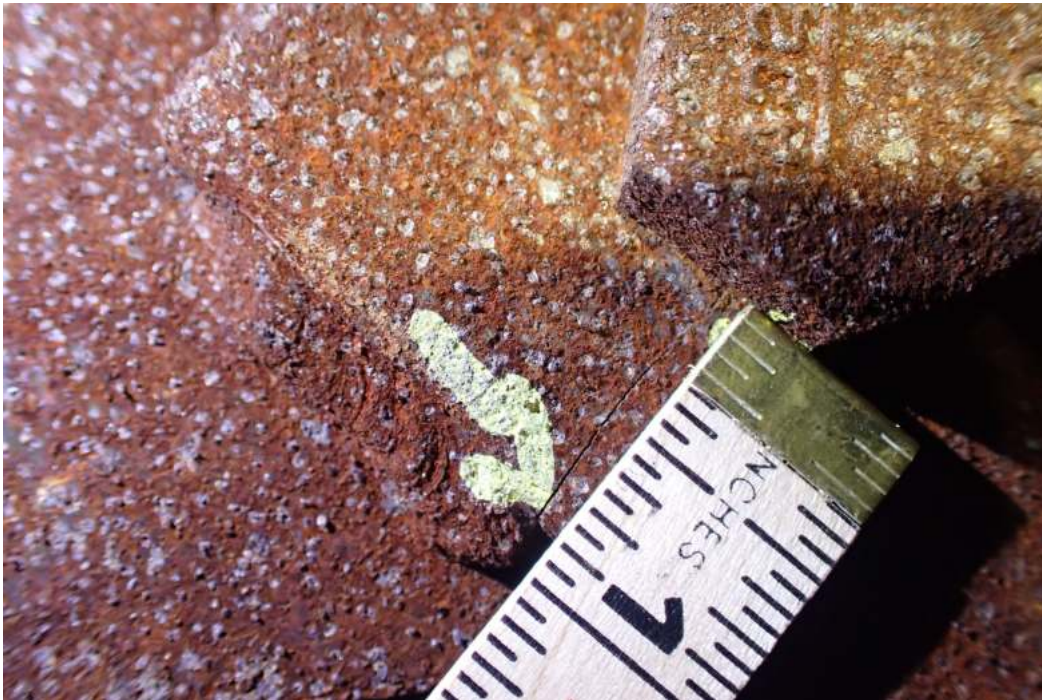
PHOTO 10 Recommended Maintenance Needs

Description 3/4" long crack in the north diagonal angle of Diaphragm 3 on interior of Girder 1 in Span 10, looking west.

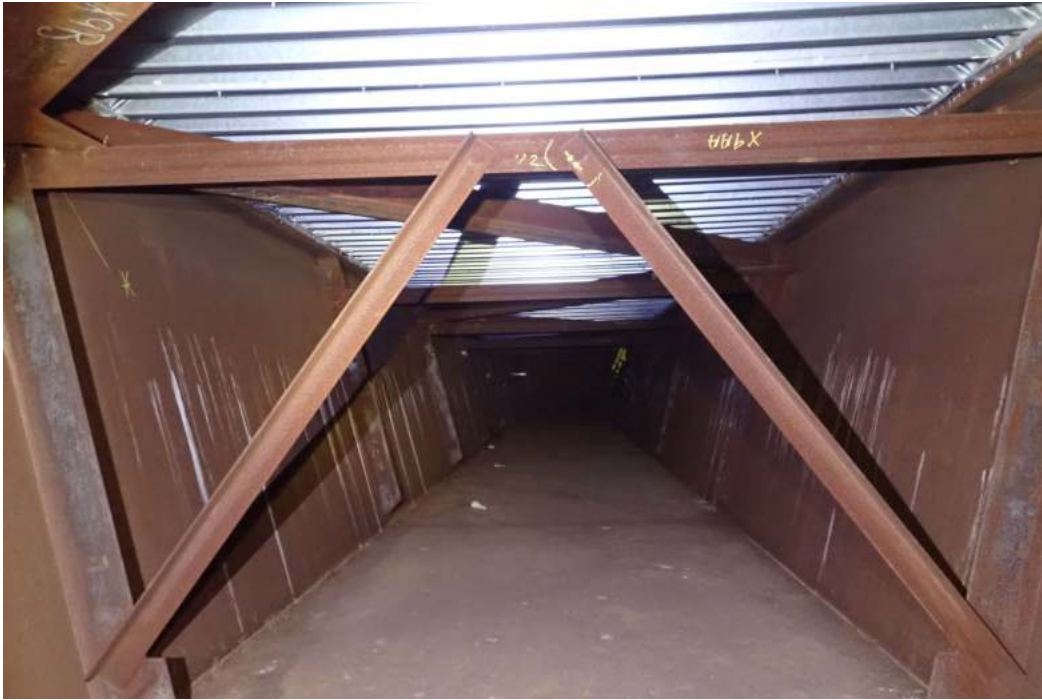
PHOTO 11 Recommended Maintenance Needs

Description 3/4" long crack in the north diagonal angle of Diaphragm 1 on interior of Girder 1 in Span 9, looking west.

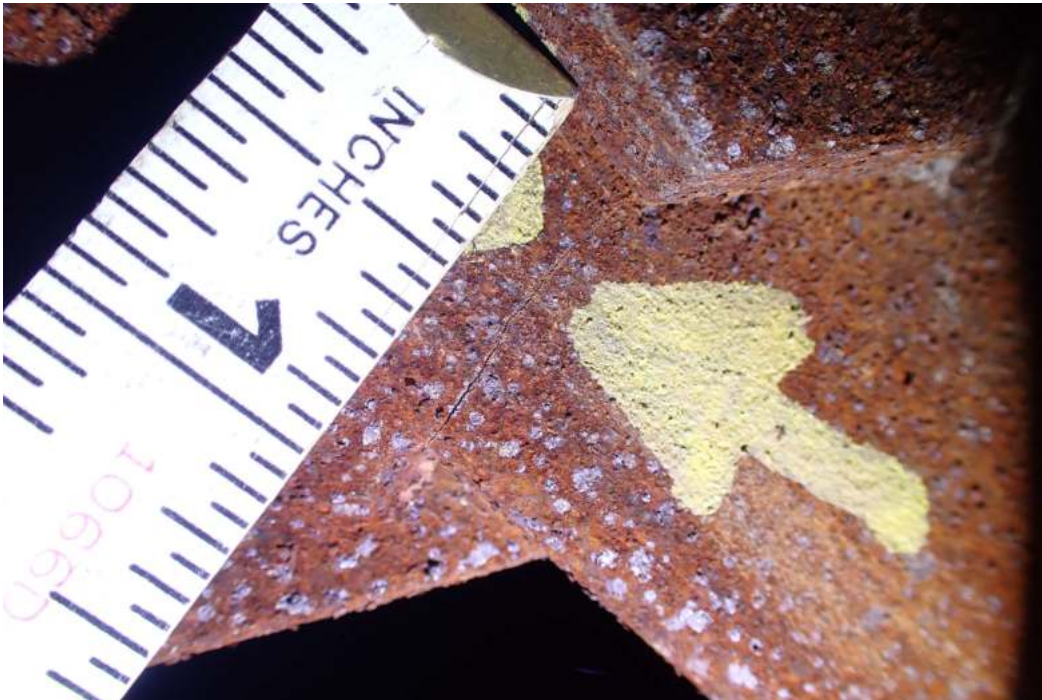
PHOTO 12 Recommended Maintenance Needs

Description 3/4" long crack in the north diagonal angle of Diaphragm 1 on interior of Girder 1 in Span 9, looking west.

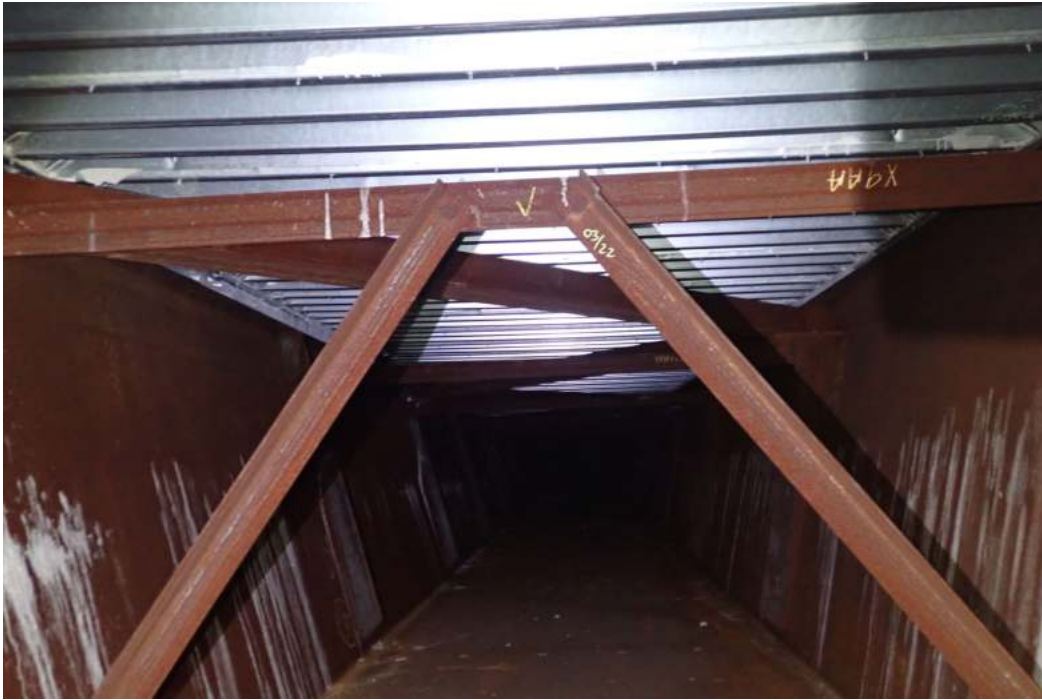
PHOTO 13 Recommended Maintenance Needs

Description Fractured north diagonal angle of Diaphragm 3 on interior of Girder 1 in Span 11, looking west.

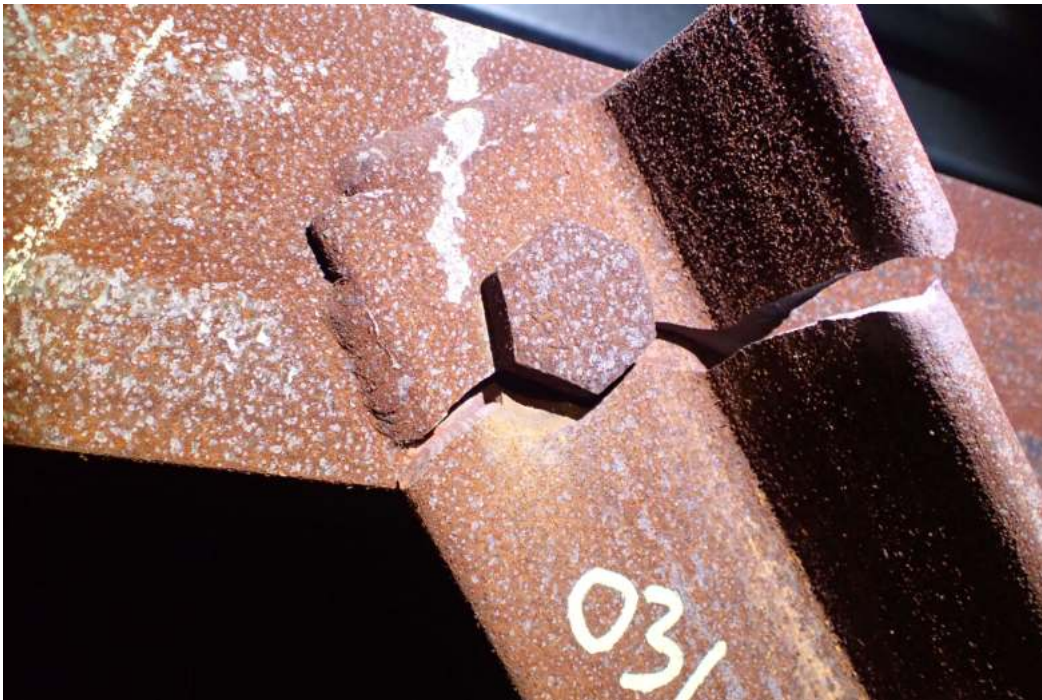
PHOTO 14 Recommended Maintenance Needs

Description Fractured north diagonal angle of Diaphragm 3 on interior of Girder 1 in Span 11, looking west.
