Bridge # 070001

12/08/ 2023

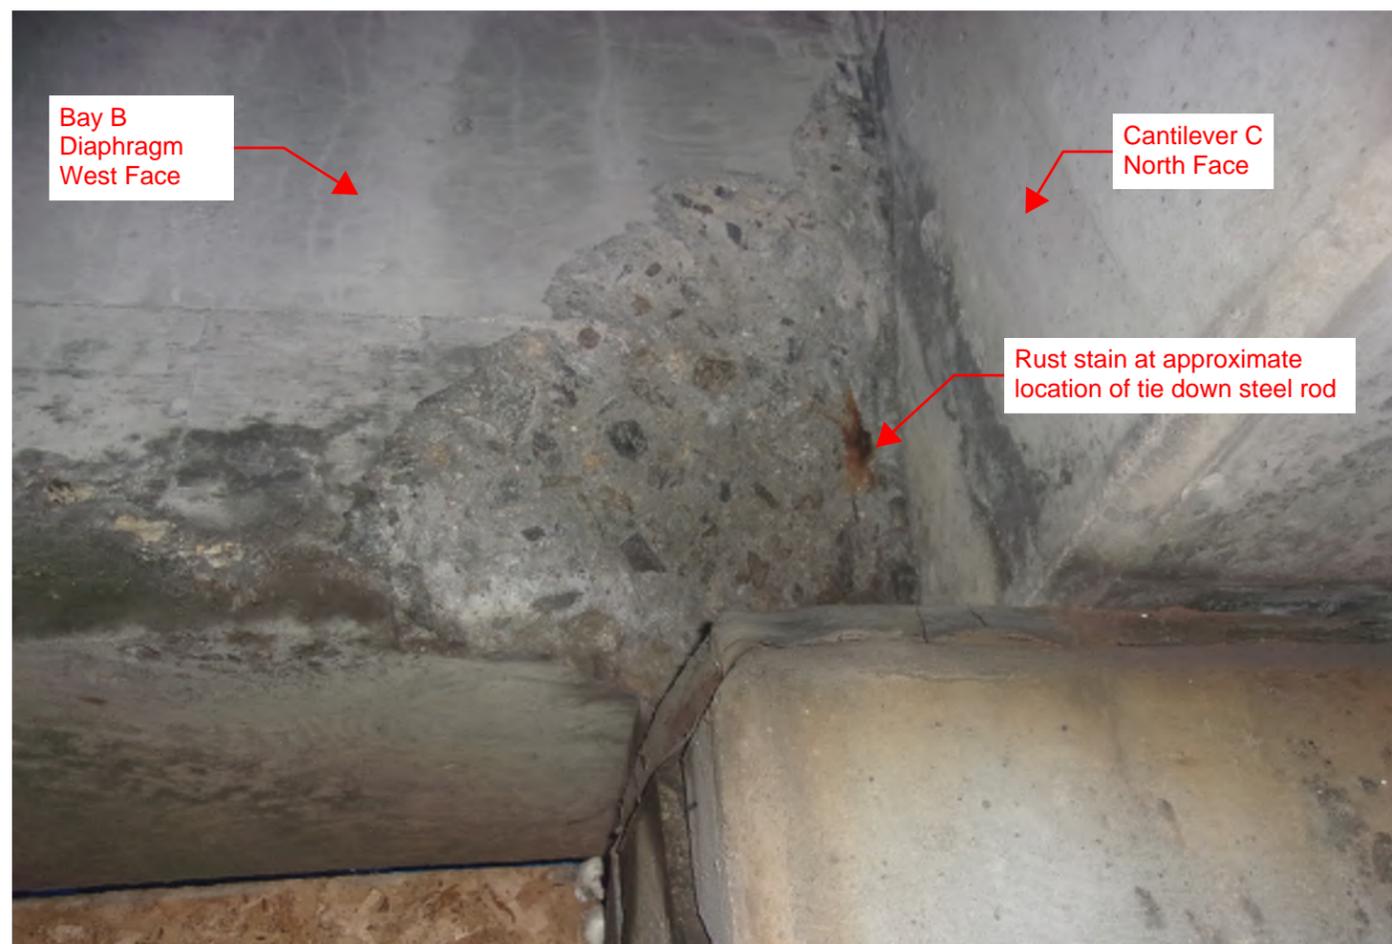
Cantilever C North Face

Note:
 - Spalls on diaphragm at Cantilever C north and south face. Rust stain on the Bay B diaphragm at approximate tie down steel rod location, and exposed steel rod at Bay diaphragm.

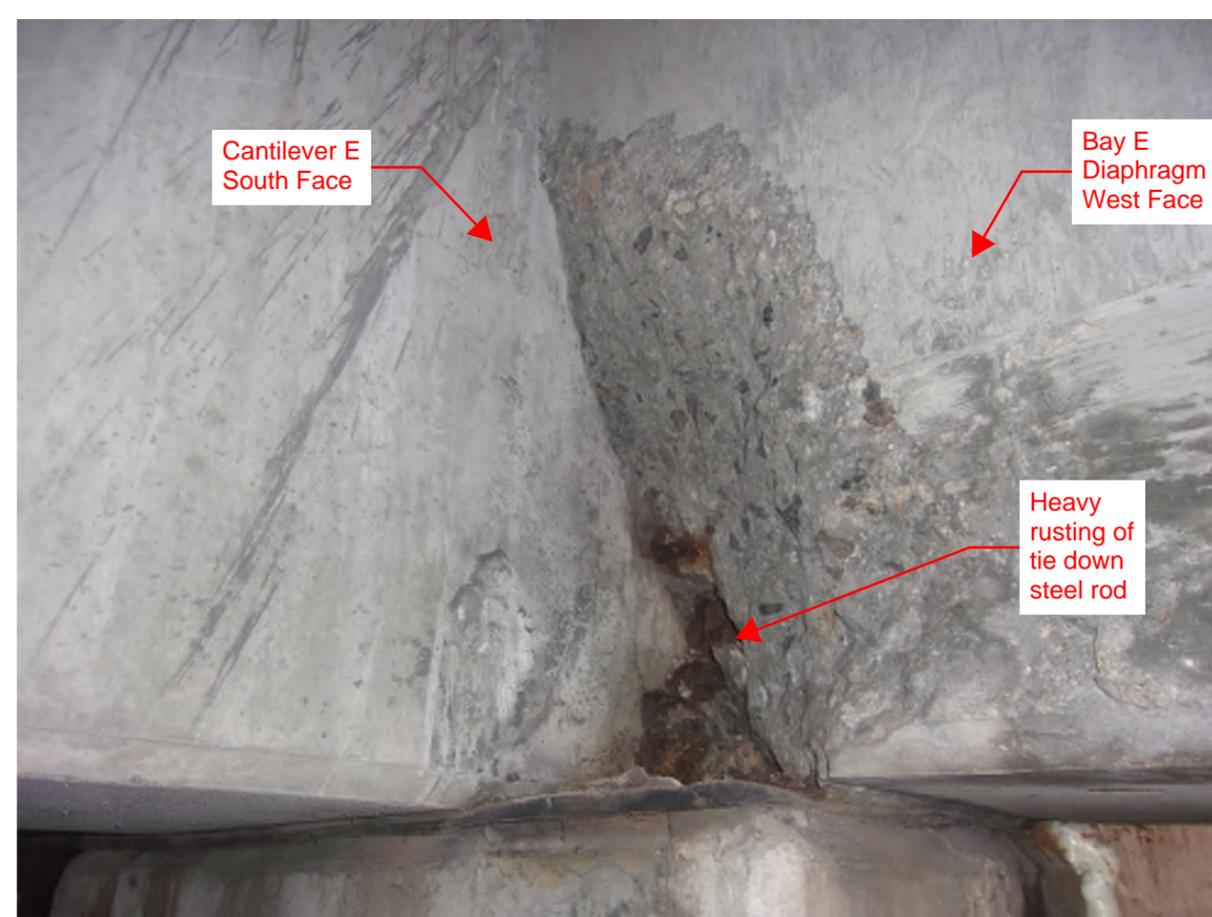
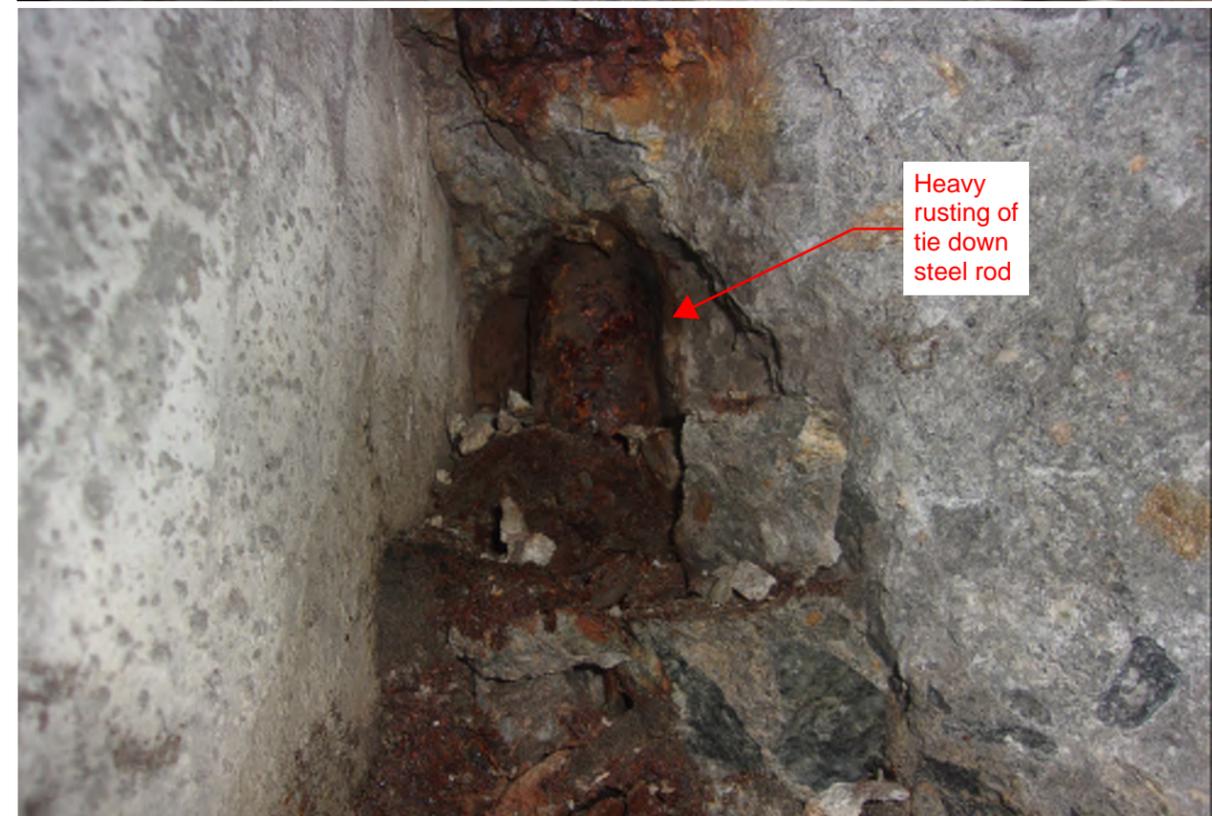
Cantilever E North Face

Cantilever E South Face

Note:
 - Spalls on diaphragm at Cantilever E north and south face. Tie down steel rod exposed with heavy rusting.

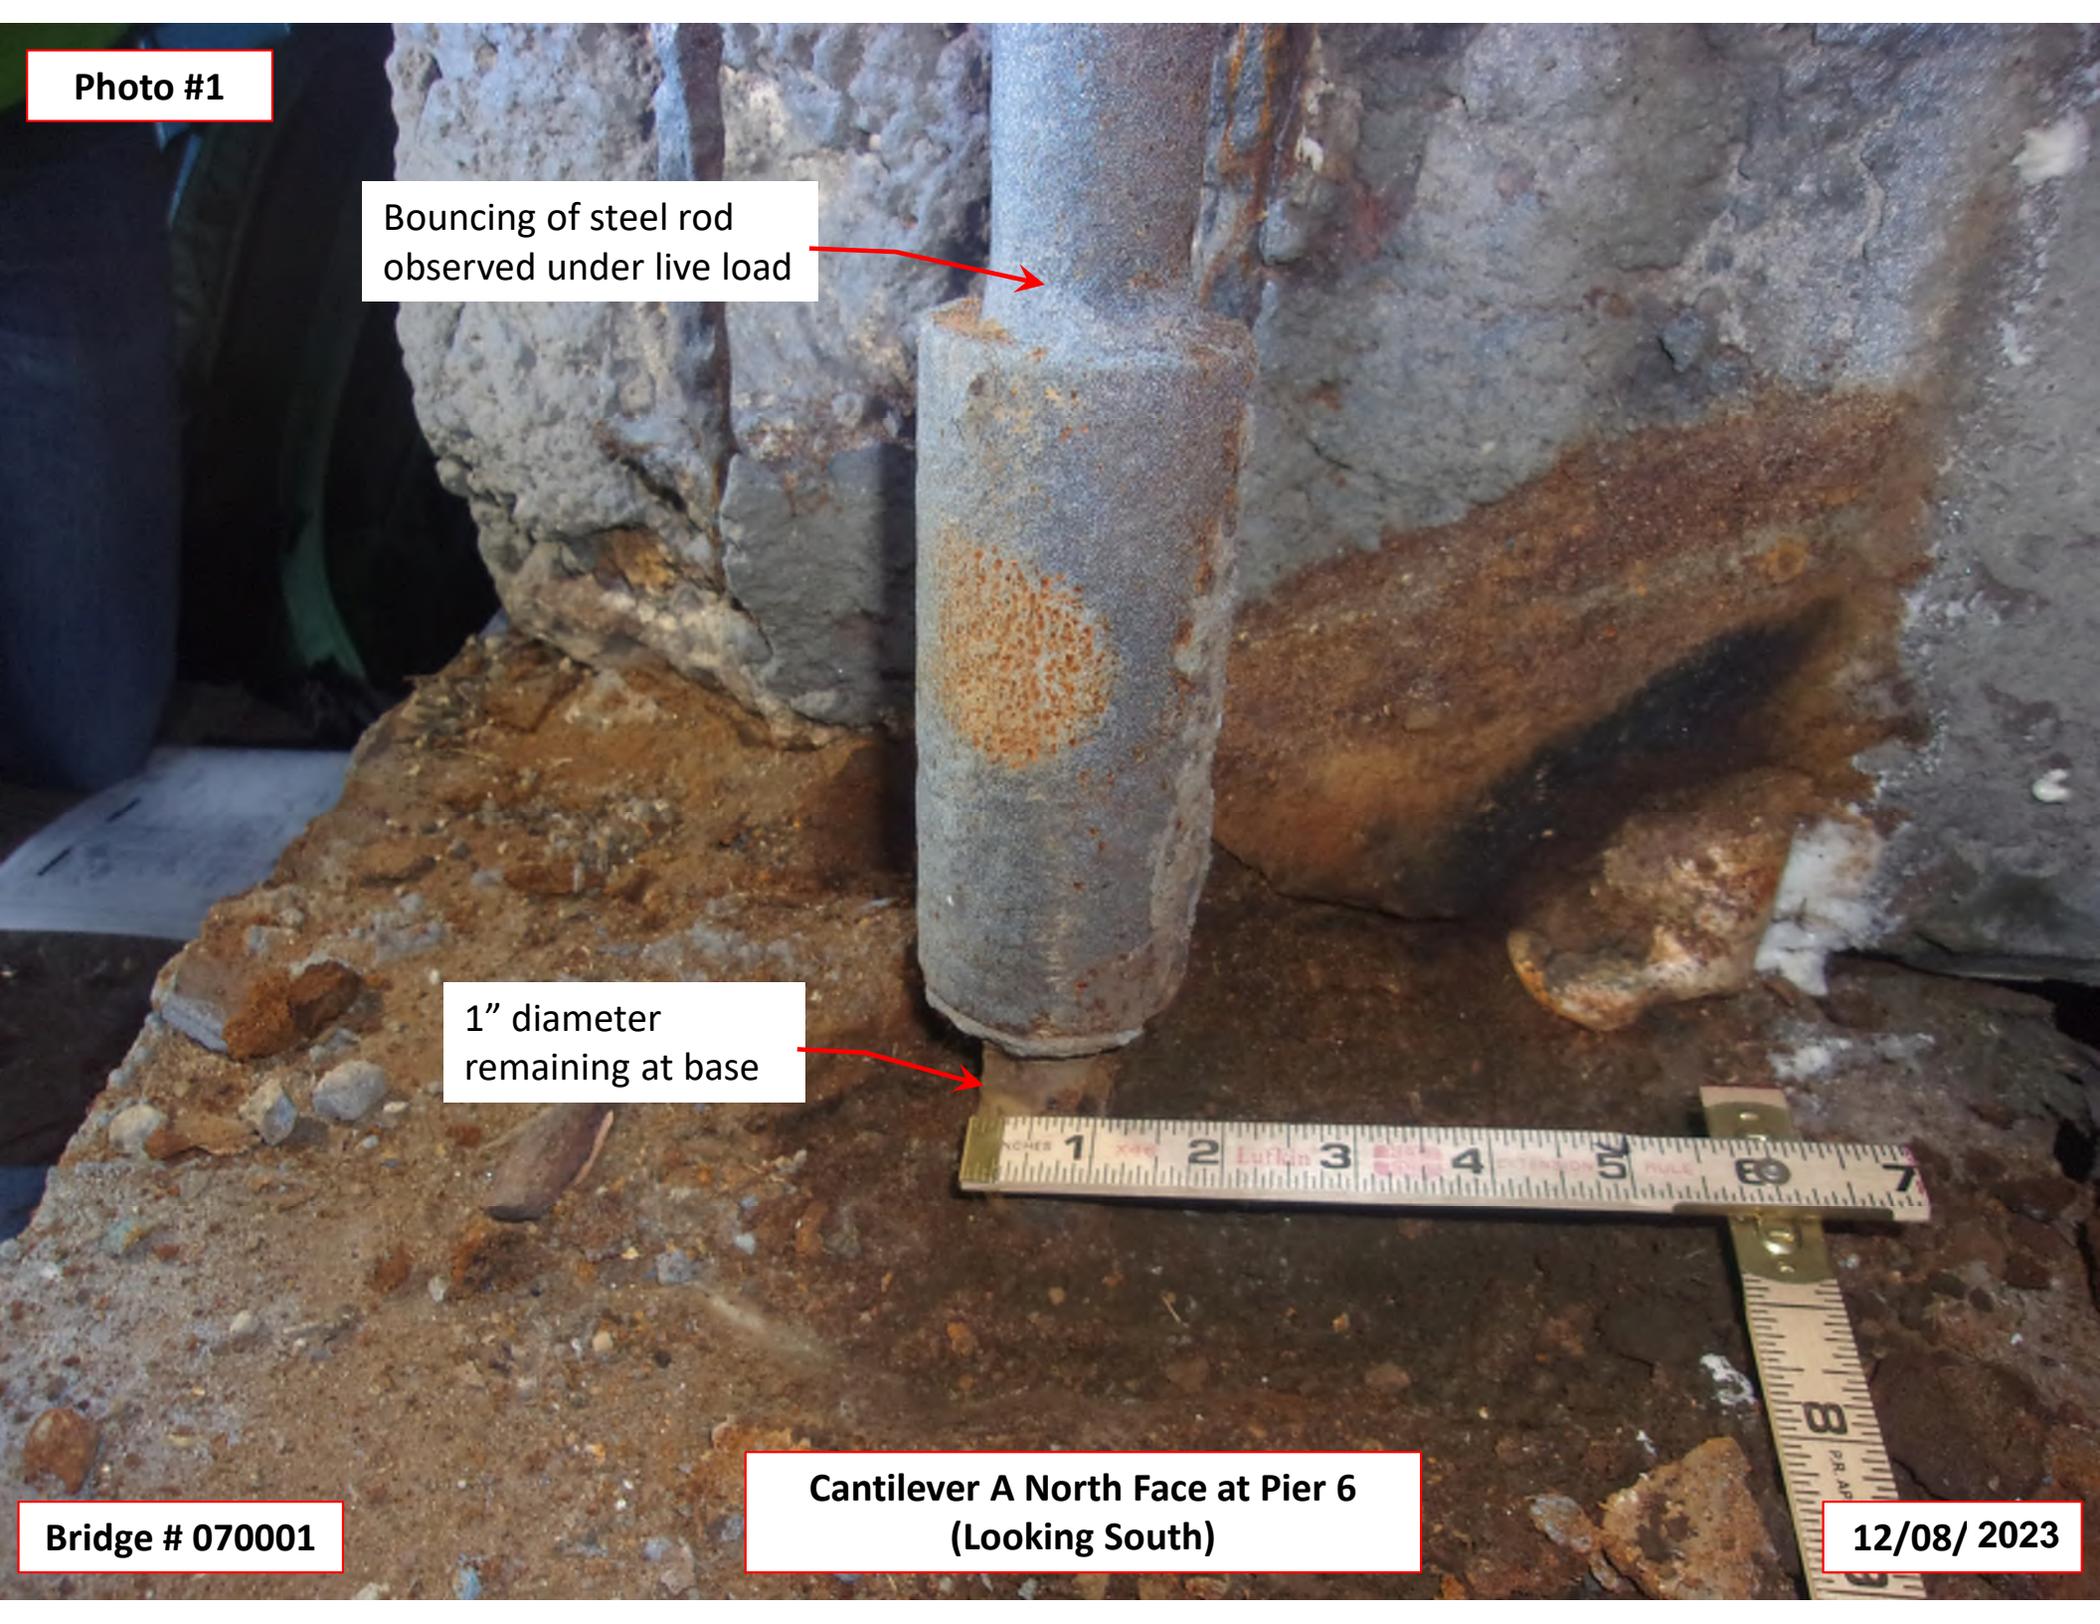
Photo #1

- See photos 1 and 2.
- 1" diameter remaining at base of steel rod (original 1 3/8" diameter based on 1967 record plans) (See Photo 1).
- Defect to cause failure of tiedown not found, however, it was observed a gap between cantilever end and beam seat (fit 11" long section of clipboard in gap), bouncing of cantilever end and tiedown under live load. It is assumed based on the observations that the tiedown has failed with the failure location not visible. (See Photos 1 and 2)

Bouncing of steel rod
observed under live load

1" diameter
remaining at base

**Cantilever A North Face at Pier 6
(Looking South)**

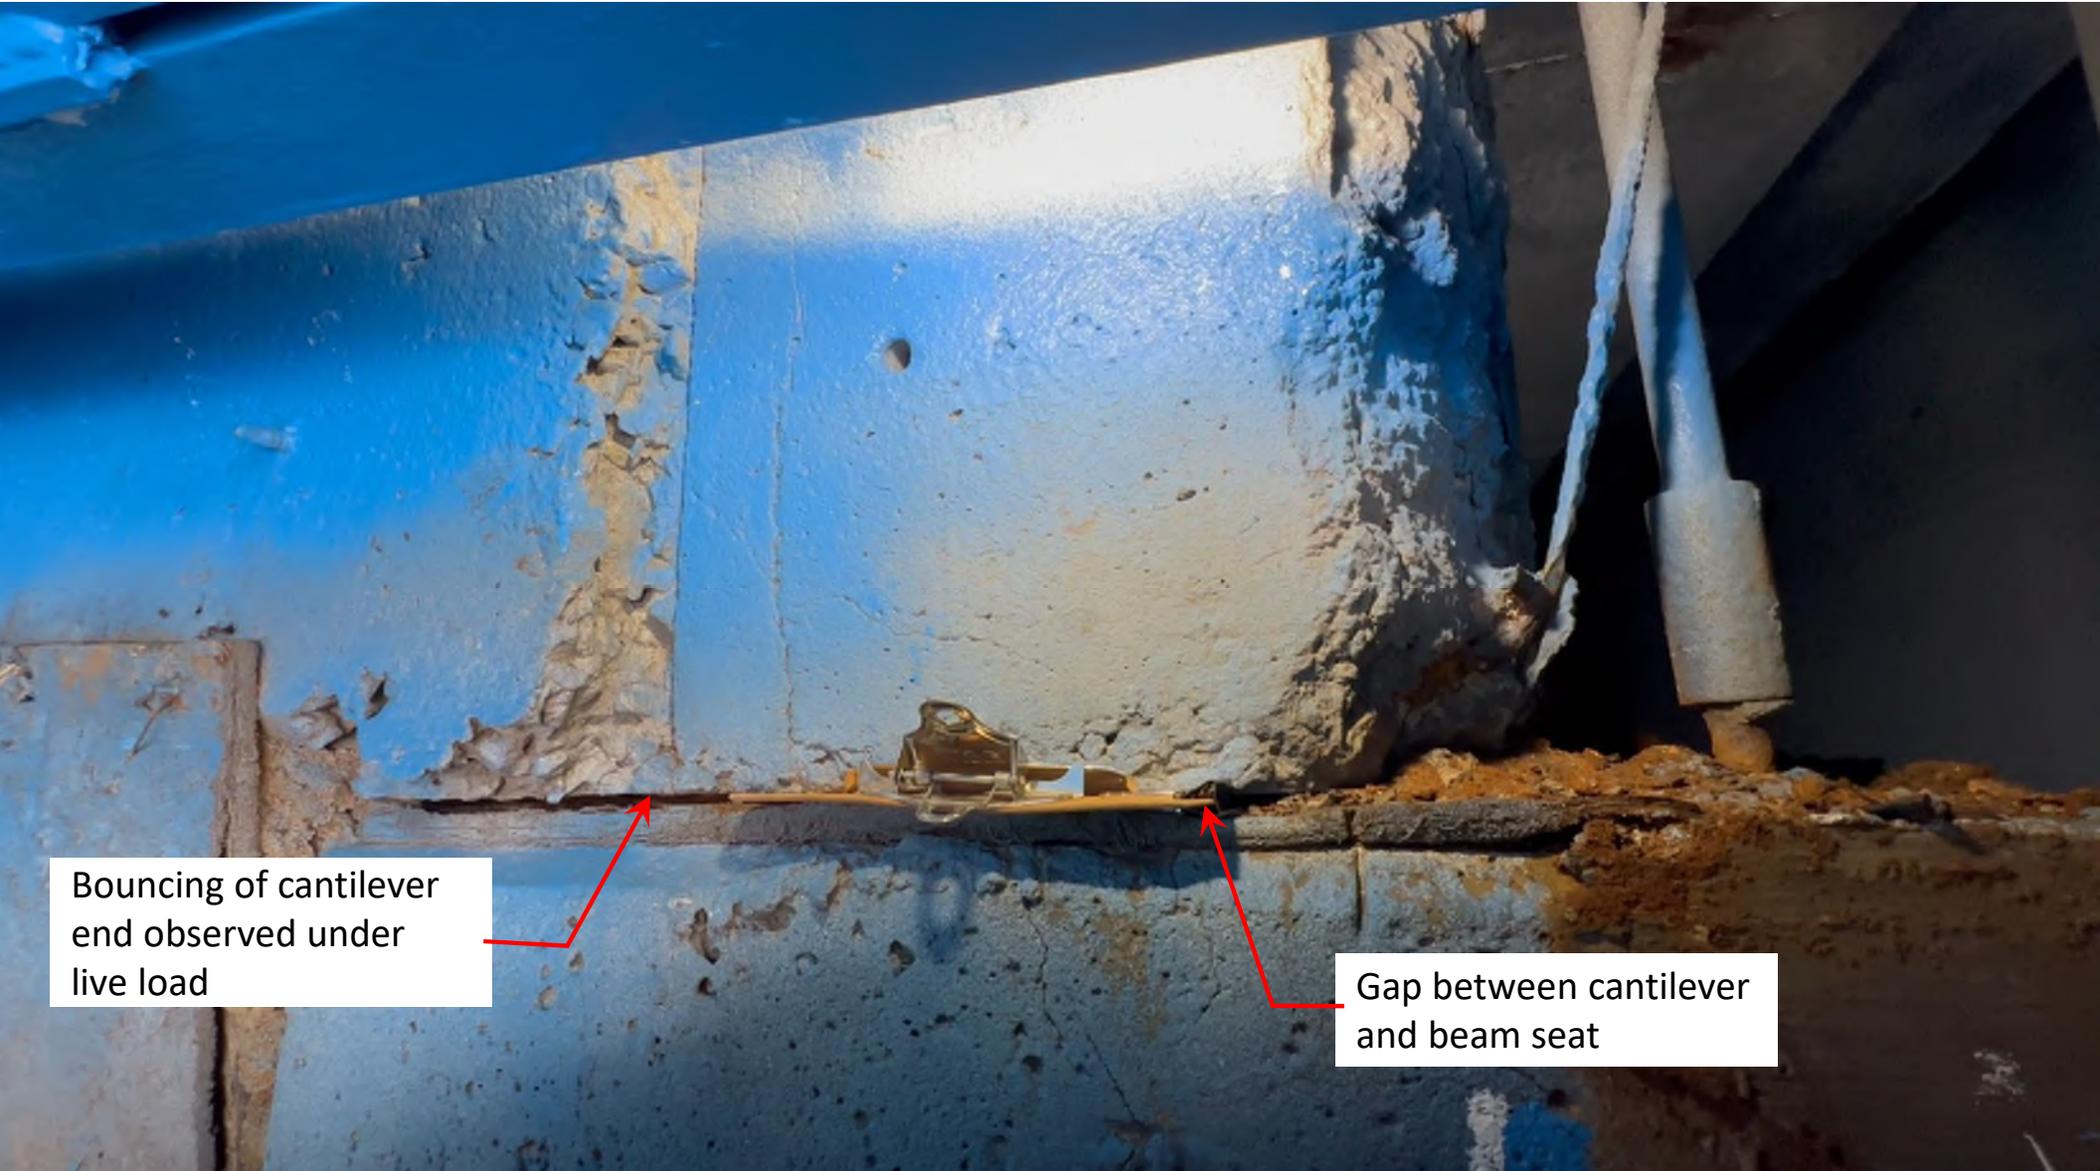
Photo #2

Bouncing of cantilever
end observed under
live load

Gap between cantilever
and beam seat

Cantilever A East Face at Pier 6
(Looking West)

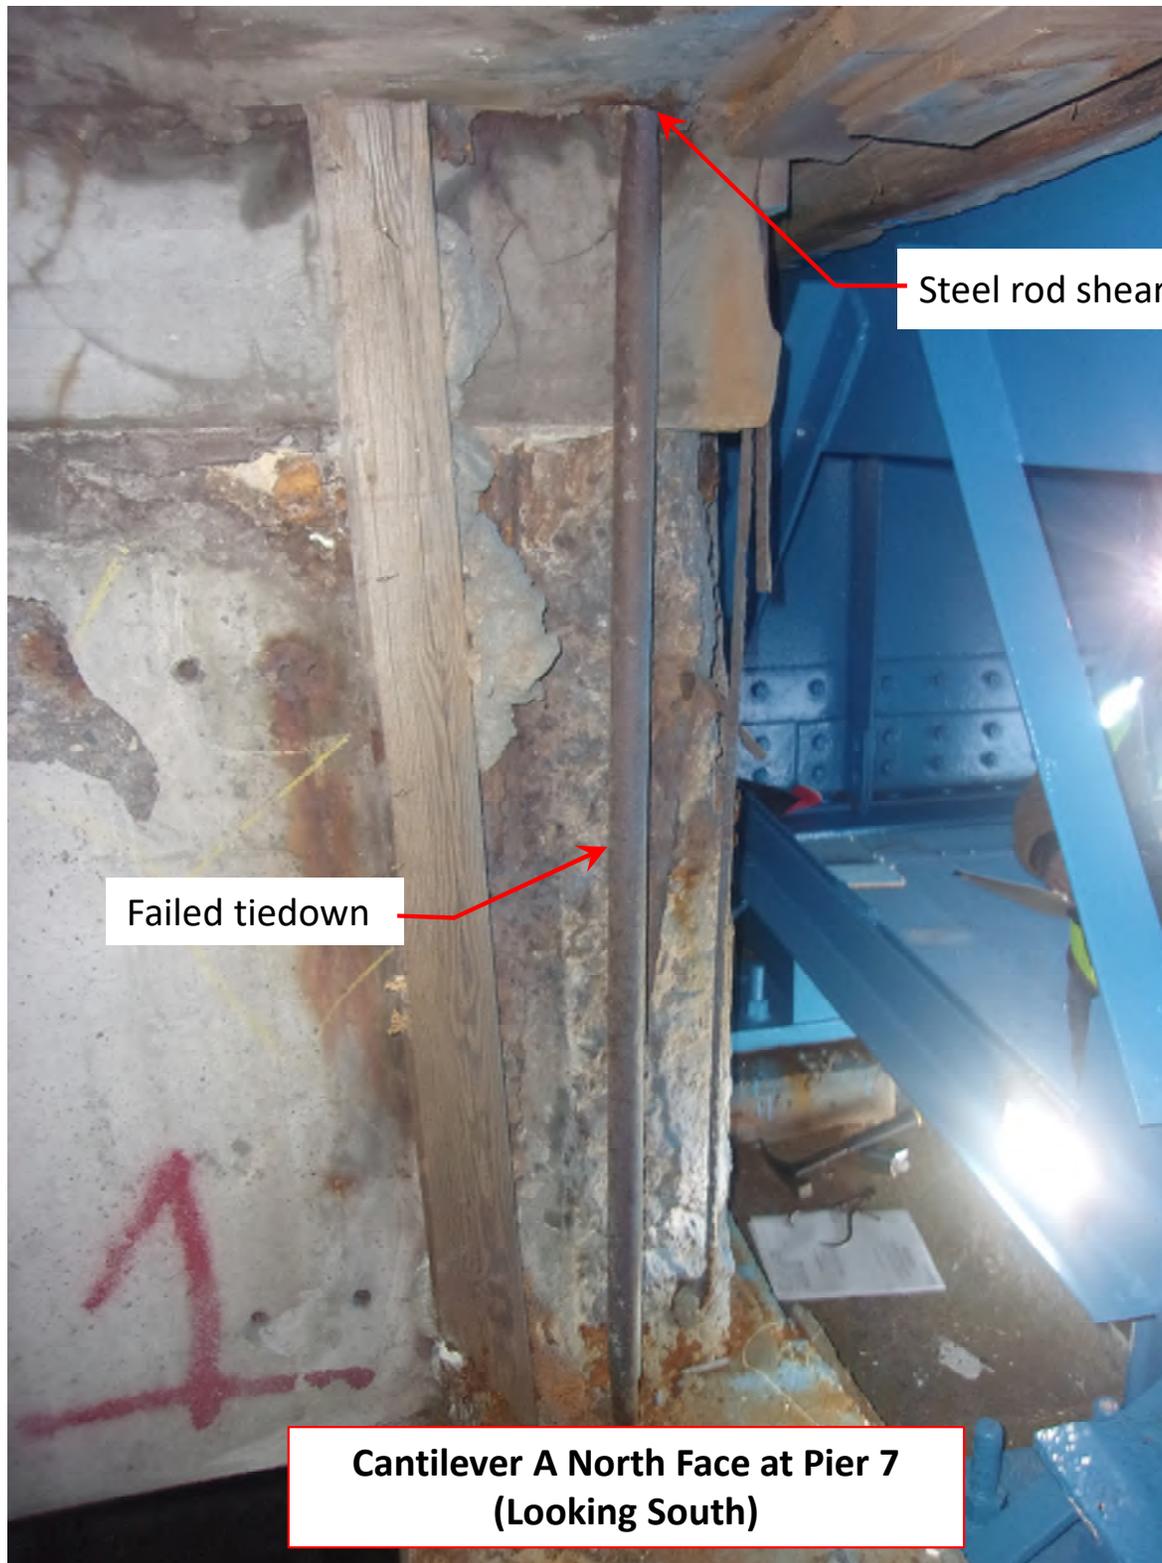
Photo #3

- See photos 3-5.
- Tiedown steel rod failed, sheared at the top below deck (See Photos 3-5)

Steel rod sheared at top

Failed tiedown

Cantilever A North Face at Pier 7
(Looking South)

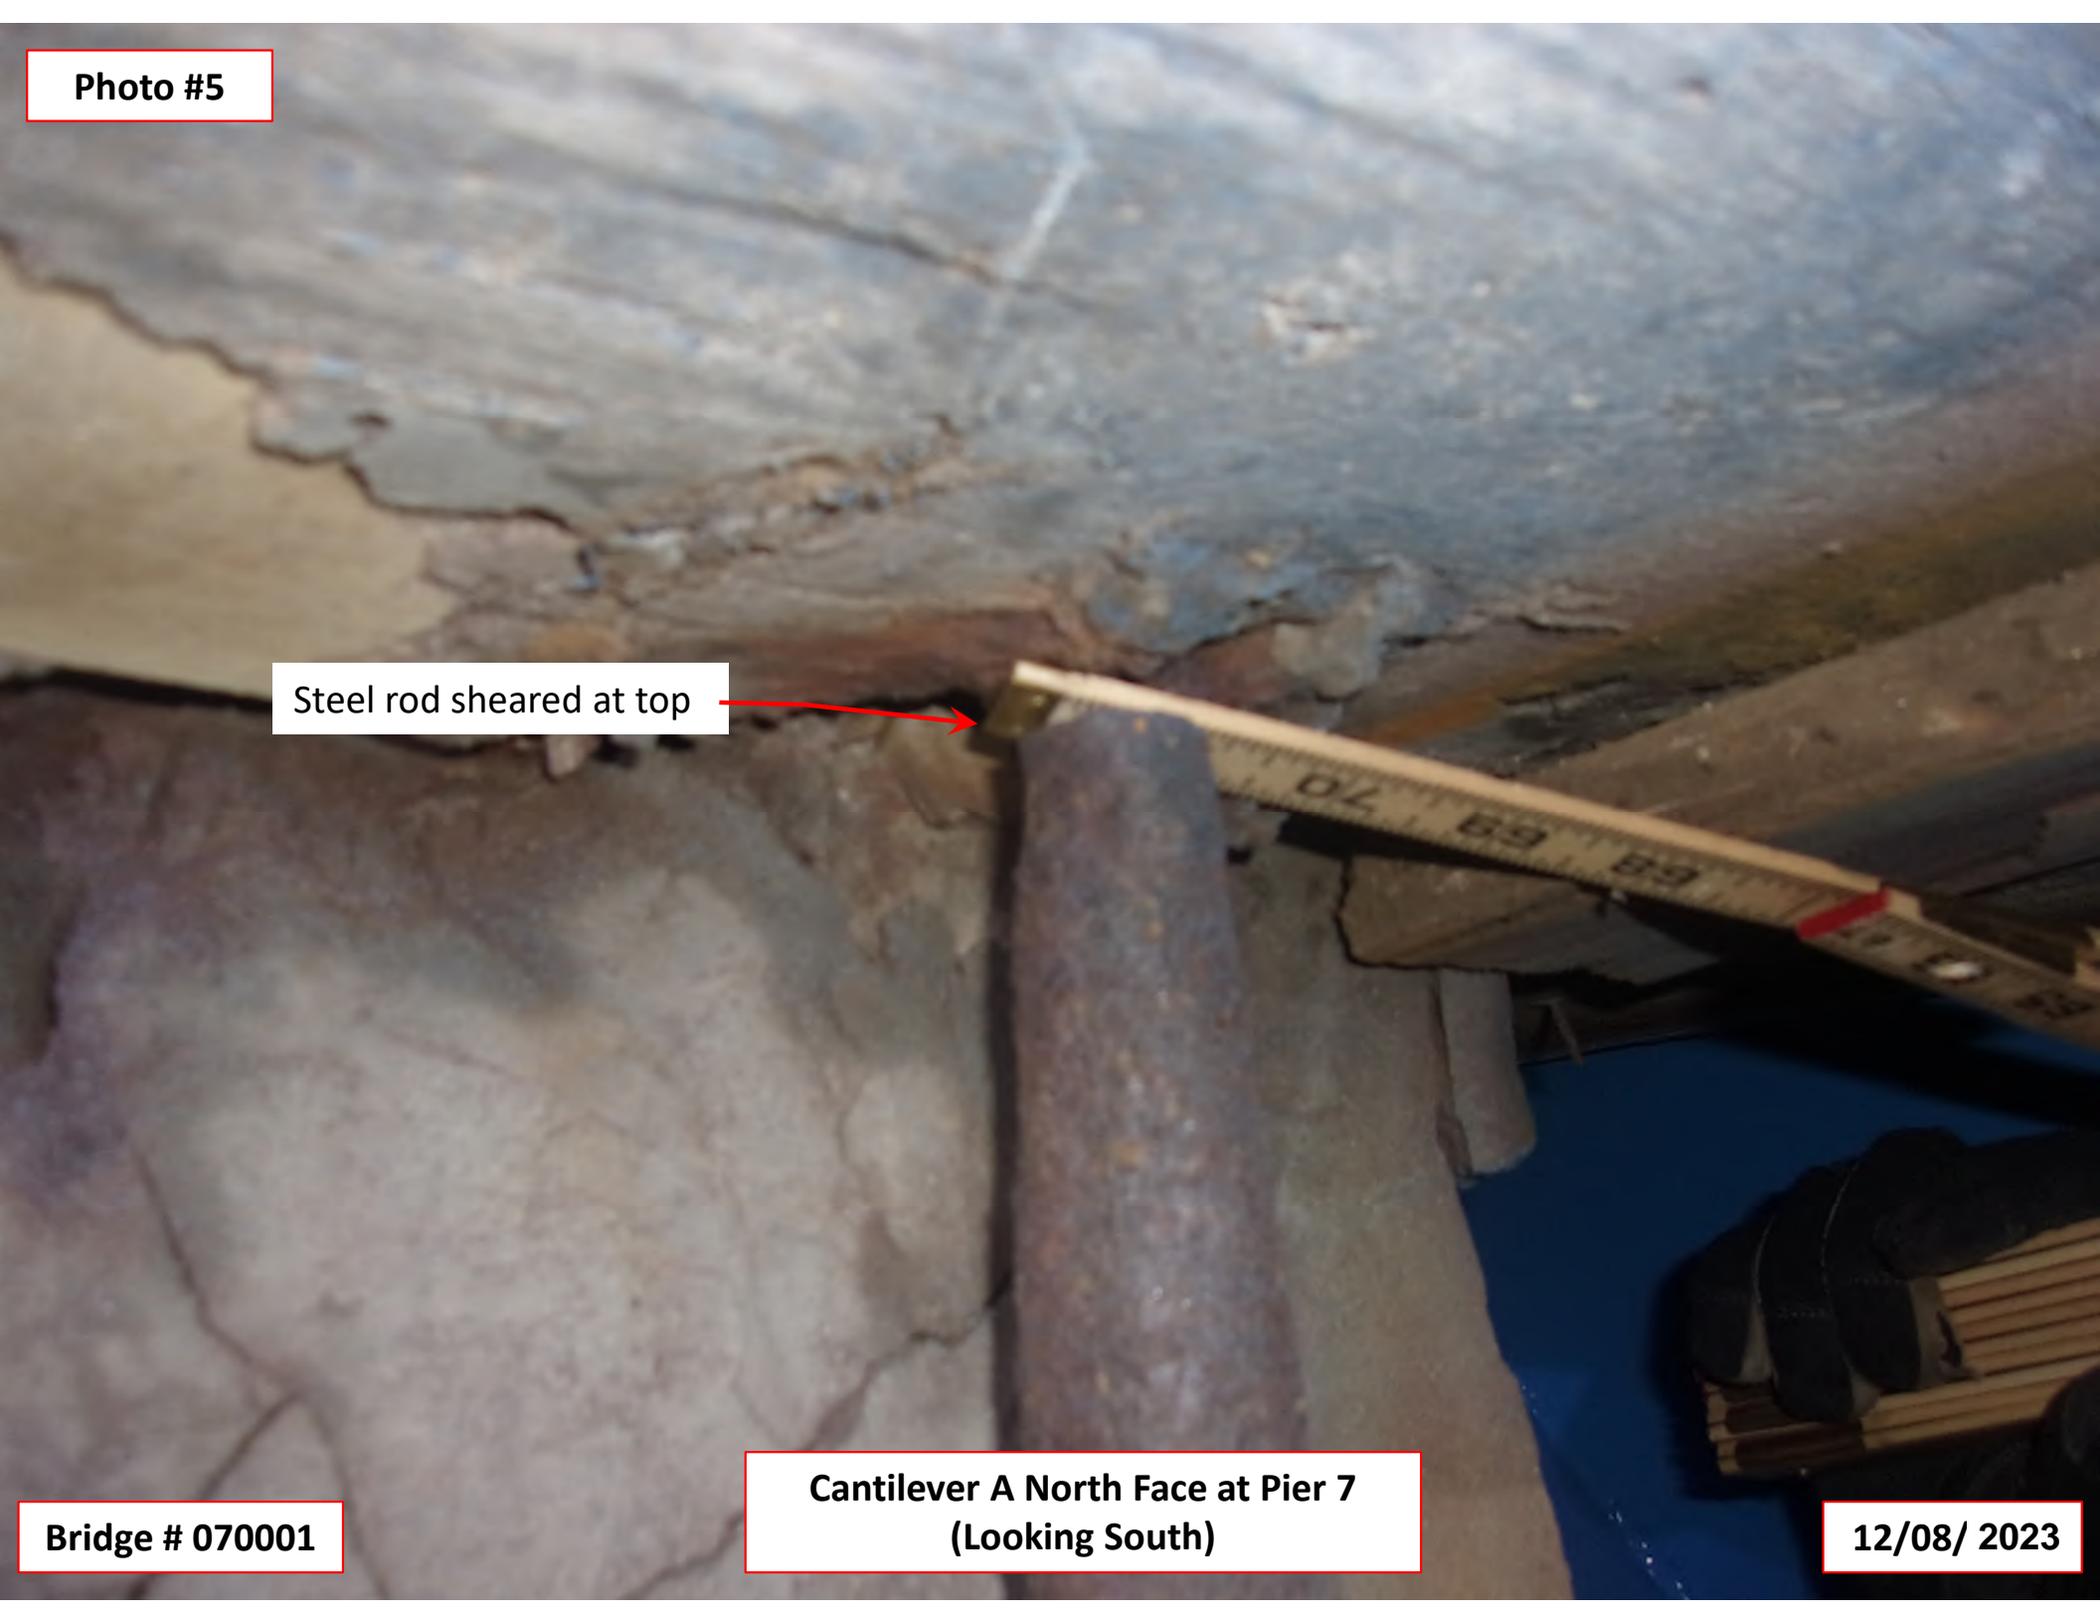
Photo #5

Steel rod sheared at top

Cantilever A North Face at Pier 7
(Looking South)

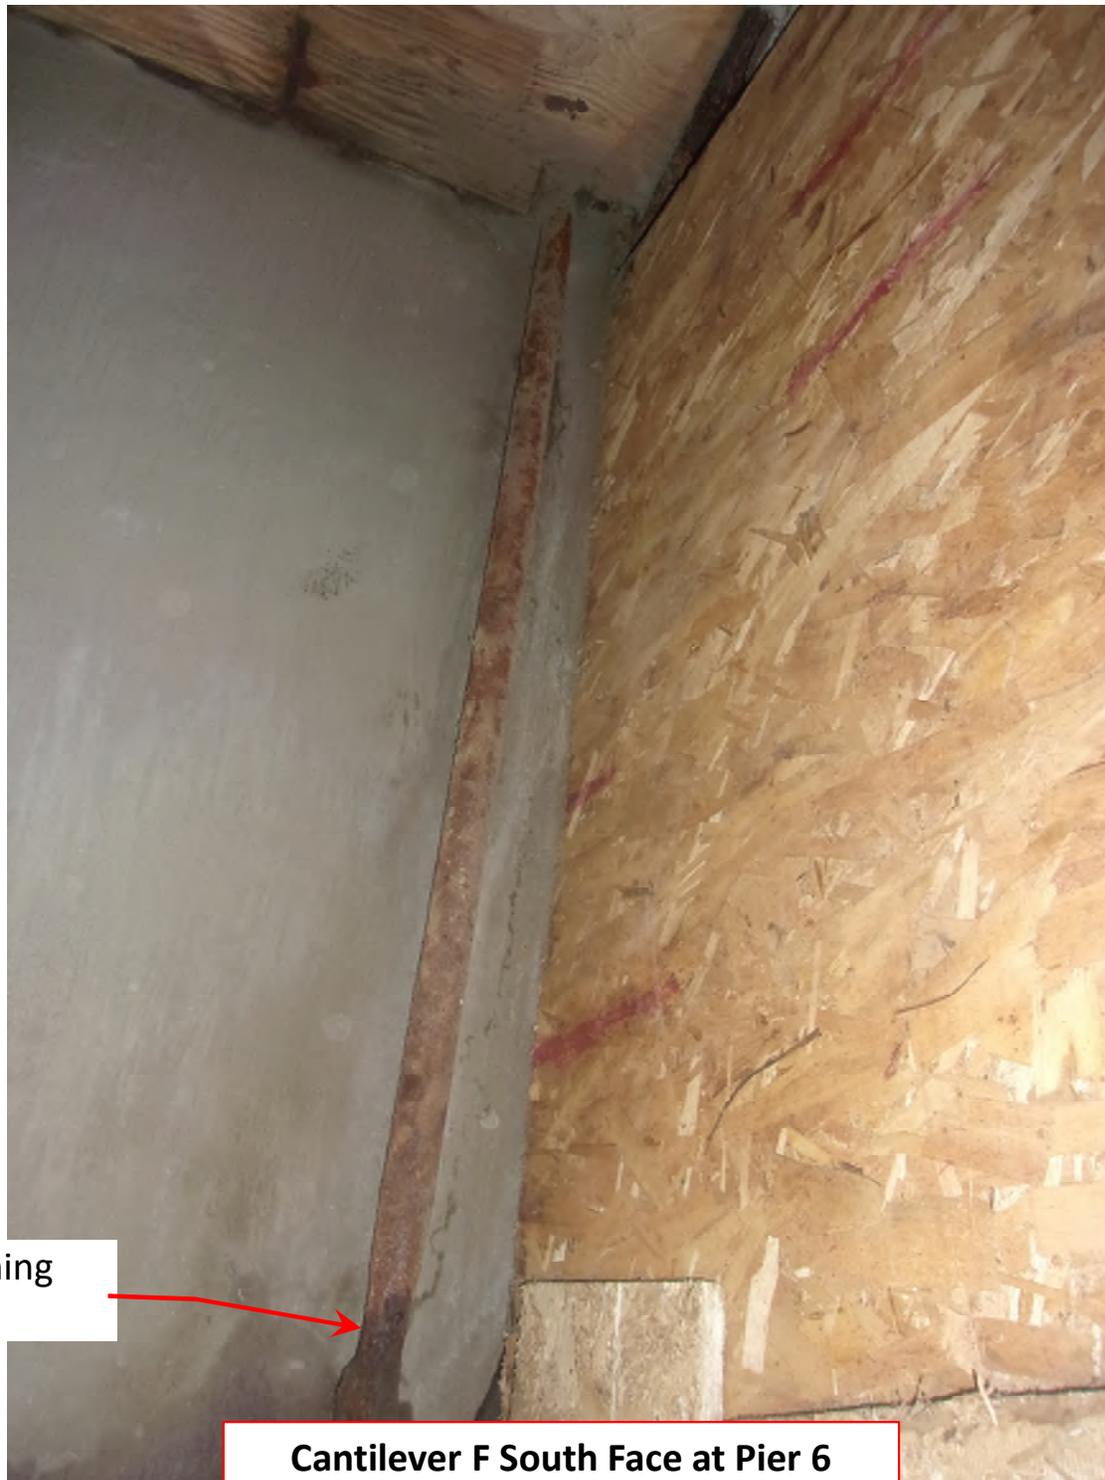
Photo #7

- See photos 6 and 7.
- 1" diameter remaining at base of steel rod (original 1 3/8" diameter based on 1967 record plans) (See Photos 6 and 7).

1" diameter remaining
near base

**Cantilever F South Face at Pier 6
(Looking North)**
