# Key damage –replaced

## 22c Impeller keyway damage... replaced

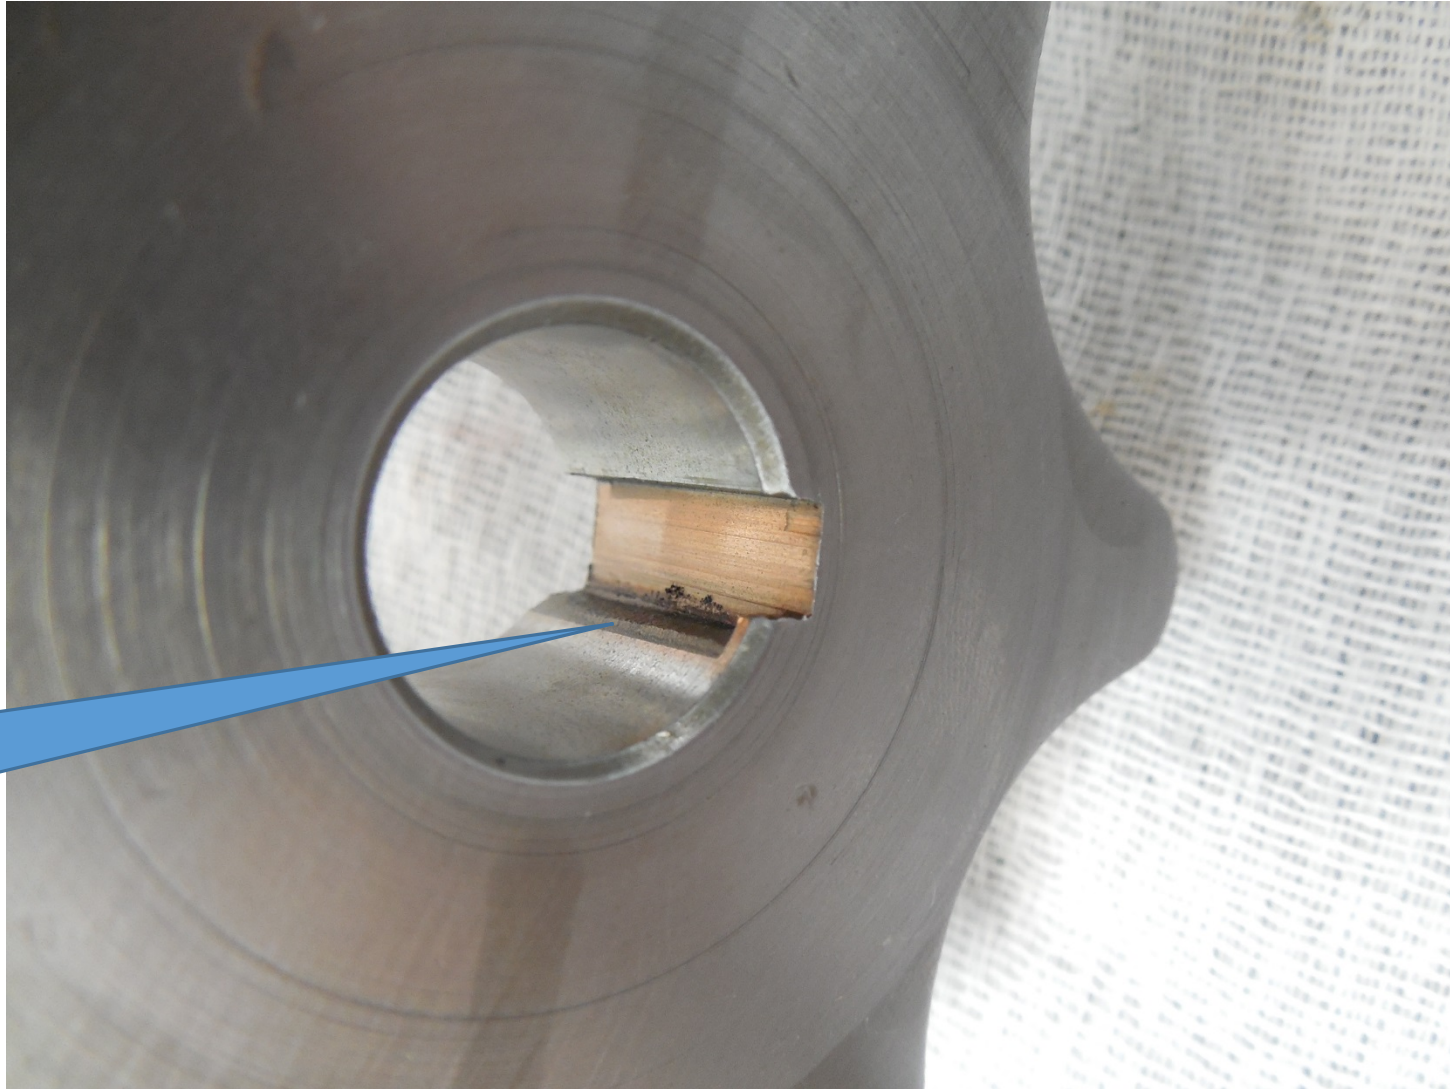
Presumed  
wear  
against key

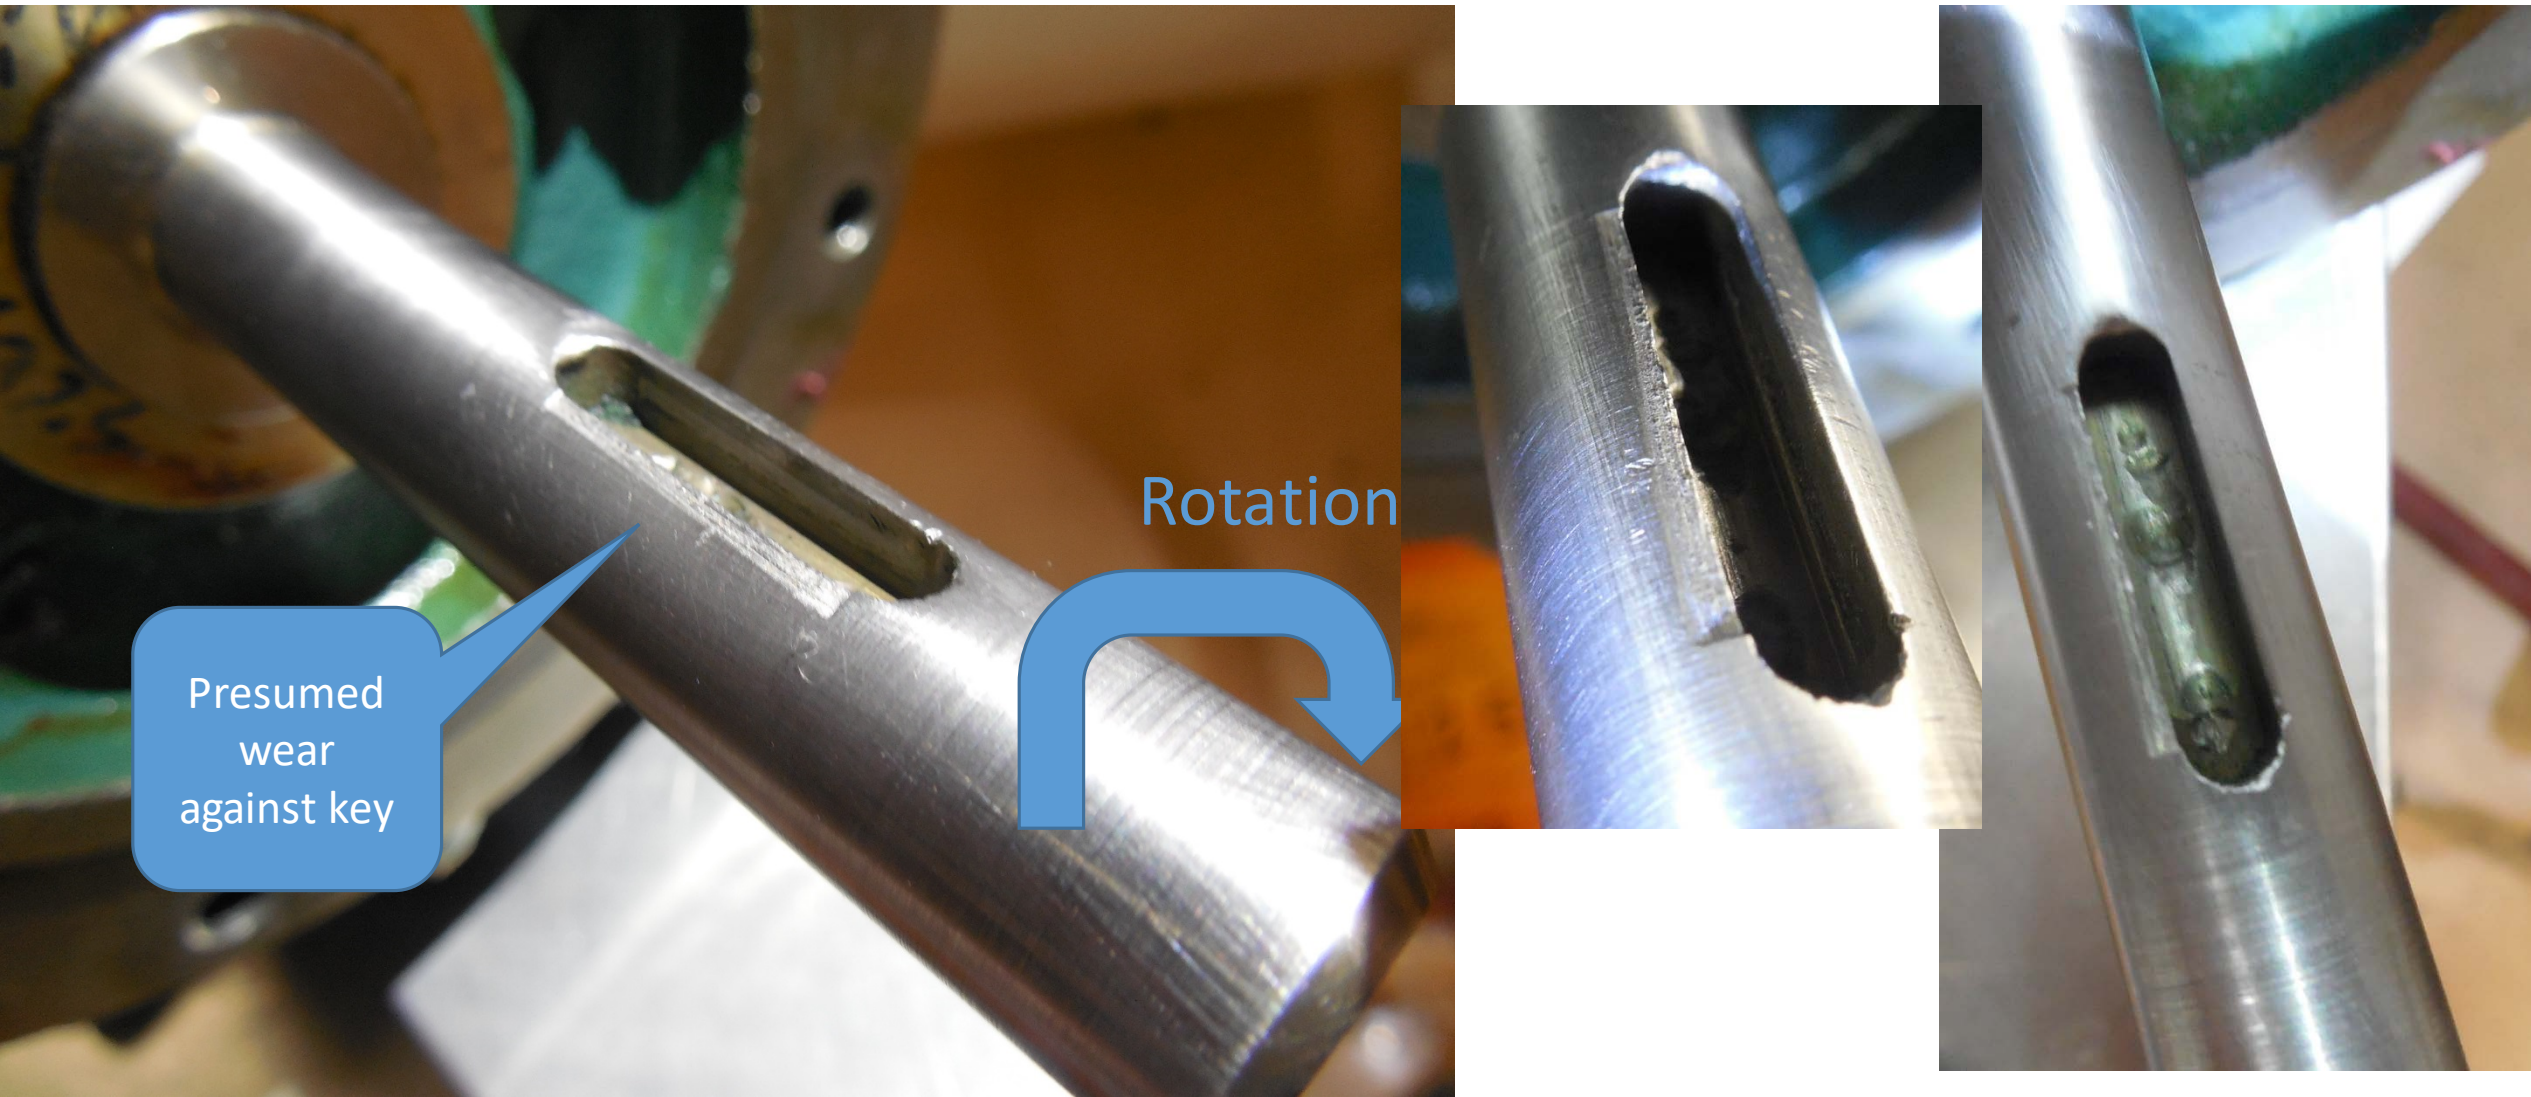
Shaft keyway damage.
