FAILURE ANALYSIS OF A SLIP-ON FLANGE

The following is a report by Columbus Metallurgical Services, Inc. on the failure analysis of a slip-on flange.

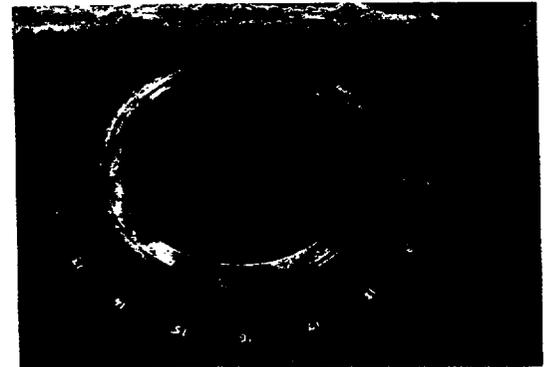
The installation of a 14" slip-on flange in a pipeline was recently witnessed by Al Justin, chief inspector for the State of Minnesota. The flange originally had a 14-3/4" inside diameter, which was reduced by welding a 3/4" ring and machine welding. The ring, however, separated from the flange, giving the appearance of a crack. The flange is reported to have been manufactured in the People's Republic of China.

Figure 1: Gasket side of flange.

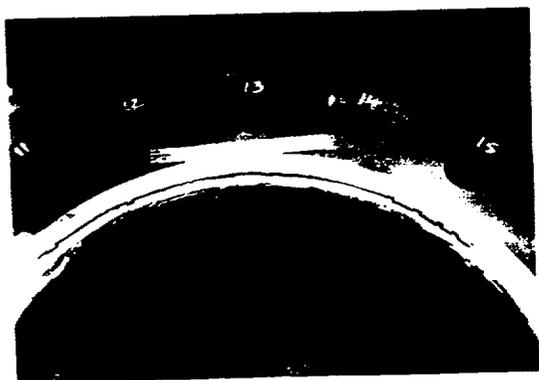
Figure 4: A close-up of the pipe side showing the "crack".
