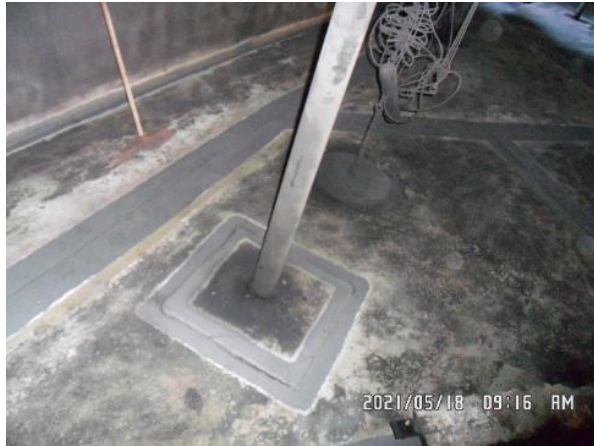
Legs' bottom plates checked with 100% MPI (Acceptable)

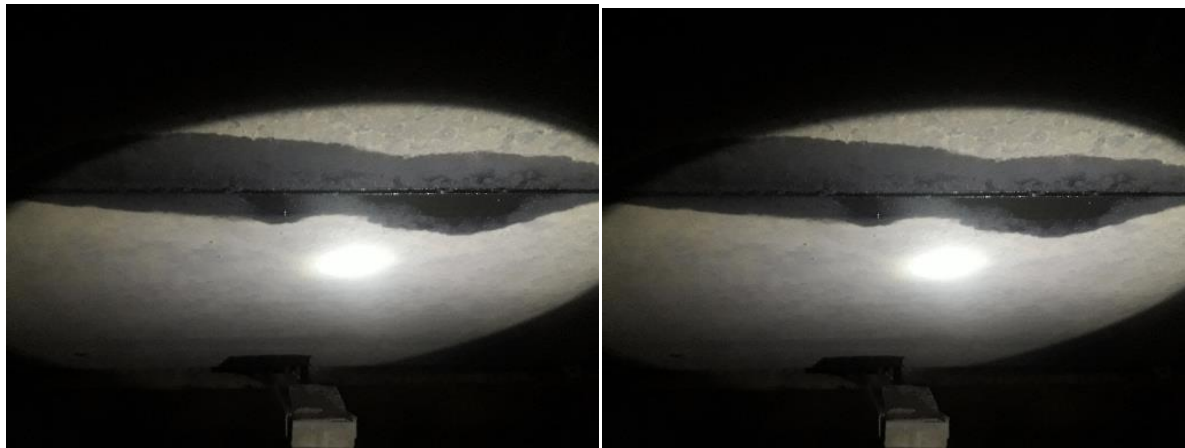
Sign of Leak in Some Zones Before entry inside the Deck

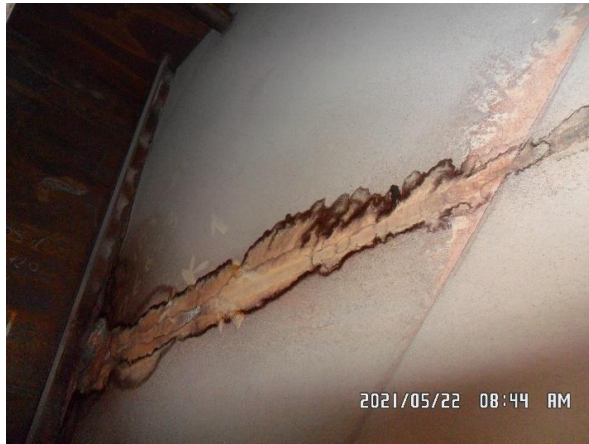
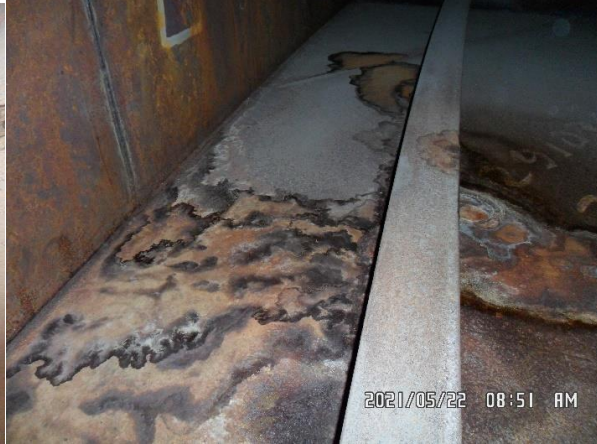
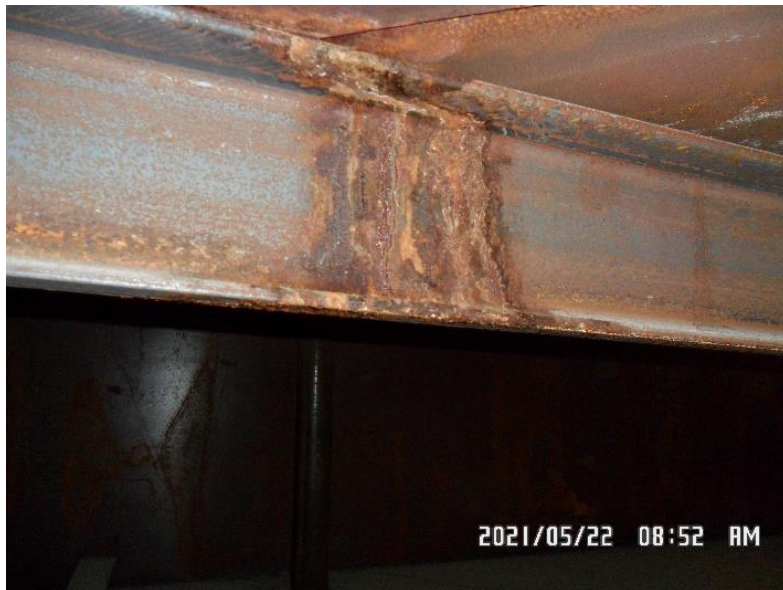
Roof Plate inside the Deck through Sample Port

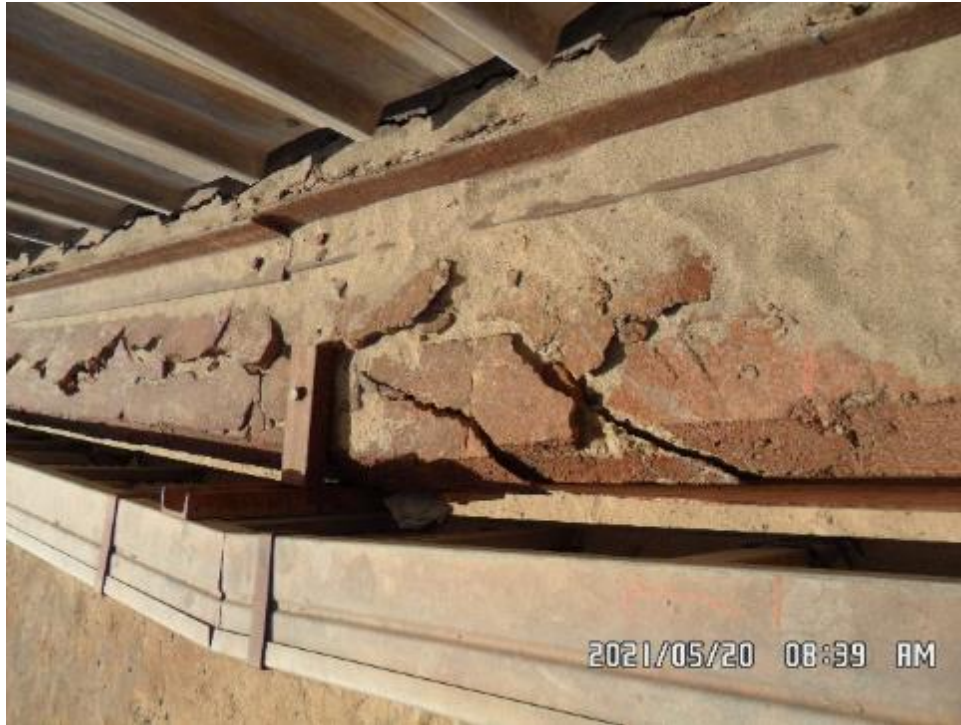
Cracked Concrete Ring
