Rough sketch of bearing arrangement in shaft based on strip down of failed unit (anti-rotation device may be shown reversed)

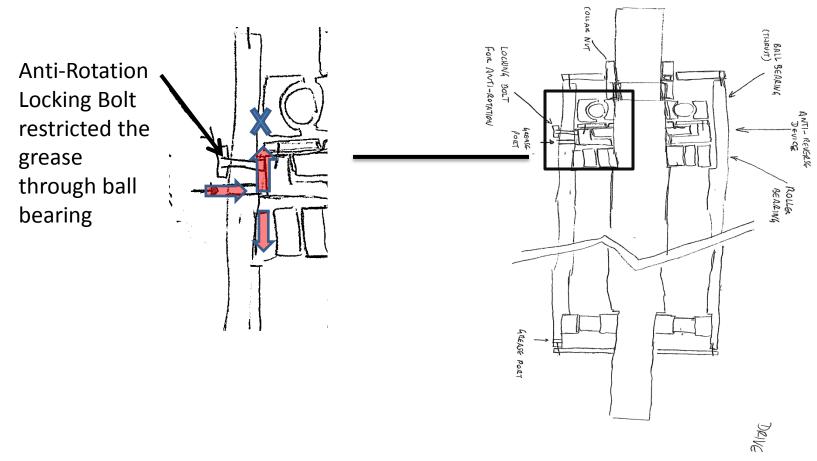
Concern is that the grease cannot get to ball bearing due to presence of anti-rotation device and the locking bolt for the anti-rotation device, which largely fills the slot where it locks the outer part of the anti-rotation device.

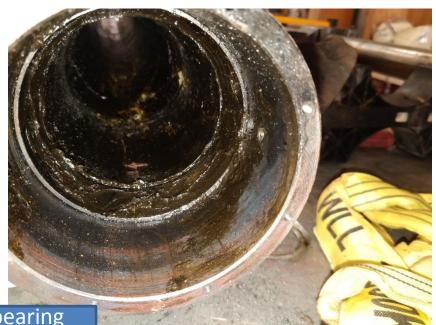
Grease path to roller bearing restricted by locking bolt
