2a - Responses, Photo reference - #1

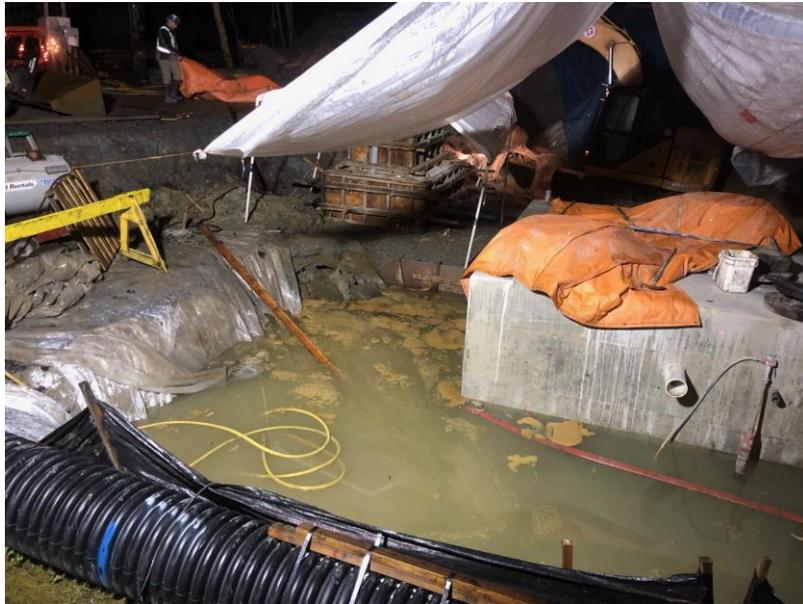
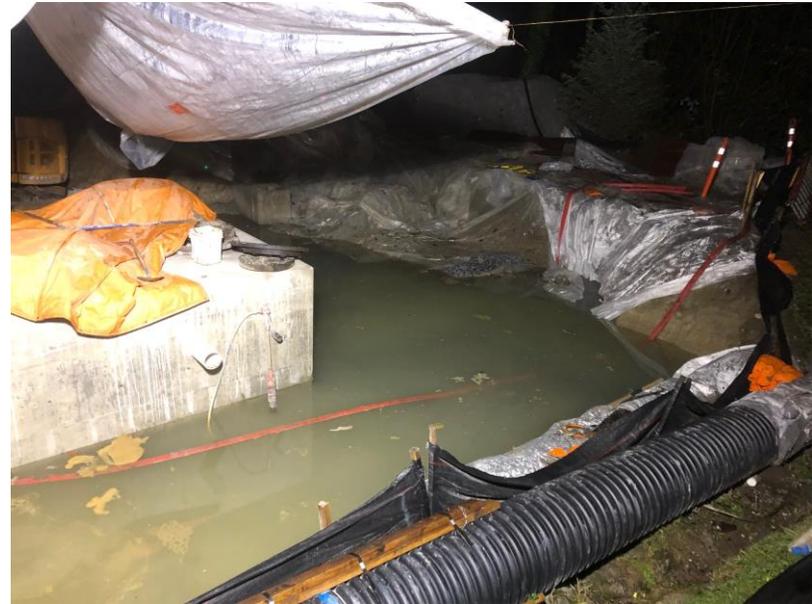
Section 5.4 in WSP's geotech report for site specific, F-014a indicates no groundwater and that the soil was wet about 2.1m.

Section 6.1 in WSP's geotech report generalizes all the sites in the report and states that "significant groundwater seepage may also be encountered from adjacent utility trench backfill / pipe bedding where excavation for construction of the proposed chambers exposes these materials".

Given the photos above, the "significant groundwater seepage..." seems to be quite significant and from KCL's point of view should've been detailed or shown in the drawings had this been known. KCL believes that is was not included because notes were taken in Section 5.4 rather than note taken from Section 6.1.
